**Sub-Slab Depressurization Systems  
Buildings TR-20 (partial) and Stormwater  
Treatment Plant  
Interim Corrective Measure  
ONONDAGA, NEW YORK**

**Construction Completion Report**

**NYSDEC Site Number: 734043**

**NOVEMBER 11, 2025**

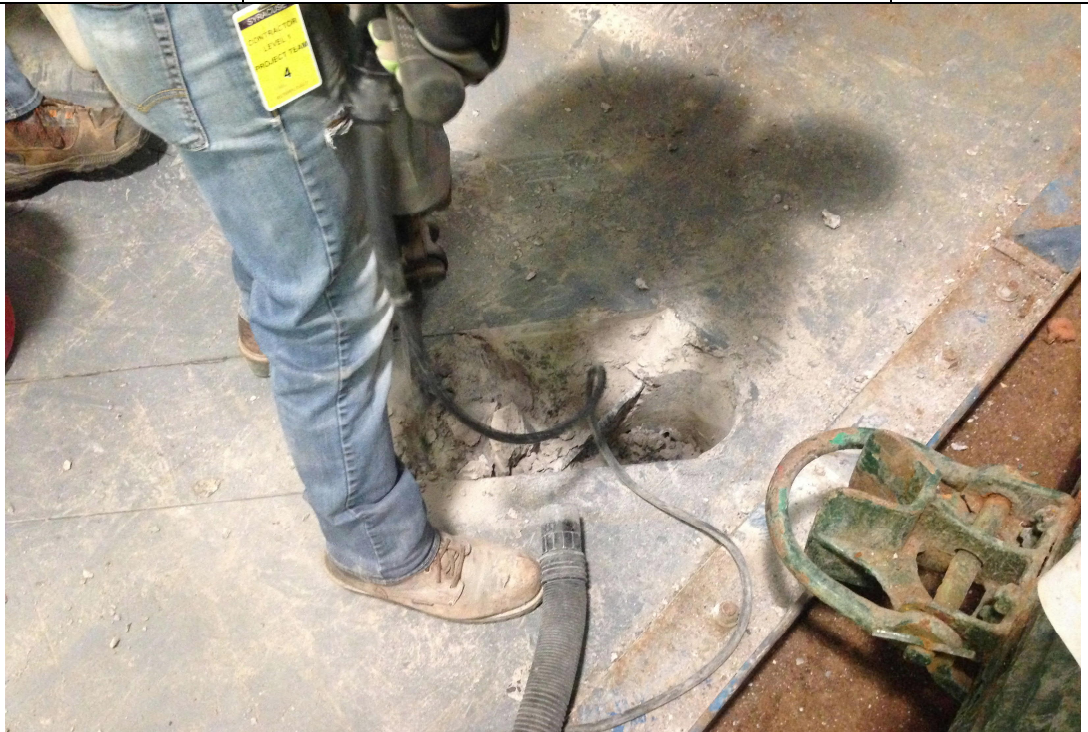
Jackhammering of trench from EP-7 to south wall.

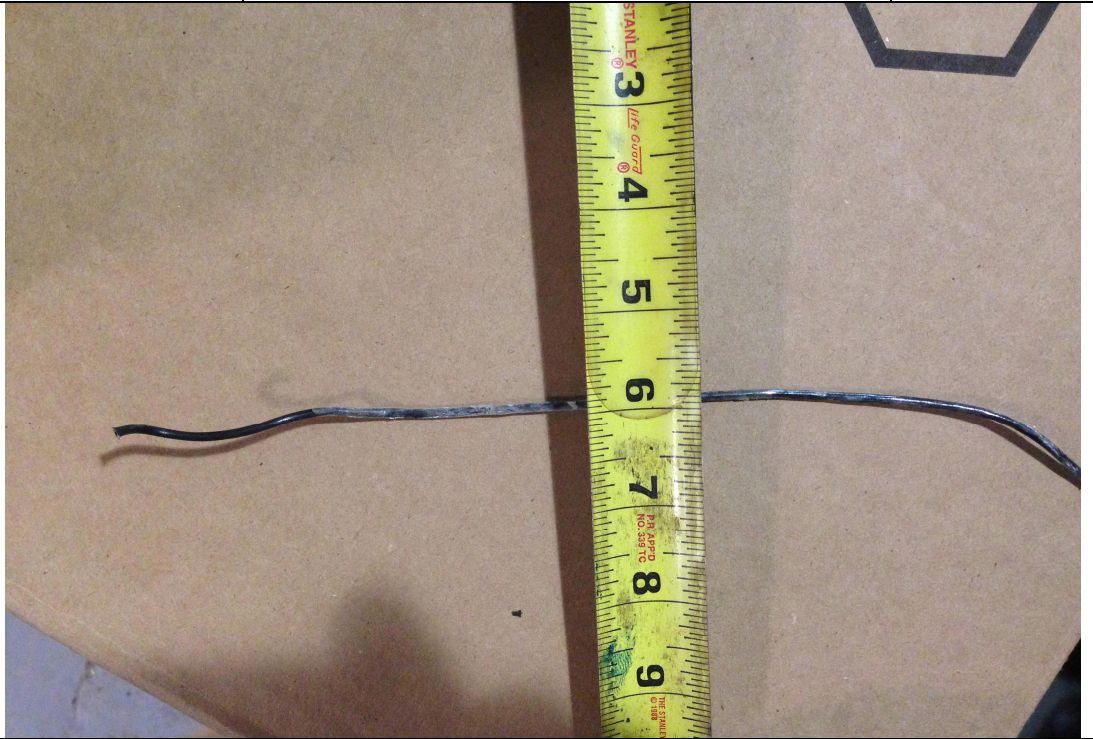
Copper wire found ½ inch below top of concrete slab.

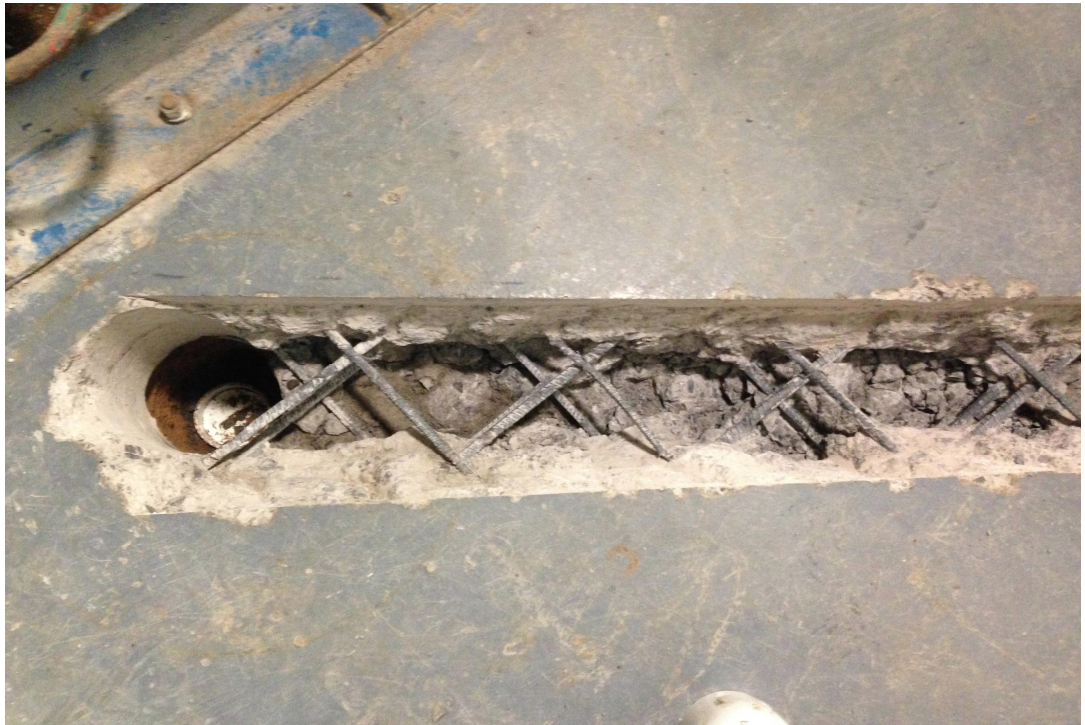
Trench EP-7.  
Exposed 4 layers of  
various sized rebar.

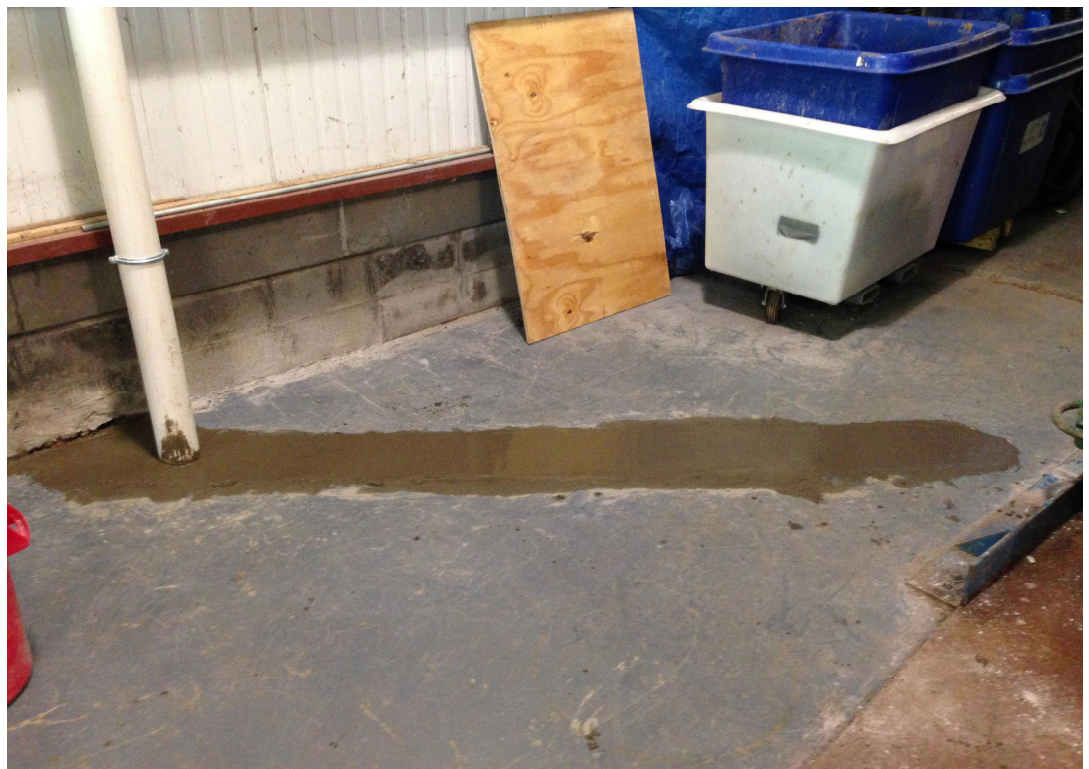
EP-7 trench piped and concreted with stick up.

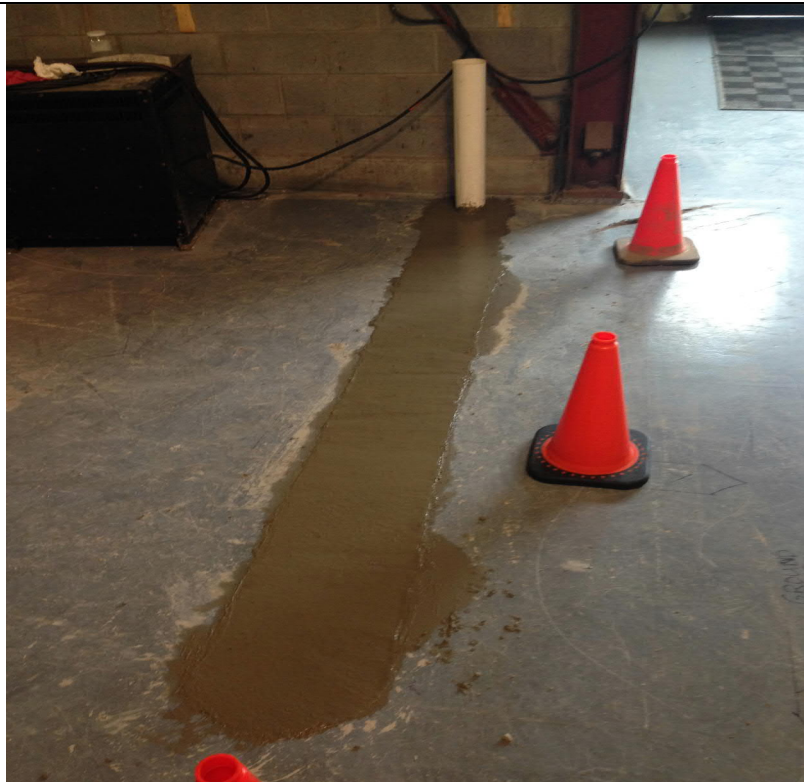
EP-5 trench  
concreted.

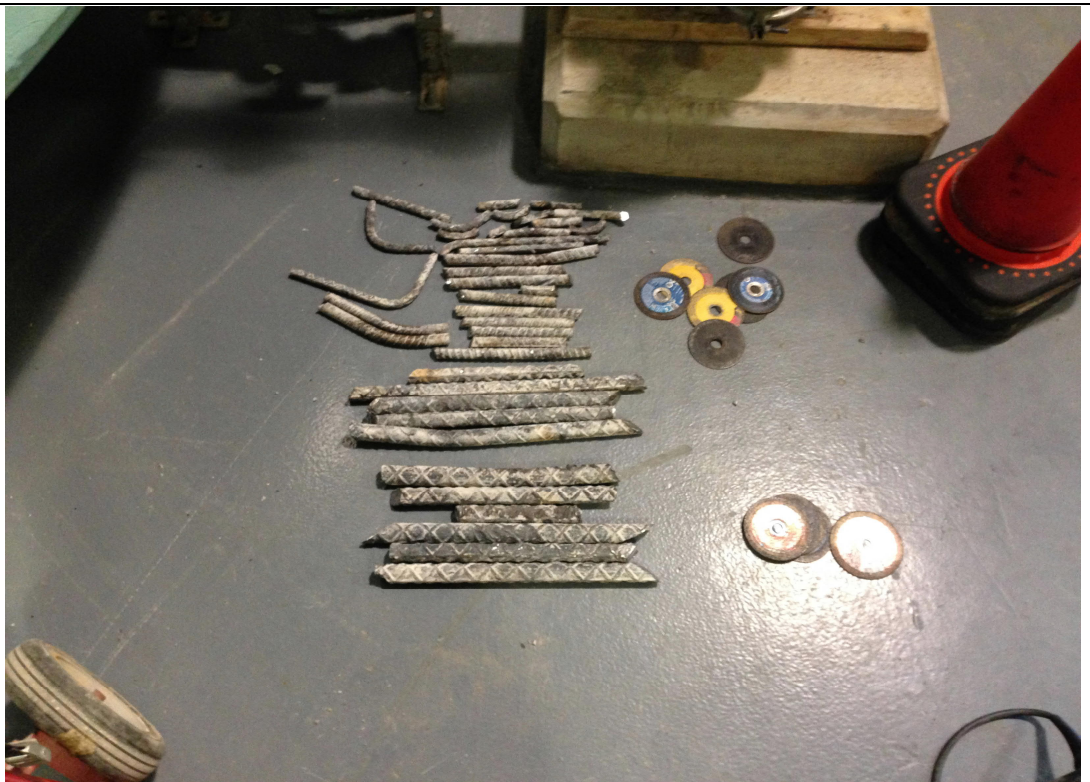
Approximately 30 pieces of cut rebar of various size.

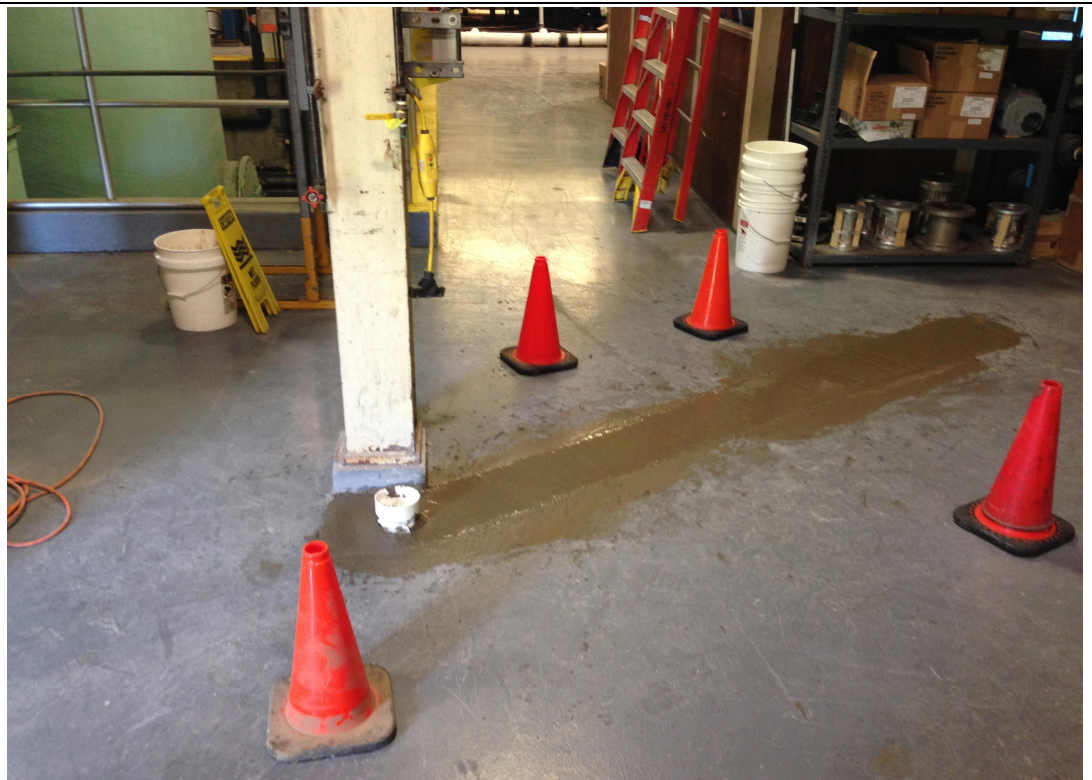
Completed EP-2 trench from screen to north side of column O50.

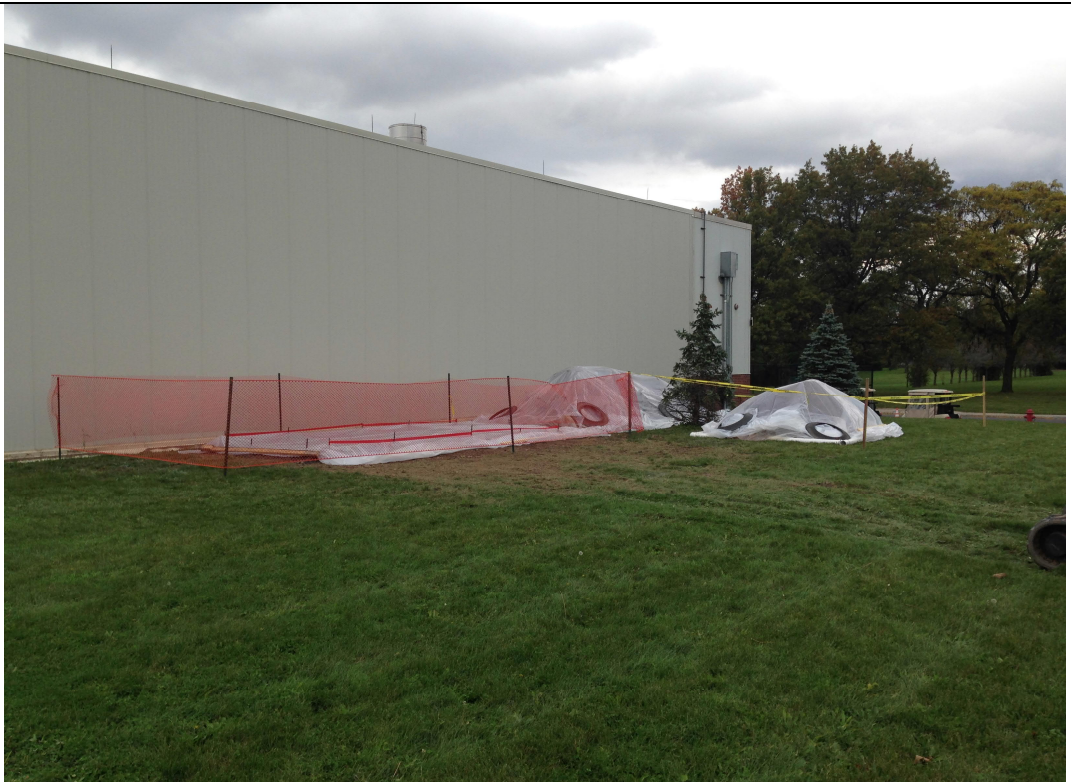
Condition south side of SWTP left in. Concrete pad was covered due to threat of rain.

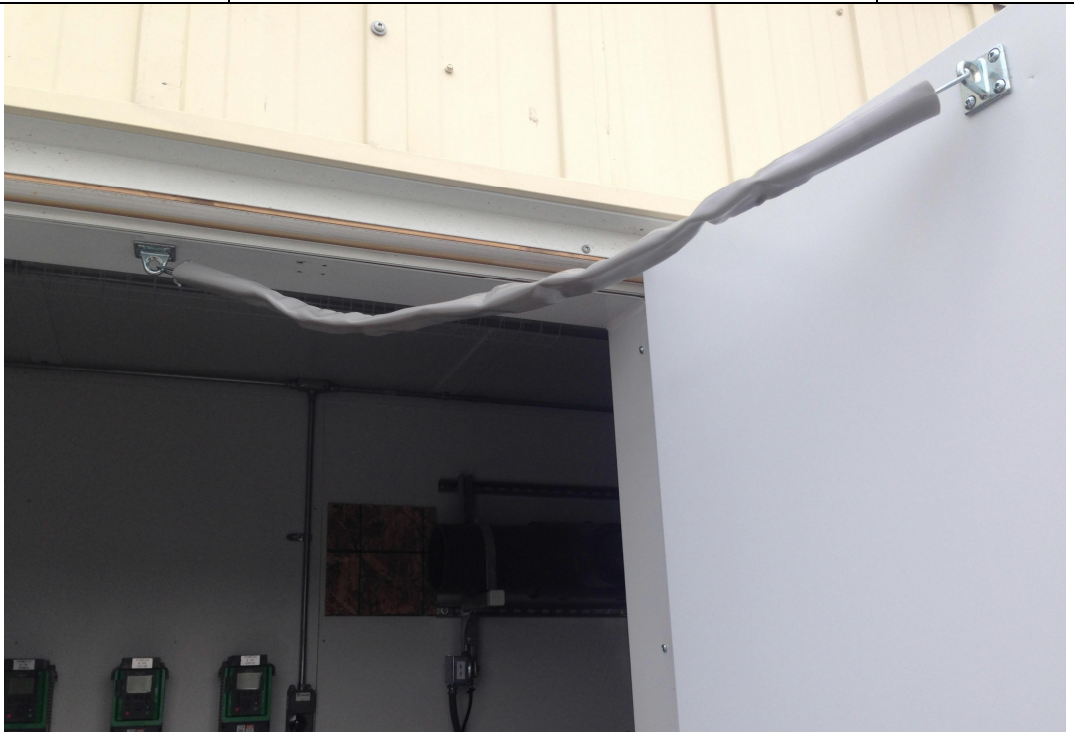
Moved door chain to prevent wide opening of door.

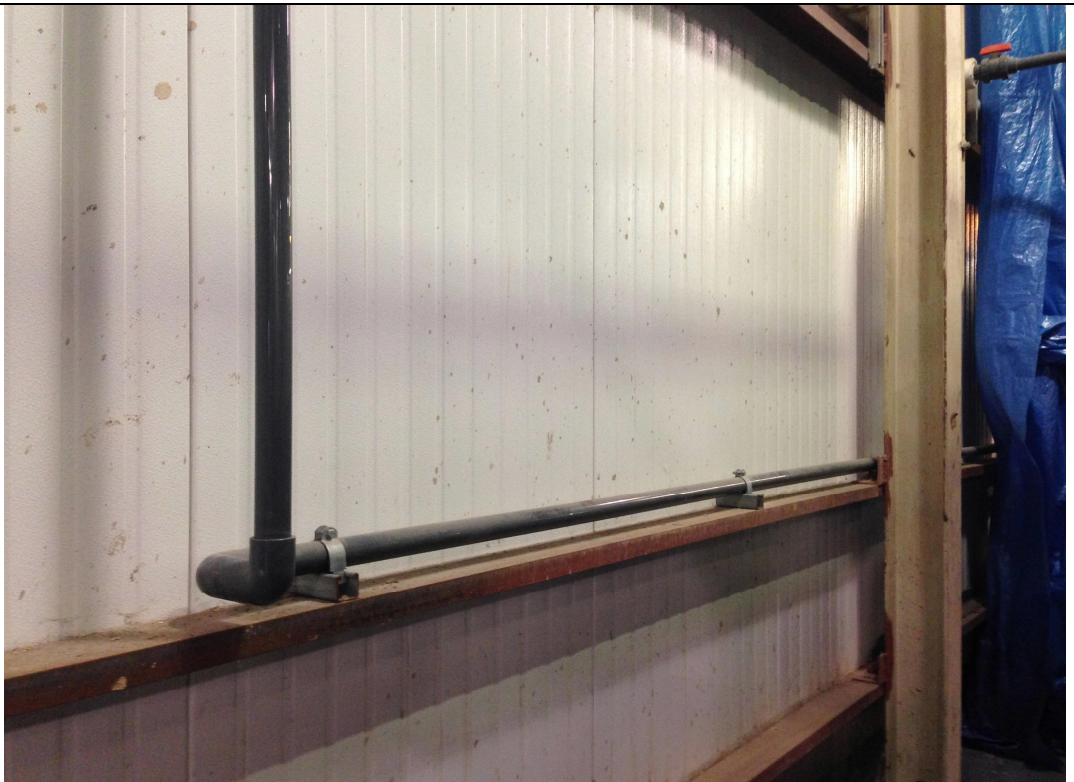
Grey 1.5" water pipe to be moved due to future wall piping penetration interference.

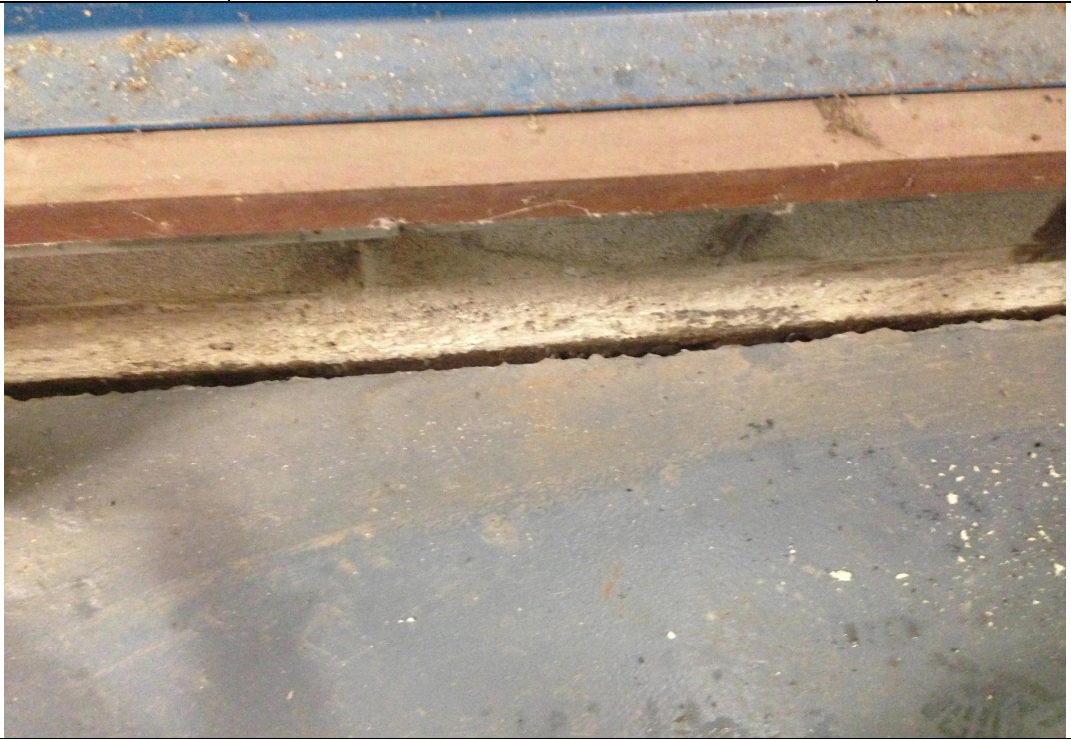
Typical cleaned out gap between slab and south wall of SWTP.

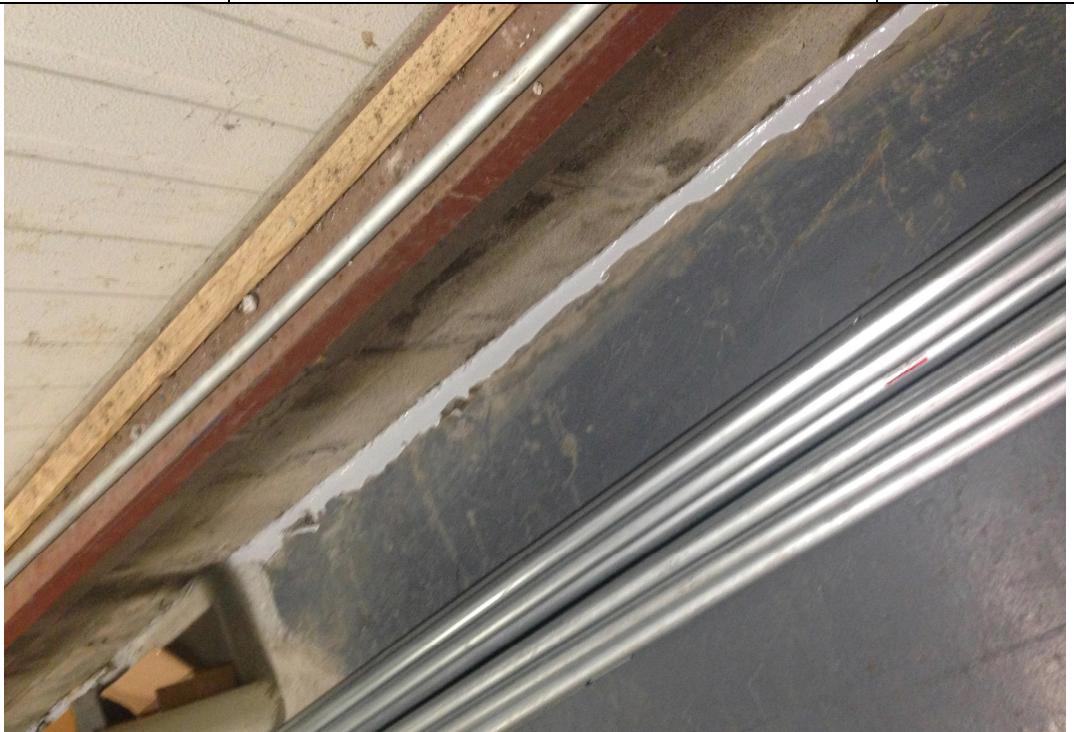
Caulking of floor/south wall seam. Electrical conduit pictured adjacent.

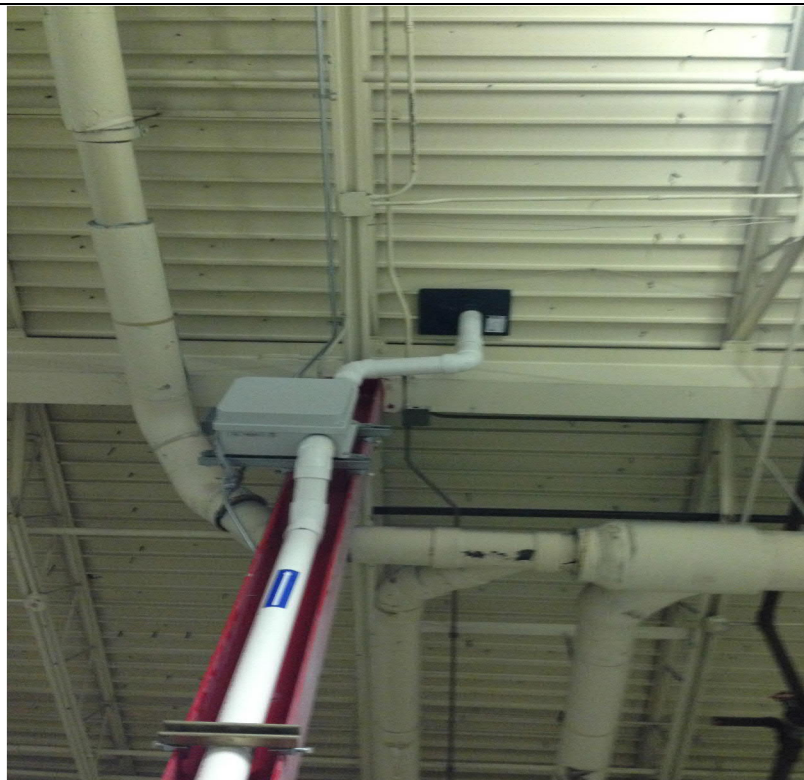
Roof penetration at column U3. Black plastic pipe flashing.
