DOCUMENT NAME MARLEY.021
DOCUMENT FOLDER TXTHSCKW
REFERENCE
AUTHOR kd
SUBJECT REPORT of DEC Investigation

REPORT
OF
THE MARLEY SITE
PRELIMINARY INVESTIGATION
by
New York State Department of Environmental Conservation
Division of Hazardous Waste Remediation
Bureau of Hazardous Site Control

Performed on 13 July 1989

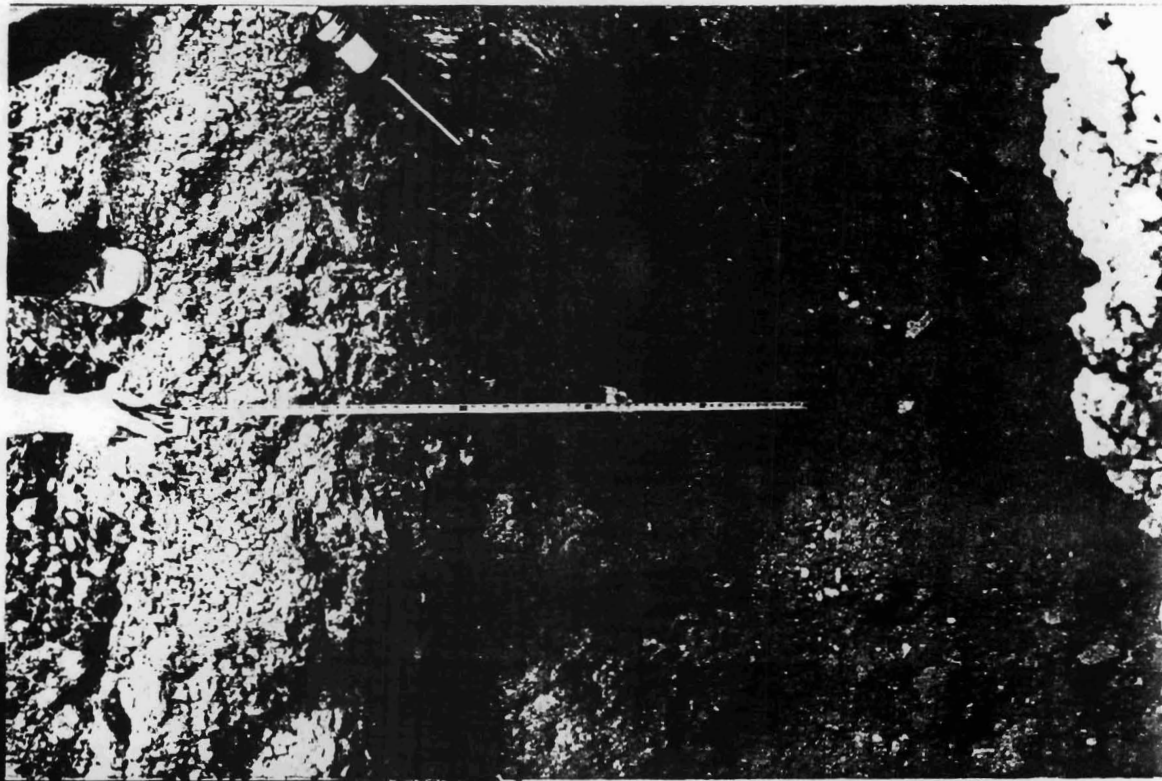
Pit →

tape is
5 ft. long

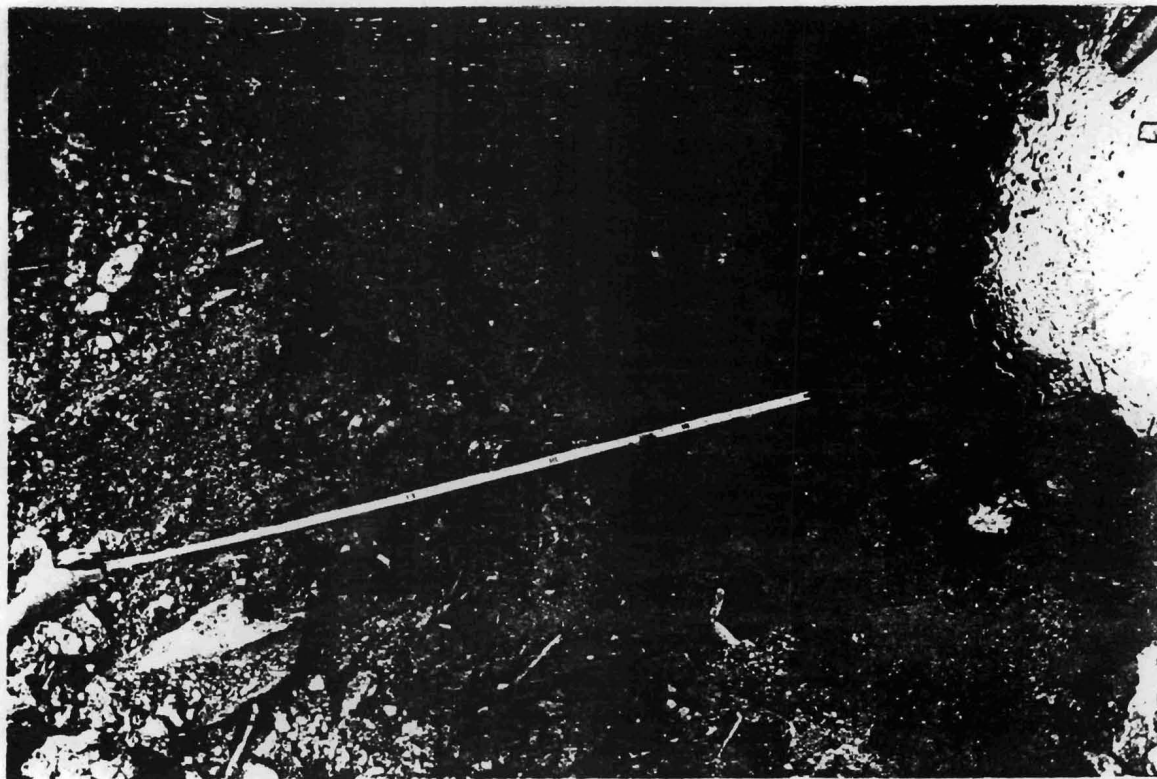
Location Z-2

Surface

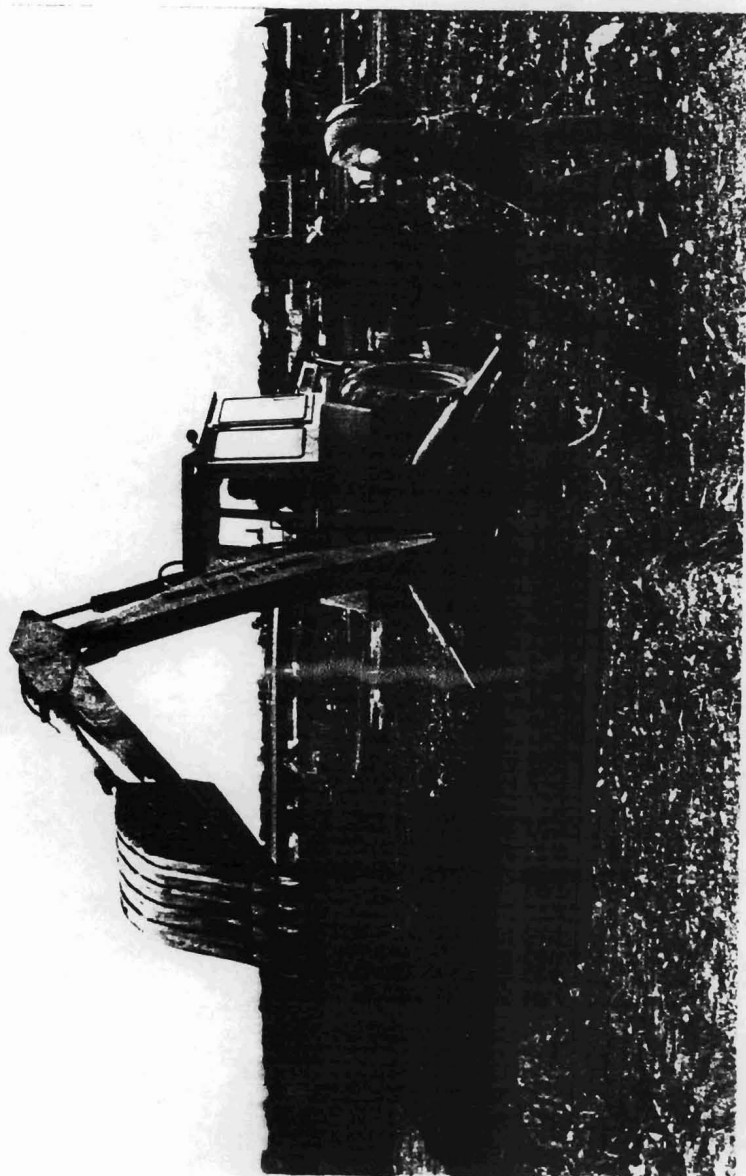
Pit,
with
wet
bottom

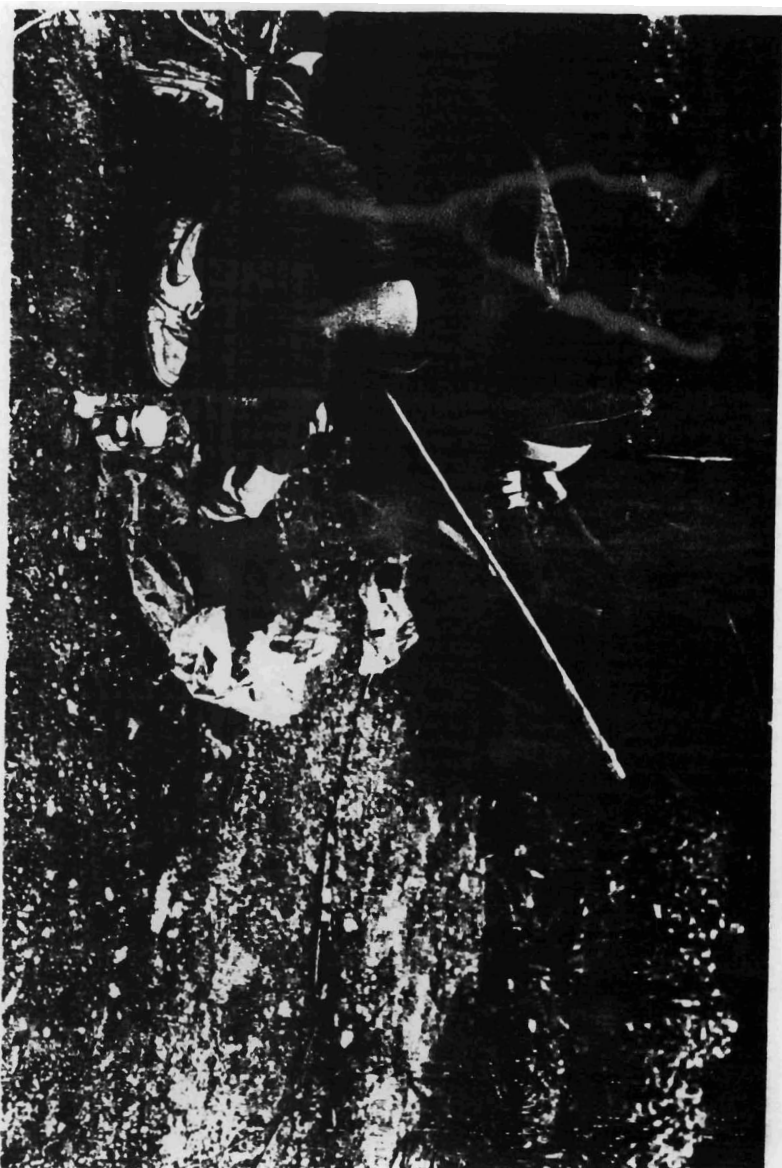
Location Z-3

Surface

(This is the David Yarrow Area)

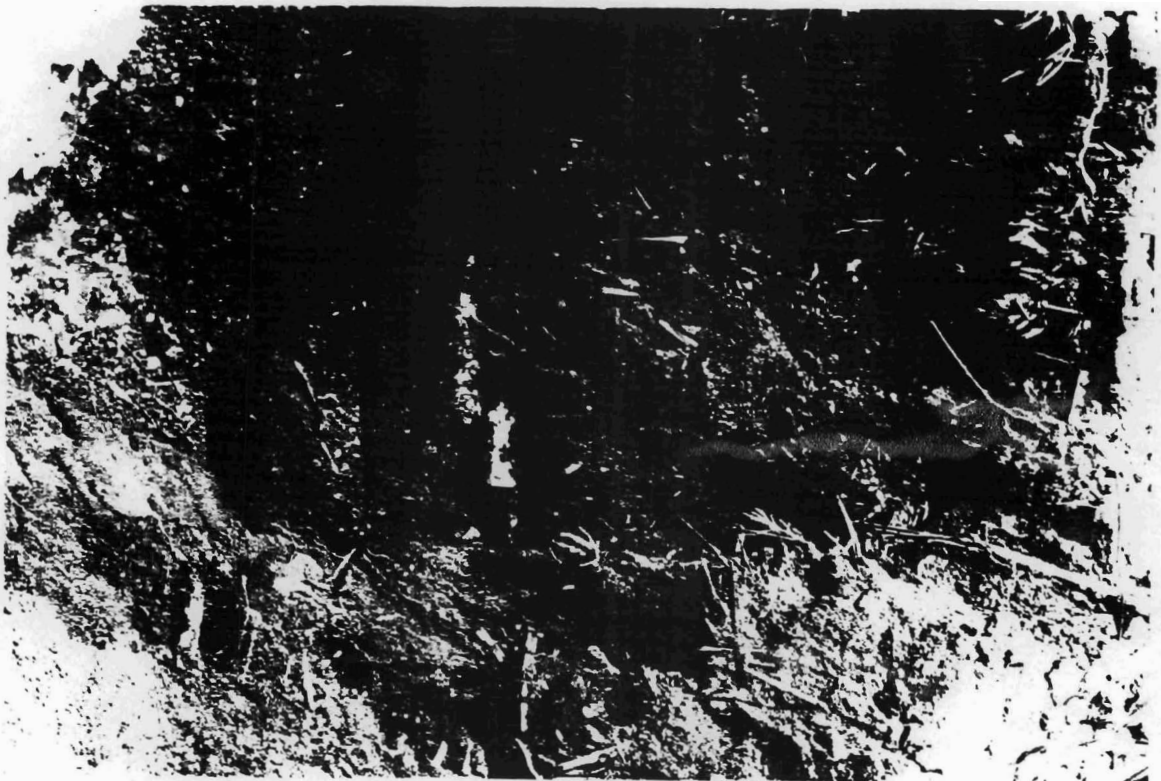
Wet bottom

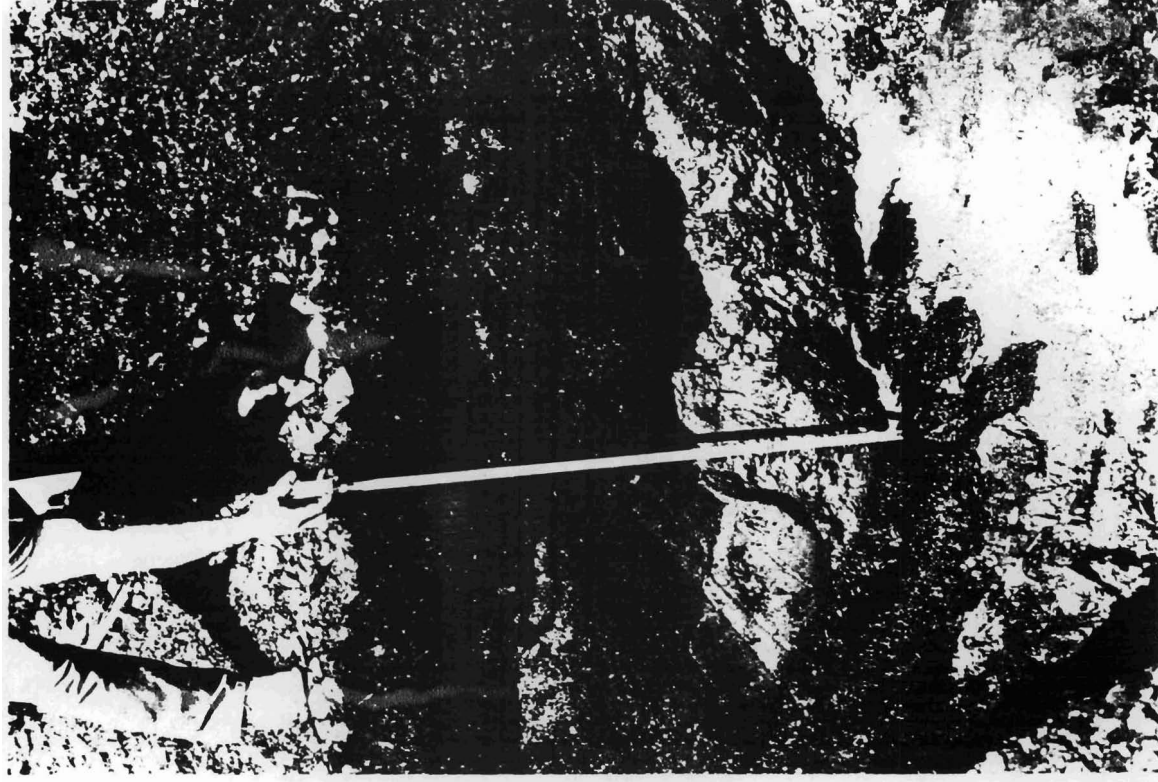
Location Z. 4

(This is in the
former railyard)

Water inflow

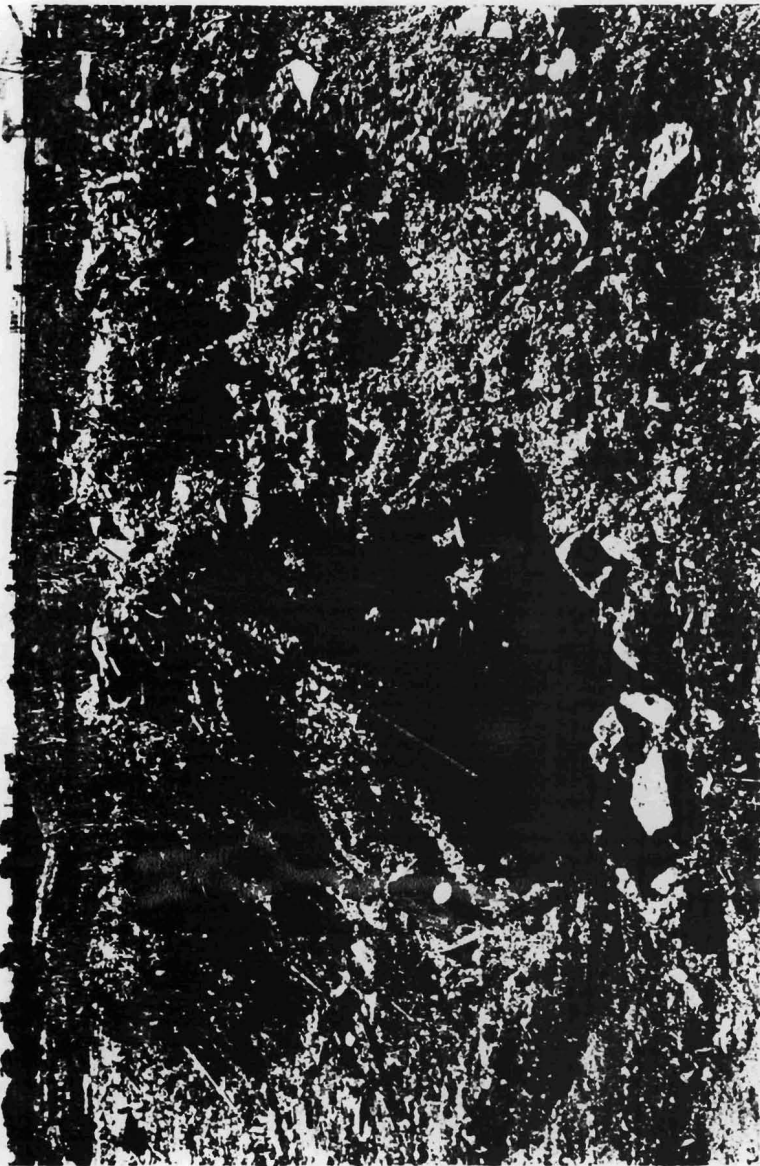
Location Z-5

outcrop
of
"GOOP"
(Tape is 4ft.
long)

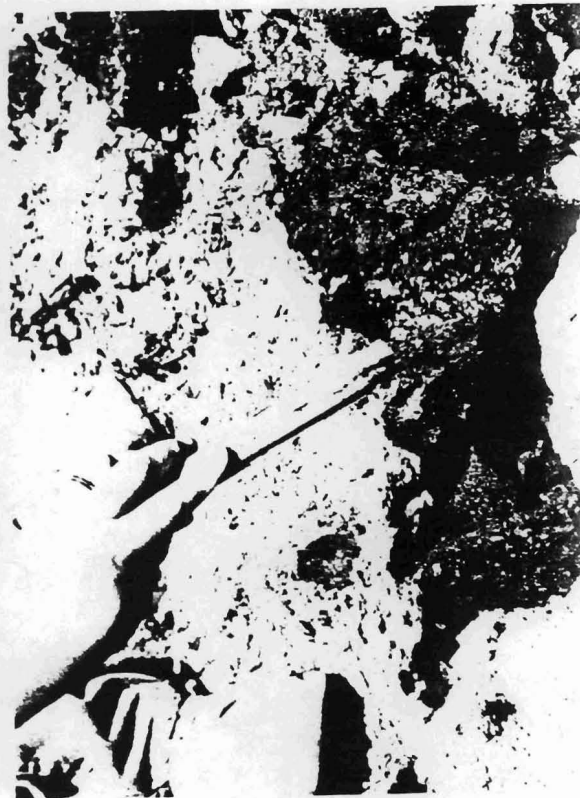
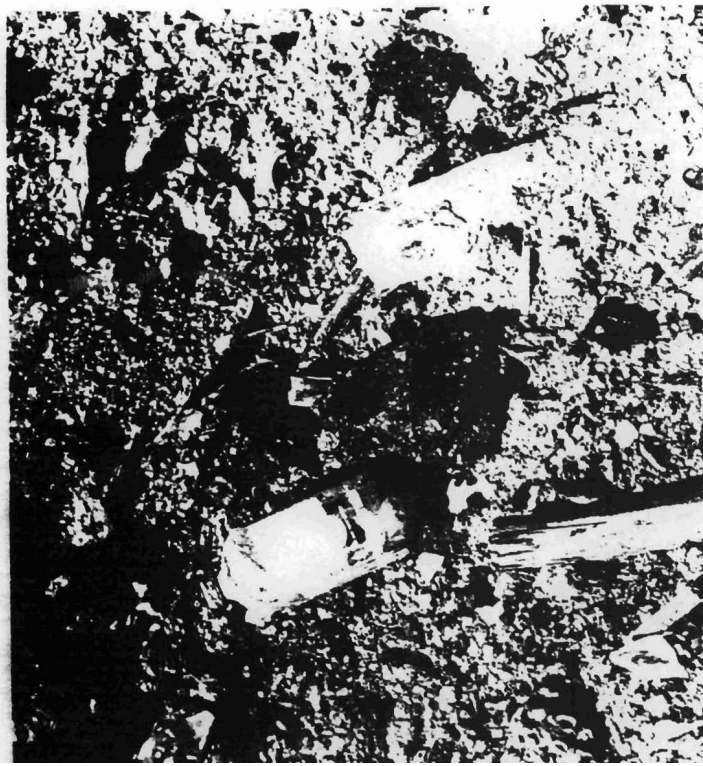
Location Z-5

Bottle of "Gum Turps" in
the landfill

Test Pit cut into "out crop"

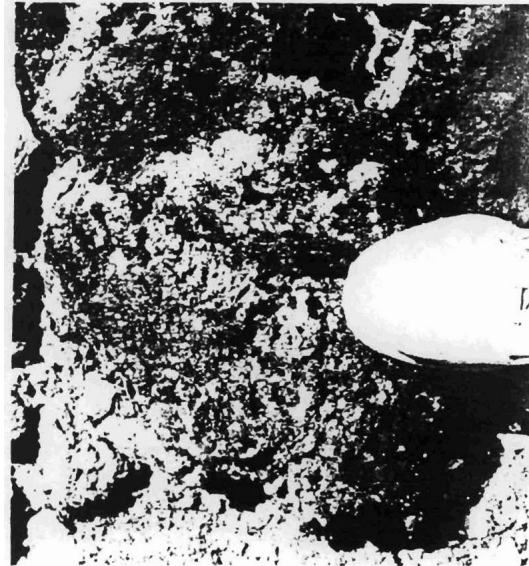
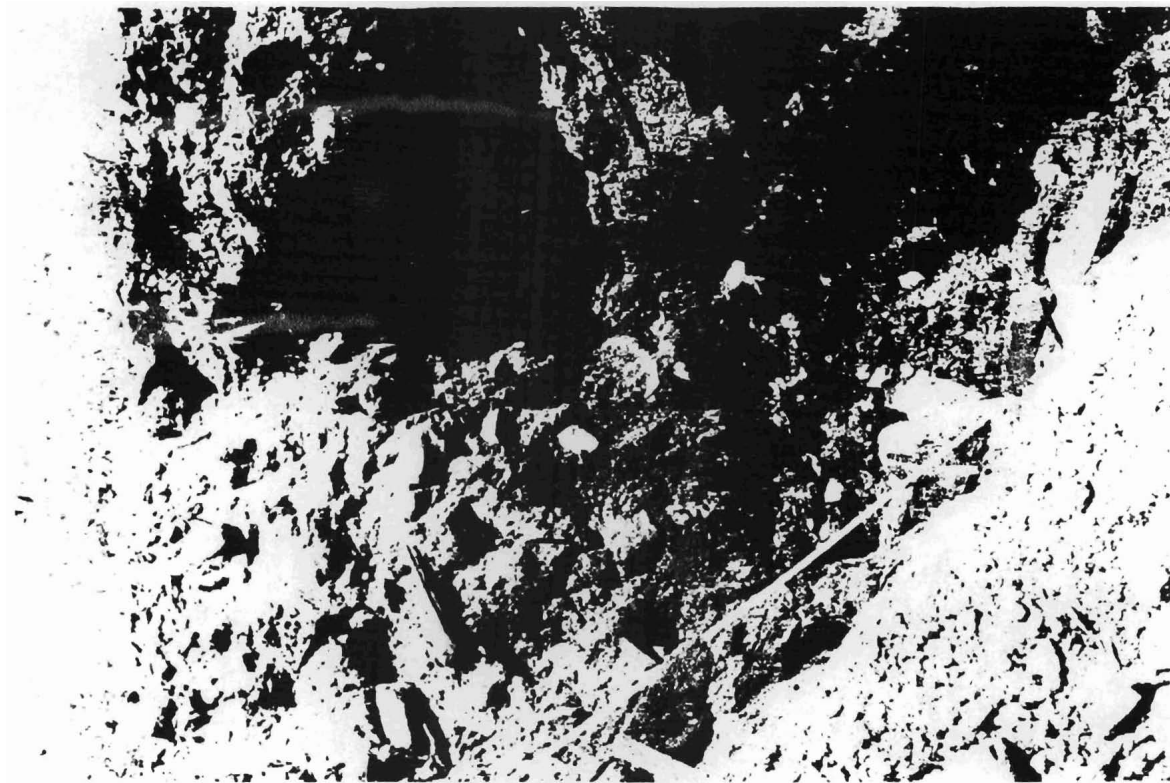
Greenish "Goop" from pit

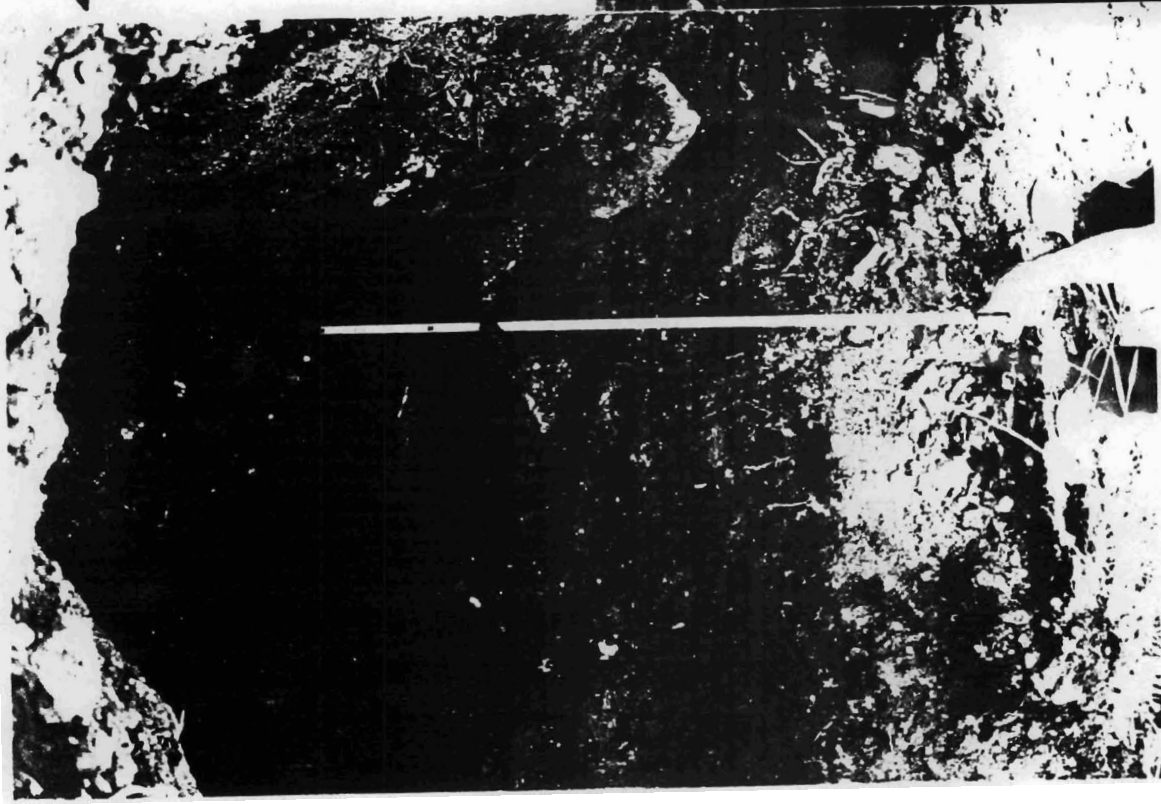
Locations
Z 6
and
Z 7

Z-7
Pit
→

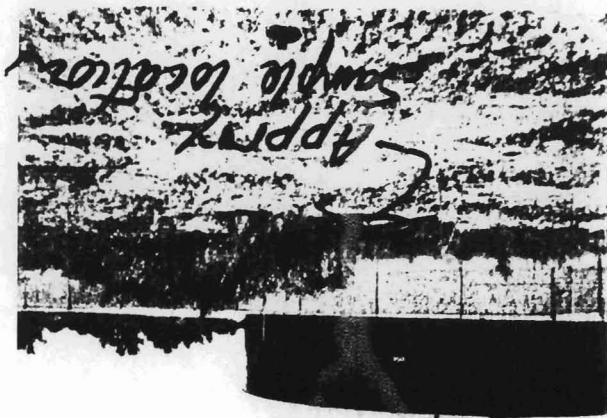
Sample No 01

Sample taken on an undisturbed
portion of land near the Clark
property boundary & not far from
the Hess Oil Co. Storage tanks.

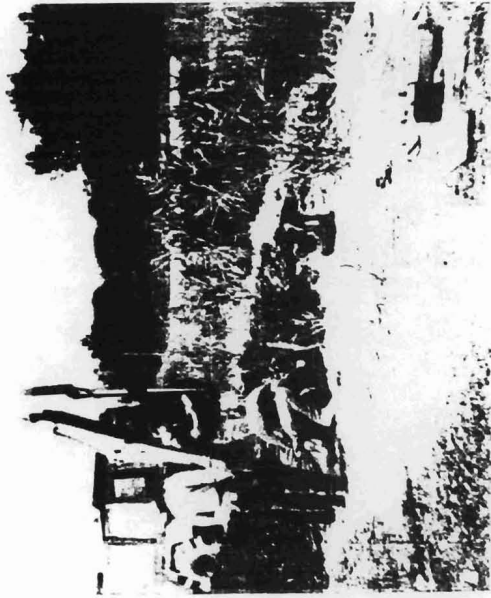
Sample Point No 5

Sampling point was between a swampy area near a stand of cattails & swamp grass & the railroad tracks. Water table was about 5 ft. below the surface @ this location.

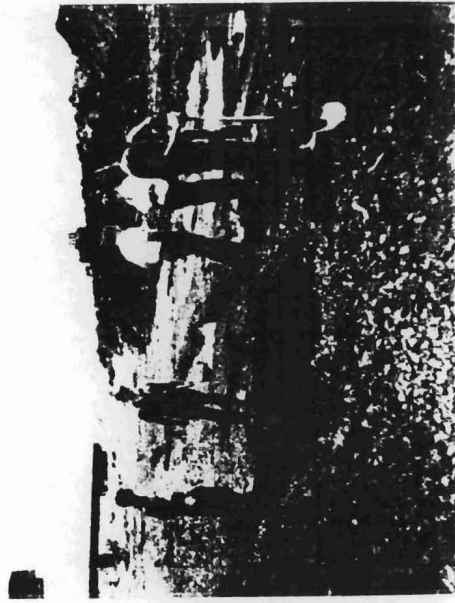
Sampling Points
No 6 & 7

This sampling point is in an area where the New York Central Penn Central tracks were once located. It is near the I-81 ramp.

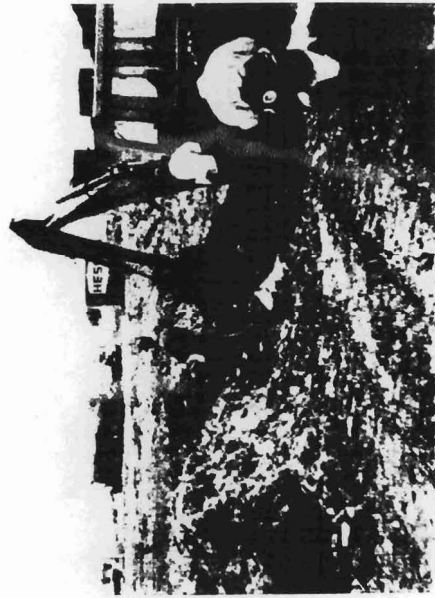
09- Taken from the pit.
The backhoe operator uncovered
some very strong smelling
waste that was blackish colored.
It smelled somewhat like strong
solvents mixed w/ municipal
waste. HNu tracing here was
about 3.5 (@ the 0-20 scale)

Sampling Point N° 9 was taken from a point about 2 ft. below the surface. Very pungent solvent/refuse odor. ^{at N° 9} reading @ 3.5 + (0-20 scale)

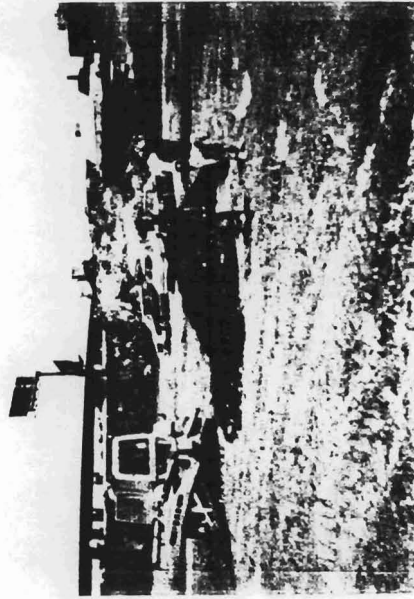
Sampling Point N° 10

Soil in this pit was dry - ~~fine~~ gritty
looking material that looked like
ground up cinders. There was
very little odor here & HNu
readings did not go above zero.
