report, hw734053, 2000-06,
FER. App A. pdf

APPENDIX A

PHOTOGRAPHS

SYRACUSE CHINA LANDFILL
TOWN OF SALINA, ONONDAGA COUNTY, NEW YORK

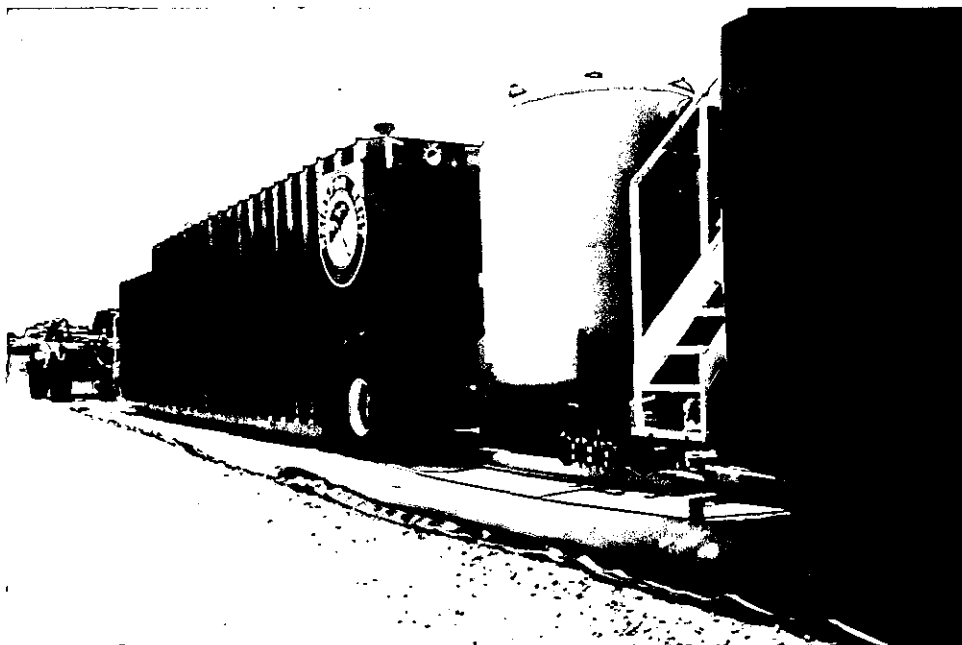
Photograph 5: Temporary wastewater treatment system consisting of Frac tanks and sand filter.

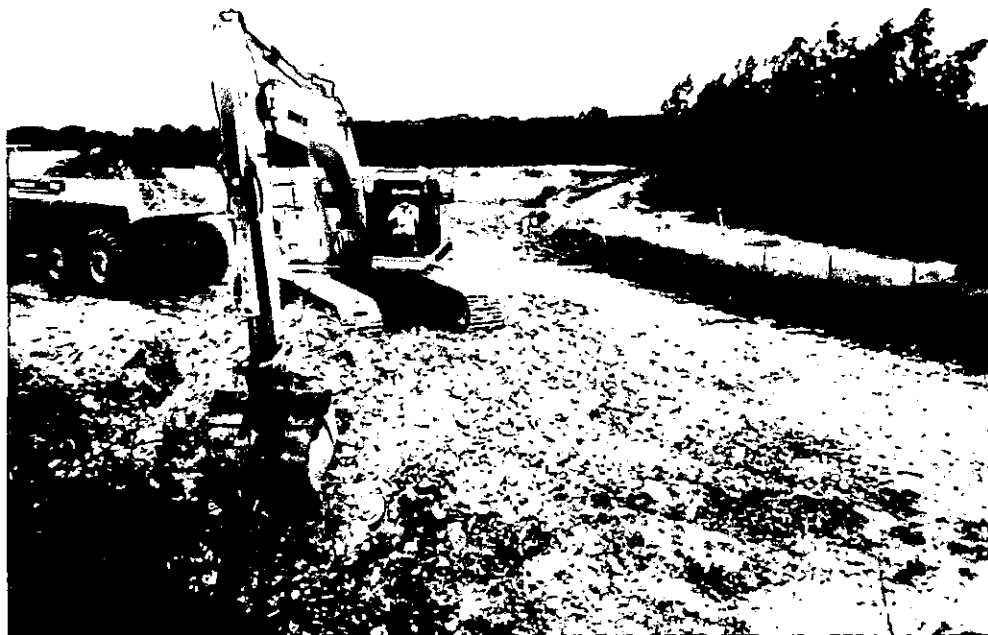
Photograph 7: Waste excavation in eastern portion of Site. Photo looks north.

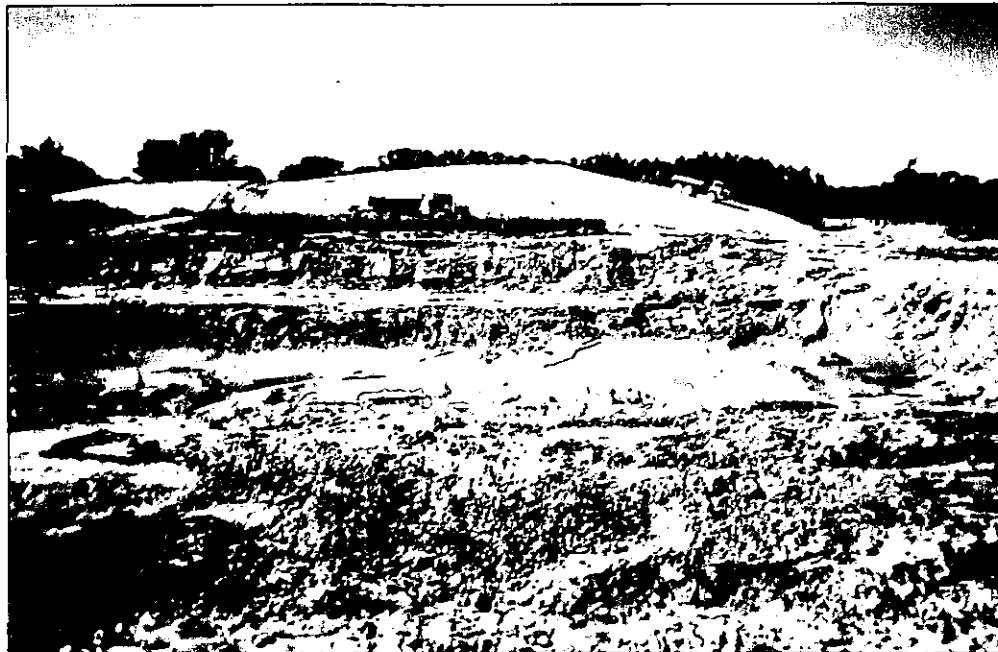
Photograph 8: Excavated eastern portion and former settling pond in foreground, landfill in background. Photo looks west.

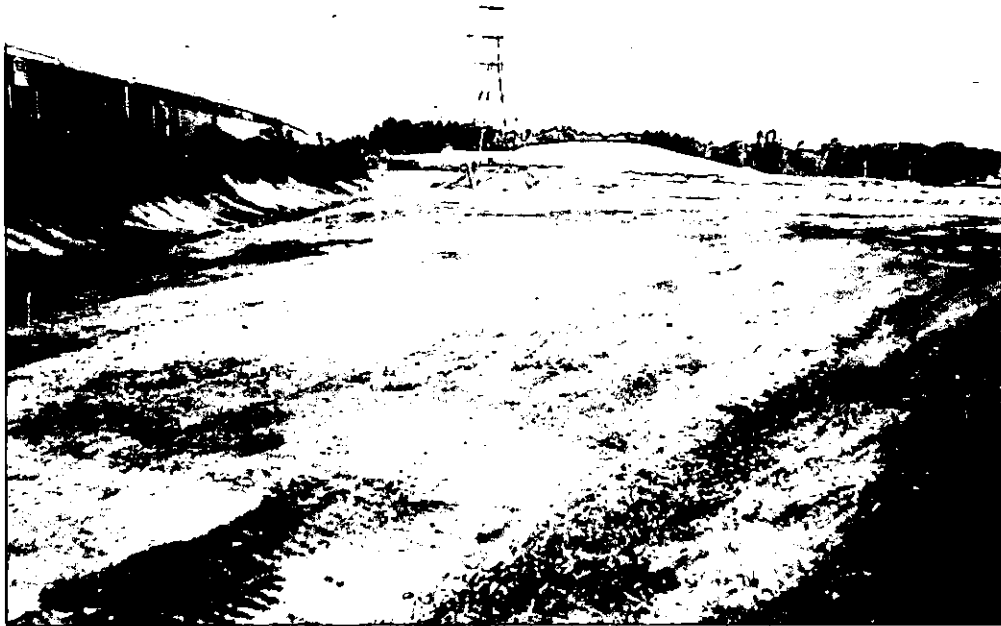
Photograph 11: Excavated eastern in foreground, landfill in background. Photo looks west.

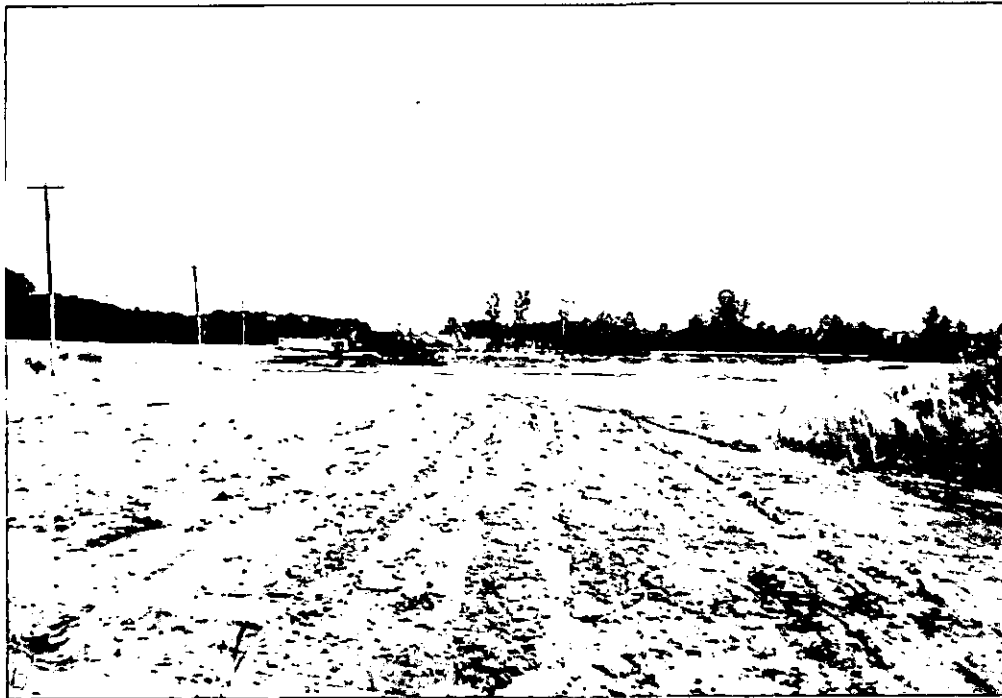
Photograph 14: Excavated northern wetlands. Photo looks east.

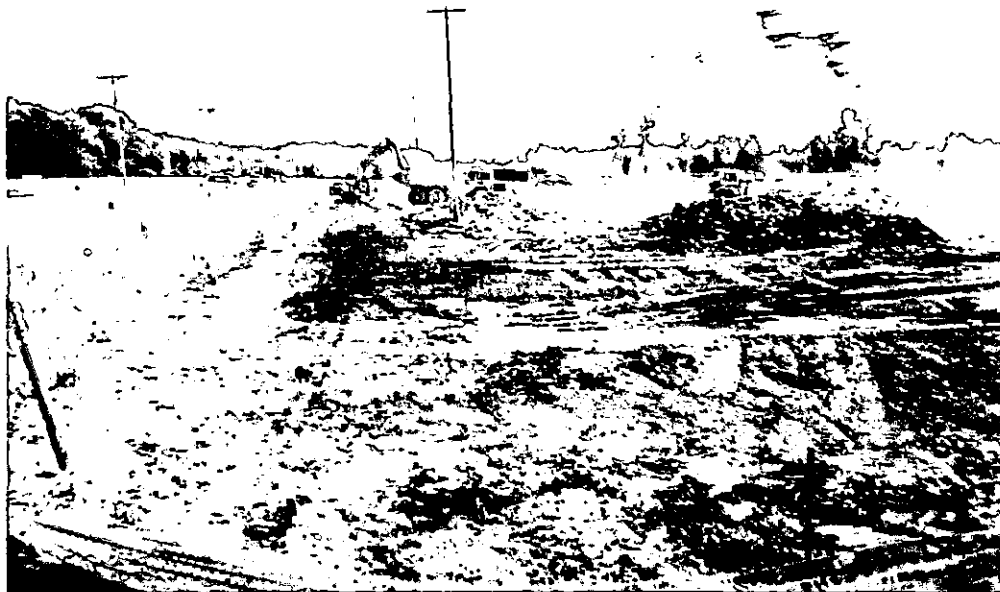
Photograph 15: Excavation and backfill within Factory Avenue right-of-way. Photo looks east.

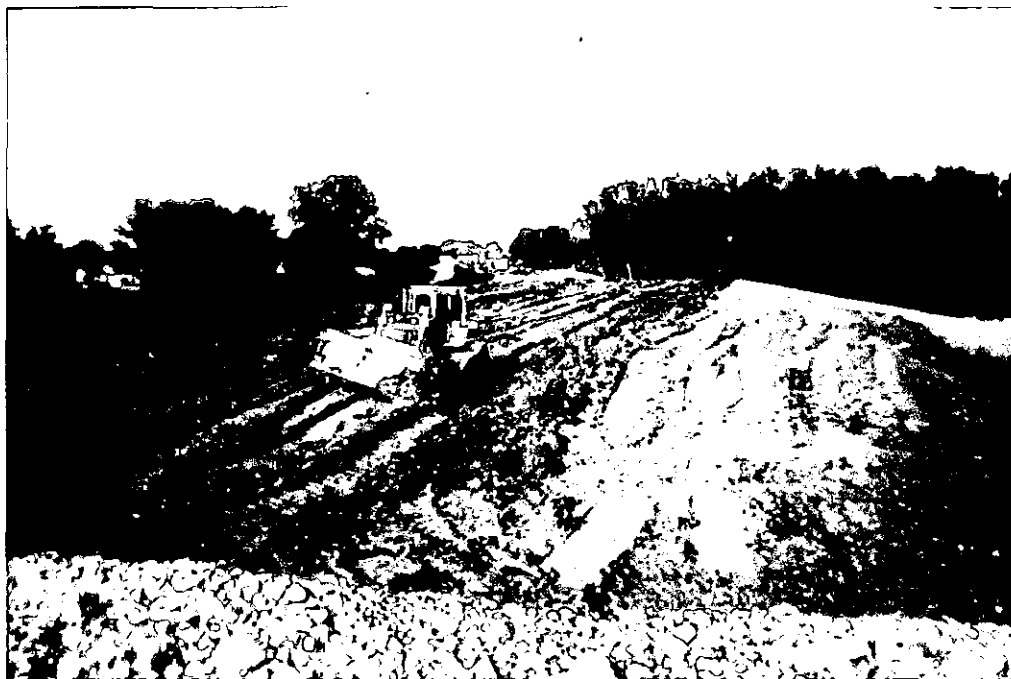
Photograph 16: Waste placement and consolidation on the landfill. Photo looks southeast.

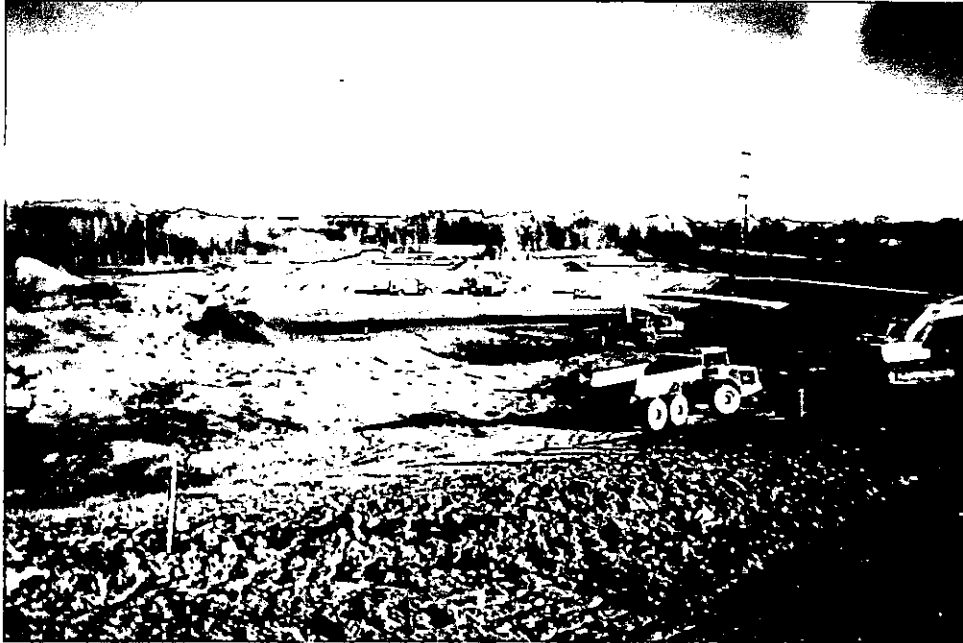
Photograph 17: Waste placement and consolidation on the landfill in foreground, new wastewater settling ponds in background. Photo looks east.

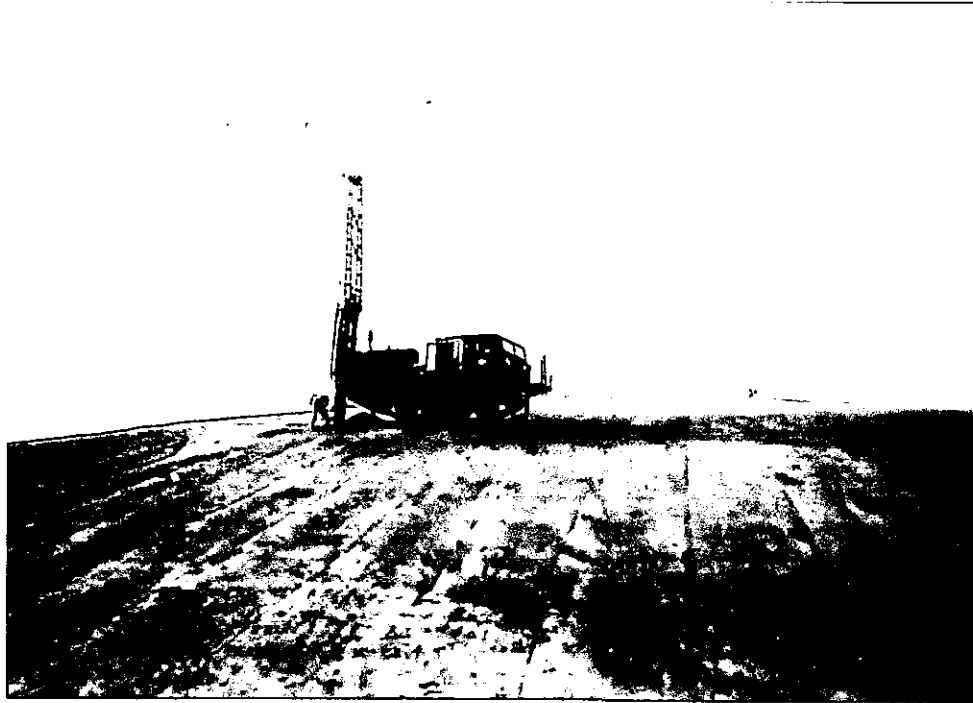
Photograph 19: Landfill gas vent installation.

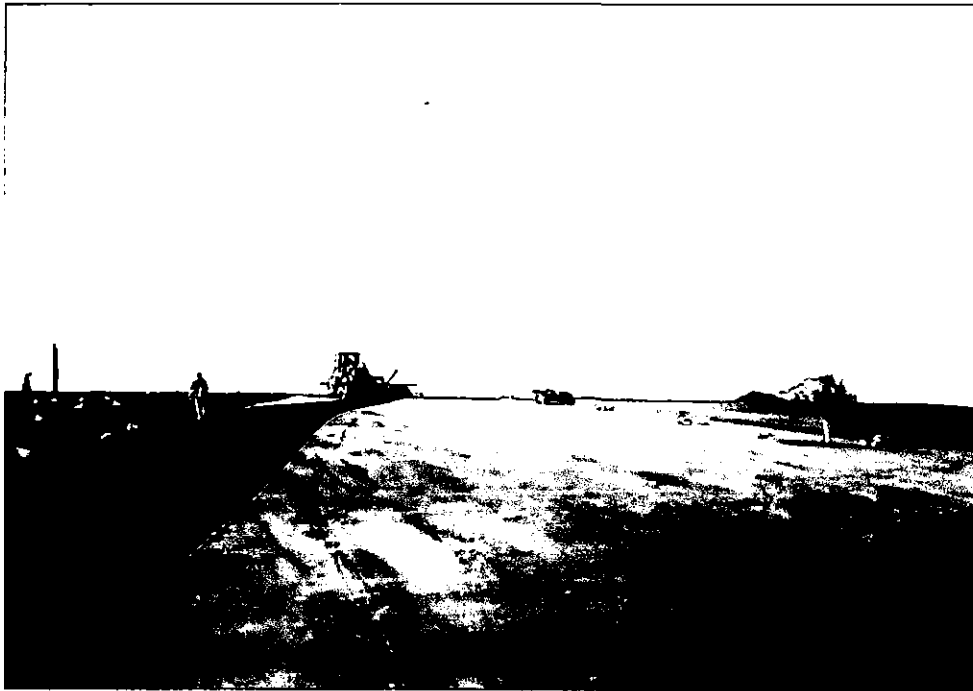
Photograph 20: Placement of geotextile on prepared landfill subgrade. Photo looks south.

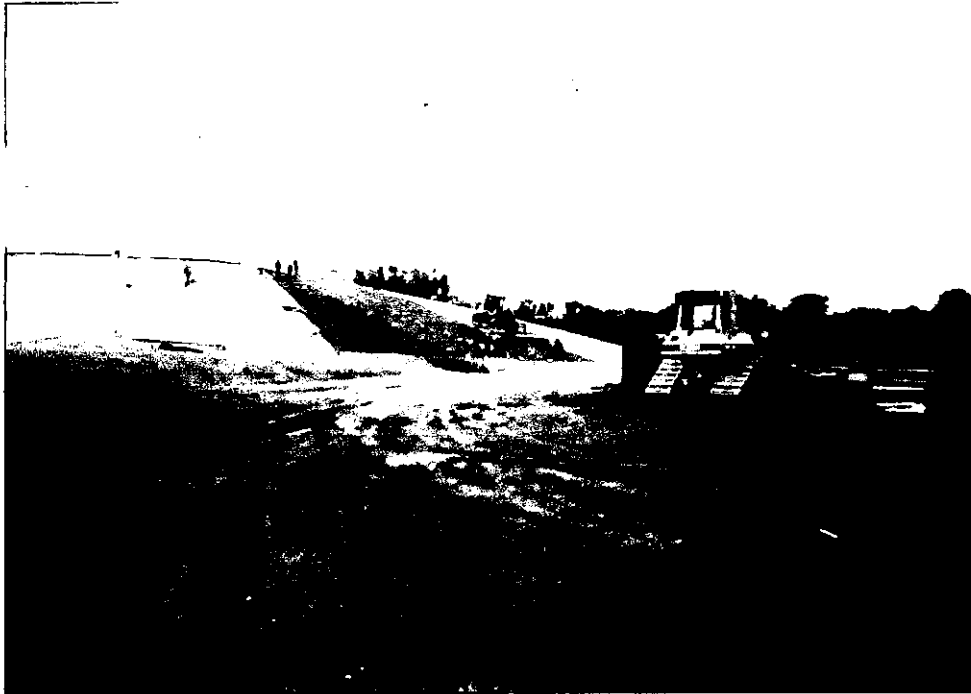
Photograph 21: Placement of geotextile and geomembrane on southern portion of landfill cap. Photo looks north.

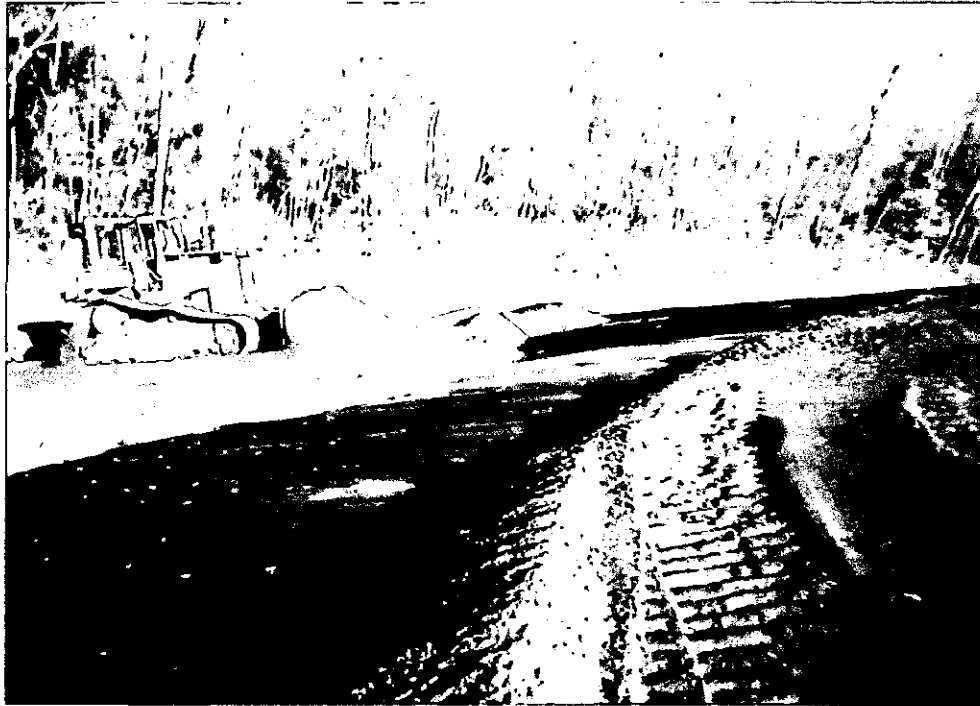
Photograph 23: Installation of sand drainage layer over geomembrane. Photo looks west.

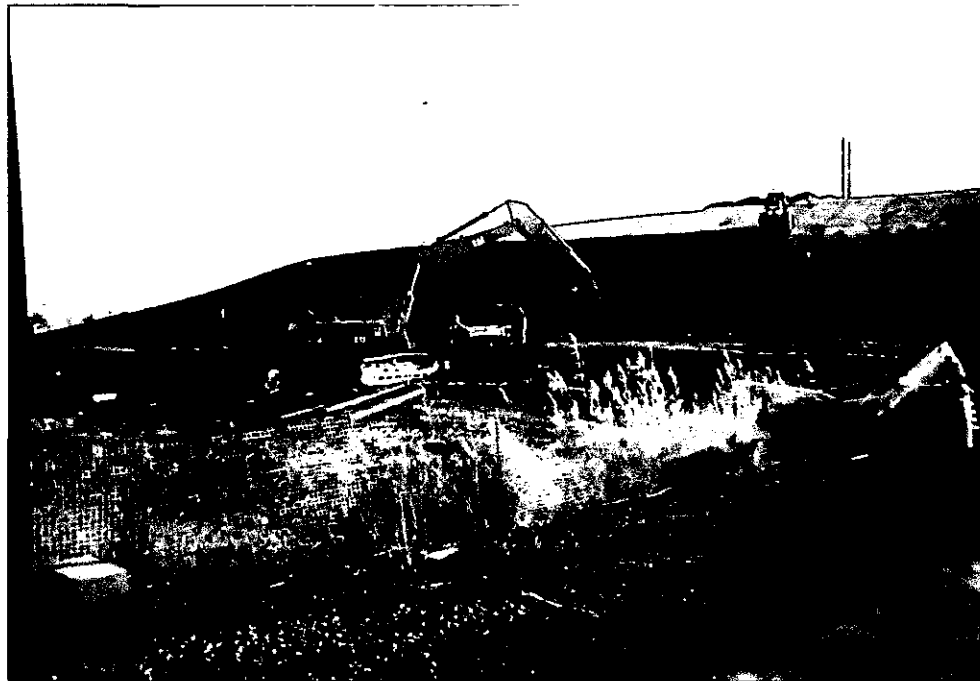
Photograph 24: Installation of barrier protection layer on landfill. Photo looks southeast.

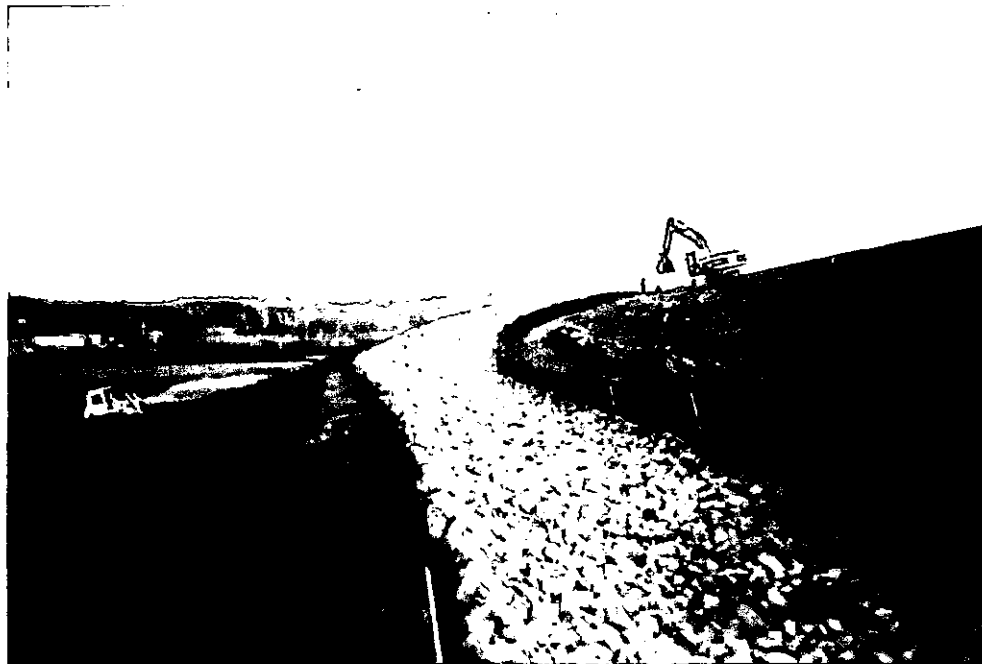
Photograph 26: Riprap placement in drainage swale and sand drainage layer of landfill. Photo looks east.

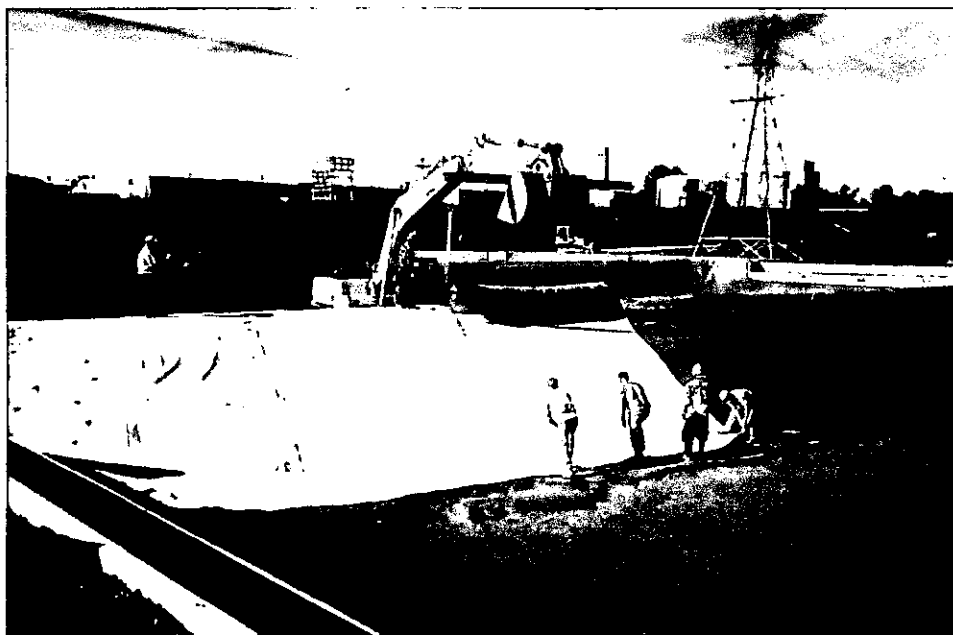
Photograph 28: GCL installation in new wastewater settling ponds. Photo looks south.

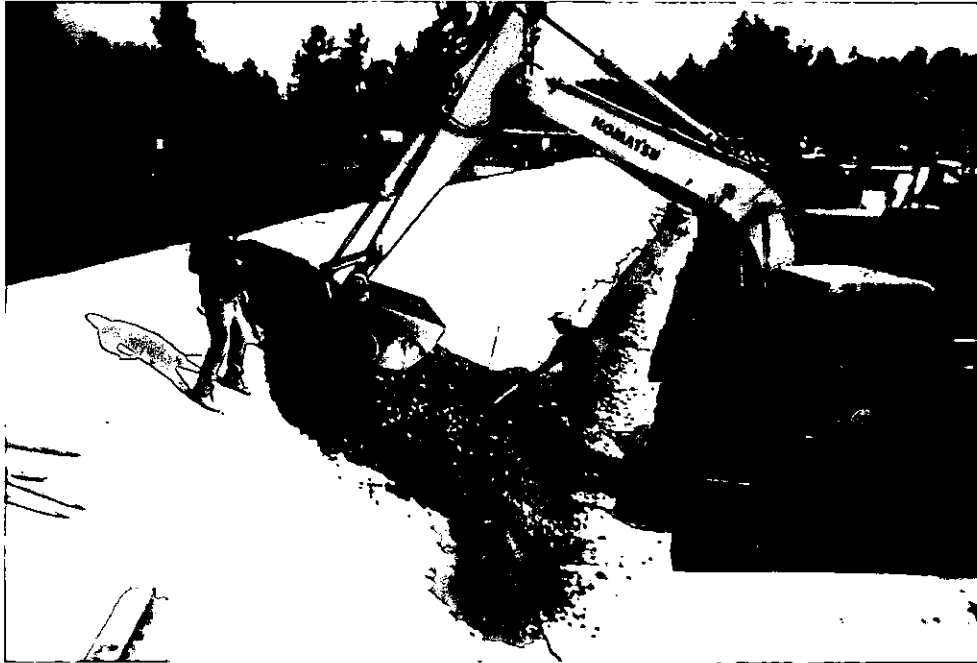
Photograph 29: Placement of gravel over GCL on new wastewater settling pond side slopes. Note weir in the background. Photo looks east.

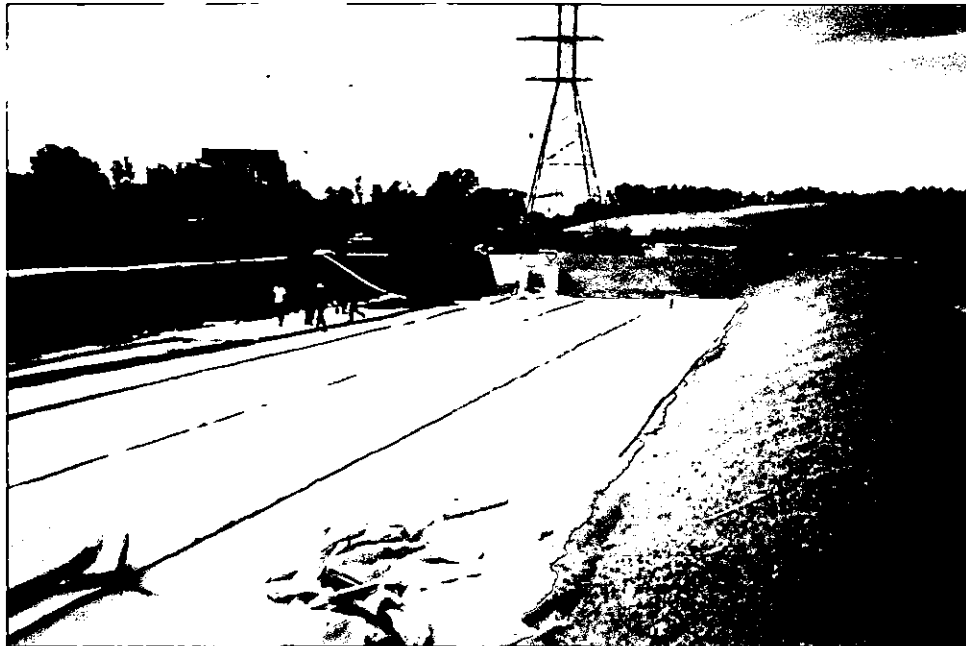
Photograph 30: GCL place on the bottom of new wastewater settling pond. Note hydraulic headwall in background. Photo looks west.

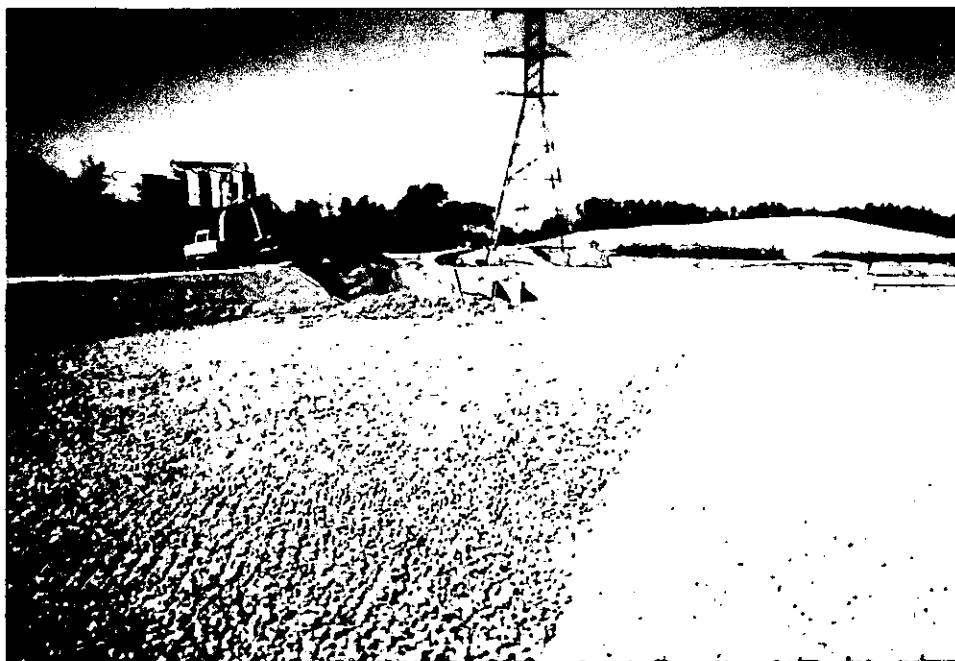
Photograph 31: Stone placed on the bottom of new wastewater settling pond. Photo looks west.

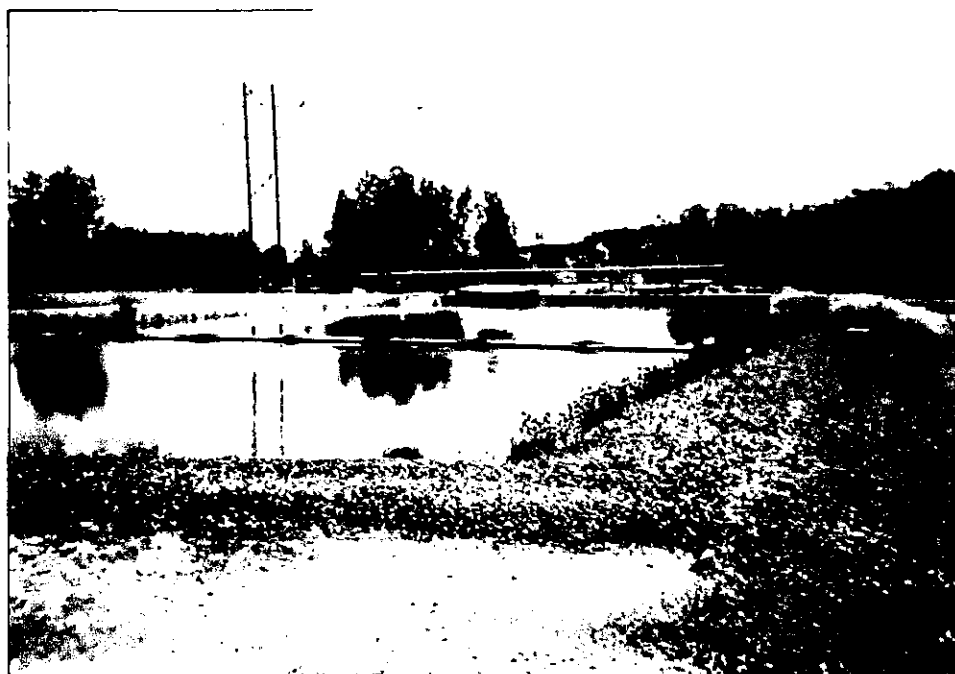
Photograph 32: New operational wastewater settling pond. Photo looks northeast.

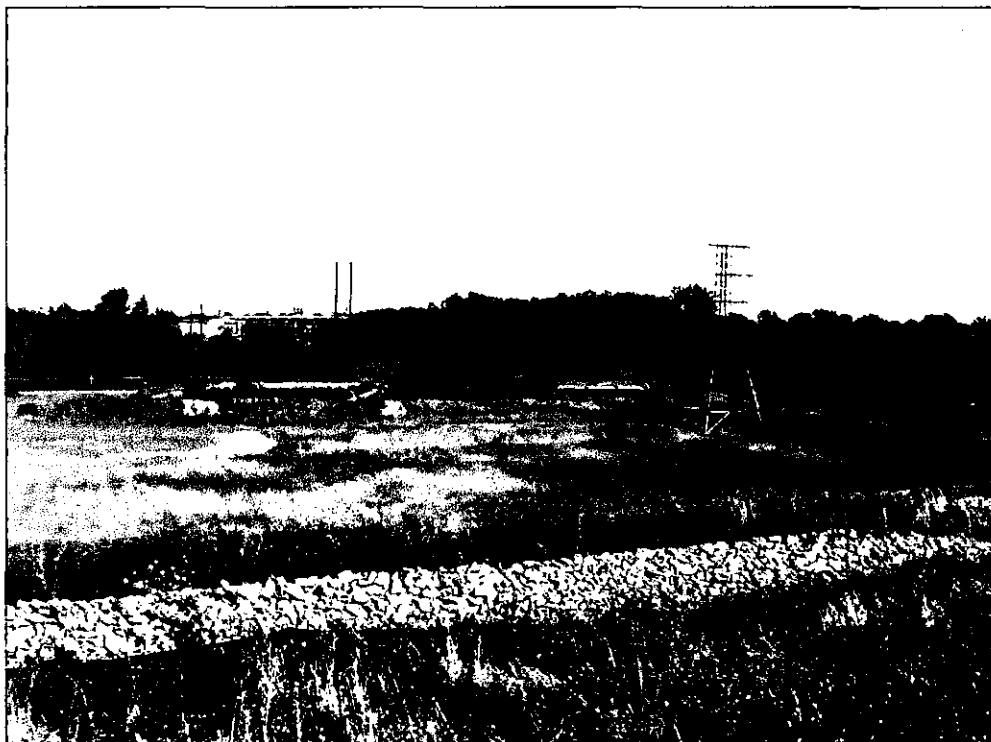
Photograph 35: Vegetated landfill and drainage swale in foreground, operating wastewater settling ponds in background. Photo looks east.

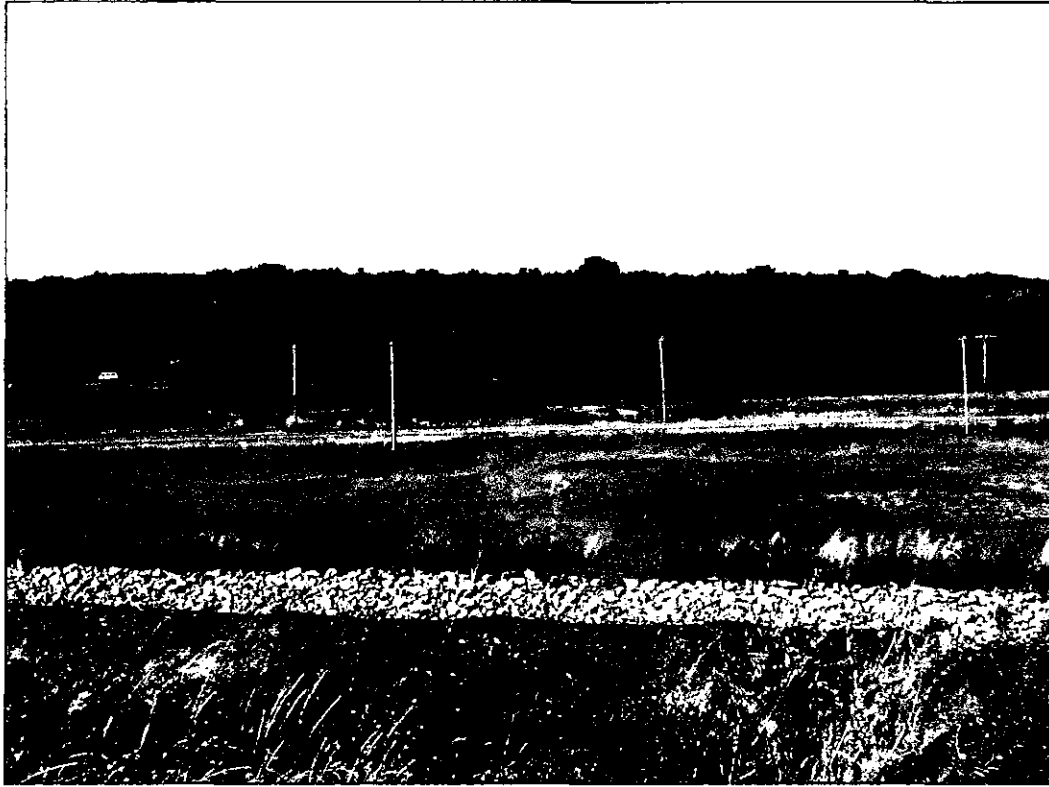
Photograph 37: Vegetated landfill and drainage swale in foreground, restored northern wetlands in background. Photo looks north.
