April 22, 2016

Re: Annual Landfill Inspection Report (Year 12)
Syracuse China Landfill
Town of Salina, Onondaga County, New York
NYSDEC Site Number 7-34-053

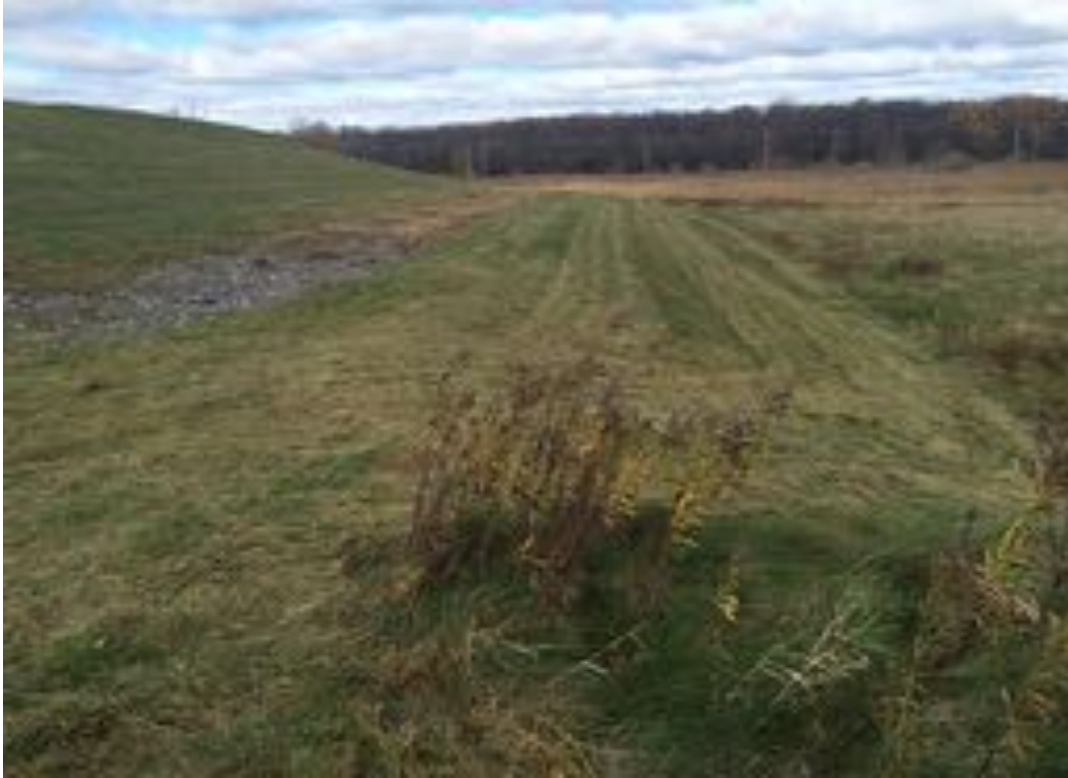
Bottom Swale: Facing North

Portions of the swales have become congested with vegetation. Treatment with a widely used aquatic herbicide Rodeo is proposed for Spring 2016. Due to harsh weather in Spring 2015, last year's treatment was incapable of being carried out.

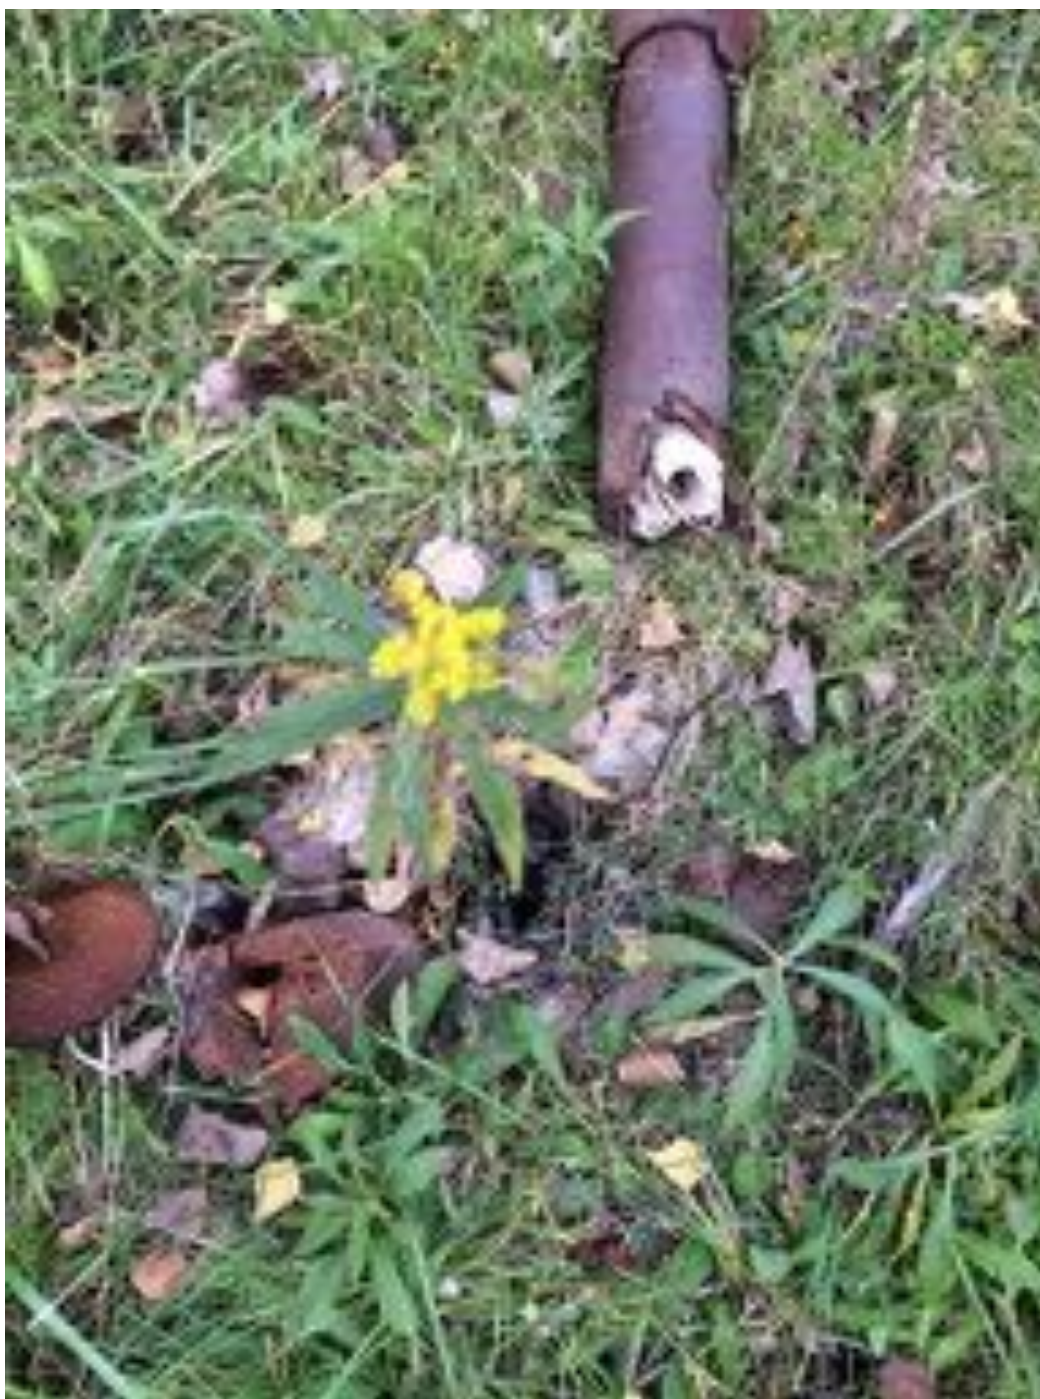
Monitoring well MW-1 was struck and has been destroyed. Photographs showing MW-1 are included within Appendix B. It is proposed that this well be abandoned per NYSDEC DER-10 guidelines and removed from the sampling network. MW-1 has been below the NYSDEC TOGS 1.1.1 standard for lead (0.025 mg/l) since it was installed in 2003 and below laboratory detection limits since 2006.

MW-1 Damage
