May 21, 2018

Re: Annual Landfill Inspection Report (Year 14)
Syracuse China Landfill
Town of Salina, Onondaga County, New York
NYSDEC Site Number 7-34-053

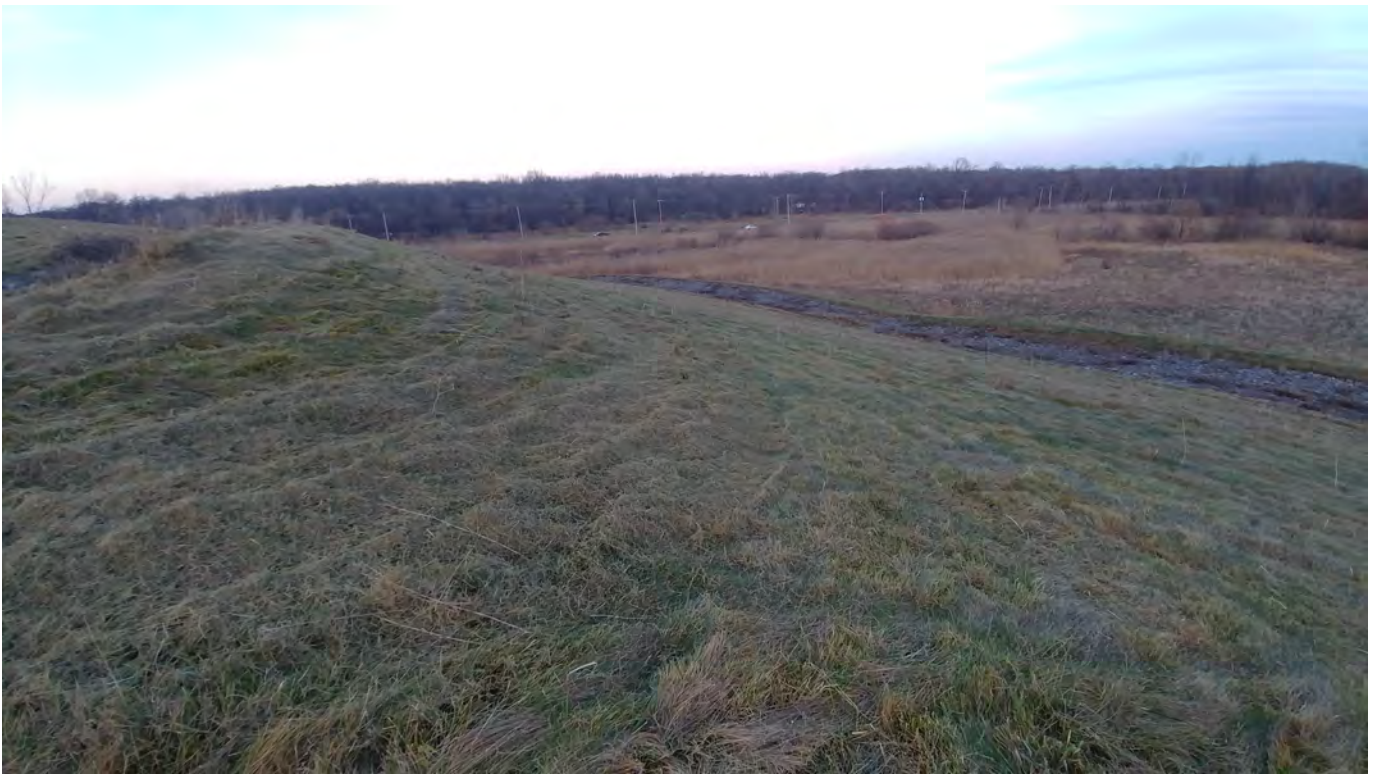
Top Swale/Bottom Swale/Slope: Facing East

Portions of the swales have become congested with vegetation. Treatment with a widely used aquatic herbicide Rodeo was completed on August 7, 2017. Additional treatments will occur and are discussed further below.

Portions of the swales have become congested with vegetation. Treatment with a widely used aquatic herbicide Rodeo is proposed for Summer and Fall 2018.

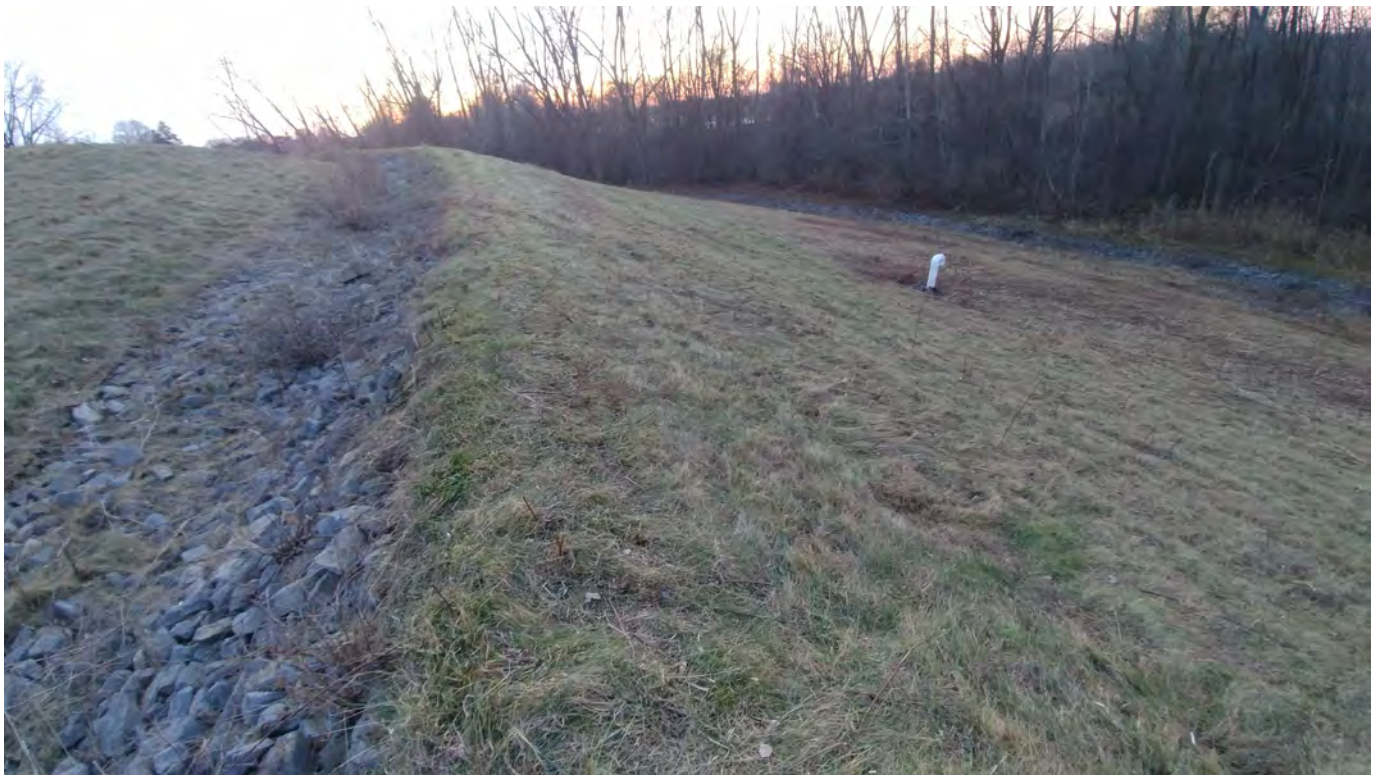
Upper Swale/Slope: Facing Southwest

40 or more rocks from the upper landfill swale were thrown onto the western slope of the landfill. All of rocks will be placed back into the swale prior to the 2018 mowing event.

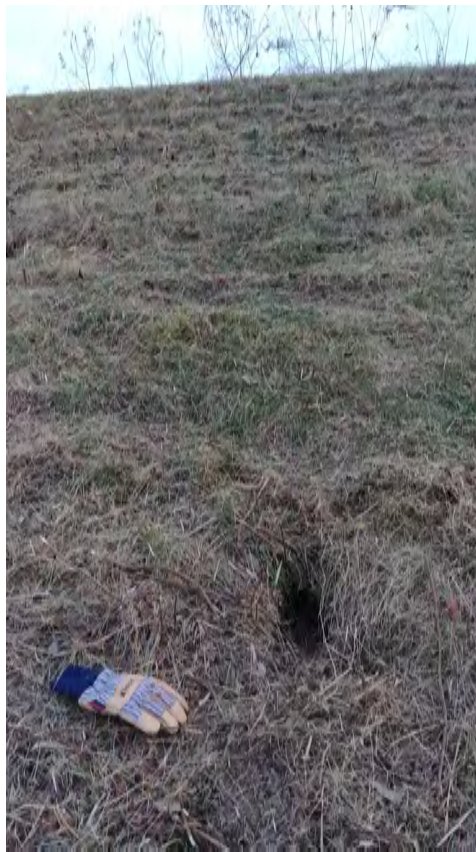
Animal Den/Burrow #1

Two animal dens/burrows were observed in the west slope of the landfill (pictures are included within Appendix B). These areas will be observed for differential settling and/or erosion during the 2018 maintenance events.

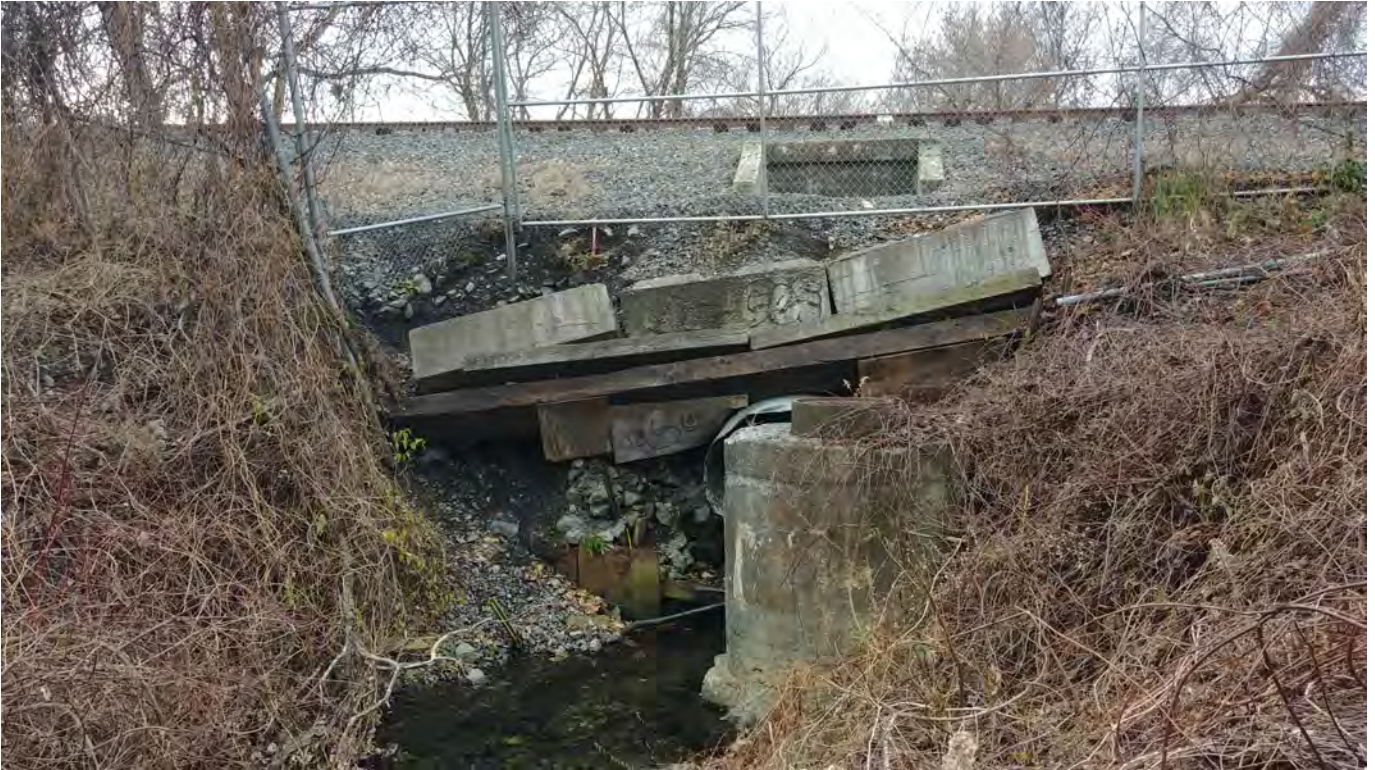
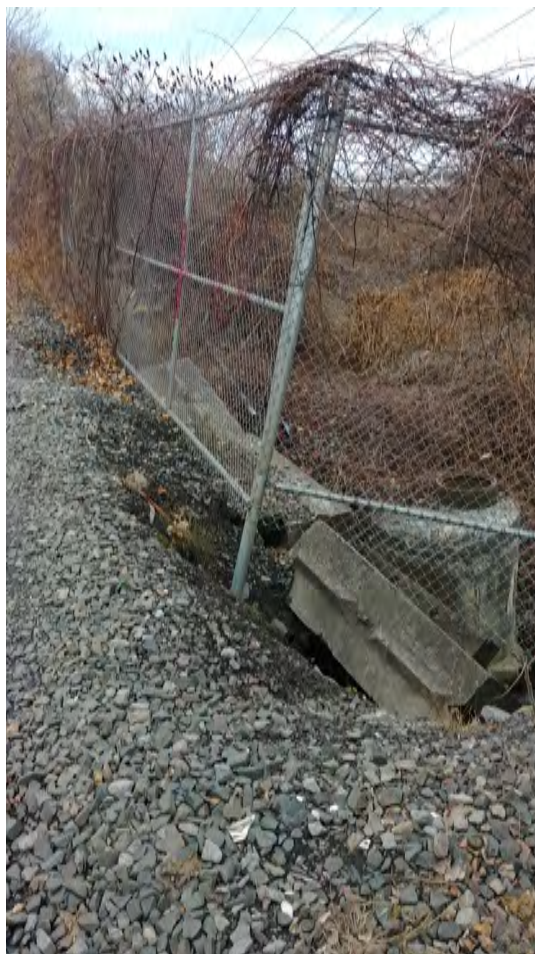
Culvert Area

A culvert that runs beneath the CSX railroad tracks and exits along the southern border of the site has lost integrity due to erosion. There is approximately 40 feet of fencing in the vicinity of the culvert that is in danger of being destabilized as a result of the culvert deterioration (pictures have been included within Appendix B). Ownership of the culvert

is being determined so that the appropriate party can be contacted to undertake the necessary repairs. As an alternative approach, an evaluation is being made of the feasibility of relocating the fence away from the culvert. However, relocation would either need to avoid the adjacent CSX railroad right-of-way or permission from CSX would need to be obtained. An update will be provided at the conclusion of the evaluation of these various alternatives.
