Re: Annual Landfill Inspection Report (Year 15)
Syracuse China Landfill
Town of Salina, Onondaga County, New York
NYSDEC Site Number 7-34-053

Rocterra, LLC (Rocterra), on behalf of TPC-York Inc. (TPC-York), has prepared this letter report to summarize the required monitoring and maintenance activities completed at the Syracuse China Landfill site located in the Town of Salina, Onondaga County, New York (Site No. 7-34-053). In accordance with New York State Department of Environmental Conservation (NYSDEC) requirements, activities for the fifteenth year of Operation, Monitoring and Maintenance (OM&M) were performed at the site. In accordance with the OM&M Plan prepared by Remedial Engineering, PC dated September 25, 2003 and the schedule approved by NYSDEC, the following activities were performed:

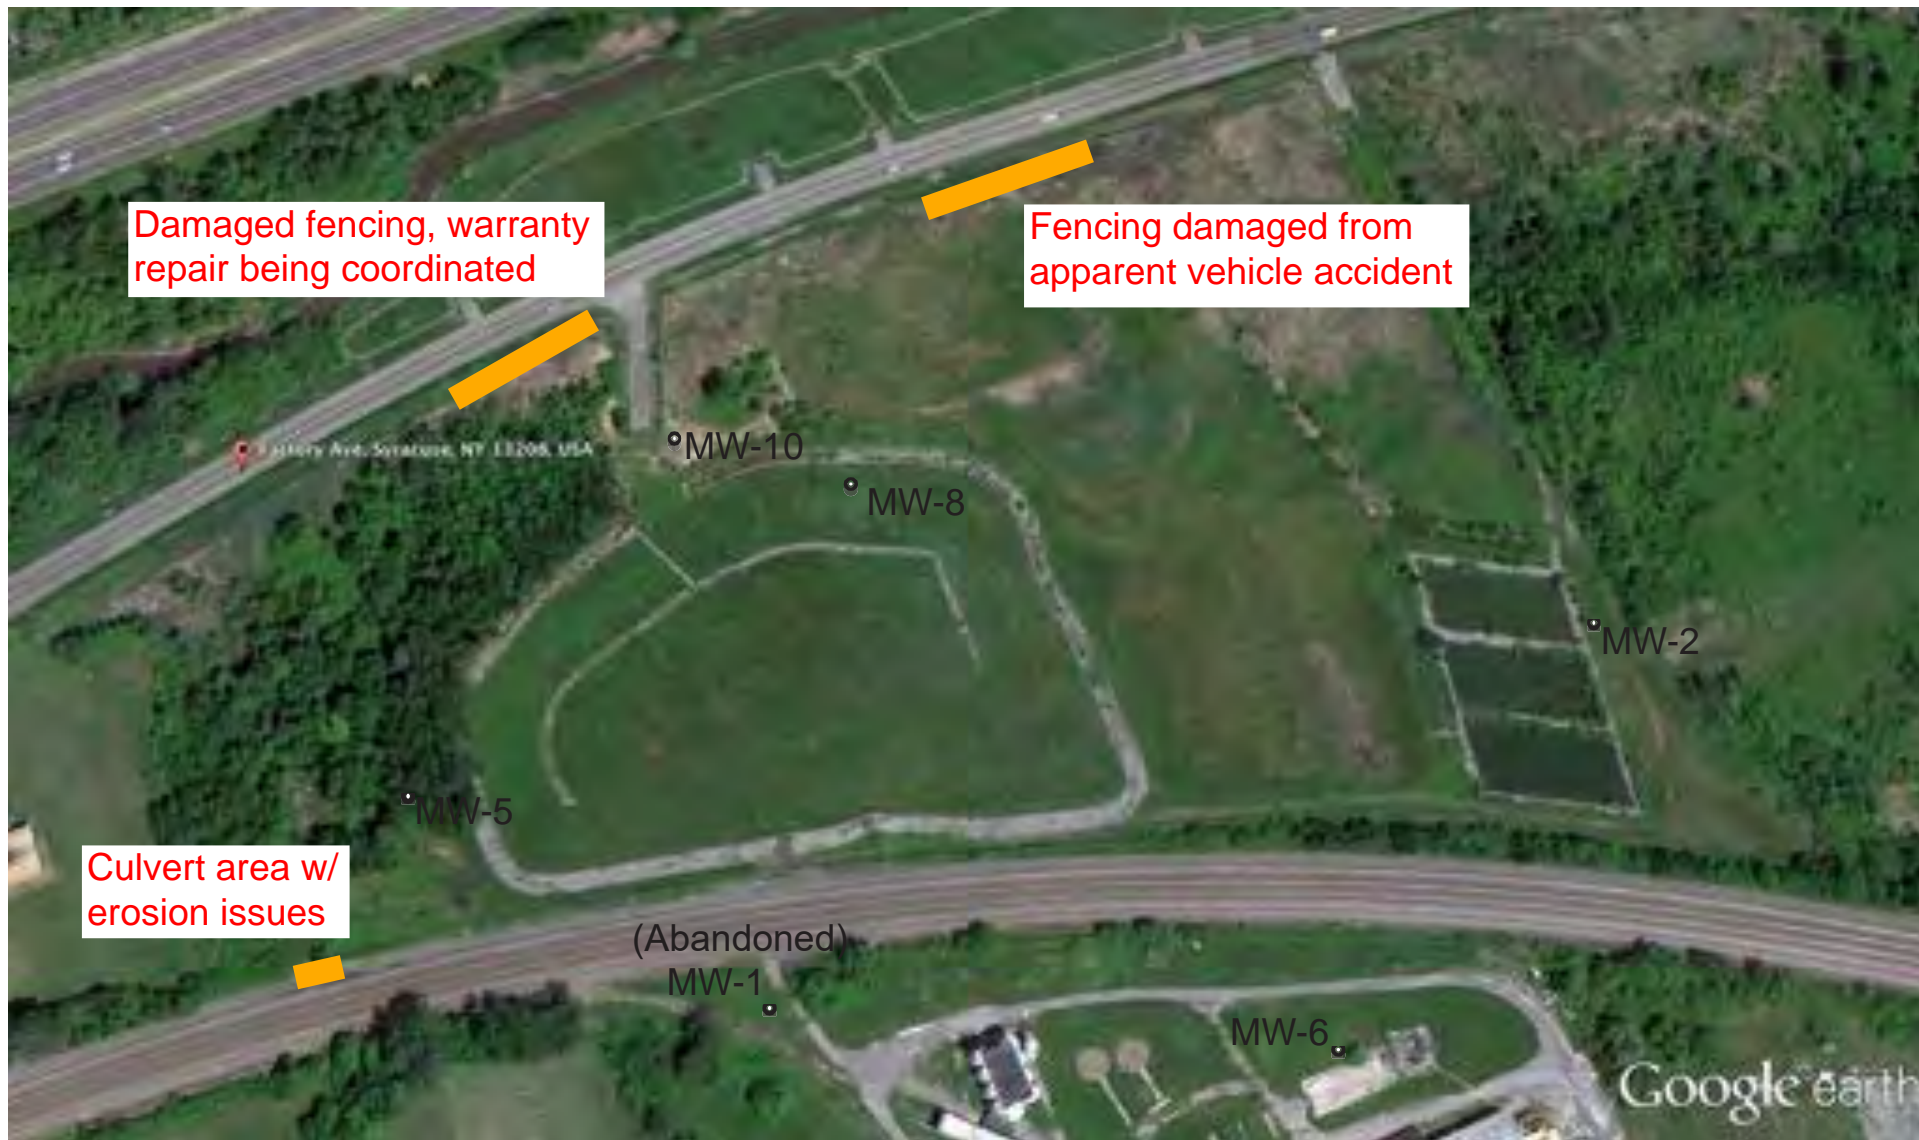
Site Feature Location Plan

Approximately 100 feet of fencing along the northern border/Factory Ave has begun to deteriorate due to oxidation of the support posts. Fencing contractors have been contacted and warranty-repair is being coordinated with the contractor. An additional, approximately 150 feet of fencing along the northern border/Factory Ave have been damaged. Damage appears to have been caused by a vehicle accident. Broken pieces of autobody parts/plastic/debris were scattered throughout this area of damaged fencing. Repair of this area will occur concurrently with the warranty repair work. Figure 2 identifies the approximate locations of these two areas.

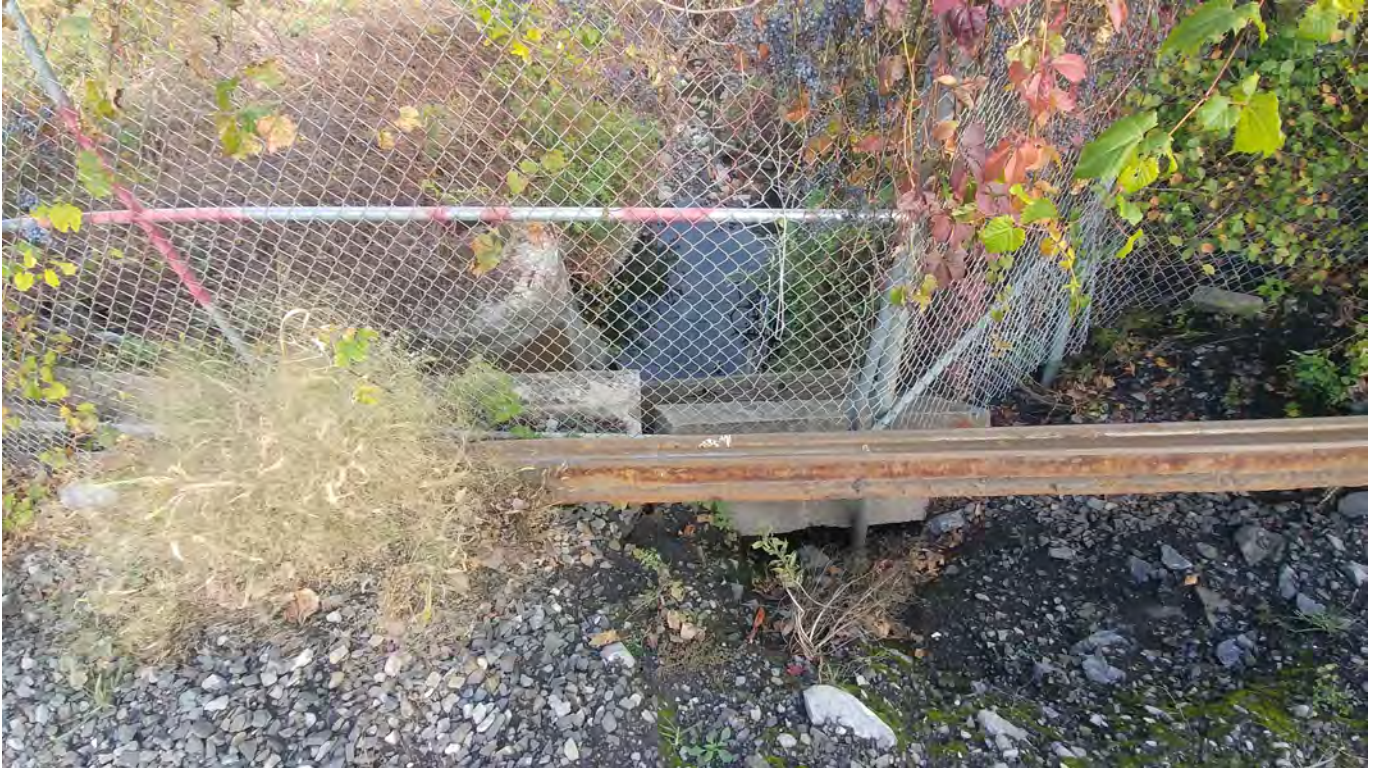
Culvert Area

A culvert that runs beneath the CSX railroad tracks and exits along the southern border of the site has lost integrity due to erosion. There is approximately 40 feet of fencing in the vicinity of the culvert that is in danger of being destabilized as a result of the culvert deterioration (pictures have been included within Appendix B). Ownership of the culvert is being determined so that the appropriate party can be contacted to undertake the necessary repairs. As an alternative approach, an evaluation is being made of the feasibility of relocating the fence away from the culvert. However, relocation would either need to avoid the adjacent CSX railroad right-of-way or permission from CSX would need to

be obtained. An update will be provided at the conclusion of the evaluation of these various alternatives.
