April 1, 2021

Re: Annual Landfill Inspection Report (Year 17)  
Syracuse China Landfill  
Town of Salina, Onondaga County, New York  
NYSDEC Site Number 7-34-053

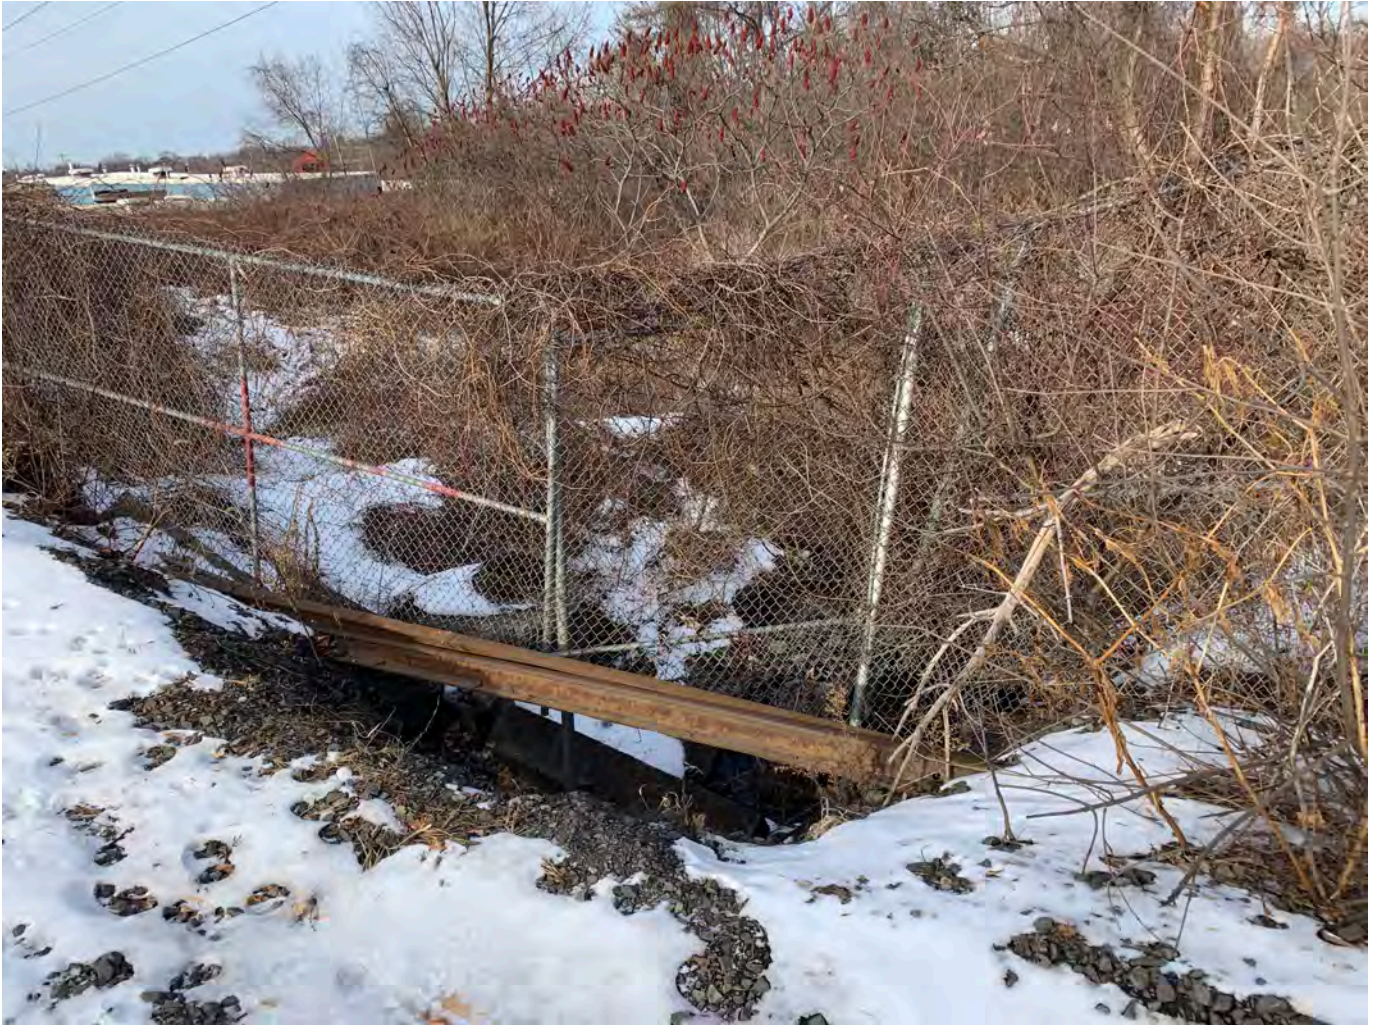
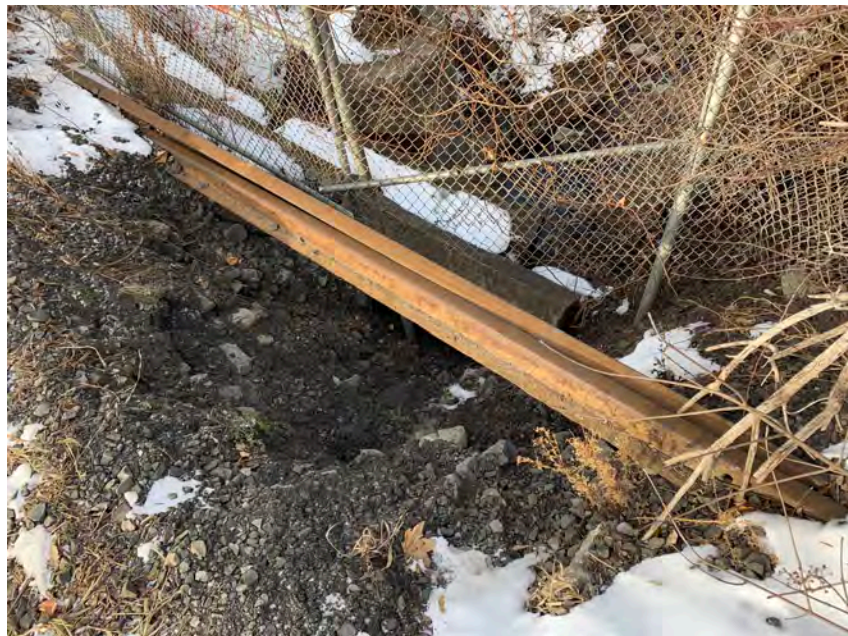
## Culvert Area

A culvert that runs beneath the CSX railroad tracks and exits along the southern border of the site has lost integrity due to erosion. There is approximately 40 feet of fencing in the vicinity of the culvert that is in danger of being destabilized as a result of the culvert deterioration (pictures have been included within Appendix B). Ownership of the culvert is being determined so that the appropriate party can be contacted to undertake the necessary repairs. As an alternative approach, an evaluation is being made of the feasibility of relocating the fence away from the culvert. However, relocation would either need to avoid the adjacent CSX railroad right-of-way or permission from CSX

would need to be obtained. An update will be provided at the conclusion of the evaluation of these various alternatives. Photographs are included within Appendix B.

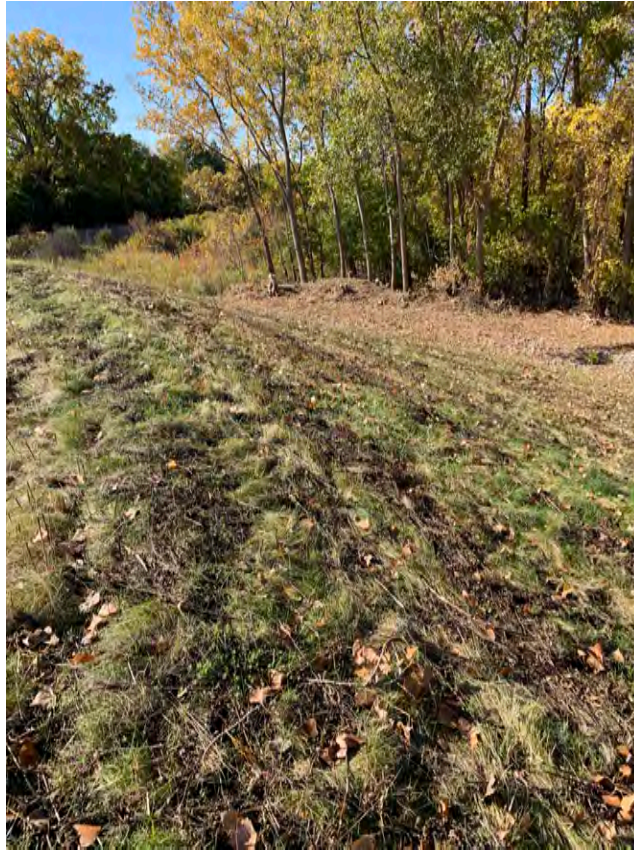
## Toe Maintenance Area

In addition, tree and brush overgrowth along the toe in the northwest corner of the landfill was removed. Photographs documenting maintenance activities along the toe are included within Appendix B.
