April 6, 2022

Re: Annual Landfill Inspection Report (Year 18)
Syracuse China Landfill
Town of Salina, Onondaga County, New York
NYSDEC Site Number 7-34-053

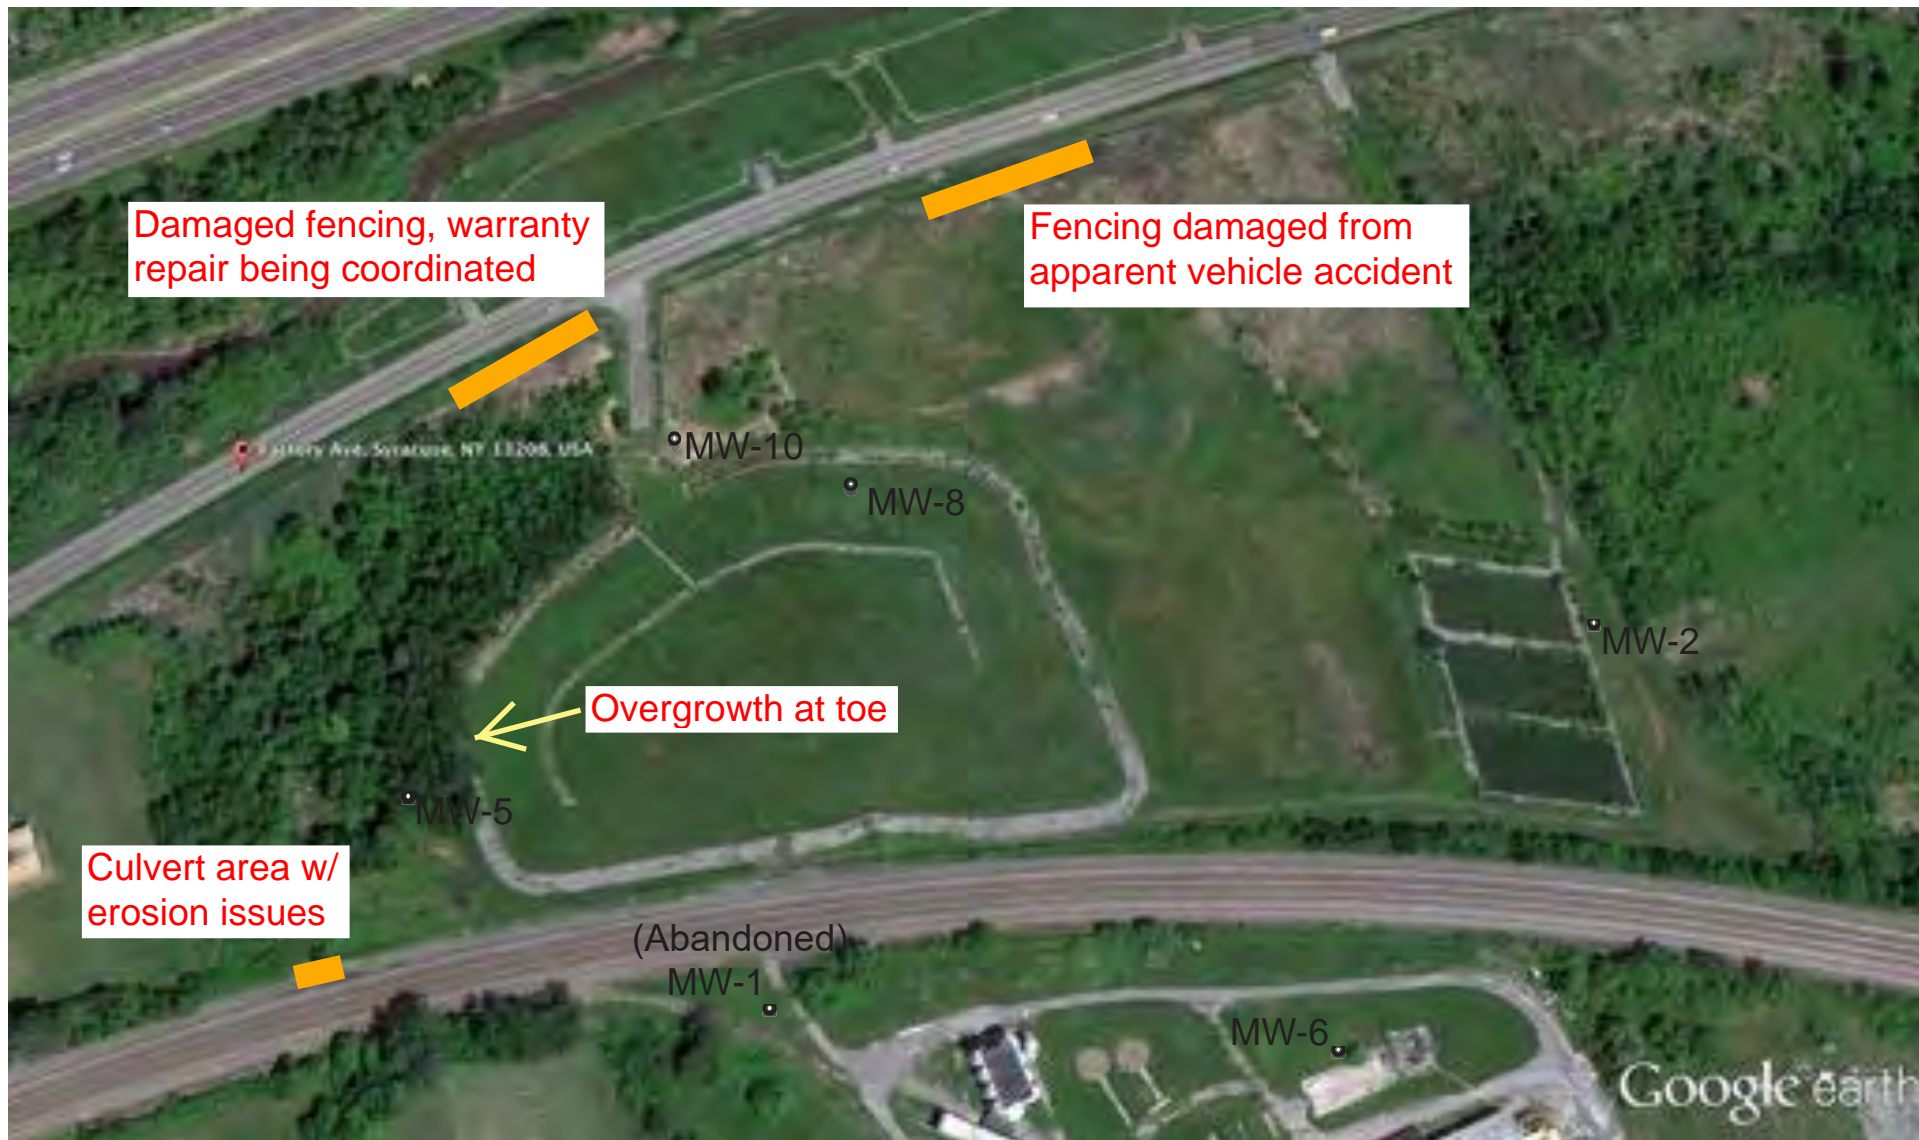
Site Feature Location Plan

An area of fencing at the west side of the culvert area has also been compromised. Stone was piled against the fencing, bending the support post and creating a large gap in the fencing. Figure 3 identifies the approximate locations of these areas. It is recommended that Onondaga County, CSX, NYSDEC and Rocterra representatives meet on site to discuss the fencing/culvert/failed slope area. Photographs are included within Appendix B.

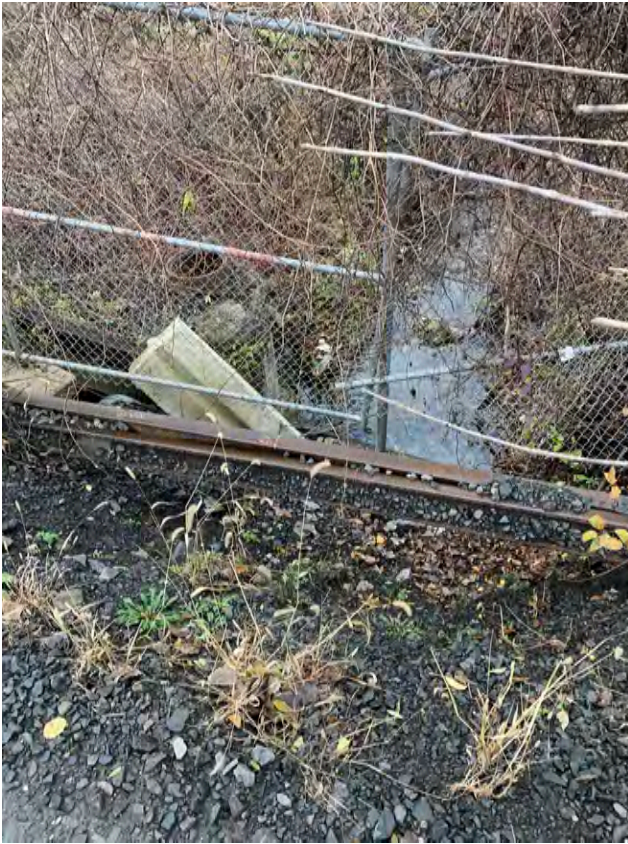
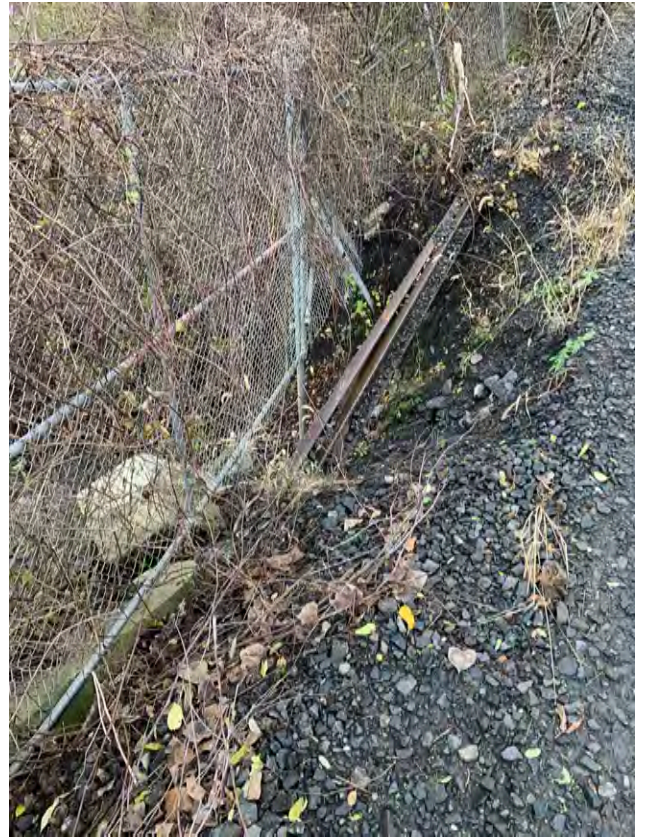
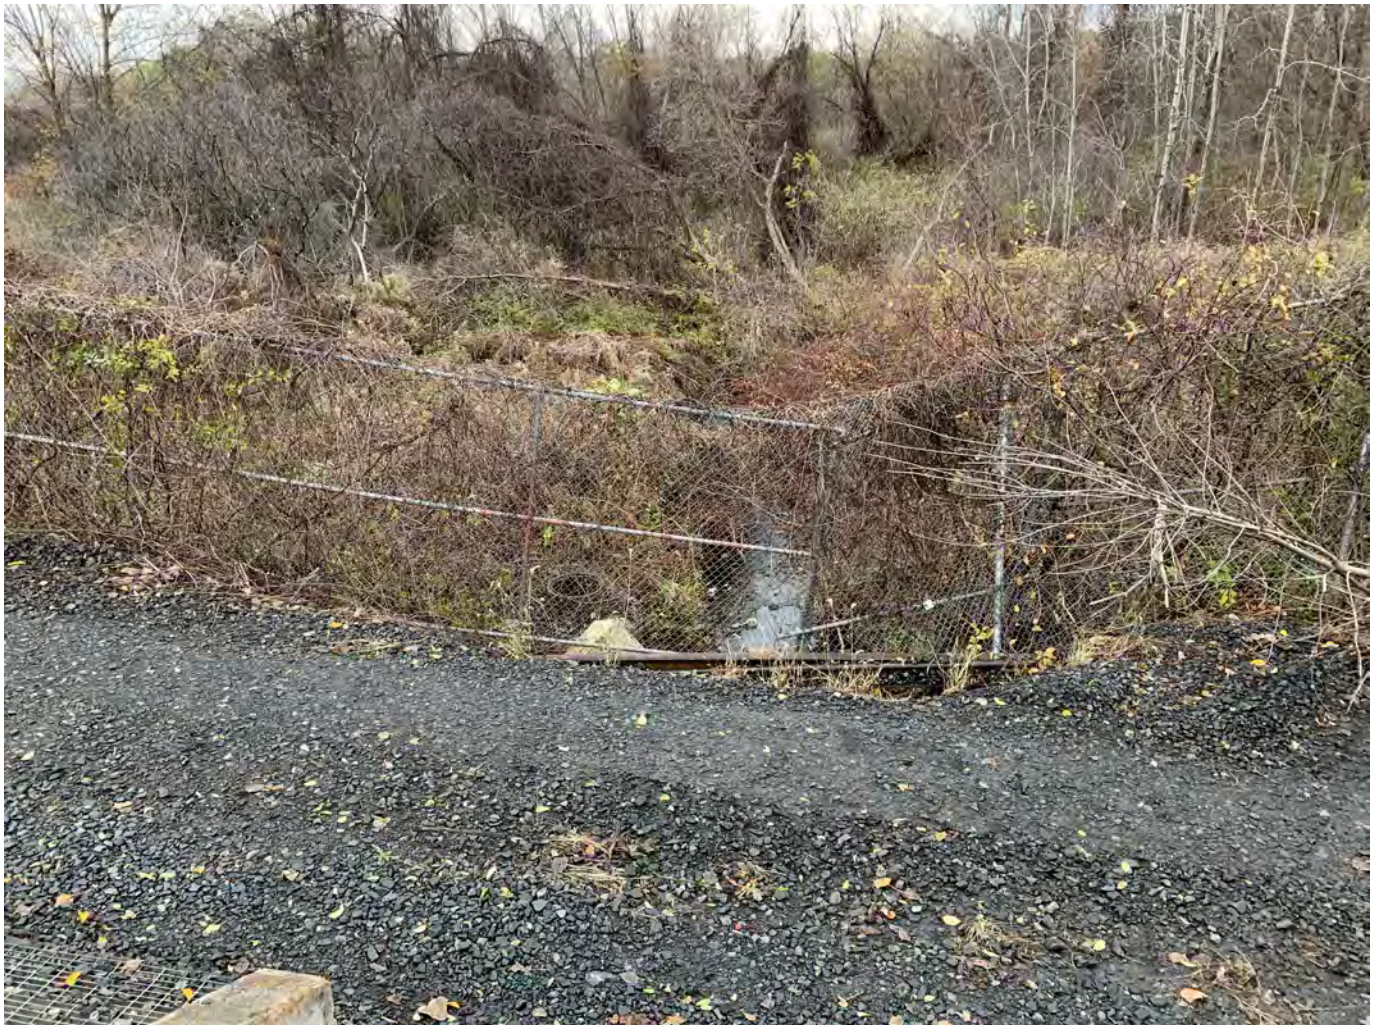
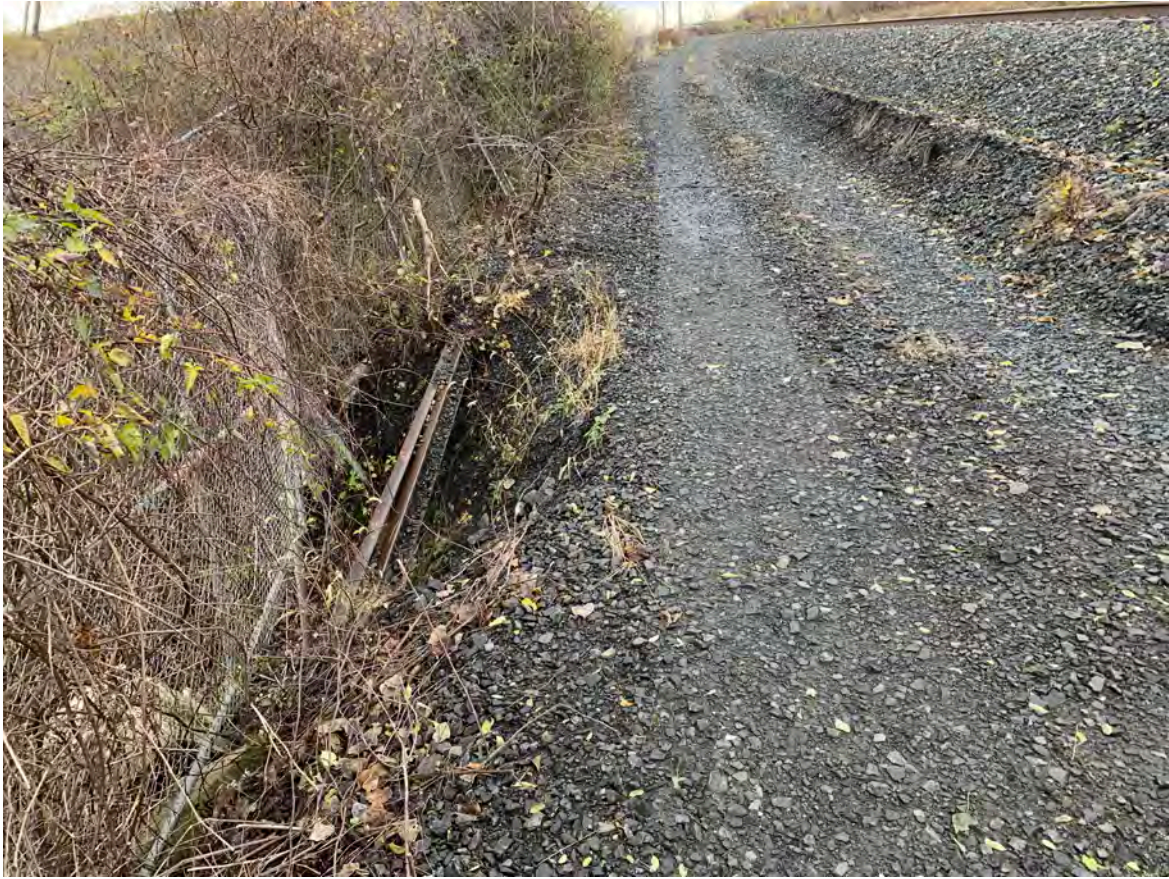
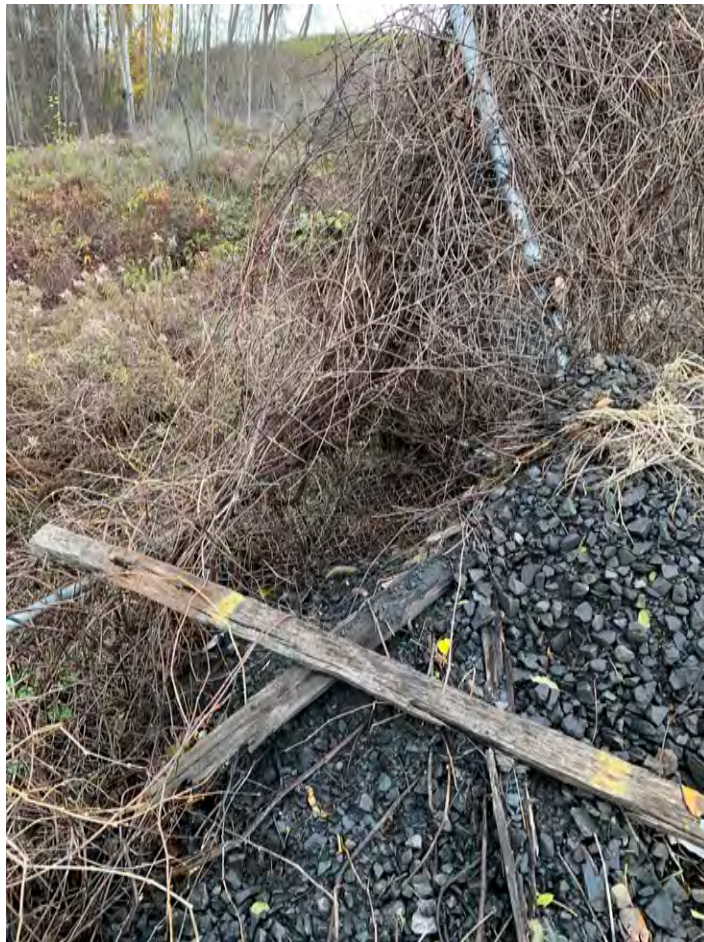
Culvert Area

A culvert that runs beneath the CSX railroad tracks and exits along the southern border of the site has lost integrity due to erosion. There is approximately 40 feet of fencing in the vicinity of the culvert that is in danger of being destabilized as a result of the culvert deterioration (pictures have been included within Appendix B). Upon review of as-built documents and evaluating the area in-person, the feasibility of relocating the fence

away from the culvert would conflict with the CSX railroad right-of-way. Photographs are included within Appendix B.
