March 31, 2023

Re: Annual Landfill Inspection Report (Year 19)
Syracuse China Landfill
Town of Salina, Onondaga County, New York
NYSDEC Site Number 7-34-053

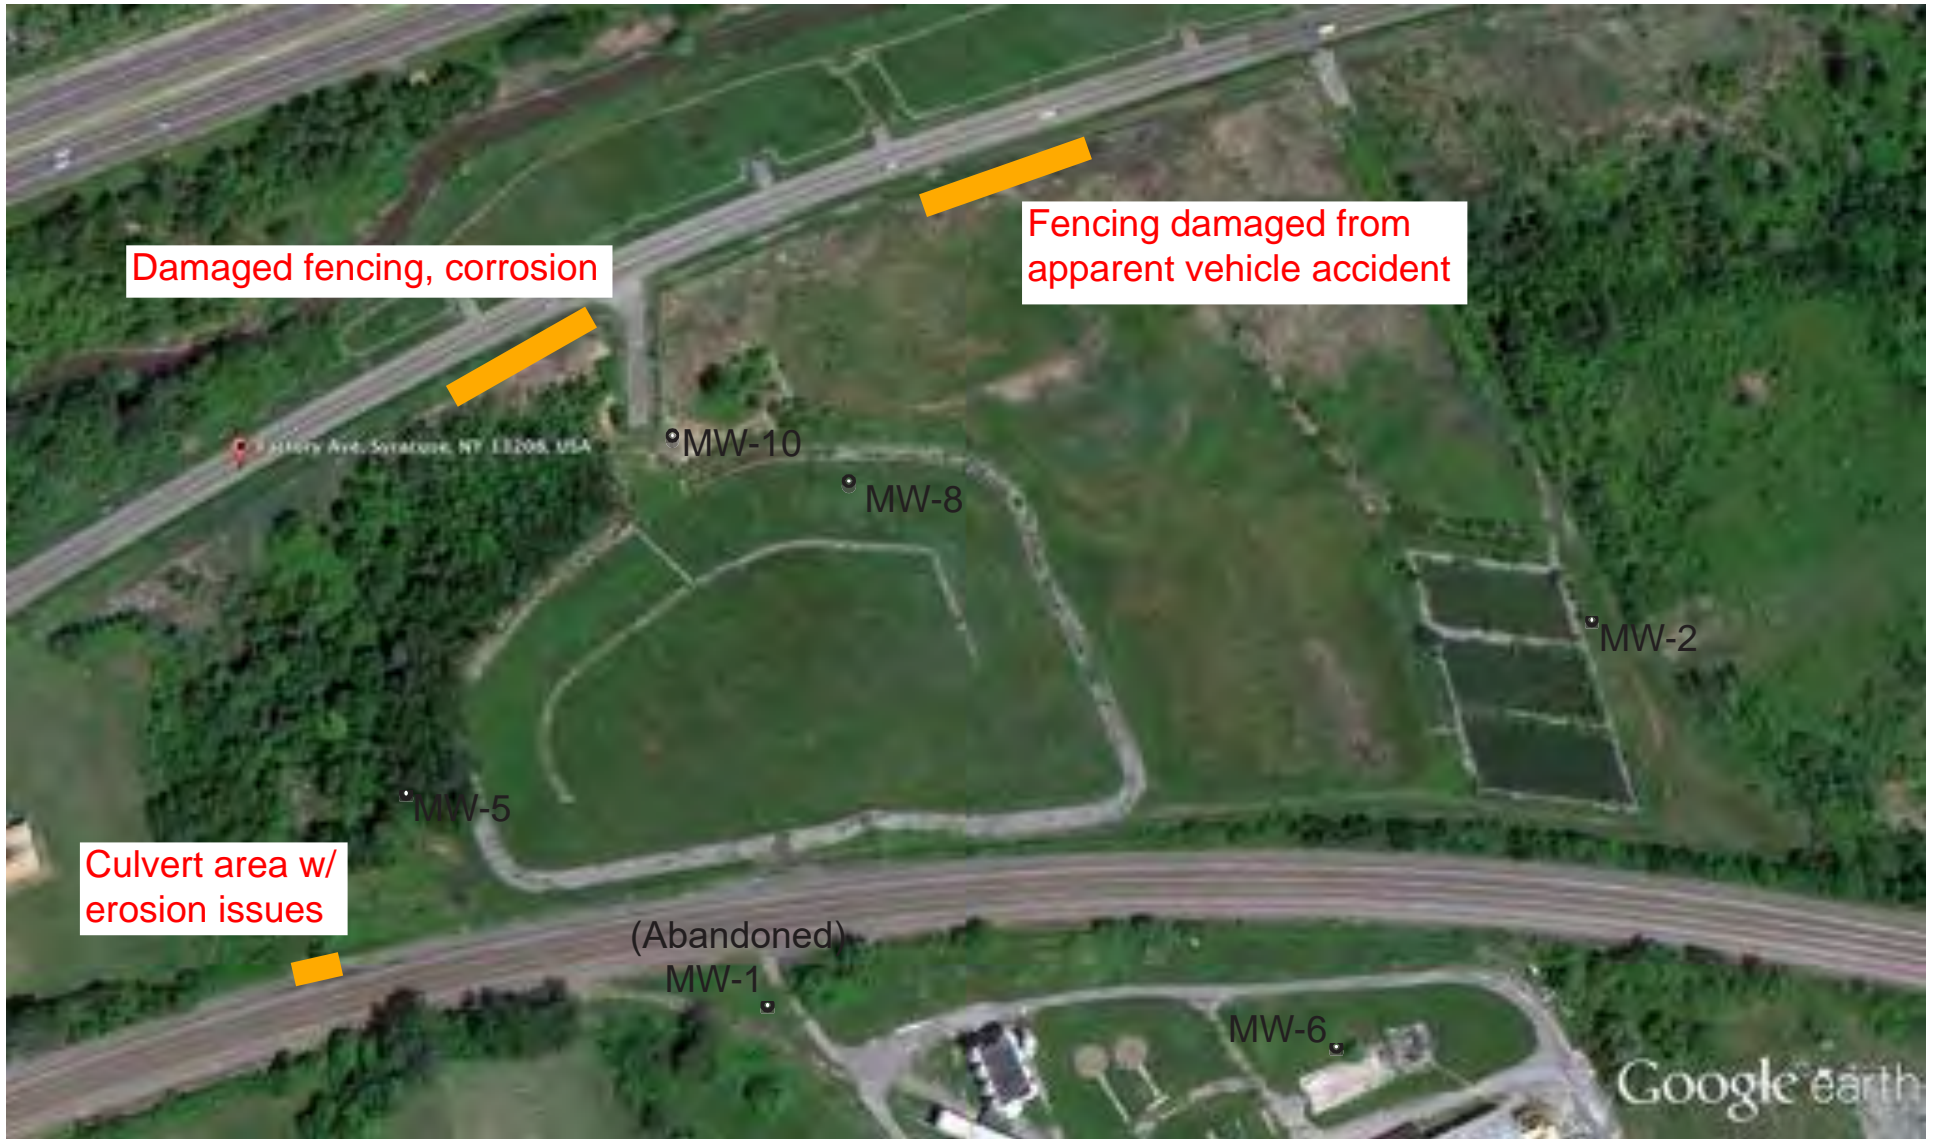
Site Feature Location Plan

Approximately 200 feet of fencing along the northern border/Factory Avenue has begun to deteriorate due to oxidation of the support posts. An additional, approximately 200 feet of fencing along the northern border/Factory Avenue have been damaged. Damage appears to have been caused by a vehicle accident. Broken pieces of autobody parts/plastic/debris were scattered throughout this area of damaged fencing. In 2021 Atlas Fence Inc. was contracted to repair the sections of fencing along Factory Avenue. During utility notification activities, it was determined that there was a conflict with National Grid. Rocterra, National Grid and Atlas Fence representatives all met on site on June 9, 2021 to review the potential conflict. On June 22, 2021 National Grid determined that a ten-foot buffer would need to be maintained from the underground gas line as-marked. This would require an offset to the current fence line.

An area of fencing at the west side of the culvert area has also been compromised. Stone was piled against the fencing, bending the support post and creating a large gap in the fencing. In accordance with NYSDEC's authorization email, dated January 30, 2023, Rocterra installed construction-style plastic panels in the gaps of the fence on February 16, 2023.

Figure 3 identifies the approximate locations of these areas. Photographs are included within Appendix B.

A workplan was submitted to address these areas of concern on October 7, 2022. The Department responded with comments on November 4, 2022. A revised workplan was submitted to the Department on March 23, 2023. This work is anticipated to be completed during Spring of 2023.
