Re: Annual Landfill Inspection Report (Year 20)  
Syracuse China Landfill  
Town of Salina, Onondaga County, New York  
NYSDEC Site Number 7-34-053

Re: Revised Summary Letter  
Syracuse China Landfill  
Town of Salina, Onondaga County, New York  
NYSDEC Site Number 7-34-053

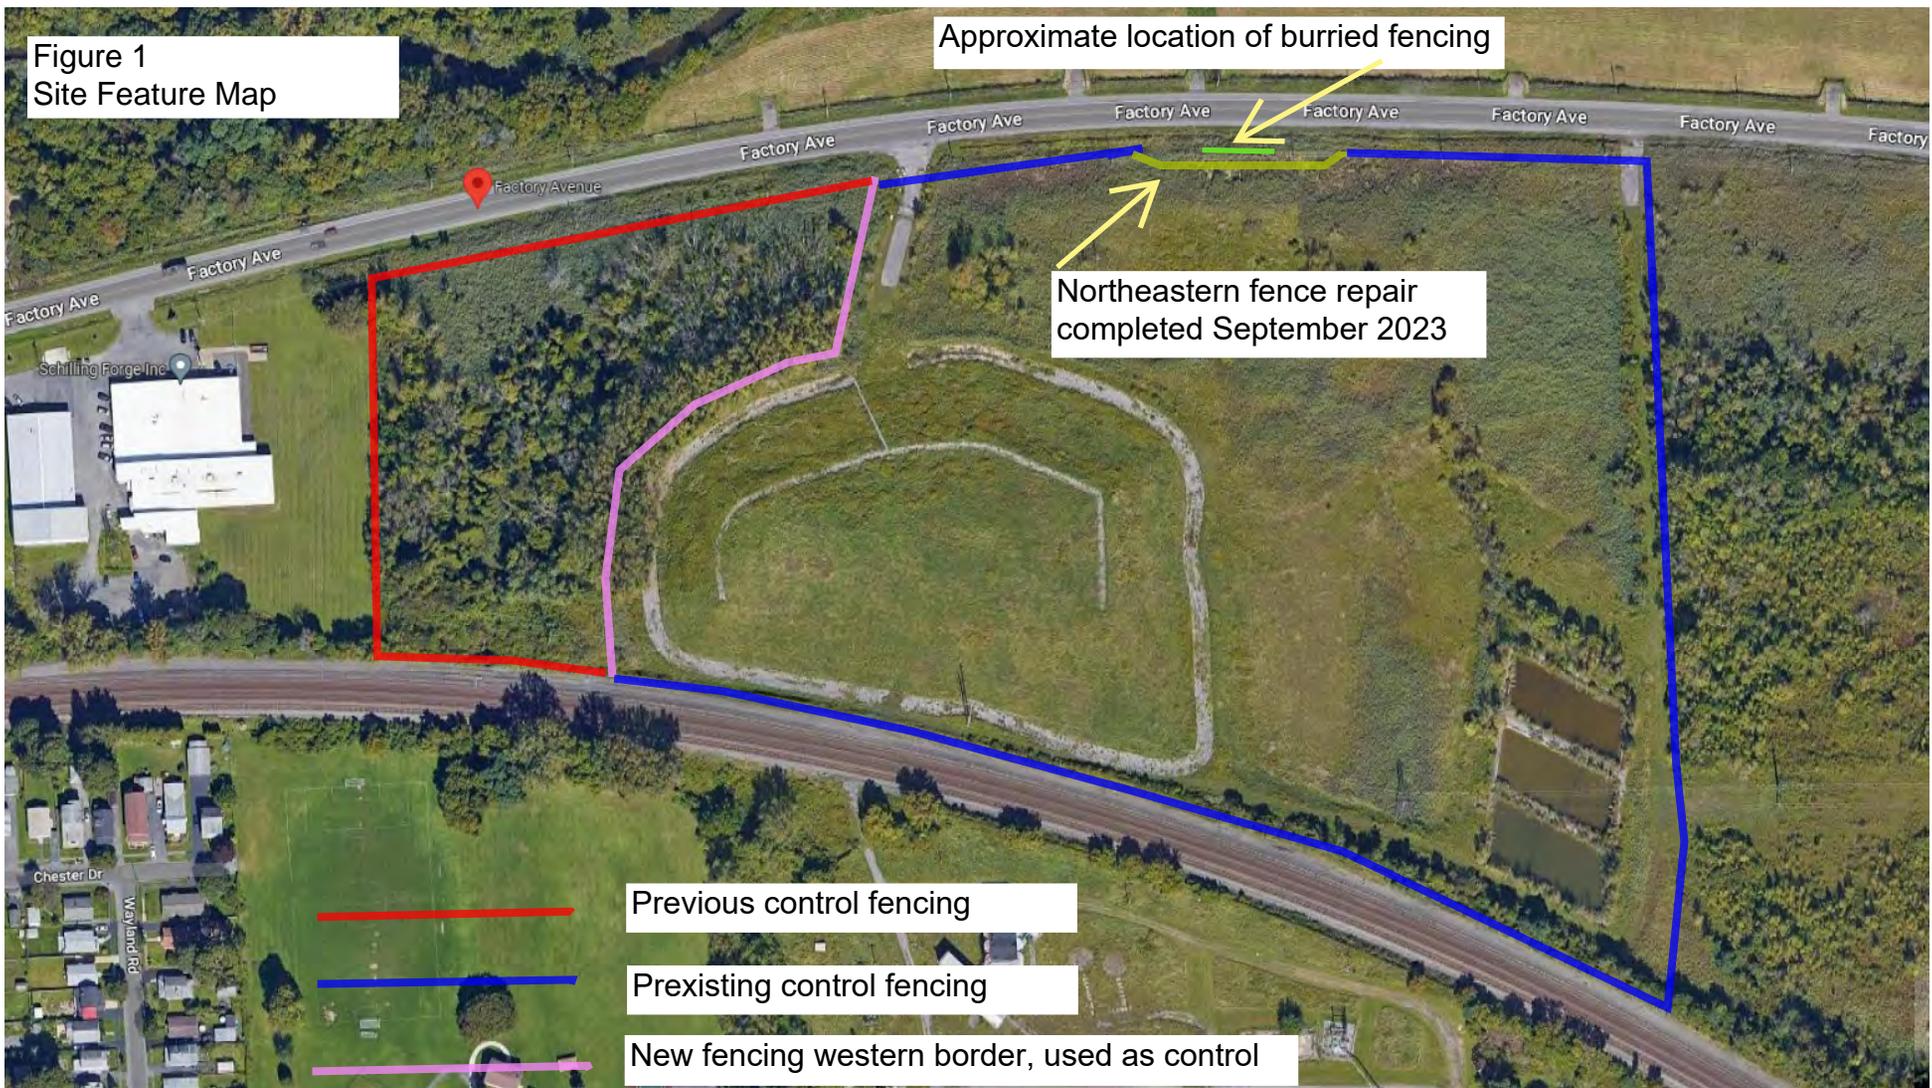
Figure 1  
Site Feature Map

In response to these requests a modified figure (Figure 1) has been included with this summary letter identifying the above items. The pre-existing fencing to the west of the newly installed fence remains in place.

Approximate location of buried fencing

Northeastern fence repair  
completed September 2023

Previous control fencing

Preexisting control fencing

New fencing western border, used as control

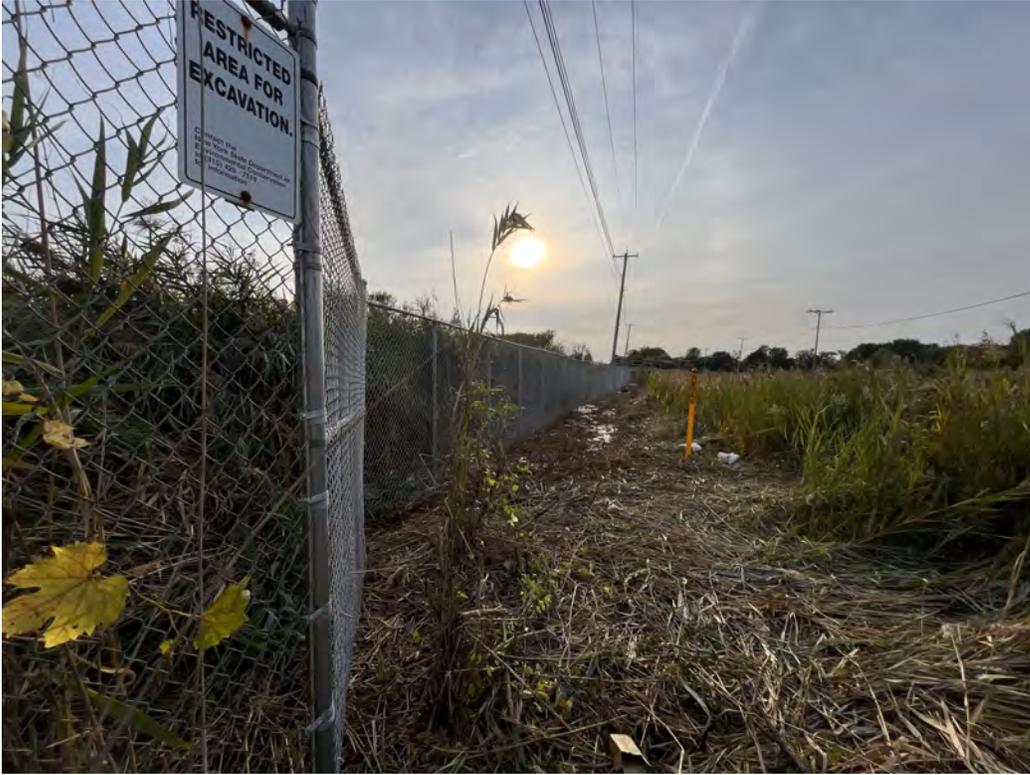
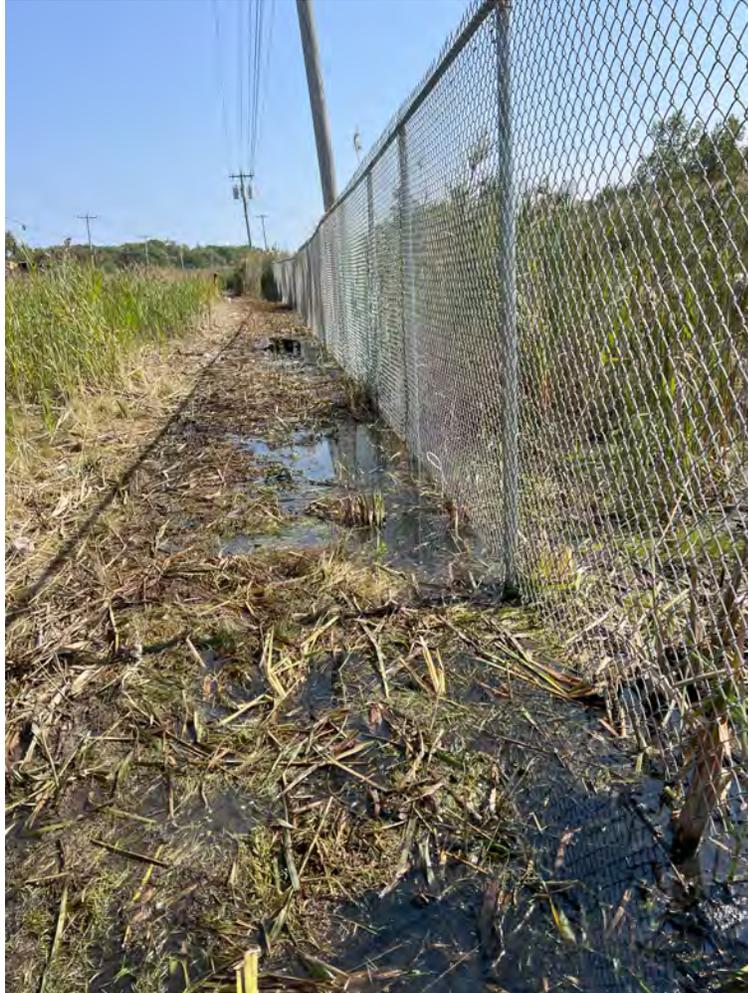
# Northeastern Fence Repair

Approximately 150 feet of fencing along the northern border/Factory Avenue had been damaged. The damage appeared to have been caused by a vehicle accident. In 2021, Atlas Fence Inc. was contracted to repair the sections of fencing along Factory Avenue. During utility notification activities, National Grid had concerns with regards to the location of the fence line in relationship to the nearby underground gas line. Rocterra, National Grid and Atlas Fence representatives all met on site on June 9, 2021 to address National Grid's concerns. On June 22, 2021, National Grid determined that a ten-foot buffer would need to be maintained from the underground gas line as-marked.

Some sections of fencing were fully submerged/buried and were left in place. An approximately 40-foot section is located approximately 90 feet from the westernmost start of the repair area and it is located between the new fence and Factory Avenue. This section would have required invasive excavation with heavy equipment and a greater level of disturbance than the six-inch estimate within the initial workplan dated February 23, 2023.

The scope of work included the removal of approximately 194 feet of existing galvanized chain link fencing located along Factory Avenue and the installation of approximately 210 feet of new galvanized chain link fencing. These repair activities were completed in September 2023.

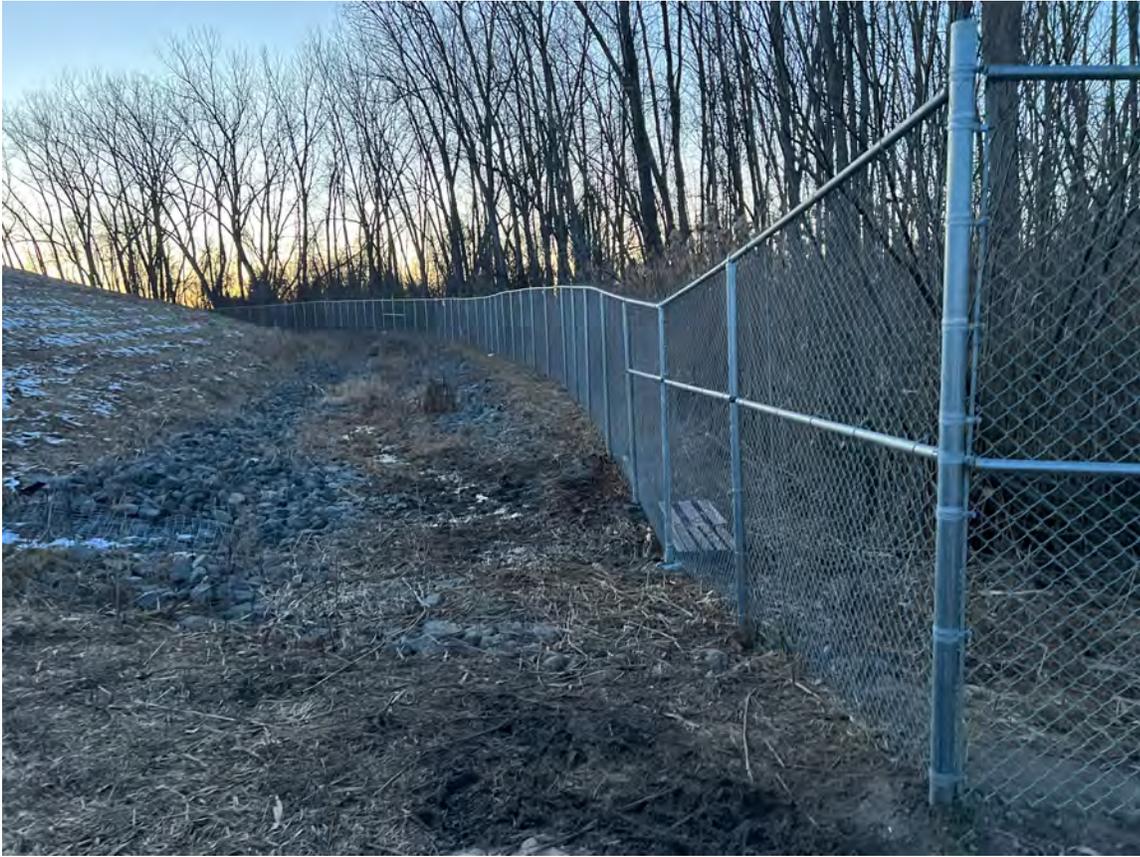
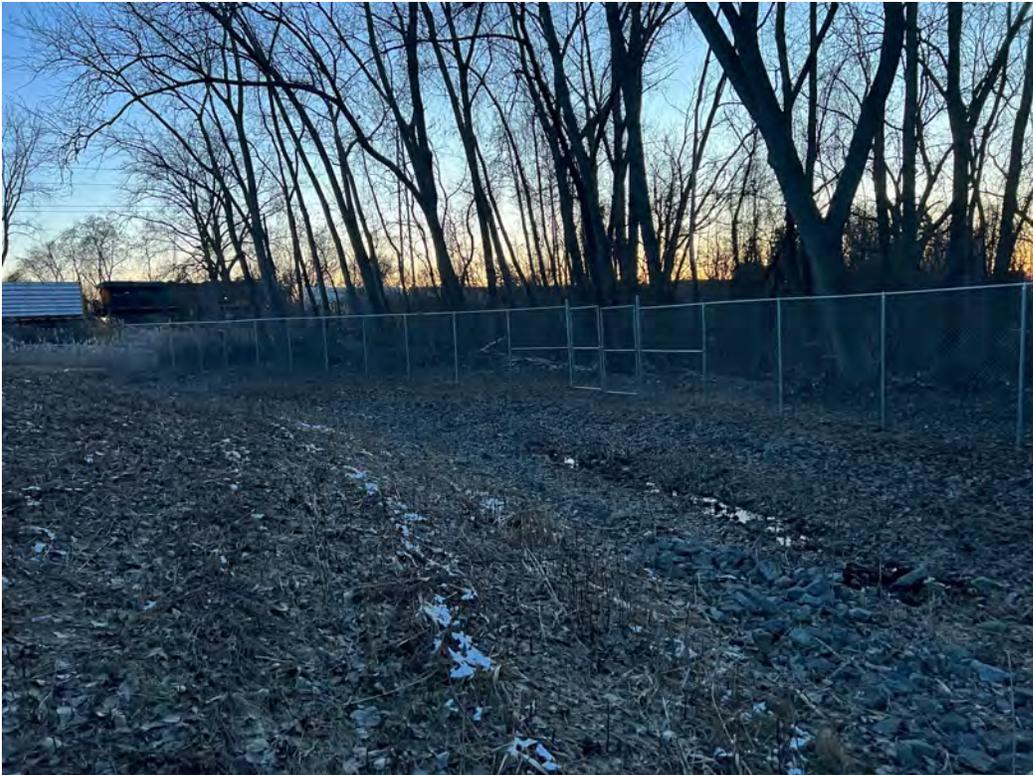
# New Fencing Western Border

A culvert that runs beneath the CSX railroad tracks and exits along the southern border of the Site has lost integrity due to erosion. There are approximately 40 feet of fencing in the vicinity of the culvert in need of repair.

In addition to the culvert area, there is approximately 194 feet of existing galvanized chain link fencing located along Factory Avenue in the northwestern corner of the Site that has lost integrity due to corrosion.

As an alternative approach to replacing both areas in kind, an entirely new section of fencing was installed connecting the southern and northern fence lines. These installation activities were completed in December 2024.
