**Storm Sewer Rehabilitation IRM
Former Inland Fisher Guide Facility
Syracuse, New York
(Site No. 7-34-057)**

General Motors Corporation
Syracuse, New York

October 2002

O'BRIEN & GERE
ENGINEERS, INC.

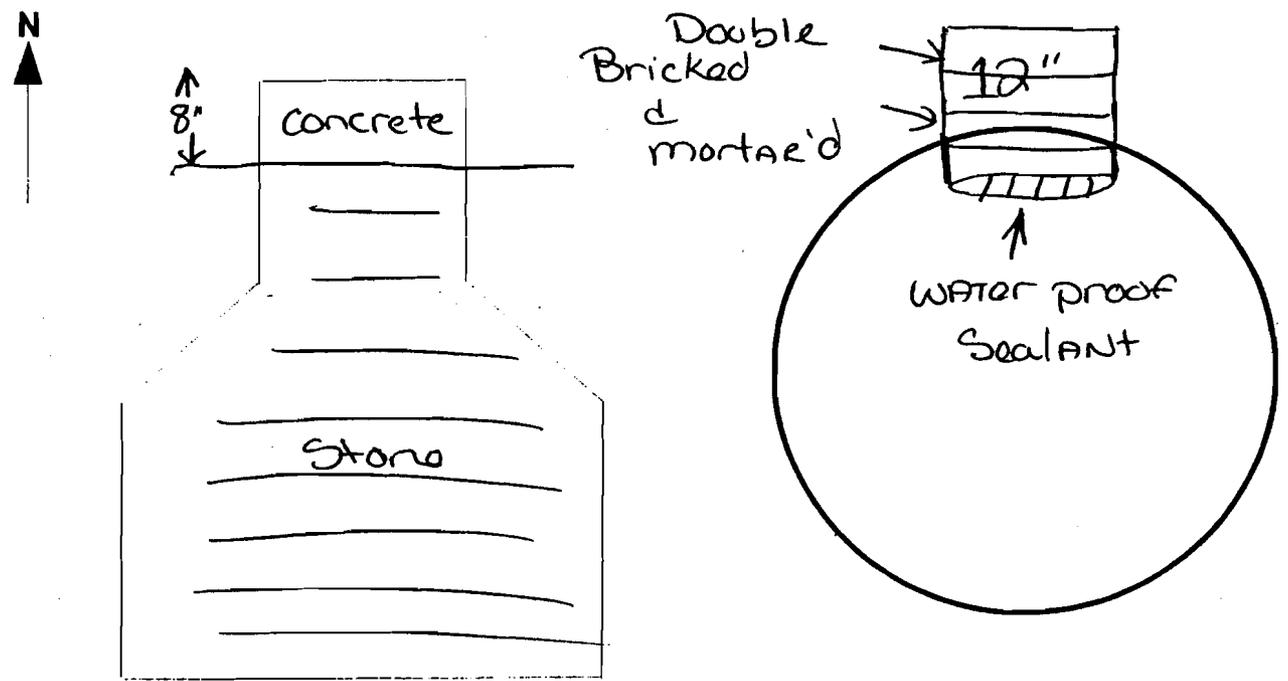
Manhole #: BK2 Sewer Branch: Eastern Date: 6-801

unable to Install mechanical Plug Because
the End of the pipe was Badly out of Round
