**PROJECT:** Former Carlyle Compressor Site

NYSDEC Site Code - 734068

Periodic Review Report, 2019

# Periodic Review Report September 30, 2019

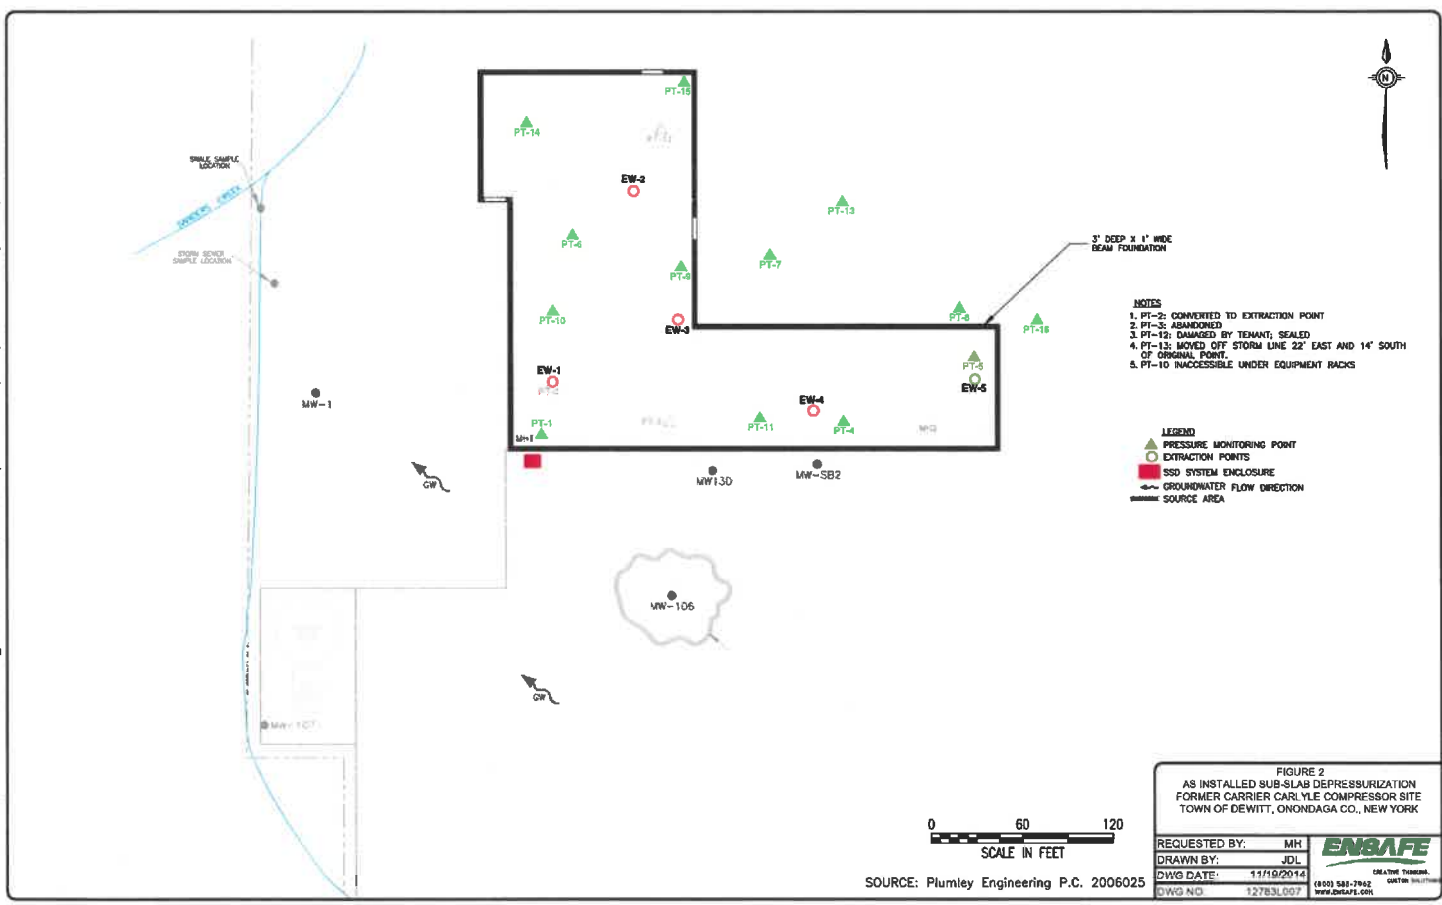
**Figure 2**  
**Sub-Slab Depressurization Layout**

Until January 2018, operation and maintenance of the SSDS has been sufficient. From January 2018 to June 2019, the system was not operating due to a malfunctioning motor blower. In June, the owner replaced the blower motor, and the vacuum to the floor slab was reinstated, according to the facility owner's consultant. Remote access/communication between the vapor mitigation system and the system operator is not currently online; however, as discussed above, the facility owner should repair this system to effectively monitor system performance.

It is recommended the SSDS performance be inspected at least quarterly by the facility owner's management. Furthermore, the facility owner should repair the remote access/communication system that allows the system operator to remotely monitor the SSDS. Carrier's consultant, EnSafe, will coordinate with facility owner management to perform an inspection of the SSDS in October 2019.
