Columbia Mills Dye Tests

Monitoring Well Inventory, 6/18-19/09

Photos with Notes

Report by
Will Welling

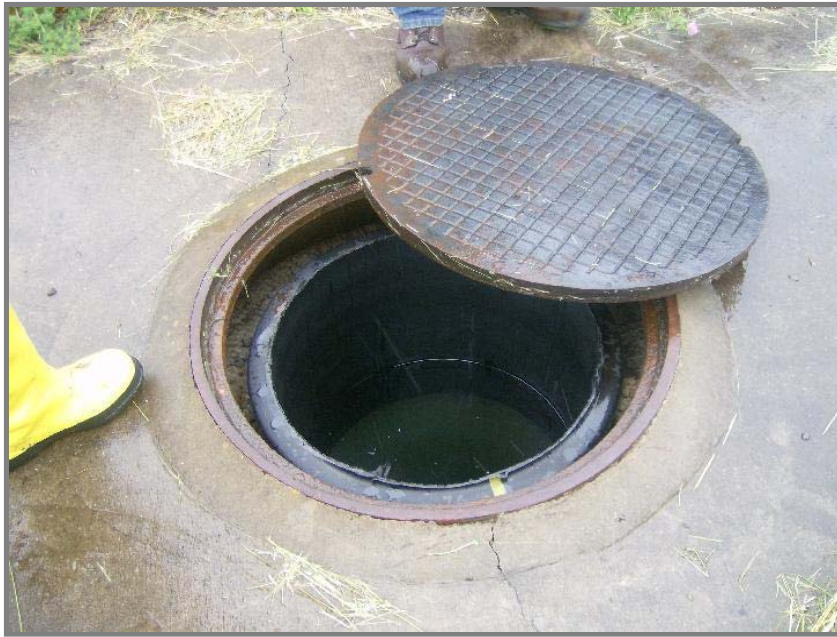
Manway riser, cover off. Water levels in both the tank and the manway riser were the same. Eventually we figured out that the influent line's collar connection to the leachate tank in the manway riser was leaky. When the leachate tank filled up, the leak allowed water to fill the manway riser and equalize to the same level as the full tank.

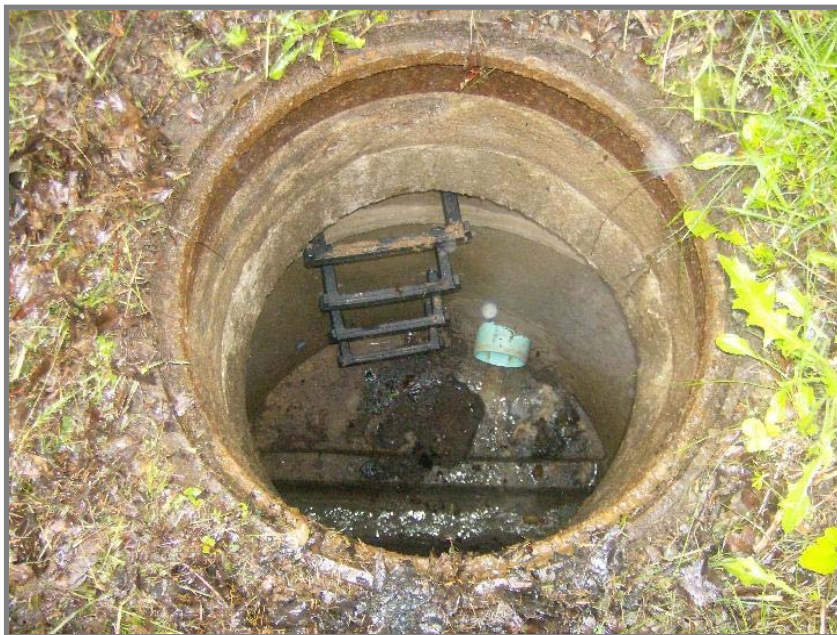
At 3:15PM we opened the sewer manhole cover approximately 1000 feet away. This manhole has a central sewer flow and two pipes which enter obliquely. One pipe, presumably a sewer pipe, was a 6" green pipe plastic pipe and another which was 4" white plastic (see the next photo).

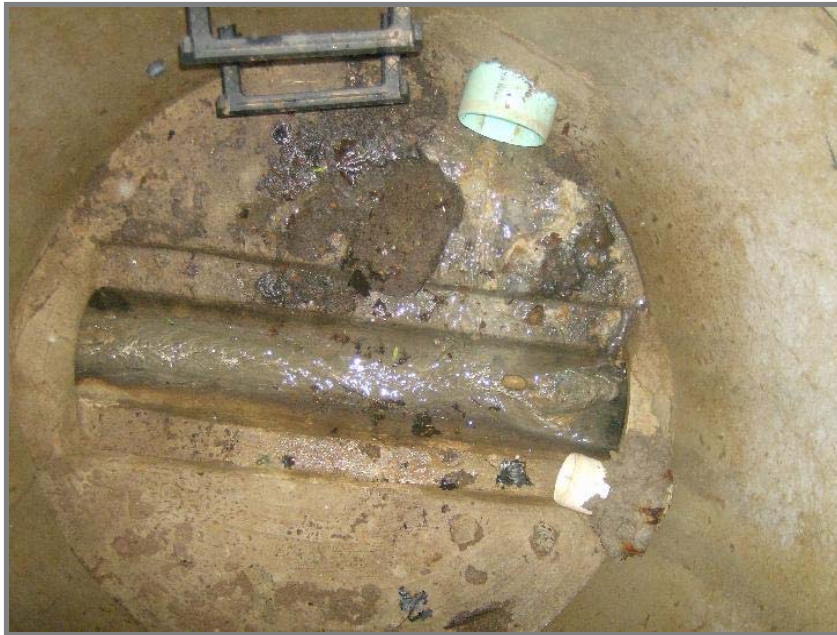
Better shot of the initial conditions inside the sewer manway. The green pipe (top) is a residential sewer connection, the white pipe is our leachate line into the sewer.

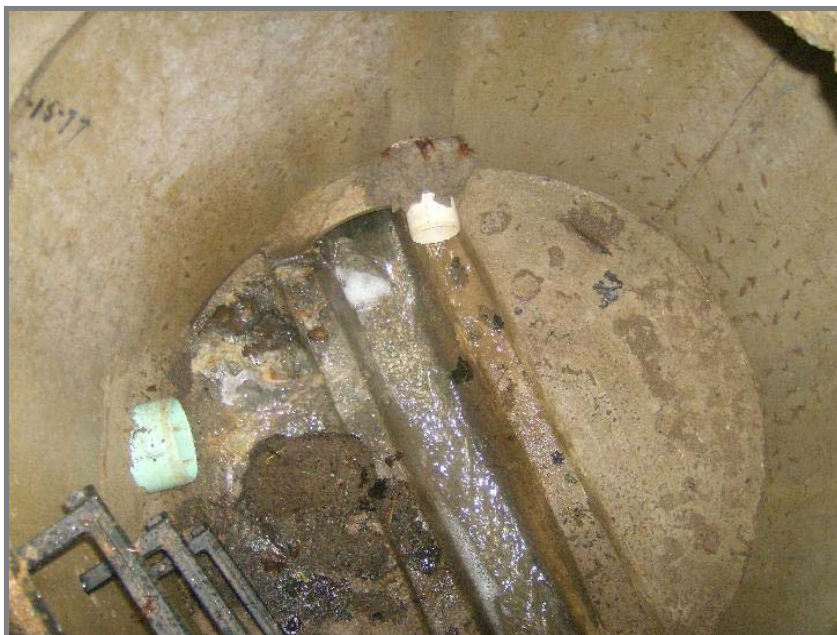
At 3:18 PM we saw slightly increased central sewer flow. Jeremy had opened the valve in the leachate manway. This valve had been in the closed position. At 8 minutes (3:18) we saw flow increase in the green pipe. Toilet flush?

3:45PM The green sewer pipe has just about stopped. There has been no color change to the flow from this big pipe.

3:45:30 There is now flow from the white pipe. Not much, but some flow. It's clear aside from some pieces of organic matter like dirt. Leaf pieces and "chunks" are coming out with the water. Maybe this pipe hasn't had water flowing in it for a while and this little bit of flow is flushing it out.

4:01 Greywater flows out of the green pipe. Makes suds. No color change at the white pipe.

4:50 Another greywater flow. For the rest of the day we saw water flow from the leachate pipe in the sewer but we saw no dye.

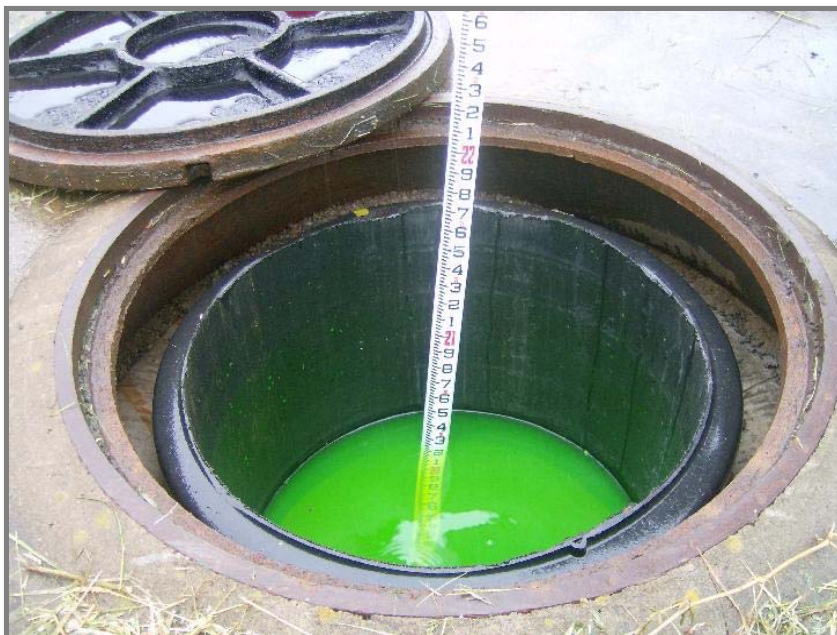
Some measurements at the tank: One side (manway riser) has a depth of 16.6 feet and the other side has a depth of 21.7 feet. Why doesn't the shallower one have an inlet/outlet that we can feel with the stadia rod?

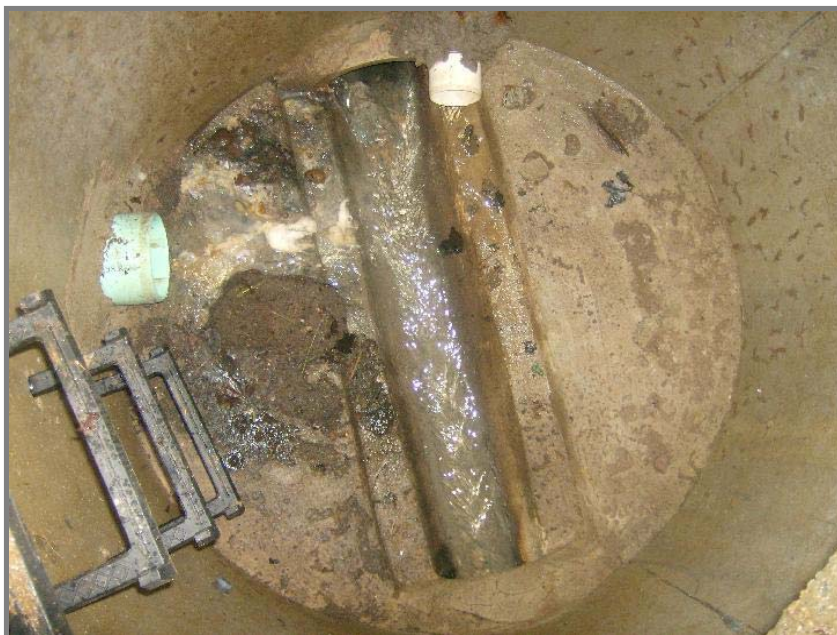
6:00PM Back at the sewer. No change in color coming from the white pipe or the big pipe down the middle. Leachate pipe still flowing clear.

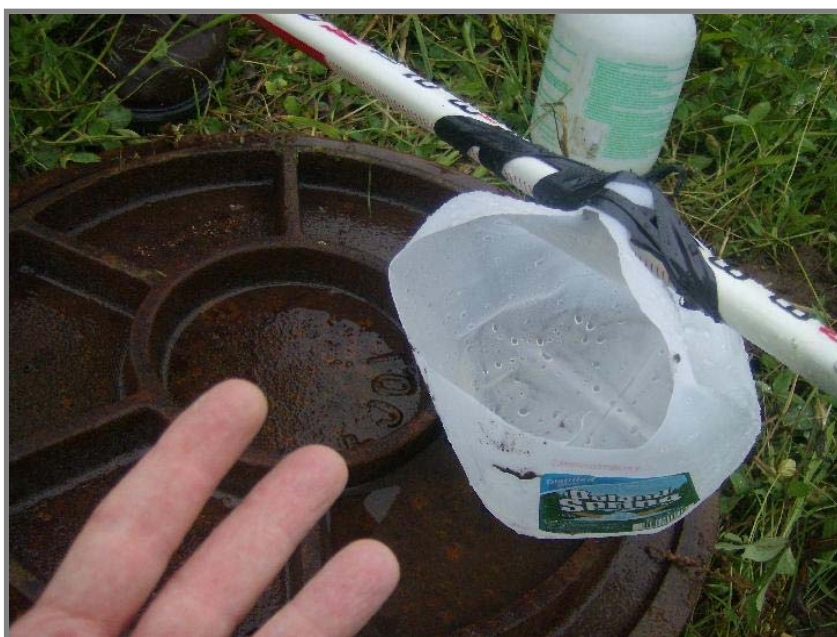
6:15 Jeremy dipped three samples one each from three pipes inside "the vault." Photos. In the photos, three fingers means the third pipe, the middle finger ("the bird") means the middle pipe and the index finger means first pipe. All dipped water samples are clear. This is a disappointment. We've dyed 10,000 gallons of water and the water coming out of the pipes is completely clear!

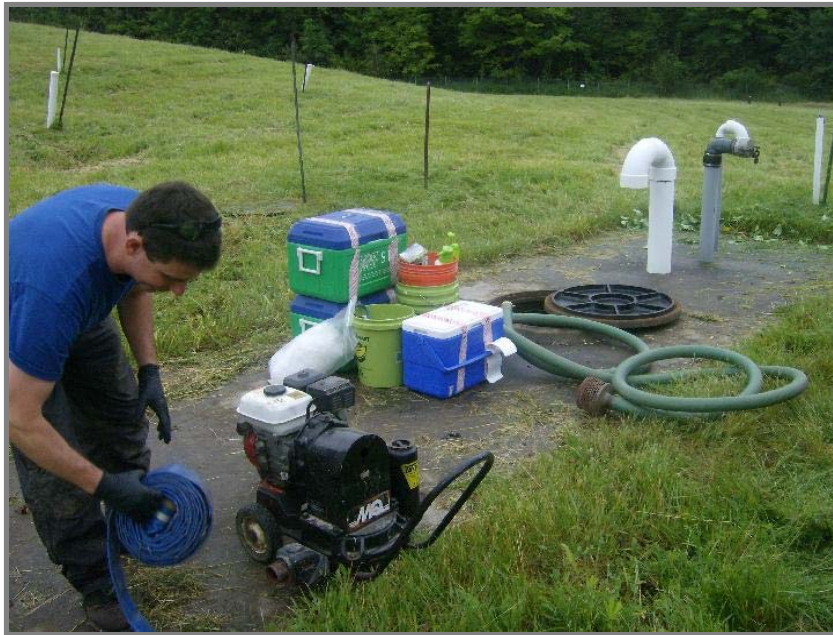
Friday we obtained a diaphragm pump. We pumped water here and there testing various theories. We drained the manway riser and discovered a leaky collar joint.

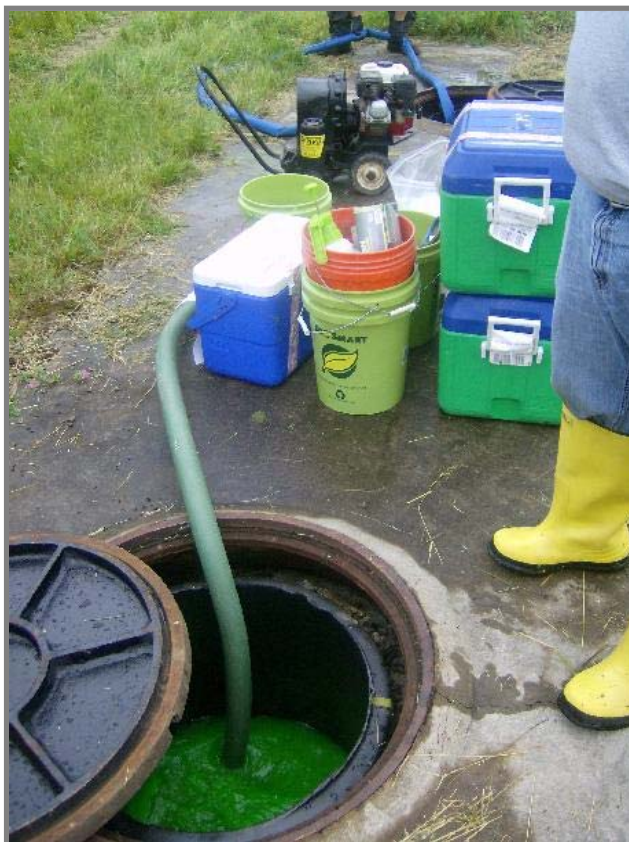
1:30 PM We've done a lot of work this morning and I haven't written much down. We've had success with the dye-tracing. The rain ended at about 11 (it had been lightly raining and misting) and so now I am able to put down the pencil and write my notes in ballpoint pen.

Summarizing the flows we traced: landfill "groundwater" is collected and piped to the vault in two pipes, each with a valve on the end of the pipe in the vault. One leachate system pipe discharges to the vault. It has no valve in the vault. This is the pipe we called "3" and the middle one was (the bird) and the other one was pipe #1. Leachate flows in two pipes to the tank. There is a valve at the entry to the tank (down in the man-way riser) and we believe this connection is leaky. When this valve is off (or when

the tank is full) water backs up and if valves are open to sewer and/or the vault are open, water flows there. We saw that the valve into the tanks was open. Up hill a few feet, until we opened the leachate valve to the sewer (one of the two small manholes) no water was flowing into the sewer (the white pipe). The second small manhole had a valve on the leachate line (before the tank) which controlled bypass overflow water flow to the vault. This was open when we popped the cover. We determined that since the tank was full, water was bypassing

and discharging to the amphibian pond. None of the water in the tank came out to the discharge points. We bailed and pumped it to the leachate system collection pipes and to the groundwater collection system to trace where those pipes went. They all bypassed the collection tank. We eventually got green water out of the white pipe in the sewer manhole.

We think the man-way riser should have been dry. The valve was on the bottom down 13 feet and would have to be turned with a reach rod. If the chamber were full of water, that would be unworkable. Examining carefully we saw that when we pumped the leachate tank to a few inches below the bulkhead the water stabilized at just below the collar in the other manway riser. The water level showed us where the hydraulic connection to the tank is!

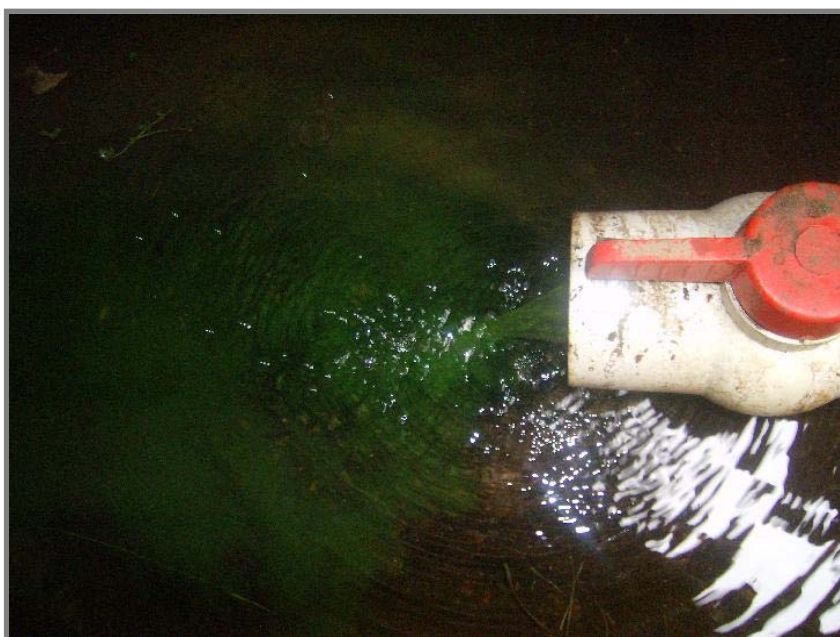
Success! We now have green dye in the first pipe inside the vault. This is a leachate pipe.

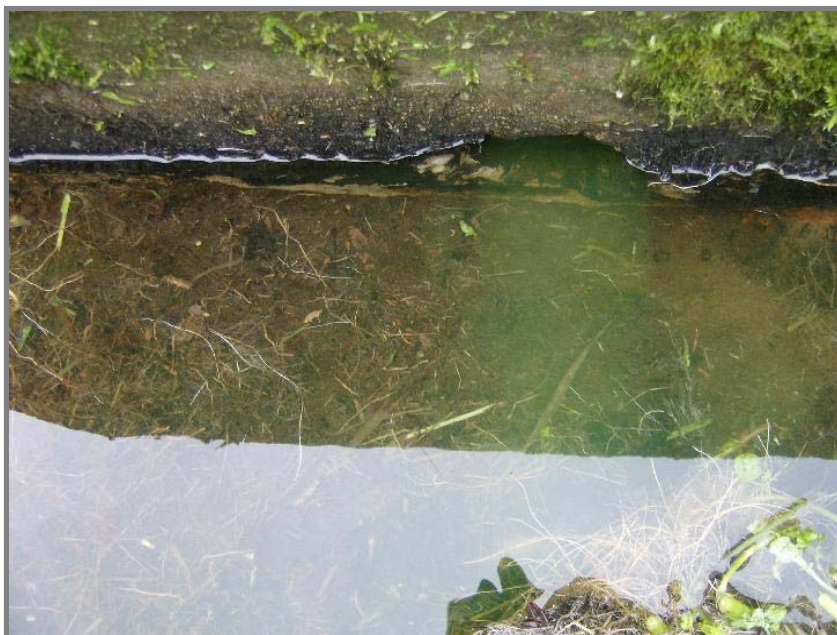
The vault slowly filled with enough dyed water so that the dye made its way into the discharge pipe. Standing at the point of discharge to the pond, water can be seen entering the amphibian pond.

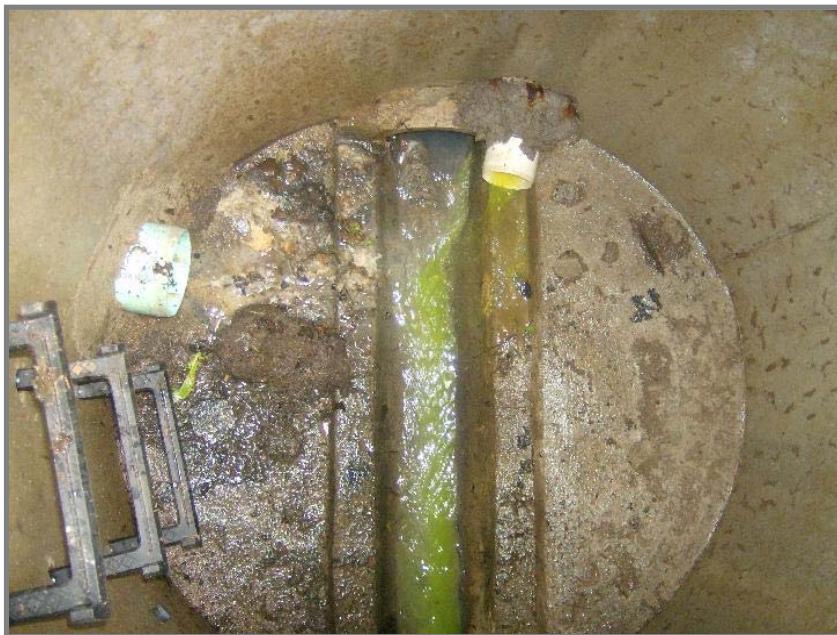
Green finally in the sewer. We had pumped some leachate into one of the leachate clean-out stickups behind the tank and the valve access manholes. About 1/2 hour later we saw the green dye.

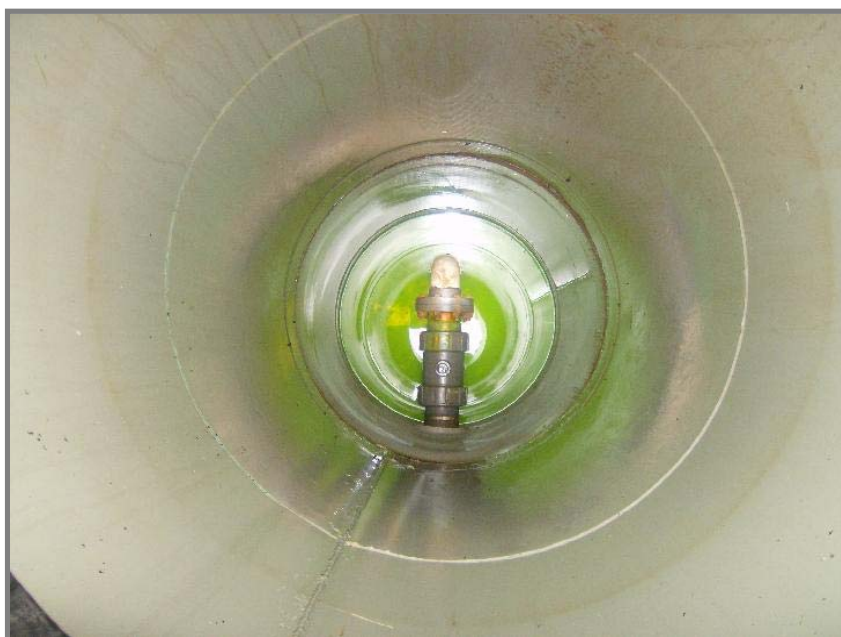
Now the plumbing is visible. The leachate fill pipe makes a 90-degree bend just beyond the valve. In this plumbing a connection must be leaking because the water height rises to the same height as that of the tank.

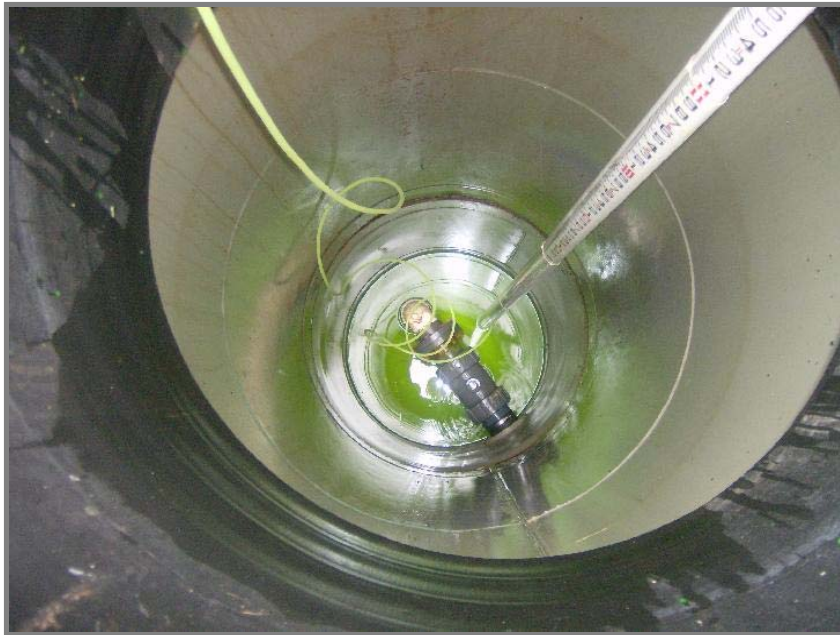
Water level paused at the leaky connection.
