PERIODIC REVIEW REPORT

Oswego Castings Site

Site Number 7-38-033

March 2021

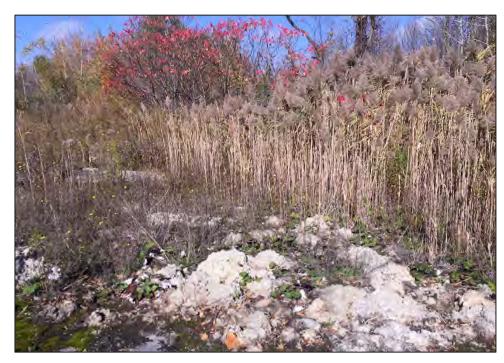
Photo: 11

Brush leading to Monitoring Well MW-3

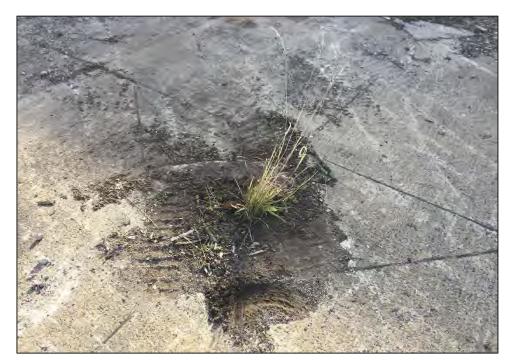
Photo: 19

Vegetation in broken concrete section

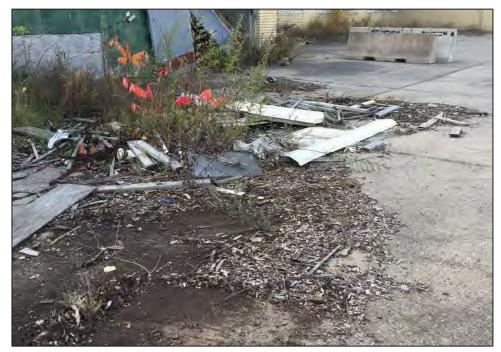
Photo: 21

Debris and vegetation on Concrete Cover

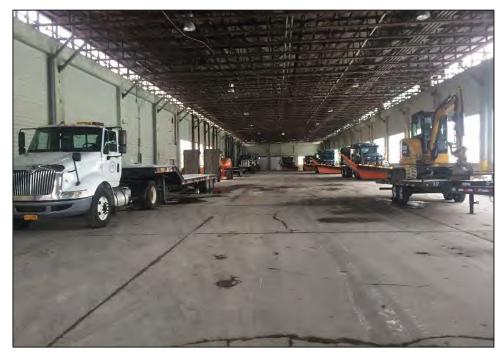
Photo: 5

Inside view of unlocked building.

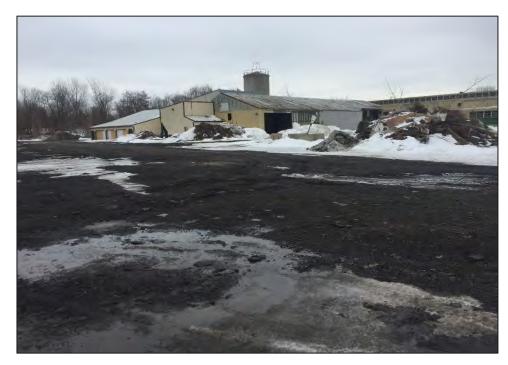
Photo: 9

Vegetation and debris stockpiles adjacent to concrete cover area.

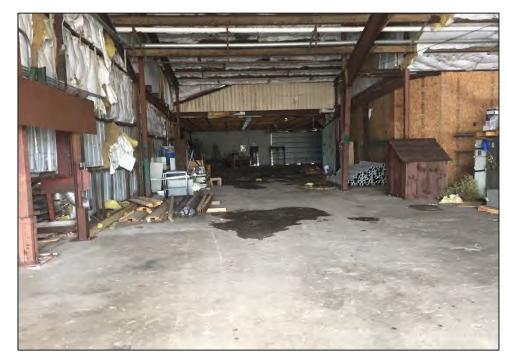
Photo: 11

Inside view of unlocked

building.

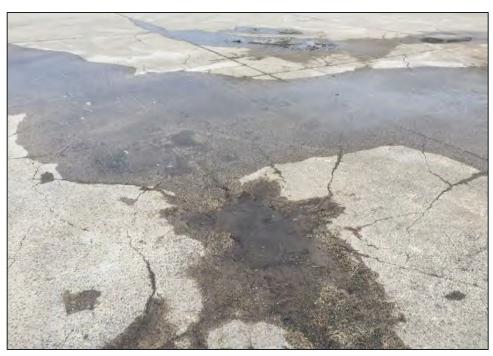
Photo: 16

View of broken section of concrete cover.

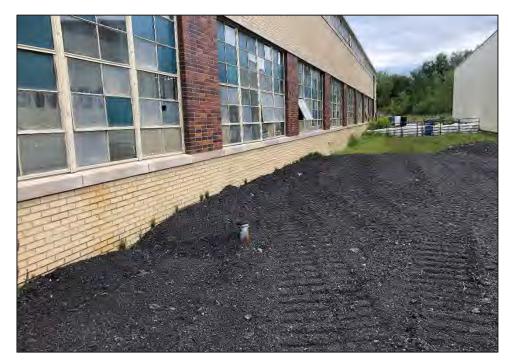
Photo: 3

Monitoring Well MW-2R partially buried.

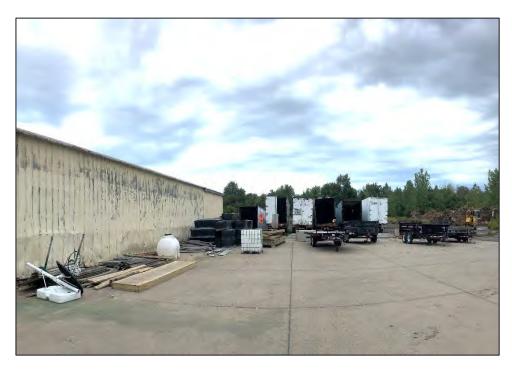
Photo: 5

View of equipment and trailers on concrete cover area.

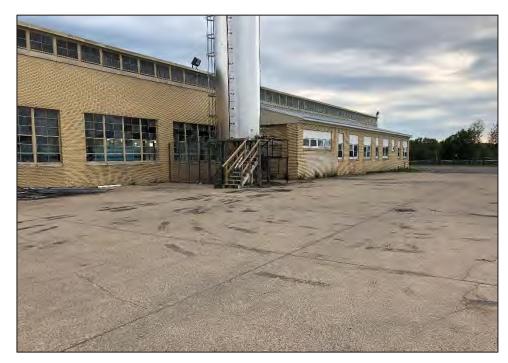
Photo: 7

the concrete cover had minor cracks but did not show evidence of settling or other damage. Cracks in the concrete cover were also noted by NYSDEC in the 2002 Remediation Summary Report, but were found to not affect the performance of the remedy (NYSDEC 2002). In addition, as shown in Appendix A and Appendix B, some debris (primarily wood chips and boards) were present on the concrete cover. As shown in Appendix B, in September 2019, trucks and equipment were stored on the concrete cover and staining was observed in the area surrounding a new above ground storage tank.

View of stained concrete cover area.

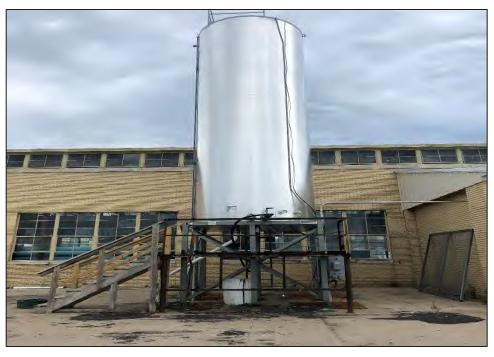
Photo: 8

View of storage tank and stained concrete cover area.

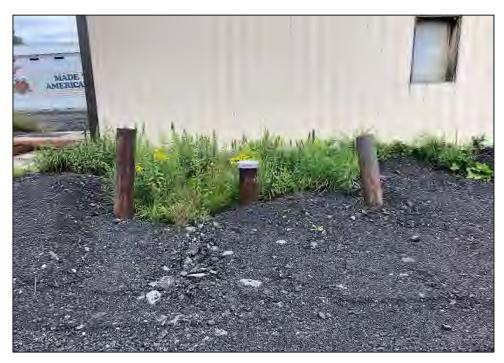
Photo: 9

Monitoring Well MW-4 partially buried.

- Removal road millings from landfill area and provide documentation of disposal or perform testing to indicate millings do not contain hazardous constituents.

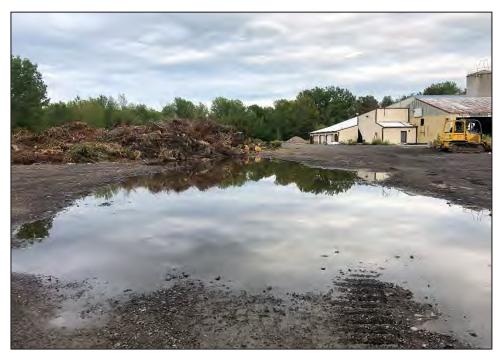
Photo: 11

View of ponding water and tree cuttings stockpile on landfill area.

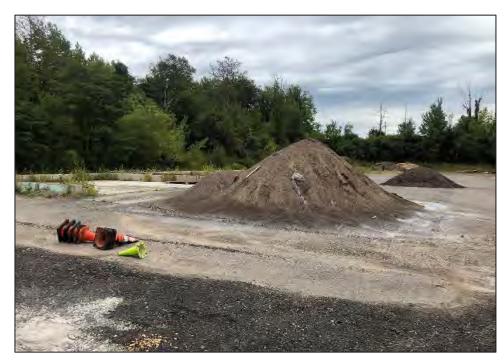
Photo: 15

View of soil stockpiles.
