2024 Annual Report Oswego Castings Site (738033) Oswego, New York

Work Assignment No. D009806-34

March 2025 Version: DRAFT

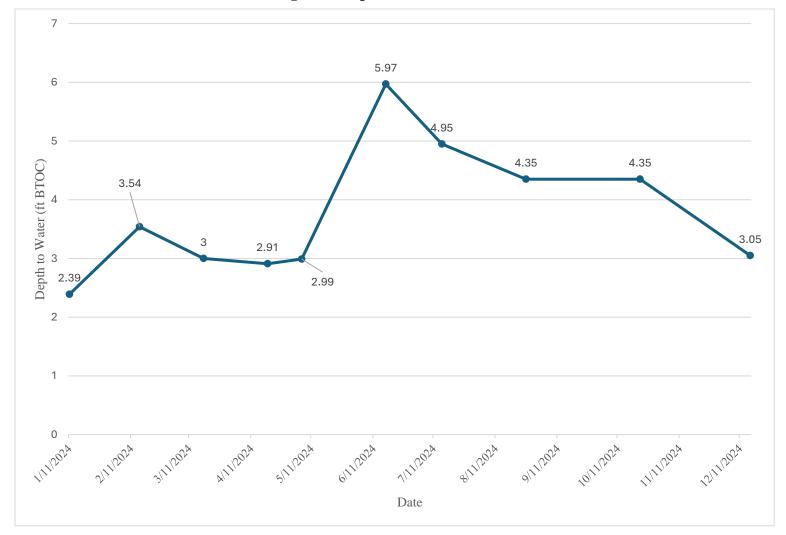
Figure 3. Depth to Water at MW-1

During the site inspection, no measurable DNAPL was observed in monitoring well MW-1. Trace amount of DNAPL was observed on the water level indicator, shown in the Daily Inspection Reports of **Appendix A**. The depth to groundwater is summarized on **Figure 3**.

EA recommends reducing the frequency of site inspections to quarterly or bi-annually. The site inspections and absorbent sock replacements of MW-1 shall continue until no product is observed or measured for three consecutive site inspections. Then, subsequent site inspections will be conducted as needed. The next sampling event of the monitoring well network is scheduled for the third quarter of 2025.

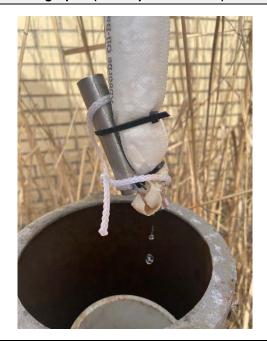
Absorbent sock removed from MW-1 with no visible DNAPL

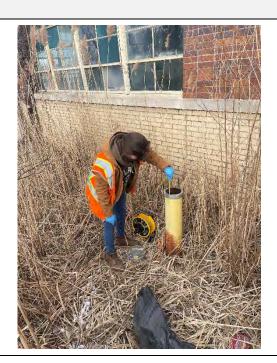
M. Gilkey gauging MW-1

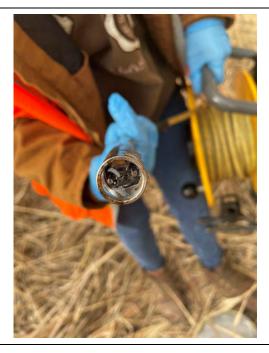
Trace amount of DNAPL present on oil/water probe

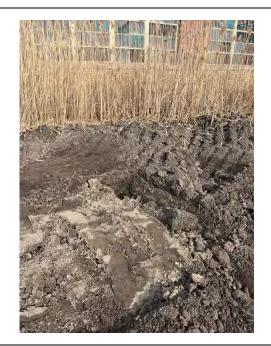
Disturbed cover near MW-2R, approximately 3 feet deep

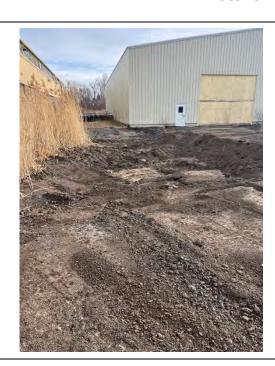
Excavation present near MW-2R

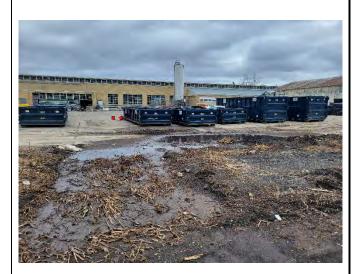
View of south-end of soft cap and north-end of concrete cap

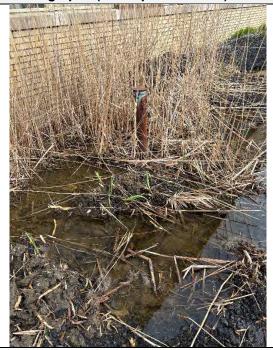
Ponding present around MW-1

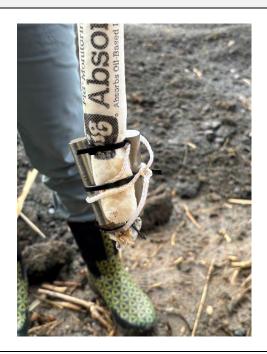
Some product observed on the absorbent sock from MW-1

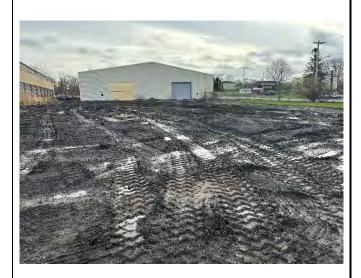
Current state the area south of MW-1

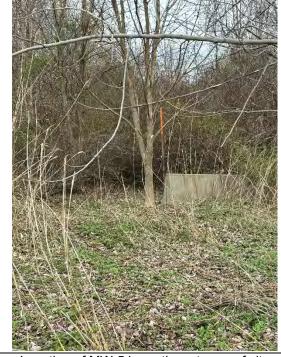
Location of MW-5 in northwest area of site

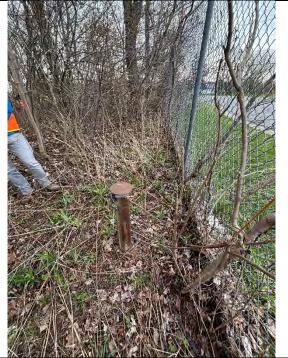
Location of MW-6 by fence in southeast corner of site

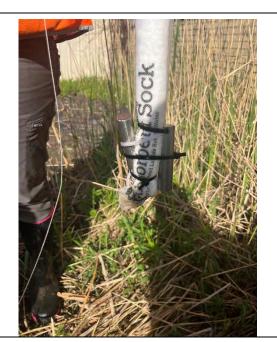
Absorbent sock pulled from MW-1. Trace amount of product present on sock. No product detected with Oil/Water interface probe.

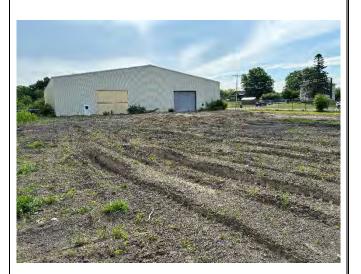
Current state the area south of MW-1, large ruts present but ground was not soft

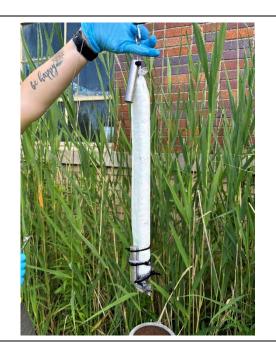
Some product observed on the absorbent sock from MW-1

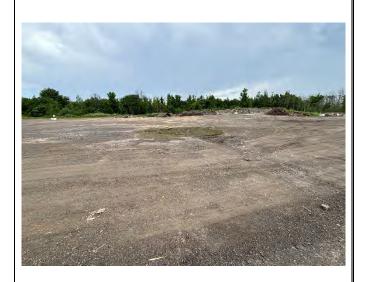
View of soft cap looking north

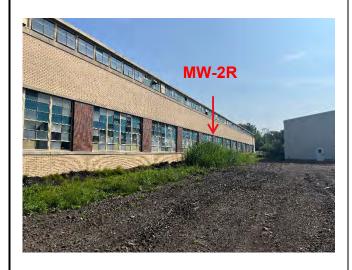
Main Building onsite and pole barn on the southern end of the site. Photo taken looking east. MW-2R is located within the phragmites in the picture.

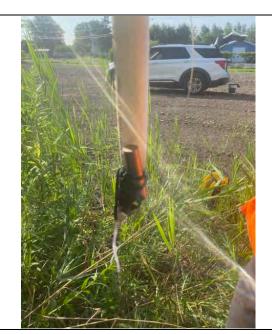
Trace oil observed on the absorbant sock

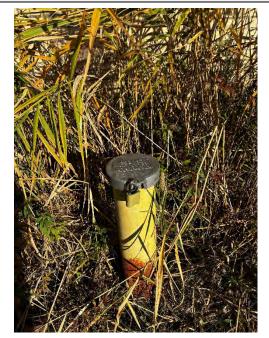
Vegetation around MW-1

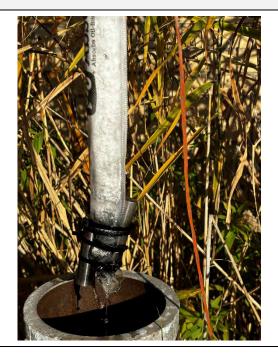
Absorbant sock that was removed from MW-1.

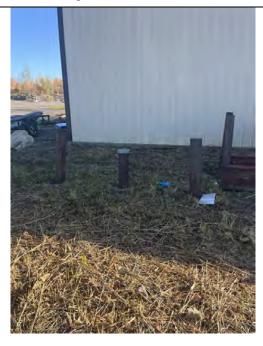
Vegetation cleared around MW-4

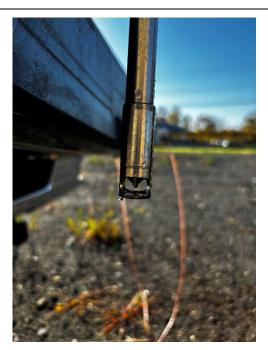
Trace amount of oil on the end of the oil water interface probe.

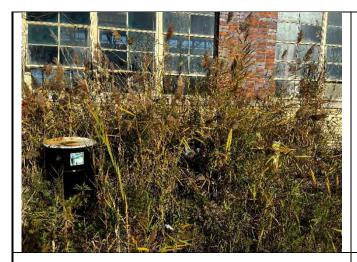
IDW drums onsite near MW-1

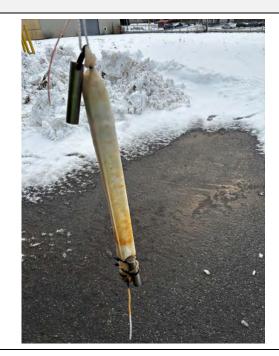
Absorbant sock that was removed from MW-1.

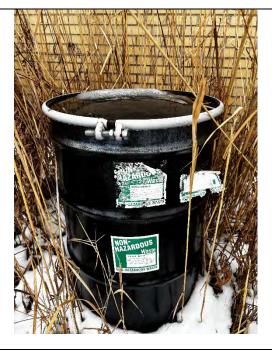
Q2 2024 groundwater sampling purge water drum

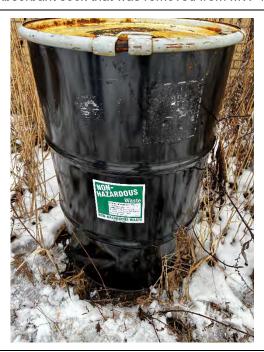
Absorbent sock drum

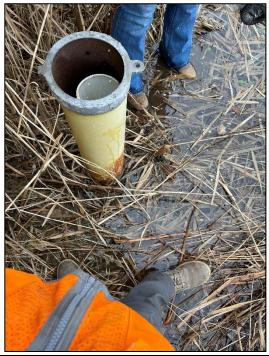
Description:	Site conditions are MW-1 included ponding water	Photograph 2
	at surface.	
Direction:	Looking east	Date: 11 January 2024

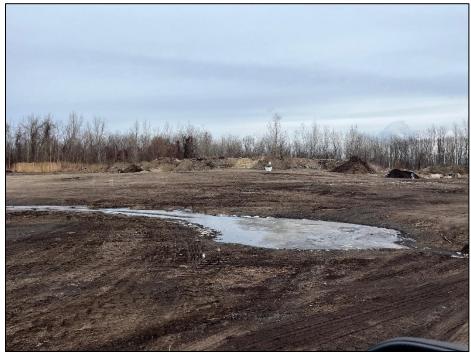
Description:	Ponded water/ice on landfill soil cap	Photograph 3	
Direction:	Looking northeast	Date: 15 February 2024

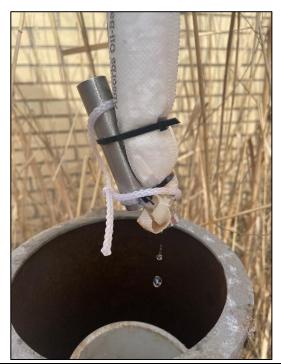
Description:	Trace produce observed on adsorbent sock.	Photograph 4
Direction:	Looking north	Date: 15 February 2024

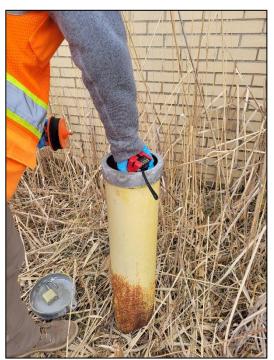
Description:	Collection of PID measurement at MW-1.	Photograph 5
Direction:	Looking north	Date: 18 March 2024

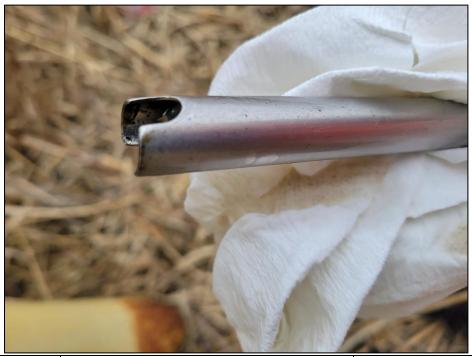
Description: Trace product on oil water interface probe after inspection of MW-1		Photograph 6
Direction:	Looking east	Date: 18 March 2024

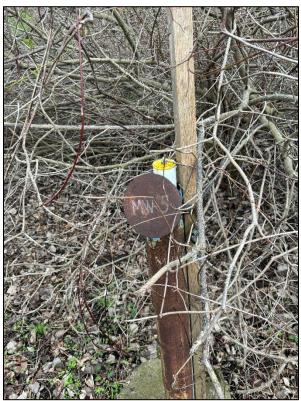
Description:	Monitoring well MW-5 is in need of repair as the inner casing extends up and over outer casing.	Photograph 7
Direction:	Looking north	Date: 19 April 2024

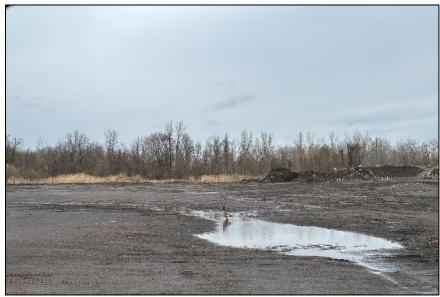
Description:	Ponded water on landfill soil cap	Photograph 8
Direction:	Looking north	Date: 19 April 2024

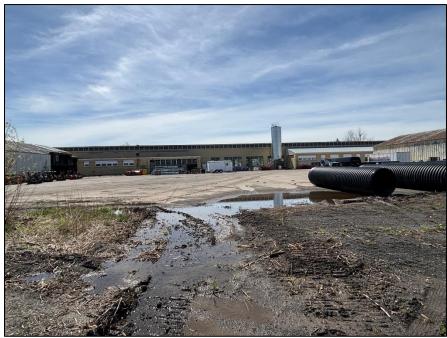
Description:	View of south extent of landfill soil cap and	Photograph 9
	concrete cap	
Direction:	Looking south	Date: 6 May 2024

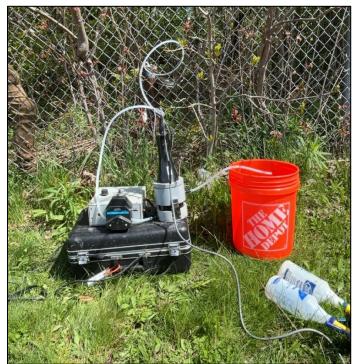
Description:	Low-flow groundwater purge setup on MW-6.	Photograph 10	
Direction:	Looking east	Date: 6 May 2024

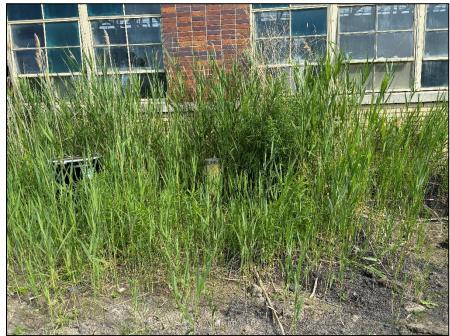
Description:	Phragmites growth at MW-1.	Photograph 11
Direction:	Looking north	Date: 17 June 2024

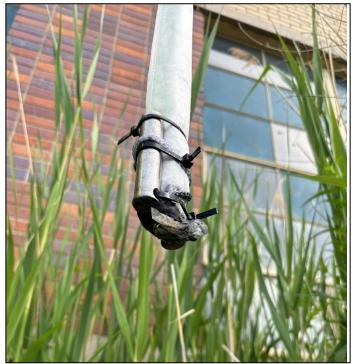
Description:	Trace product observed on absorbent sock that was	Photograph 12
	removed from MW1.	
Direction:	Looking north	Date: 17 June 2024

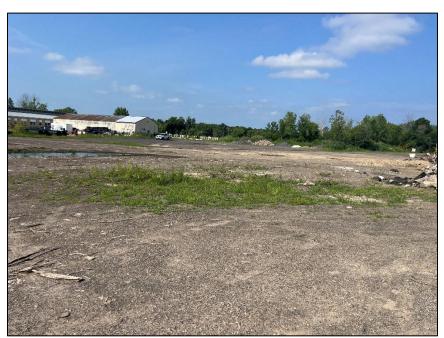
Description:	View of ponding water on the landfill soil cap	Photograph 14
Direction:	Looking southwest	Date: 15 July 2024

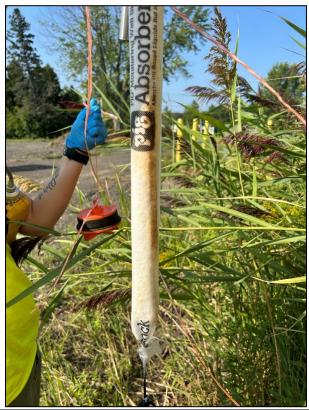
Description:	Trace product on absorbent sock removed from MW-1.	Photograph 15
Direction:	Looking west	Date: 26 August 2024

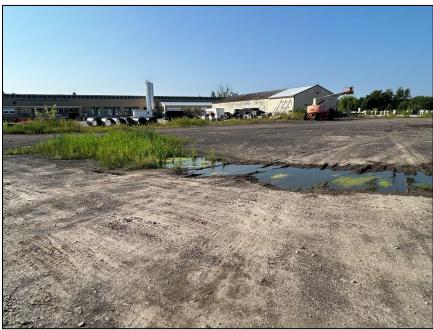
Description:	View of ponding water on the landfill soil cap	Photograph 16
Direction:	Looking southwest	Date: 26 August 2024

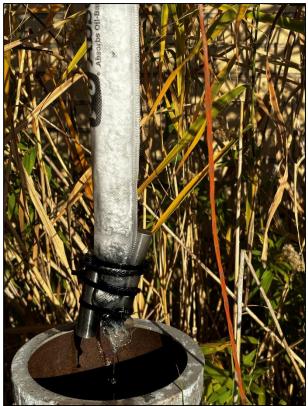
Description:	Trace product on absorbent sock removed from MW-1.	Photograph 17
Direction:	Looking north	Date: 22 October 2024

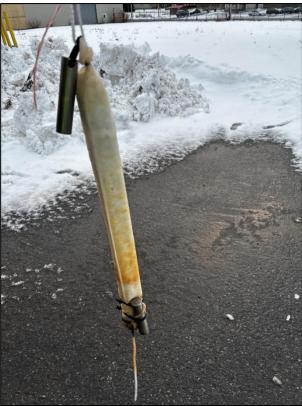
Description:	Trace product on absorbent sock removed from MW-1.	Photograph 19
Direction:	Looking southeast	Date: 16 December 2024

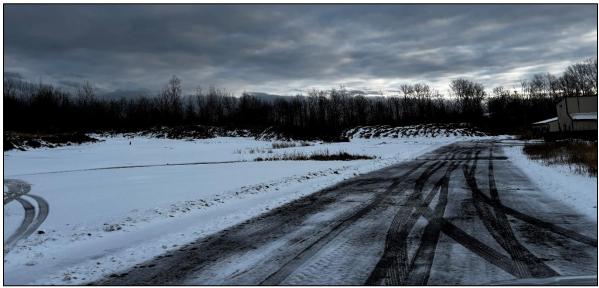
Description:	View of landfill soil cap covered in snow. Compression and ponding water visible in center.	Photograph 20
Direction:	Looking northeast	Date: 16 December 2024
