TIOGA CASTING FACILITY, 754012 Monitoring Well Inventory, 04/01/2009

Photos with Notes

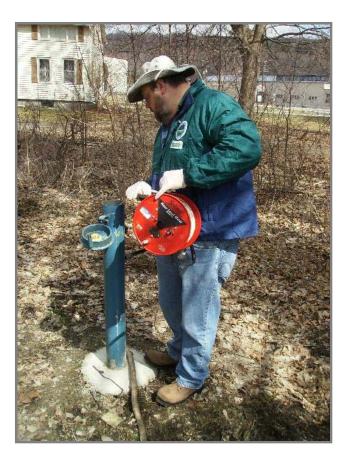
MW-1R		
NYTM-X:	NYTM-Y:	
395158 4662246

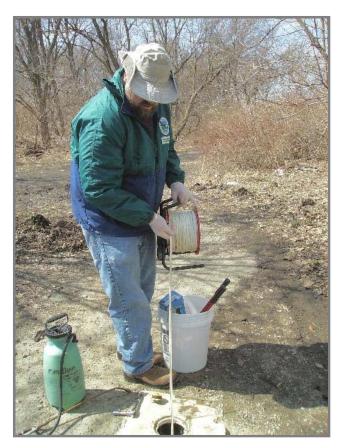
MW-7			
NYTM-X: NYTM-Y:			
395101 4662176

WC: 9.54'			
DTW 12.76' DTB 22.30'

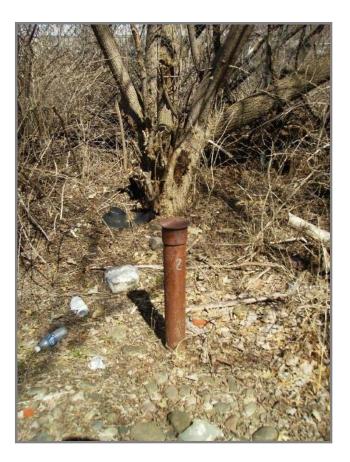
Gauging MW-1

MW-2			
NYTM-X: NYTM-Y:			
395036 4662179

WC:6.23'			
DTW 13.20' DTB 19.43'

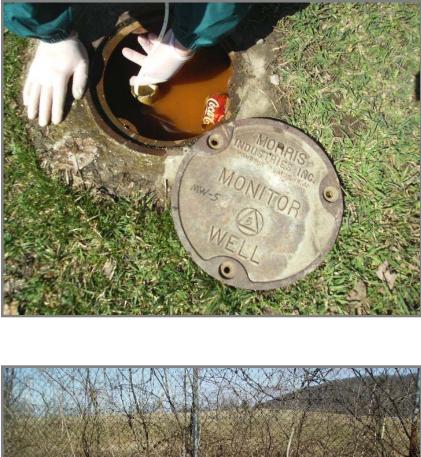
Water above the seal.

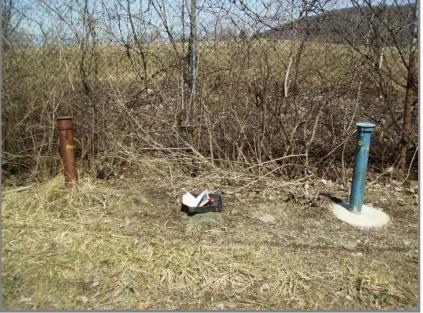
MW-3 (left)			
NYTM-X:	NYTM-Y:		
394889	4662216		
WC:2.06'			
DTW 16.42' DTB 18.48'			
MW-3D (right)			
NYTM-X:	NYTM-Y:		
394892	4662215		
WC:	8.71'		
DTW 16.25'	DTB 24.96'

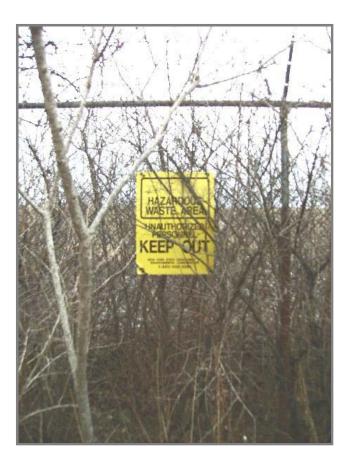
Sunlight completely fades the red word "DANGER." This is another reason why we need cut-out signs as are proposed for Davis-Howland site.

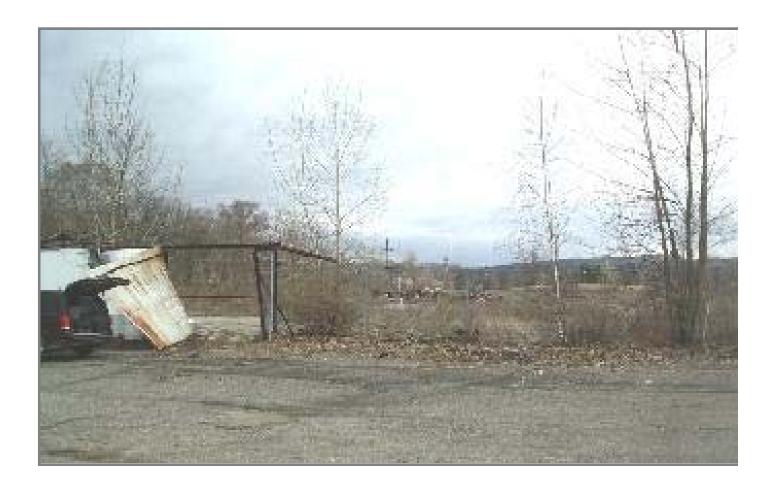
Tioga Casting Facility, Site ID No. 754012

Fence is gone in the lower image. In three years there was quite a lot of tree growth.
