**New York State Department of Environmental Conservation**

Site Number 7-54-012

# **Tioga Castings Site Quarterly Report**

**Second Quarter 2010**

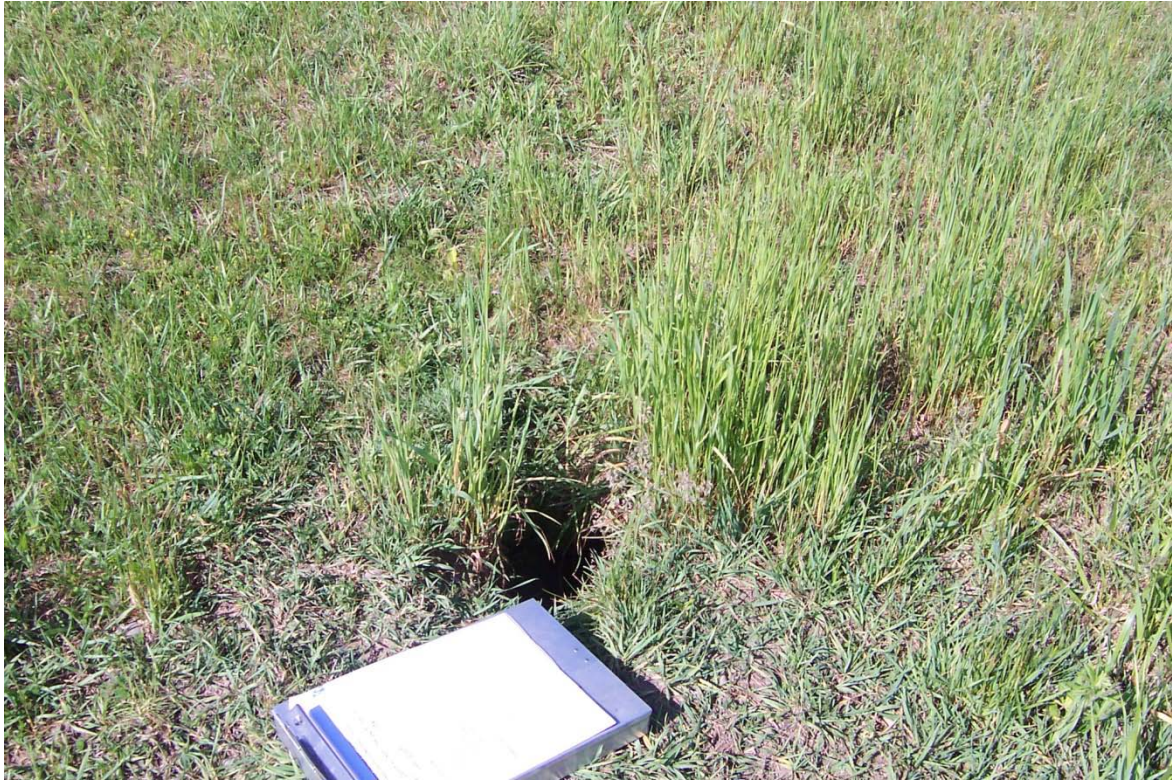
Comments: Evidence of burrowing animals was observed on the north and south sides of the landfill cap (Photograph 1). Small trees were observed growing on the sloped sides of the landfill (Photograph 2).

**Photograph 1:**  
Burrowing rodent hole on south edge of landfill cap.

Burrowing rodents should be removed from the site to reduce the potential for the landfill cap to be compromised. In addition, the burrows should be backfilled to minimize infiltration of surface water to the landfill.

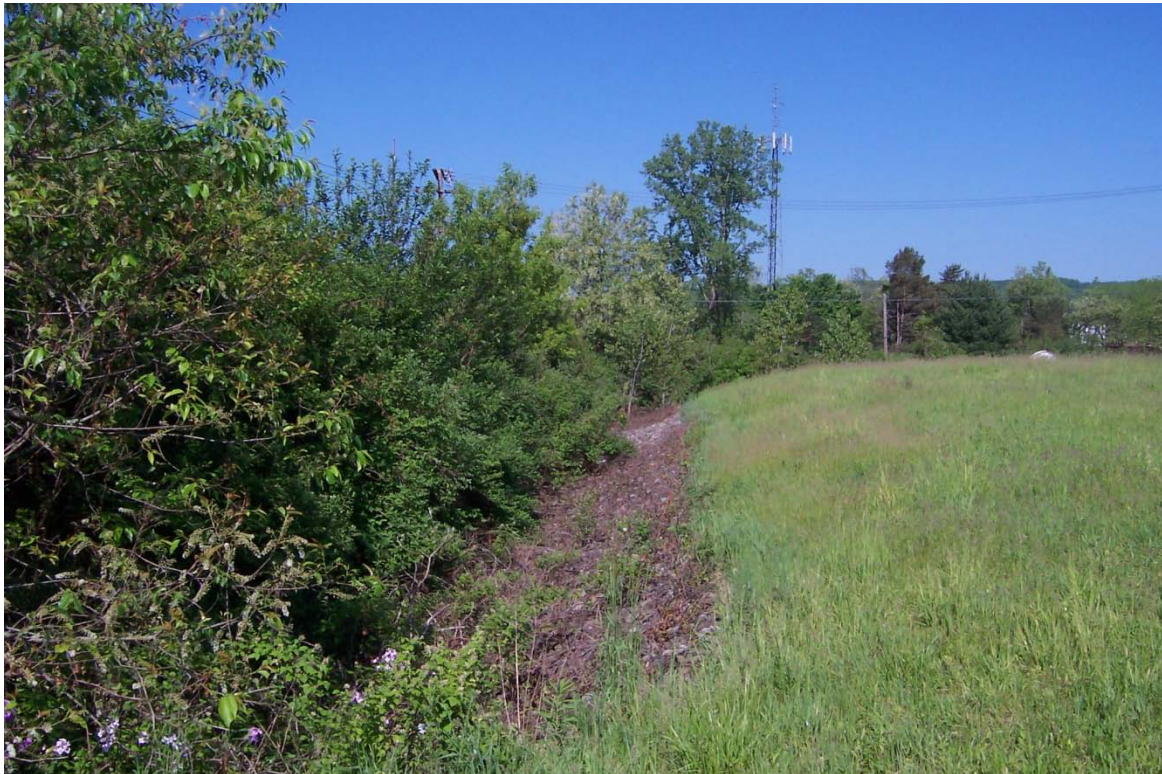
**Photograph 2:**  
Brush/woody vegetation on south slope of landfill, facing west.

Brush and woody vegetation should be removed from the landfill cap and drainage ditches to reduce the potential for their root systems to compromise the integrity of the landfill cap.

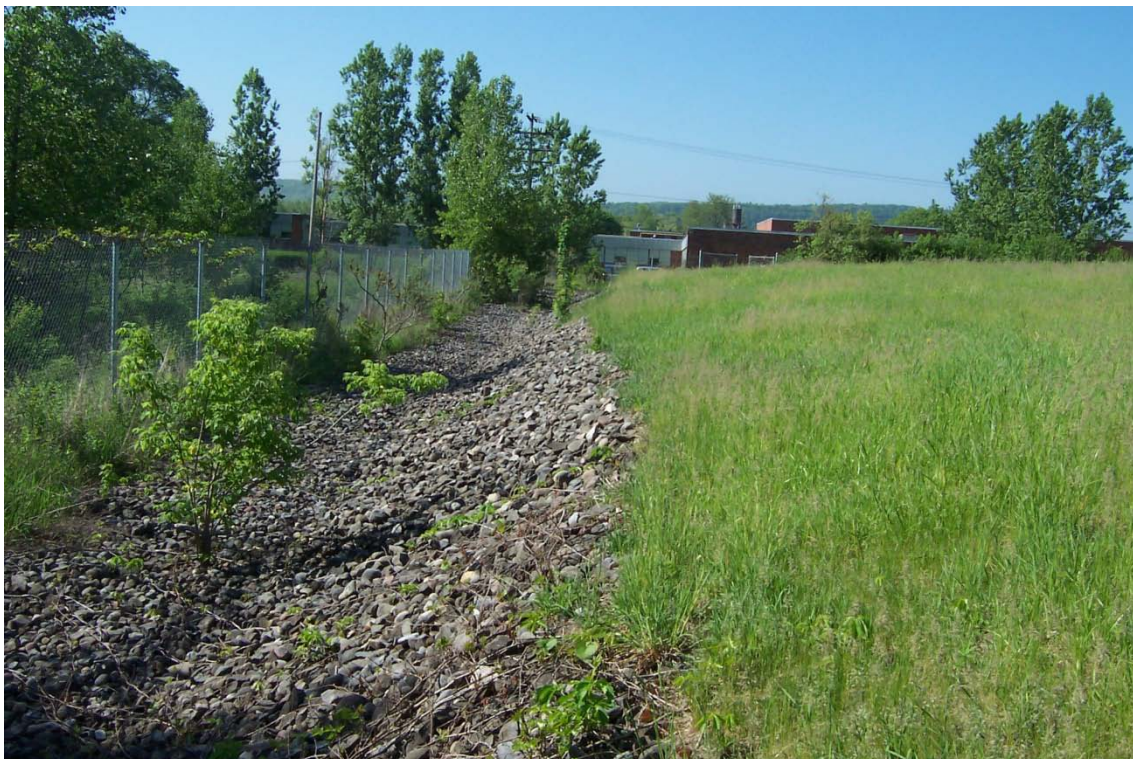
Comments: Brush/woody vegetation observed growing in drainage swales and along perimeter fencing (Photographs 3 & 4).

**Photograph 3:**  
Trees in drainage swale on east side of landfill, facing south.

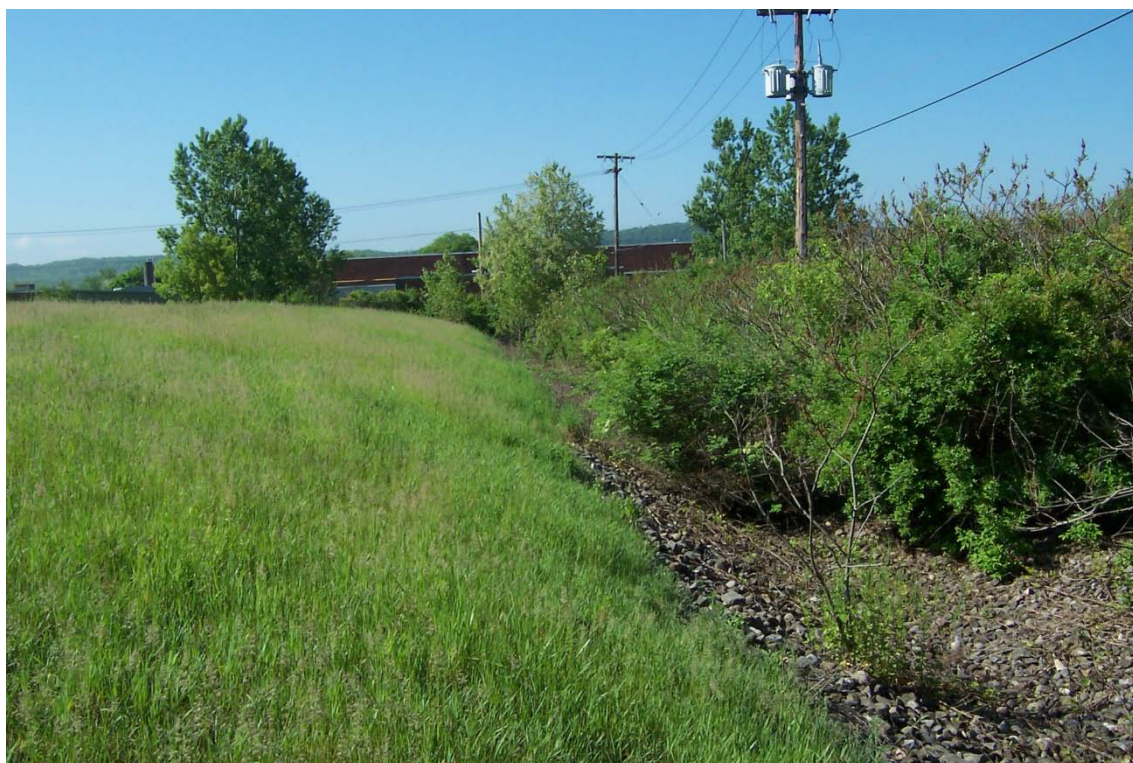
**Photograph 4:**  
Brush/woody vegetation on west side of landfill, facing south.

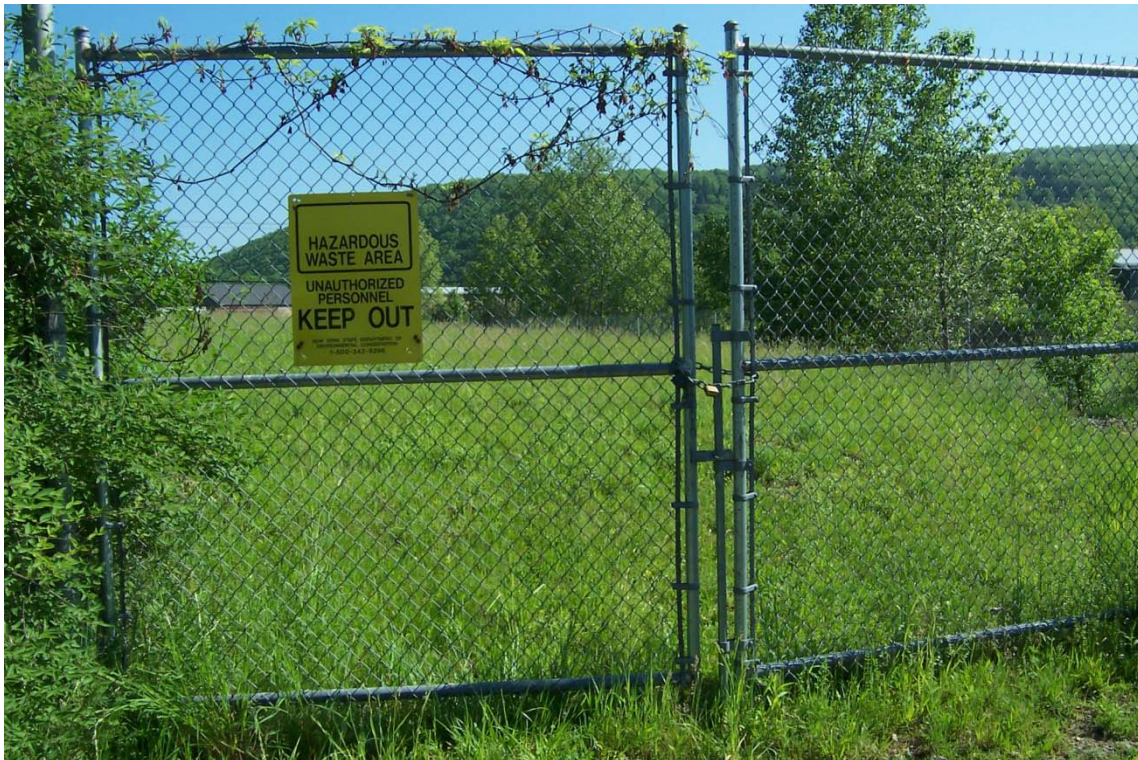
Comments: None. Gate and signage shown in Photograph 5. Landfill cap shown in Photograph 6.

**Photograph 5:**  
Landfill access gate and warning sign .

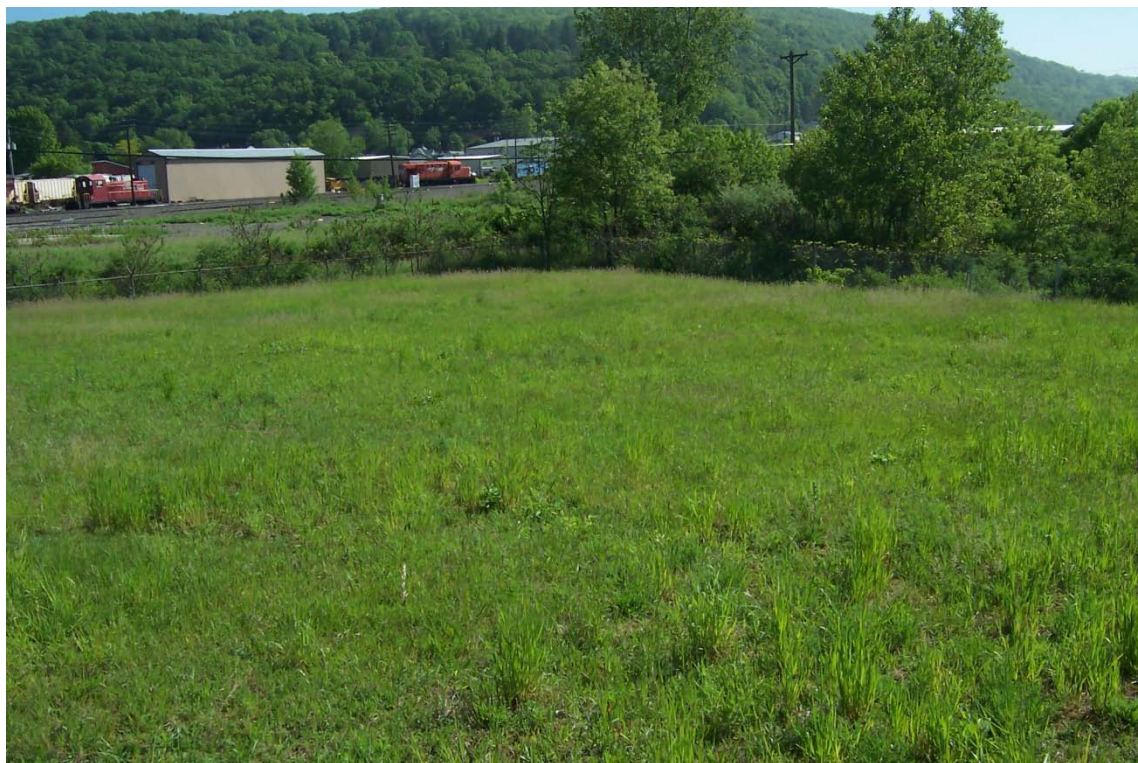
As indicated in the SMP, the landfill cap is currently mowed by the NYSDEC Operations Department. As shown in the accompanying site photographs, the landfill cap did not appear to be mowed during this (2010) growing season prior to the landfill inspection.

**Photograph 6:**  
Landfill cap, facing northeast.
