**New York State Department of  
Environmental Conservation**

**Site Number 7-54-012**

**Tioga Casting Site Quarterly  
Report**

Fourth Quarter 2011

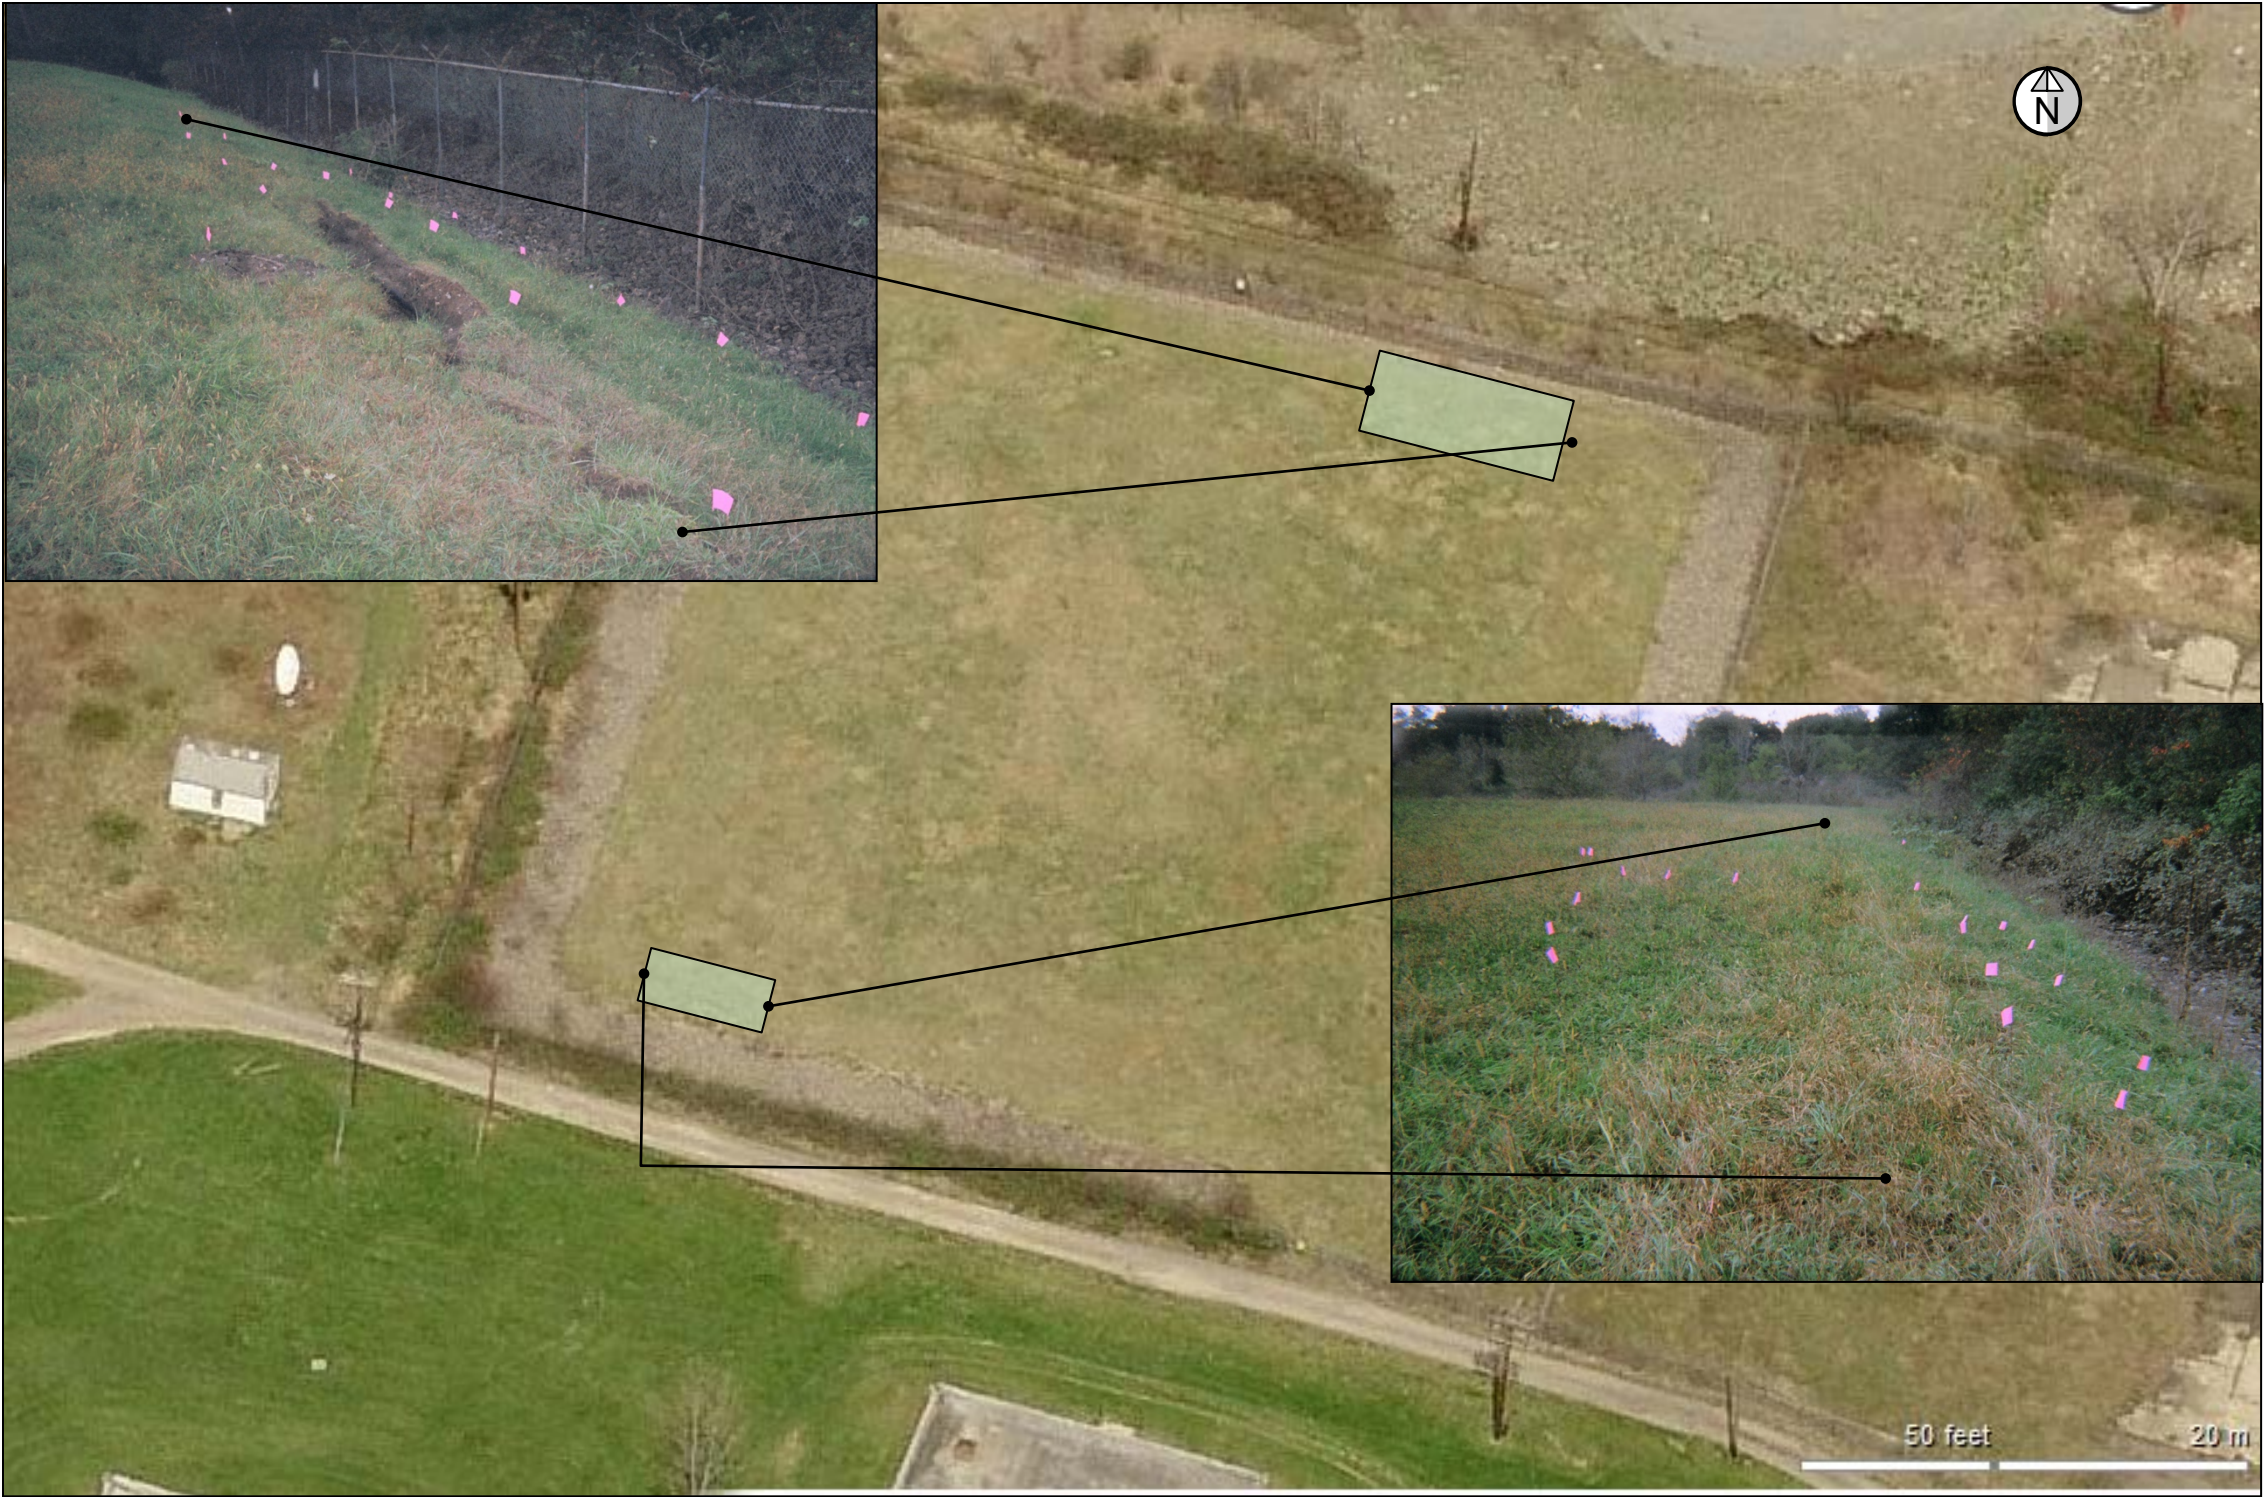
**Figure 1**  
**Landfill Repair Areas**

The landfill cap sustained flood damage in September 2011 caused by Tropical Storm Lee. As shown in Figure 1, the north and south sides of the landfill contained evidence of soil failure and minor slumping on the banks (indicated by pink pin-flags). The soil failure on the north side occurred over an approximately 50-foot area in the northwest corner of the landfill. Figure 1 shows that the sub-grade geo-textile was exposed over an approximately 10-foot linear area perpendicular to the slope of the landfill. The soil failure along the south bank consisted of visible cracking and minor bulging over an approximately 30-foot area in the southeast corner of the landfill. The NYSDEC was notified of the damage following a post-storm inspection on September 29, 2011. An opinion of probable costs for the repairs was provided to the NYSDEC on October 5, 2011. The repairs are scheduled to be completed during the first quarter 2012.

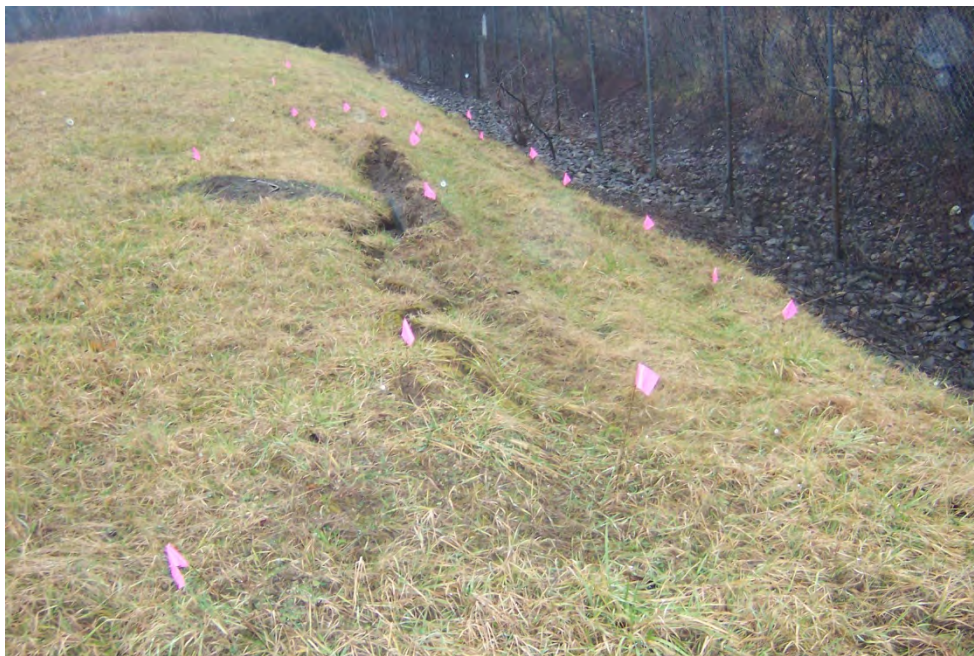
**Photograph 1:**  
**Damage to cap along north end of landfill, facing west.**

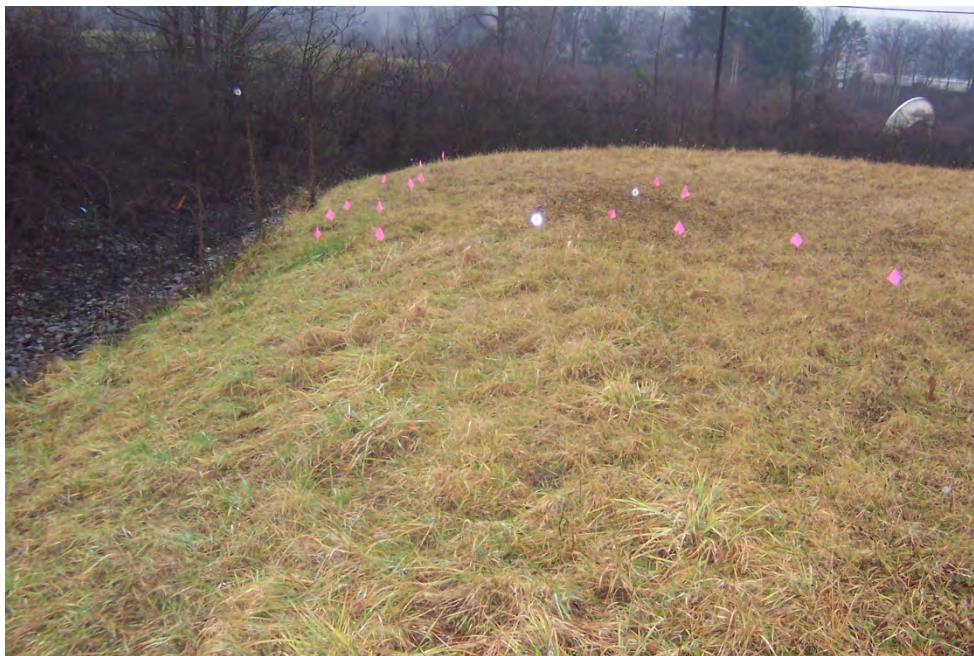
**Photograph 2:**  
**Soil failure along south end of landfill, facing west.**

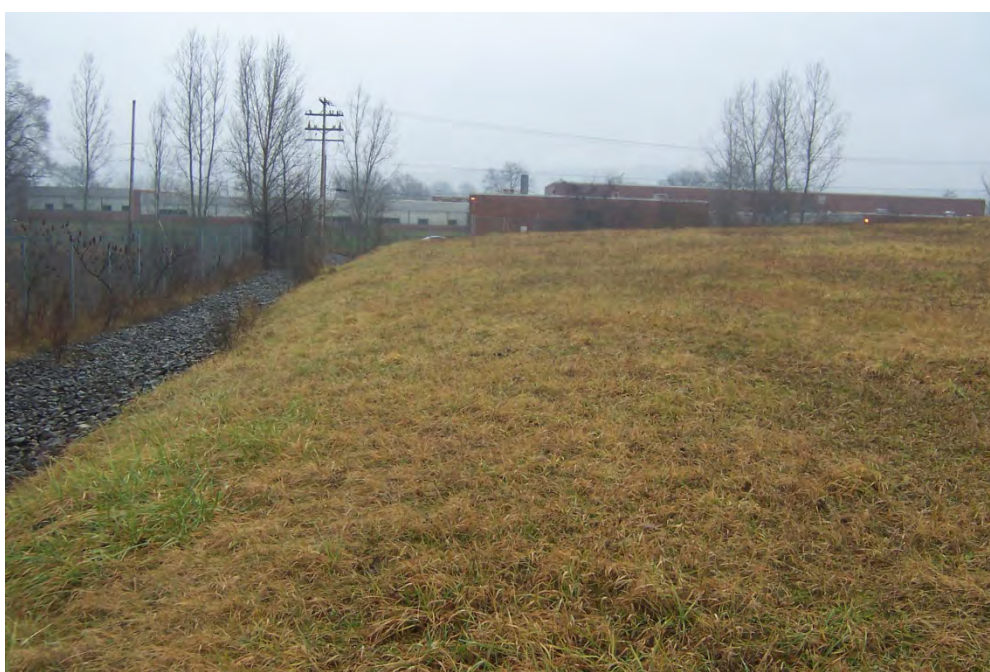
**Photograph 3:**  
**East side of landfill, facing south.**

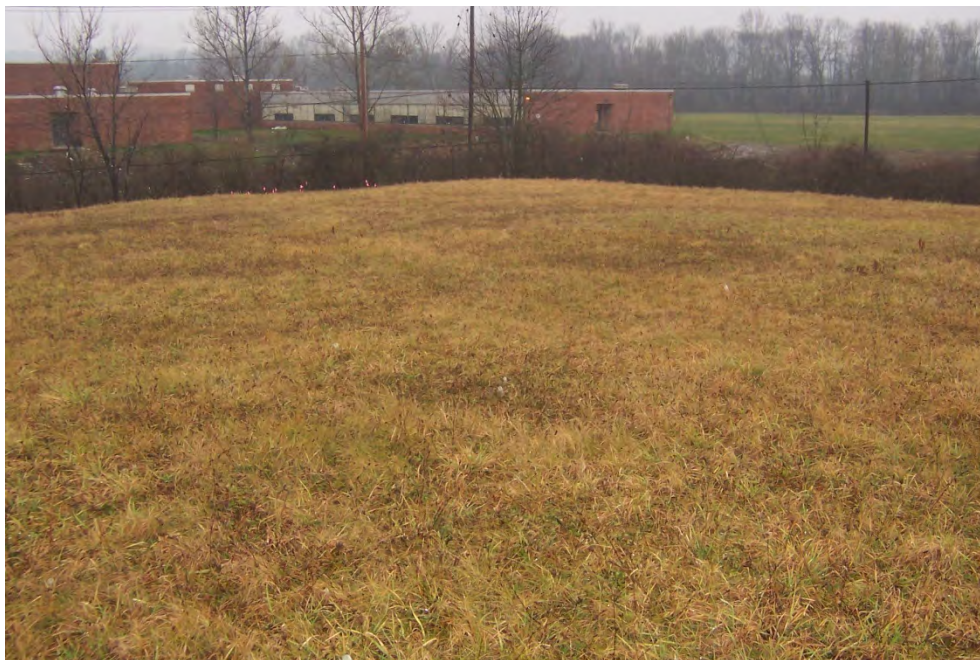
**Photograph 4:**  
**Landfill cap, facing southwest.**

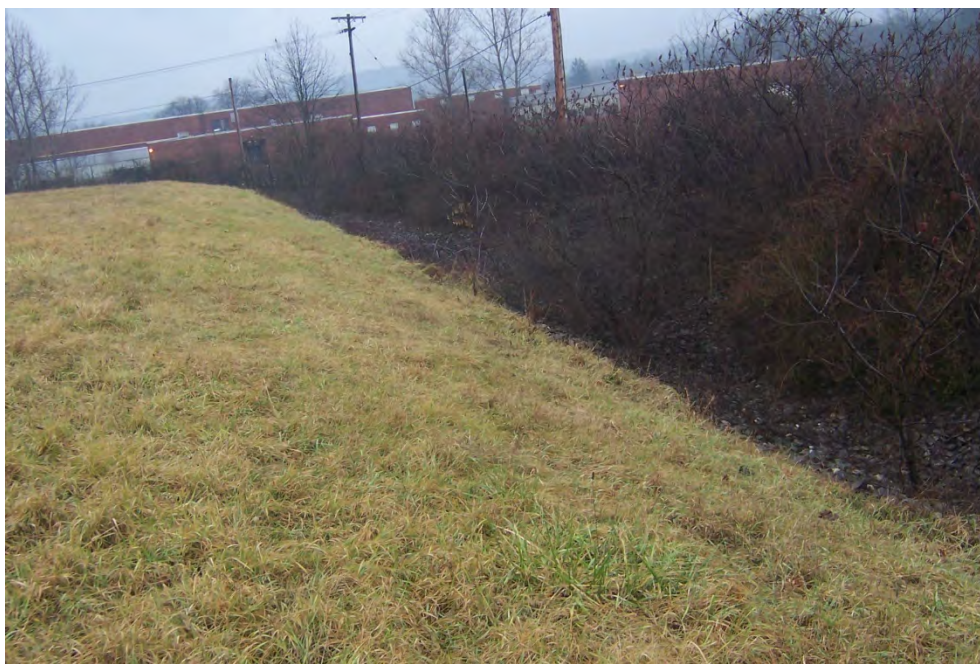
**Photograph 5:**  
**West side of landfill, facing south.**

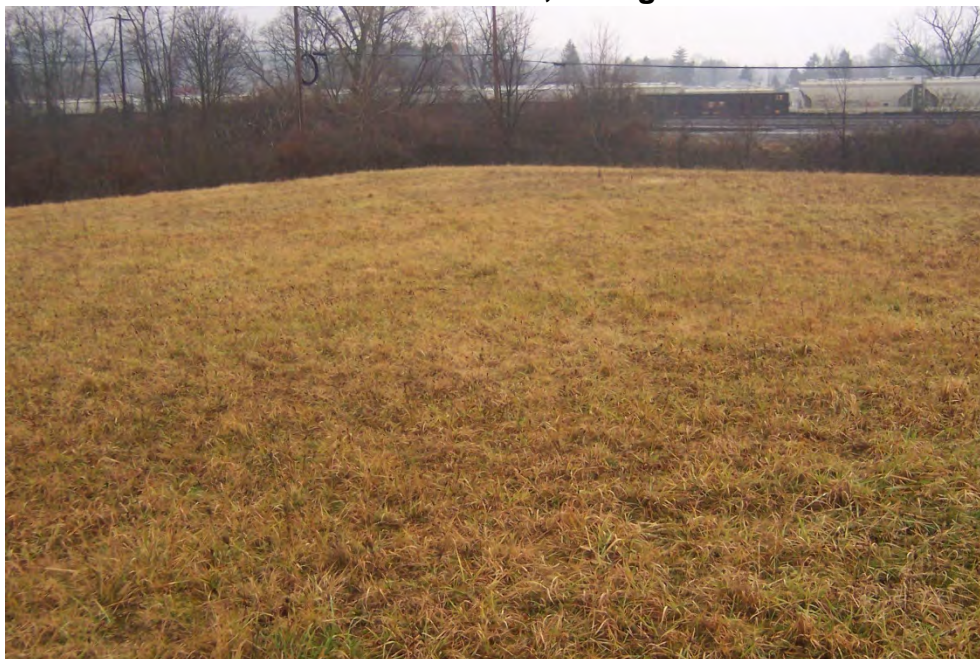
**Photograph 6:**  
**Landfill cap, facing northwest.**
