**New York State Department of
Environmental Conservation**

Site Number 7-54-012

**Tioga Casting Site Quarterly
Report**

First Quarter 2012

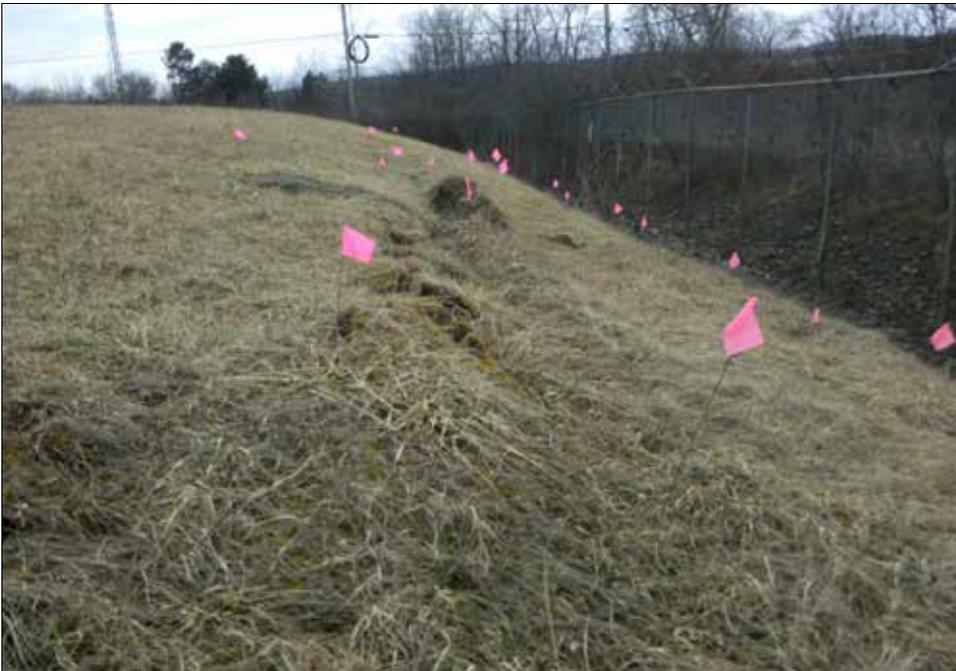
2/27/2012 1130

Liner visibly protruding through surface material.

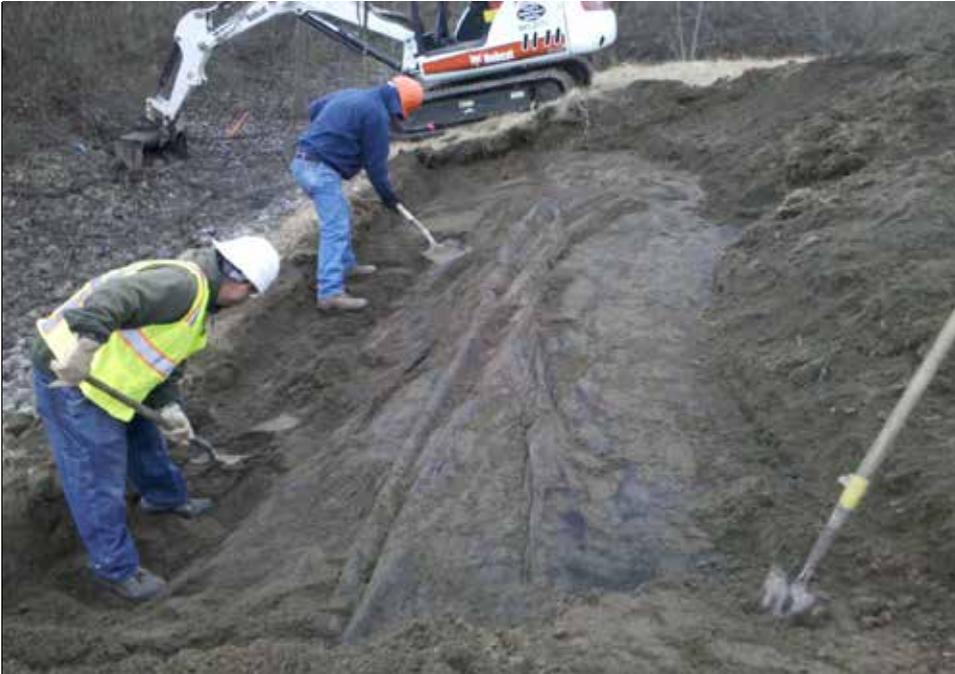
2/27/2012 1258

Aztech uncovers damaged area in southwest corner.
Soil removed by hand to avoid damaging fabric or liner.

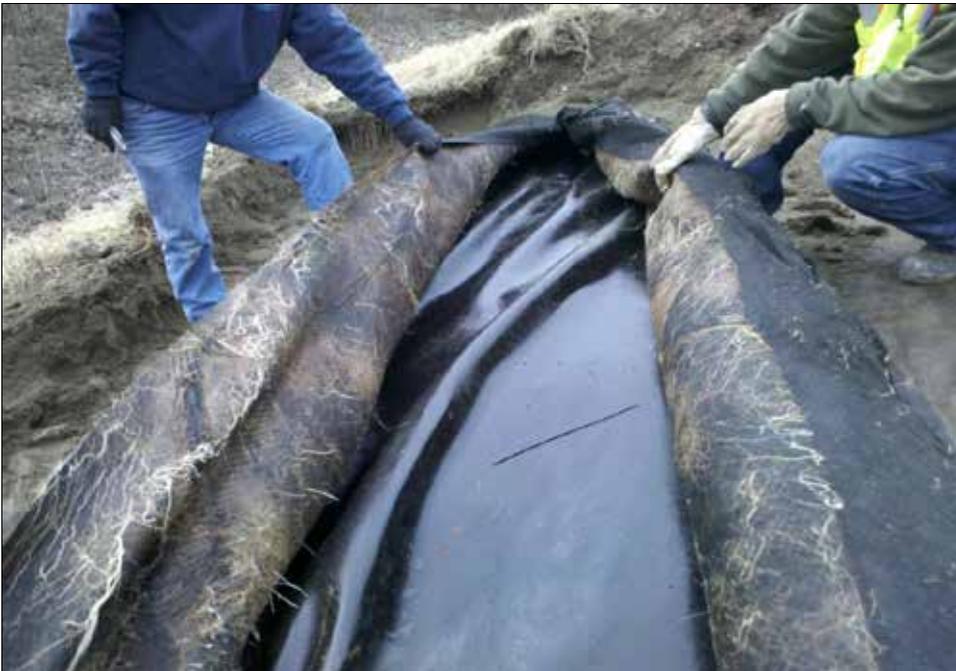
2/27/12 1334

- Soil was removed from the two damaged areas of the landfill with an excavator and hand tools.
- The geo-composite drainage net was cut to expose the underlying high density polyethylene (HDPE) liner. Wrinkles and folds were observed in the HDPE liner.

The exposed liner with wrinkles.

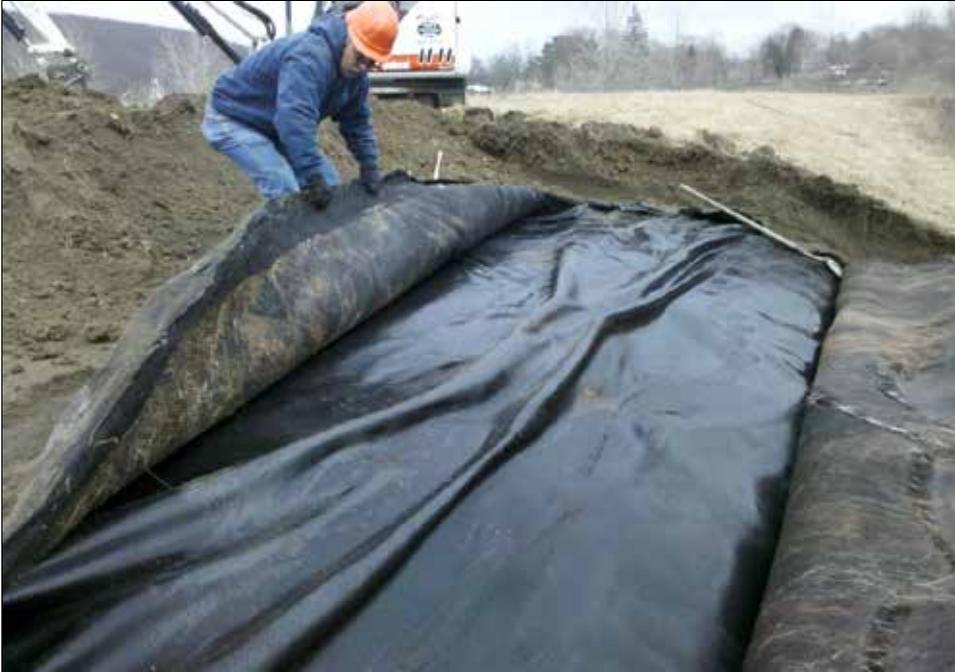
2/27/2012 1338

Liner folds flatten as they extend to the east.

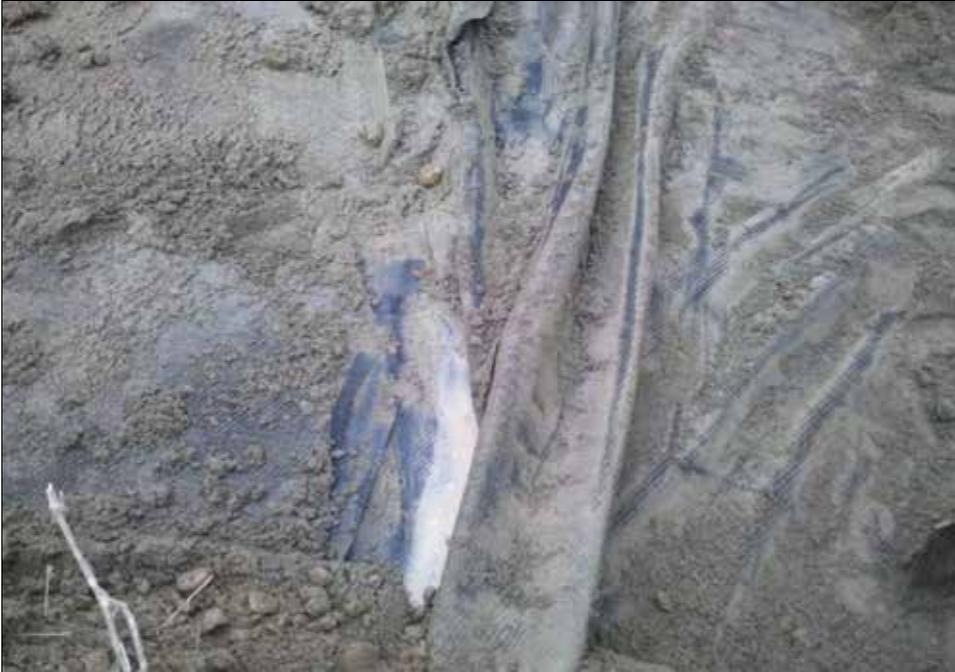
2/27/2012 1511

Liner fold in the northeast area.

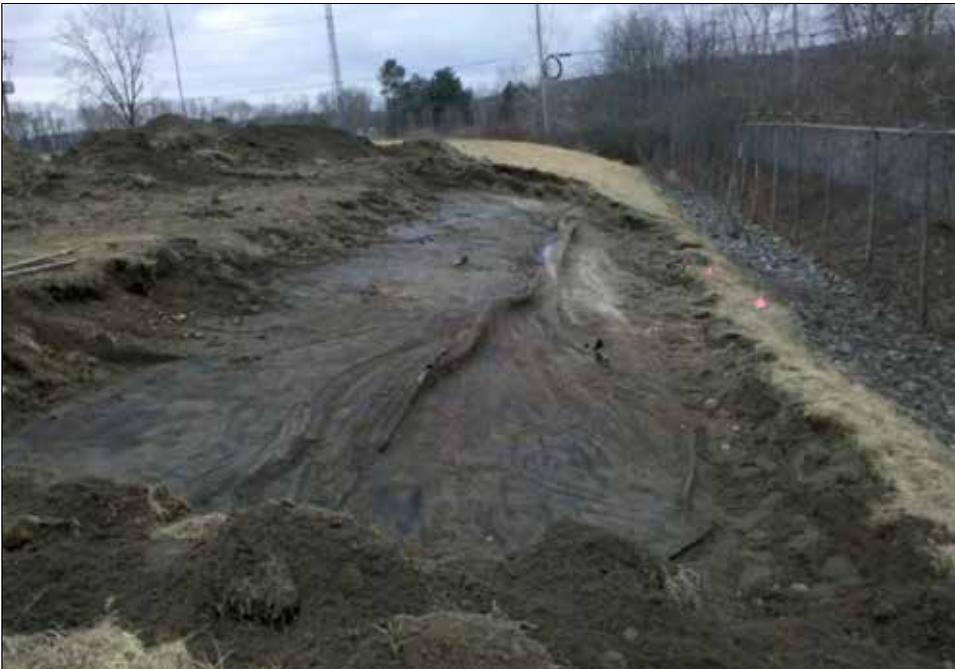
2/28/2012 1113

Liner fold extends approximately 50'.

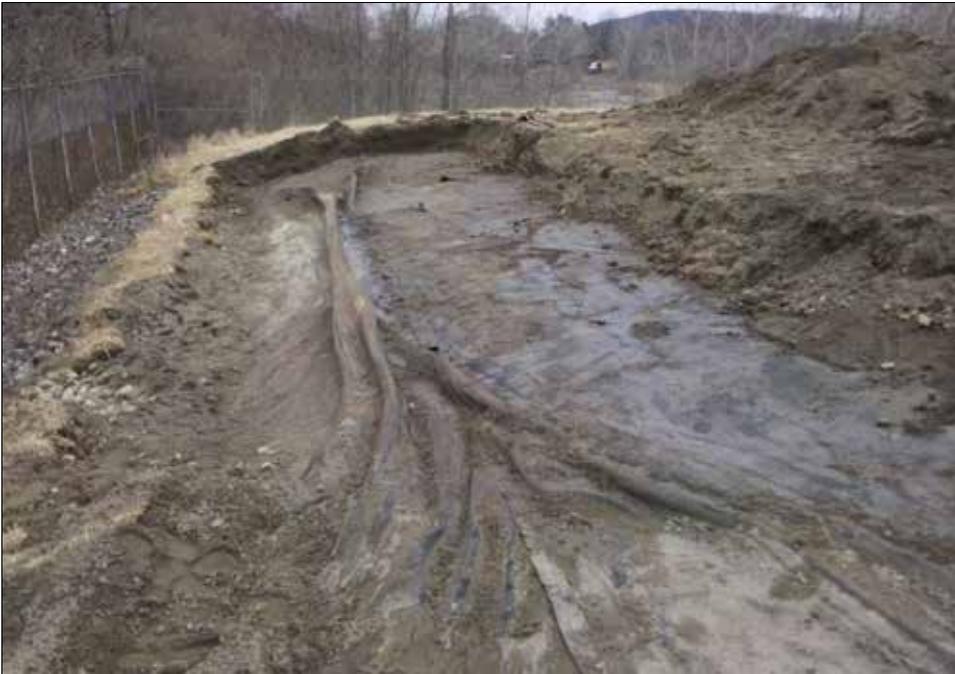
2/28/2012 1115

Northeast area - Folds flatten at the east and west extent of the excavation.

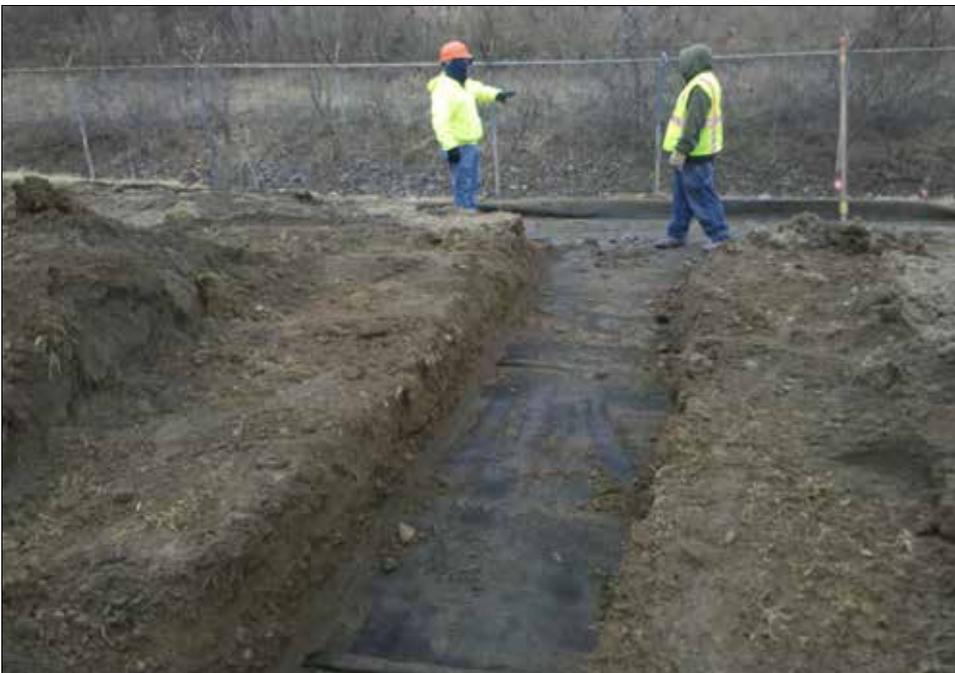
2/28/2012 1132

Exploratory trench extending towards the center of the landfill.
No visible damage to fabric seams or liner.

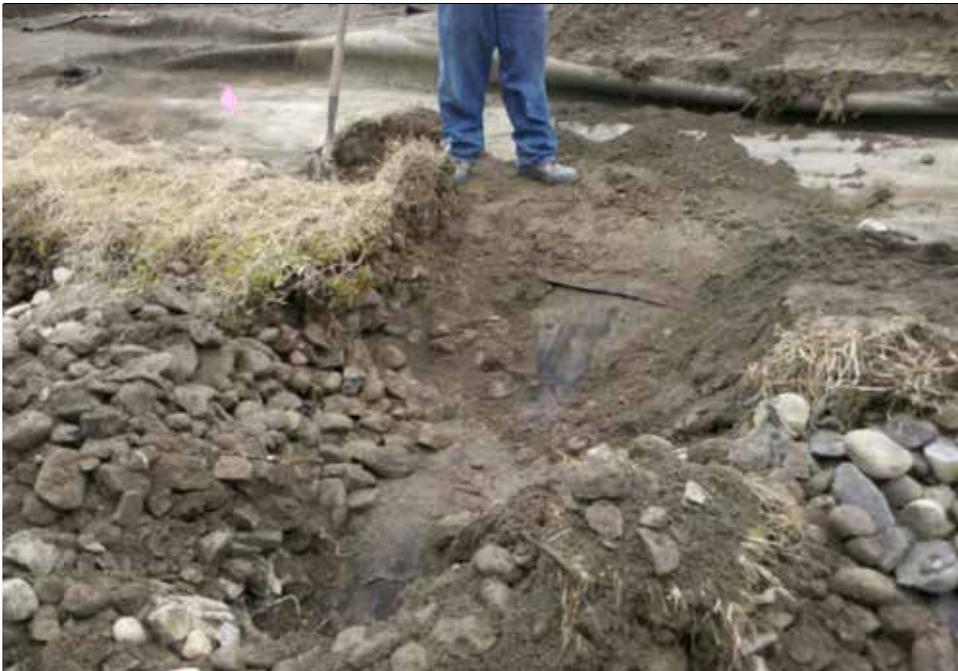
2/28/2012 1210

No damage or displacement to southern edge of anchor trench.

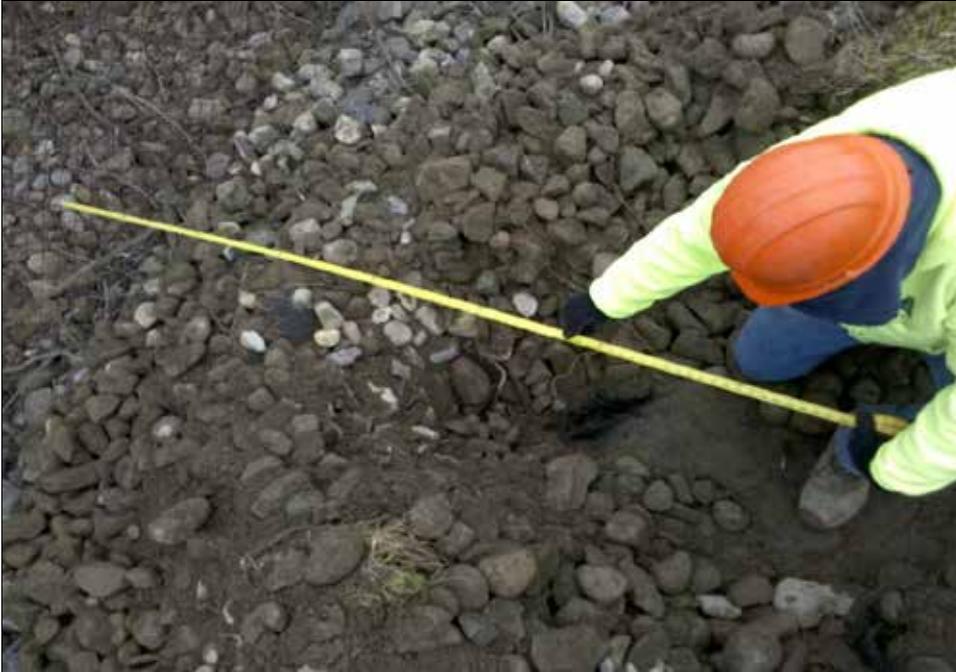
2/28/2012 1218

Edge of Anchor trench and fabric approximately 6' from eastern fence.
No damage observed in northern anchor trench.

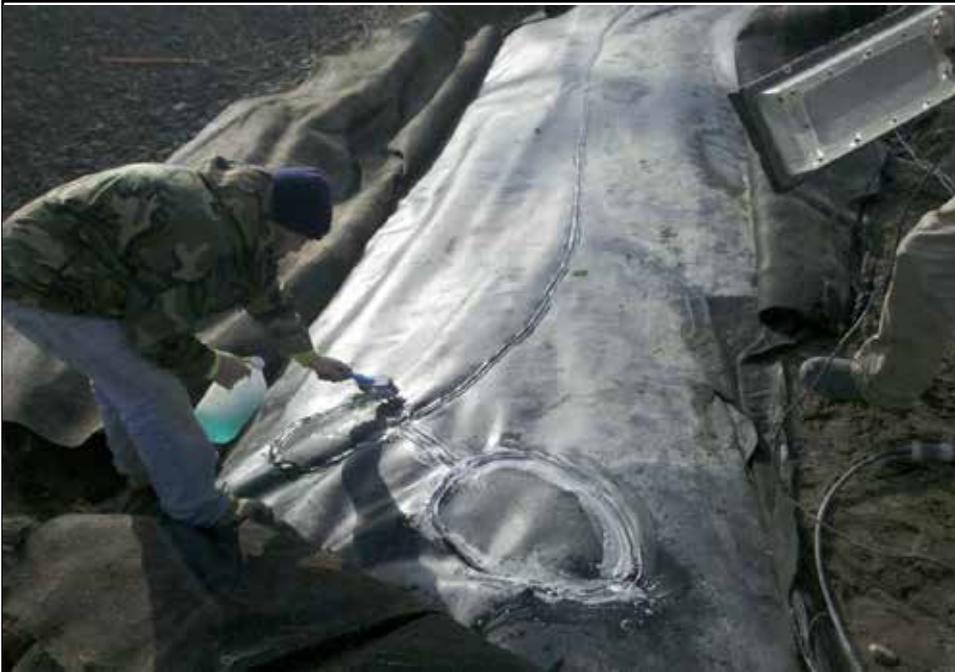
3/6/2012 1611

Vacuum testing of liner weld. No leaks found.

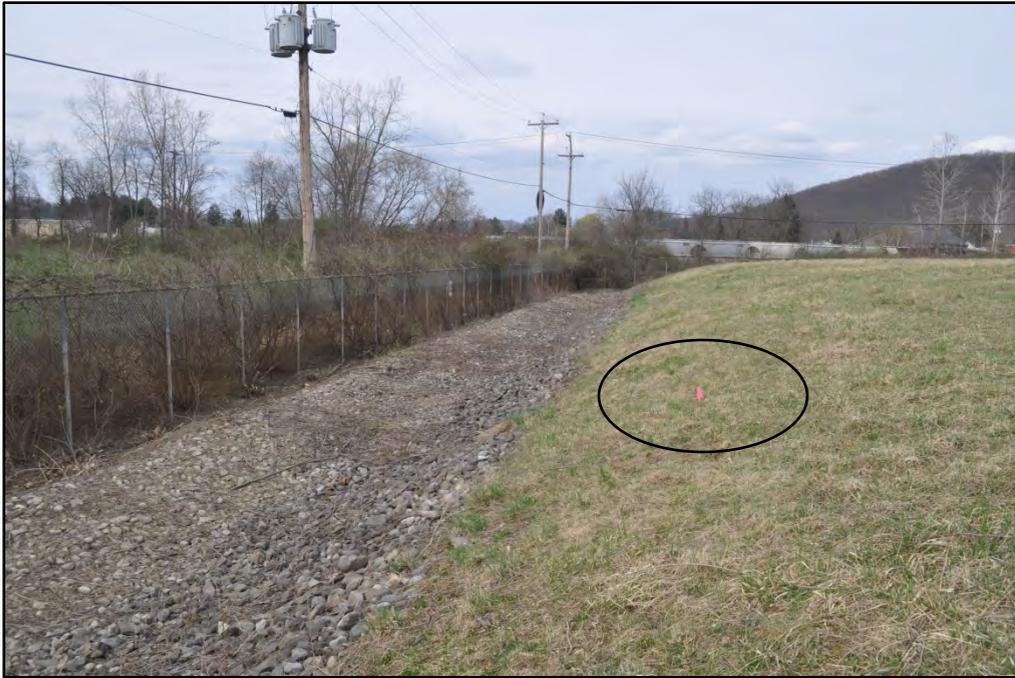
As shown in the O&M Checklist (Appendix B), one burrowing rodent hole was found along the west slope of the landfill. The hole was filled with soil and marked with a flag for future inspection.

West side of landfill – looking north.
Pink pin flag shows location of rodent burrow.

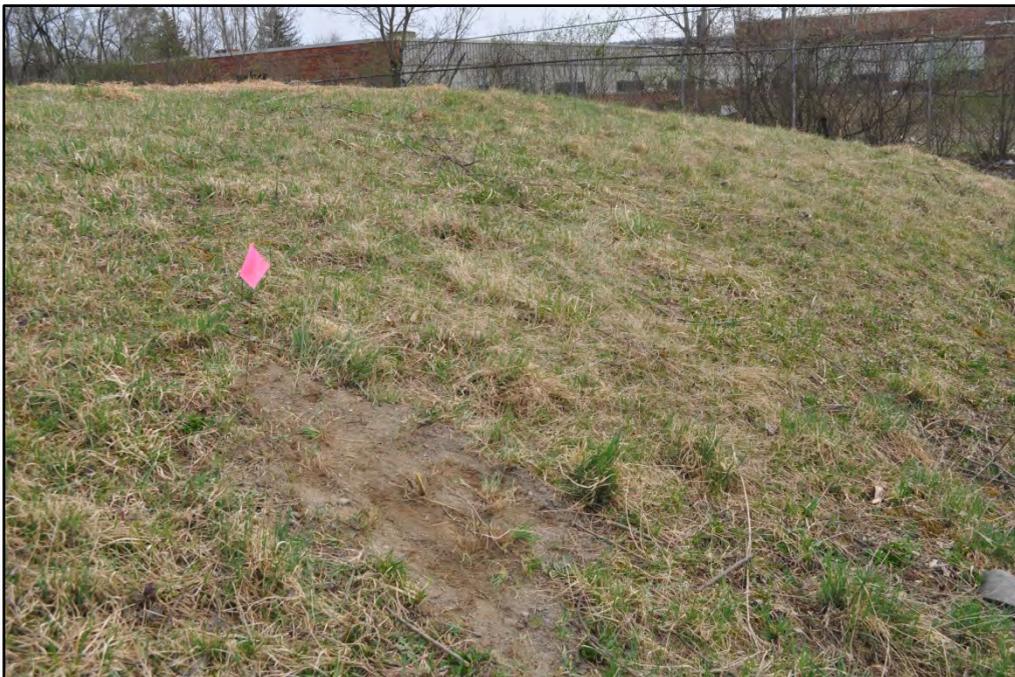
Rodent burrow on west slope of landfill. Filled and marked burrow with pin flag.

Close-up of filled rodent burrow.
