**New York State Department of  
Environmental Conservation**

**Site Number 7-54-012**

**Tioga Casting Site Quarterly  
Report**

First Quarter 2012

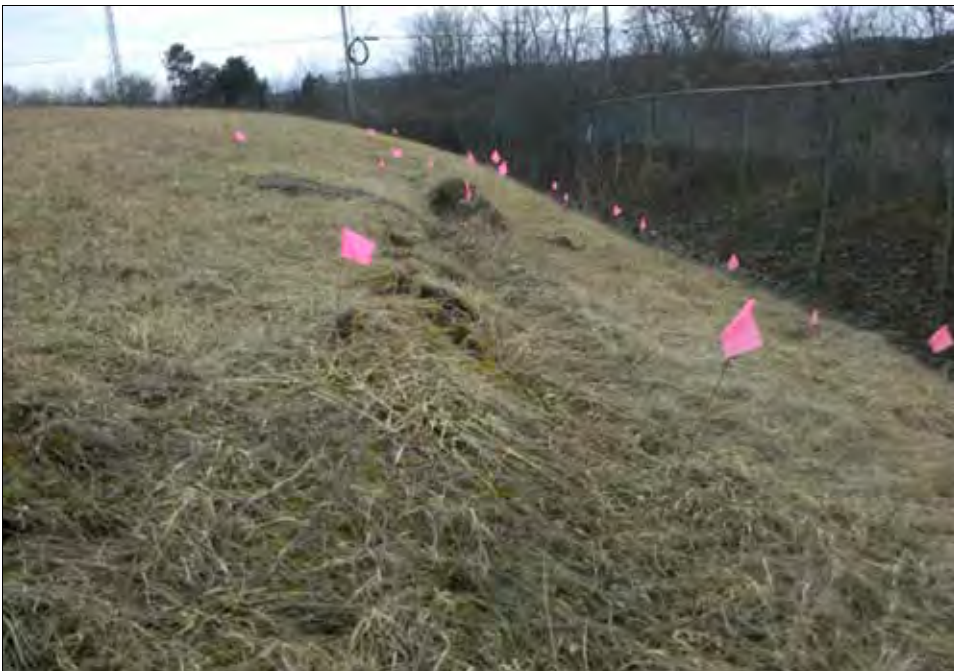
2/27/2012 1130

Liner visibly protruding through surface material.

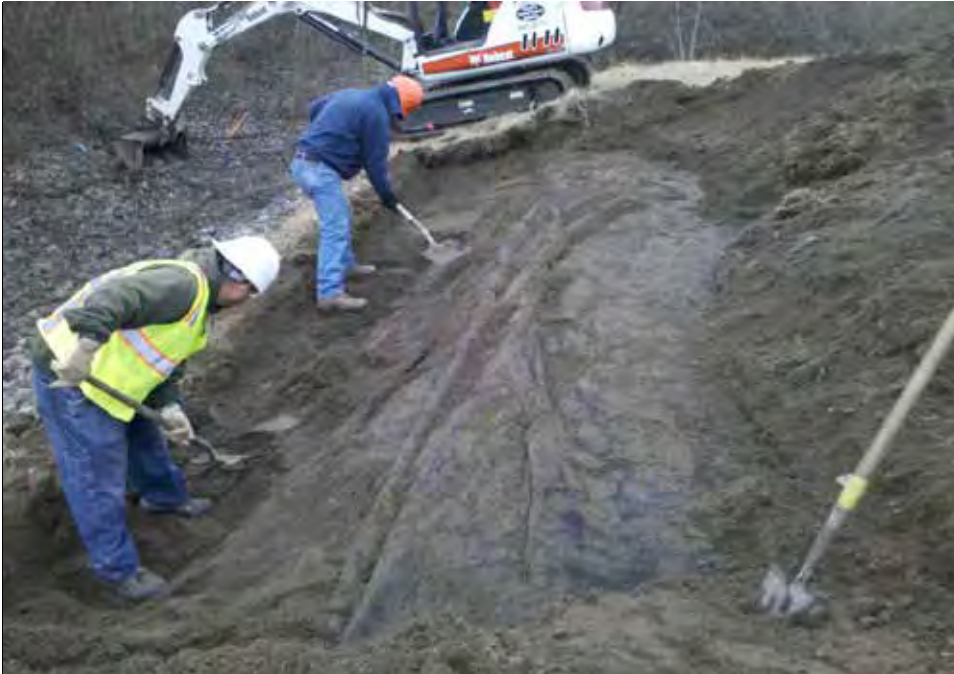
2/27/2012 1258

Aztech uncovers damaged area in southwest corner.  
Soil removed by hand to avoid damaging fabric or liner.

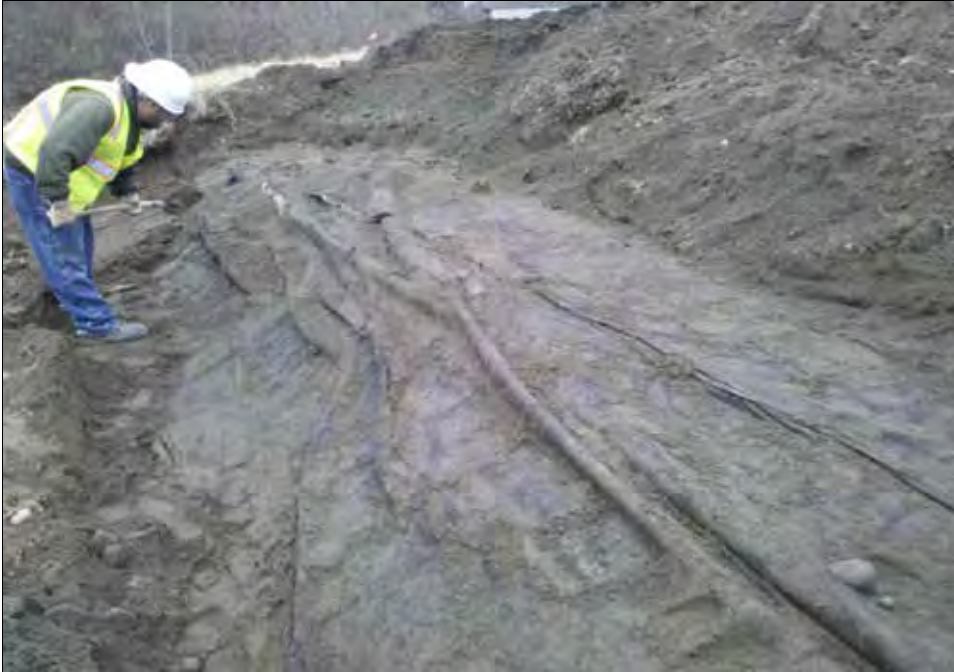
2/27/2012 1306

Inspecting fabric and liner.

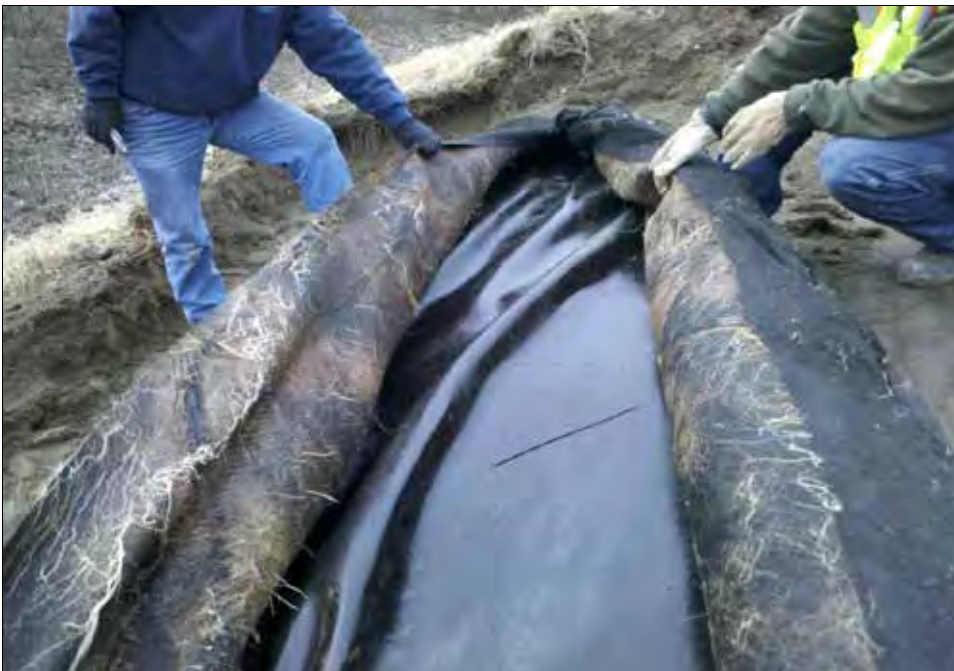
2/27/12 1334

- Soil was removed from the two damaged areas of the landfill with an excavator and hand tools.
- The geo-composite drainage net was cut to expose the underlying high density polyethylene (HDPE) liner. Wrinkles and folds were observed in the HDPE liner.

The exposed liner with wrinkles.

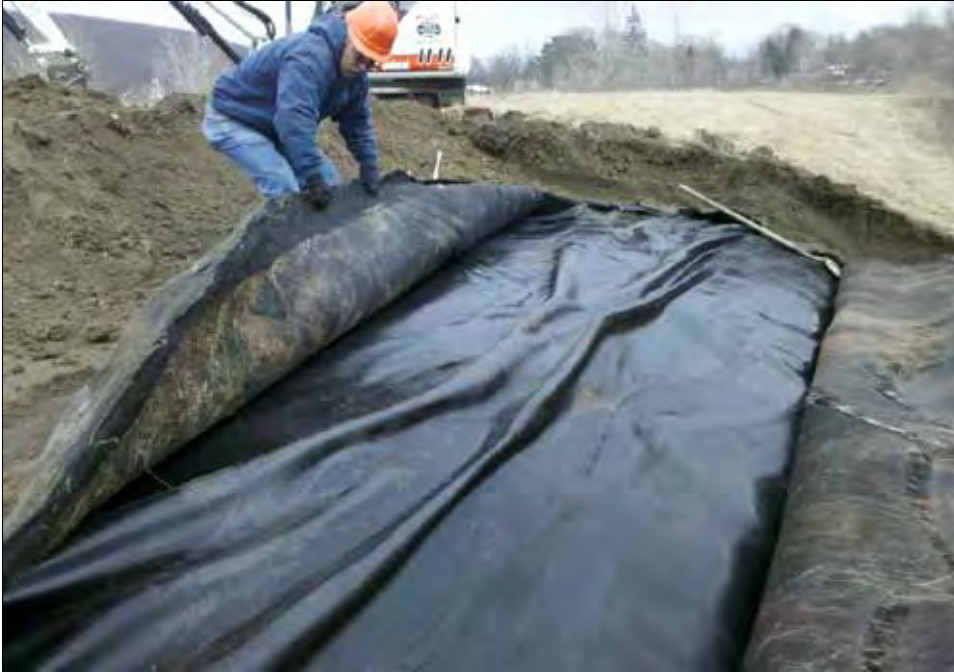
2/27/2012 1338

Liner folds flatten as they extend to the east.

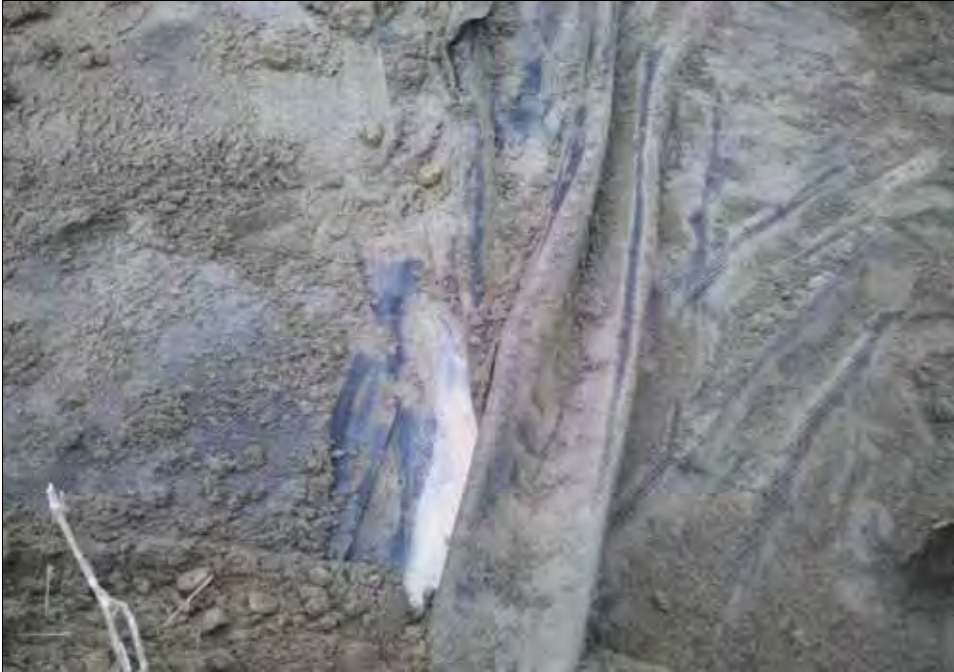
2/27/2012 1511

Liner fold in the northeast area.

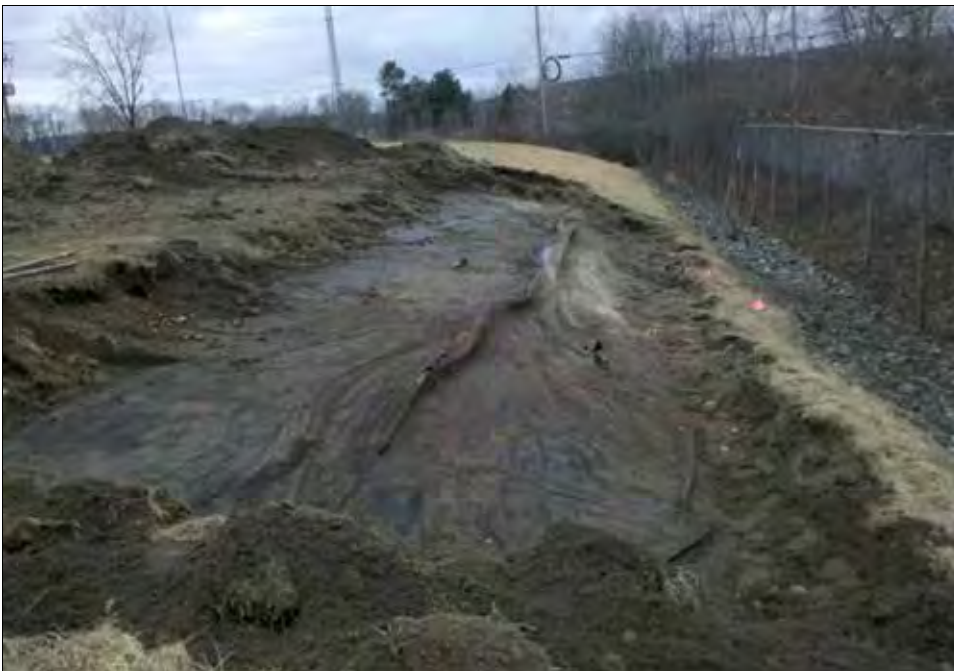
2/28/2012 1113

Liner fold extends approximately 50'.

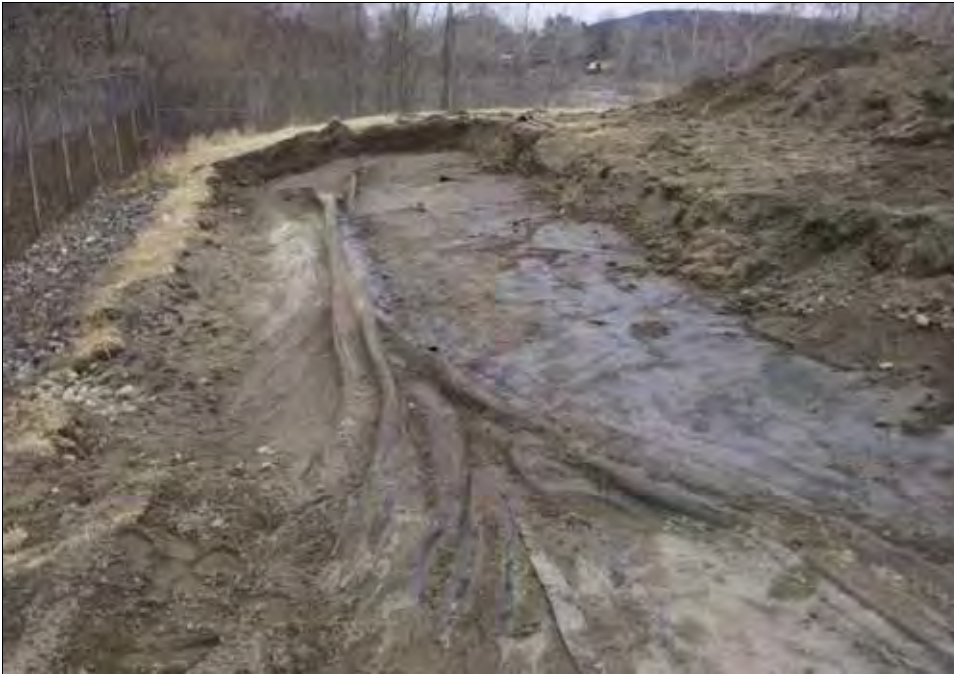
2/28/2012 1115

Northeast area - Folds flatten at  
the east and west extent of the excavation.

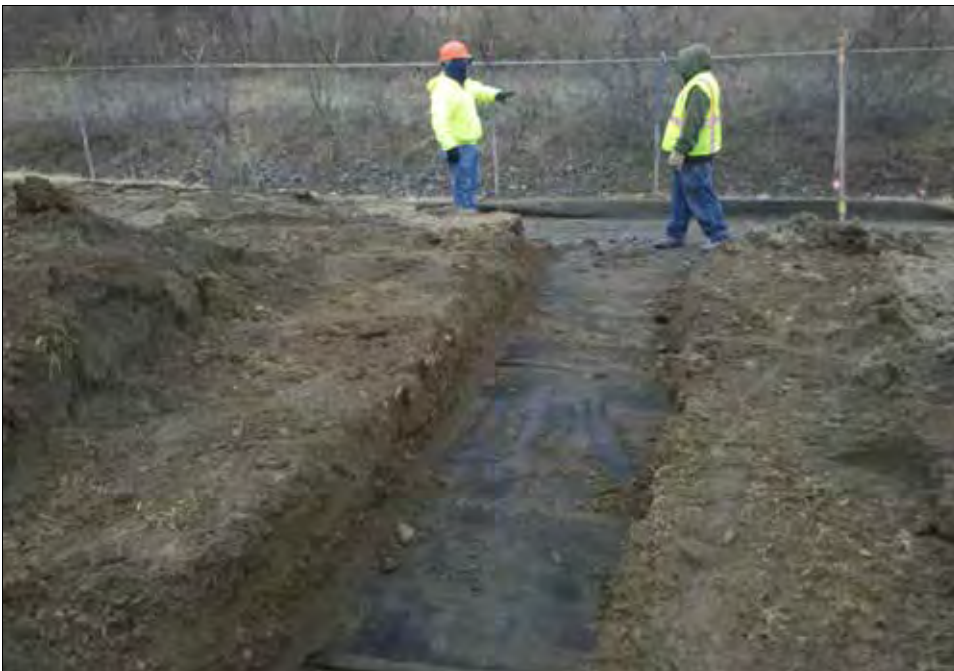
2/28/2012 1132

Exploratory trench extending towards the center of the landfill.  
No visible damage to fabric seams or liner.

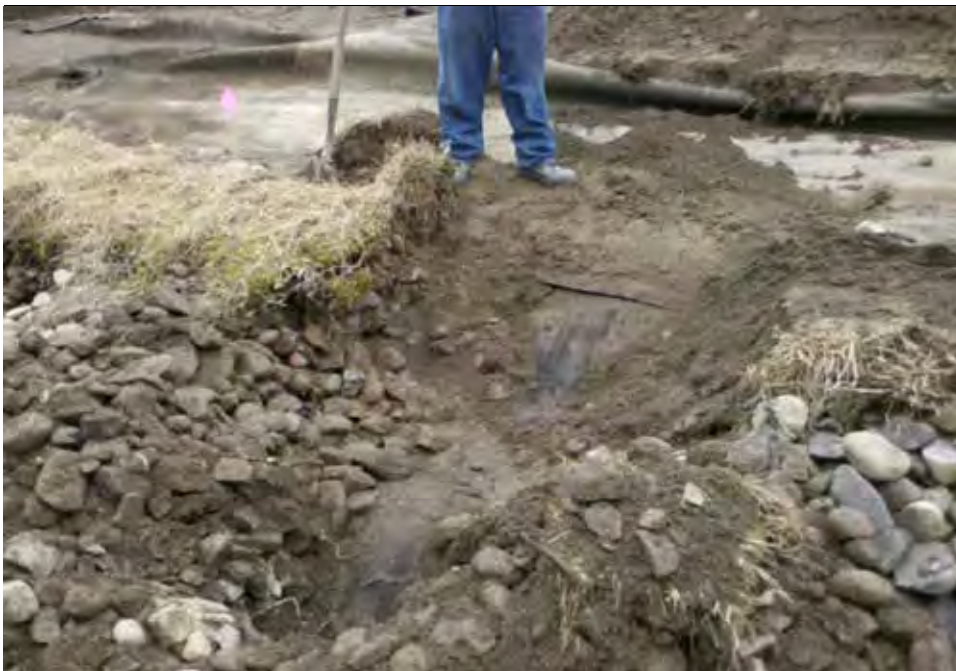
2/28/2012 1210

No damage or displacement to southern edge of anchor trench.

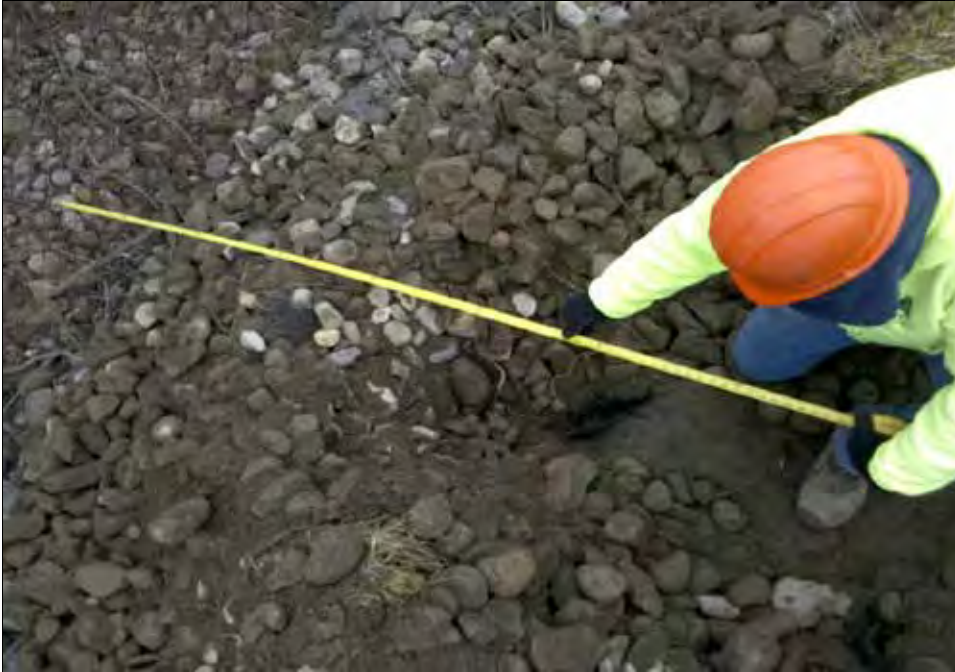
2/28/2012 1218

Edge of Anchor trench and fabric approximately 6' from eastern fence.  
No damage observed in northern anchor trench.

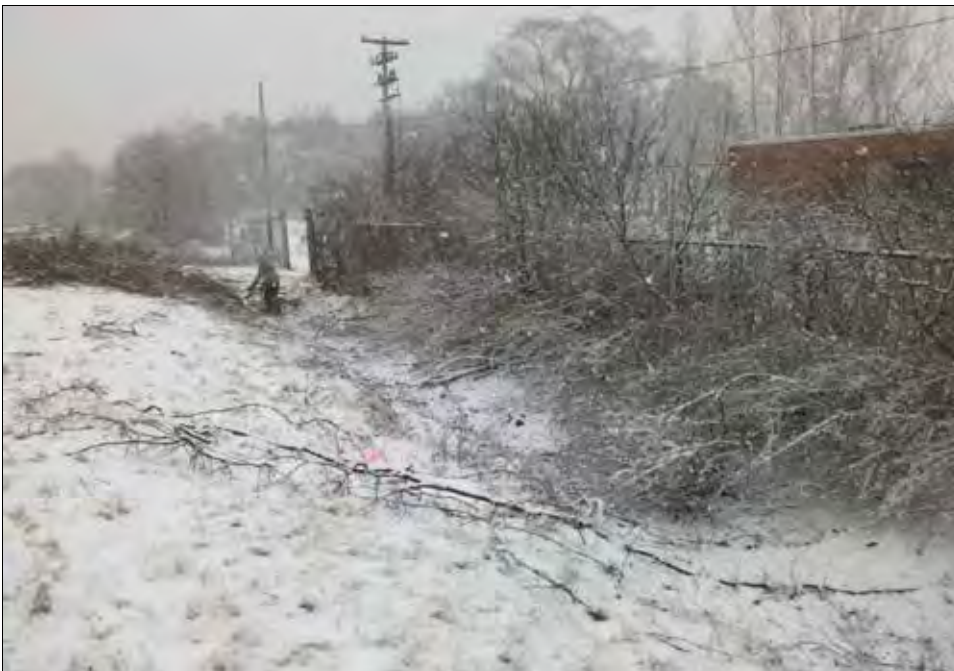
2/29/2012 1054

Southern fence boundary prior to brush removal.

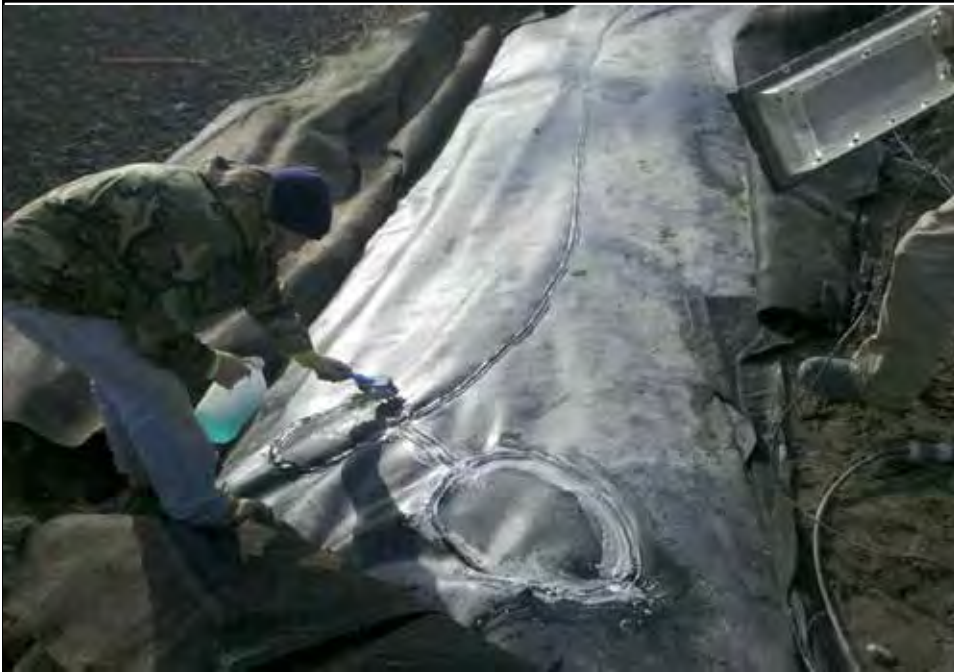
3/6/2012 1611

Vacuum testing of liner weld. No leaks found.

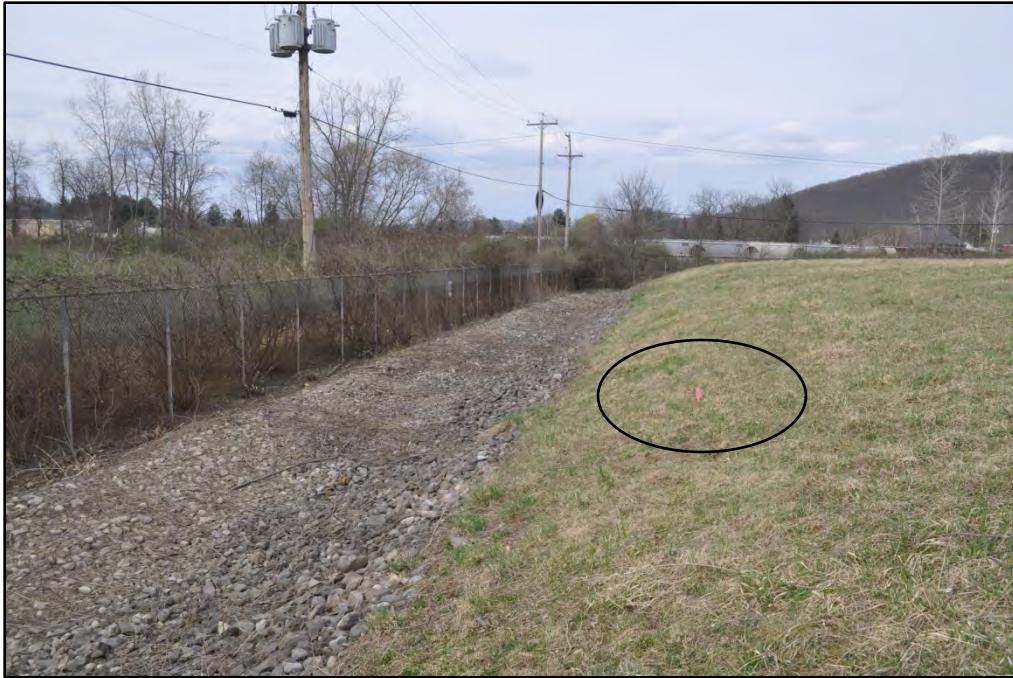
As shown in the O&M Checklist (Appendix B), one burrowing rodent hole was found along the west slope of the landfill. The hole was filled with soil and marked with a flag for future inspection.

West side of landfill – looking north.  
Pink pin flag shows location of rodent  
burrow.

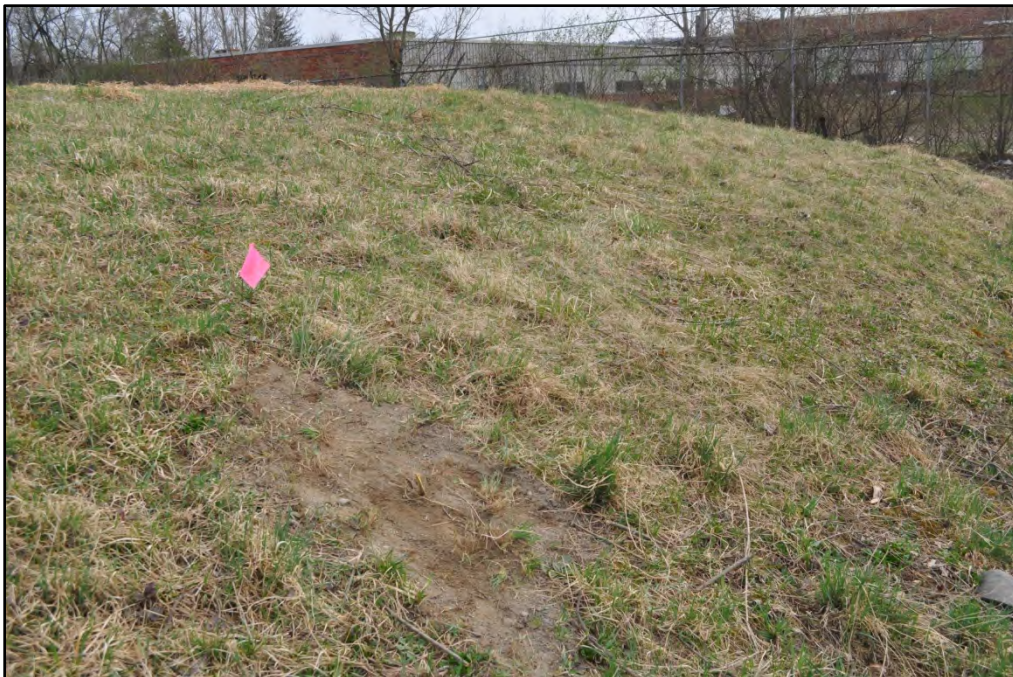
Close-up of filled rodent burrow.

Rodent burrow on west slope of landfill. Filled and marked burrow with pin flag.
