Site Number 7-54-012

**Tioga Casting Site Quarterly
Report**

Second Quarter 2014

Prepared by:
Malcolm Pirnie, Inc.
855 Route 146
Suite 210
Clifton Park
New York 12065
Tel 518 250 7300
Fax 518 250 7301

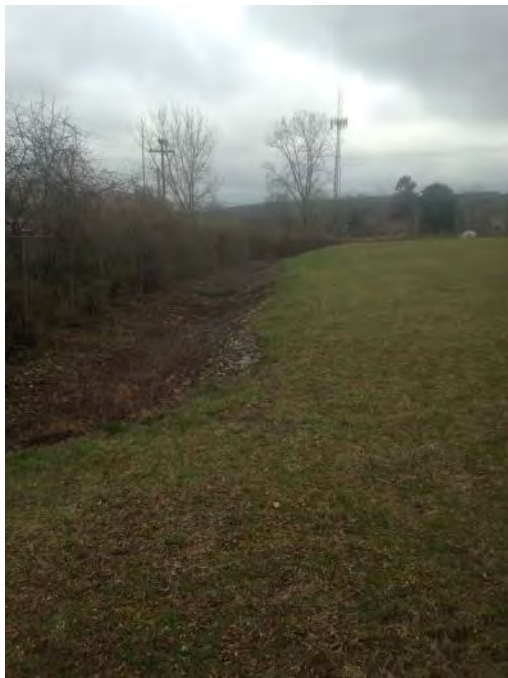
South edge of landfill – looking west

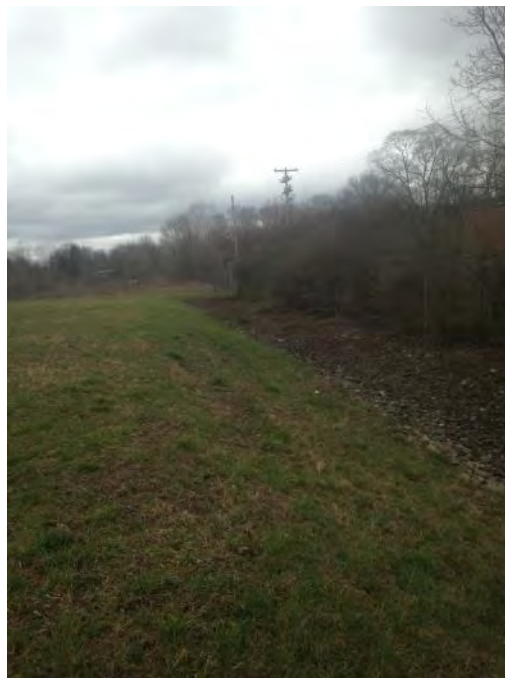
South edge of landfill – looking east

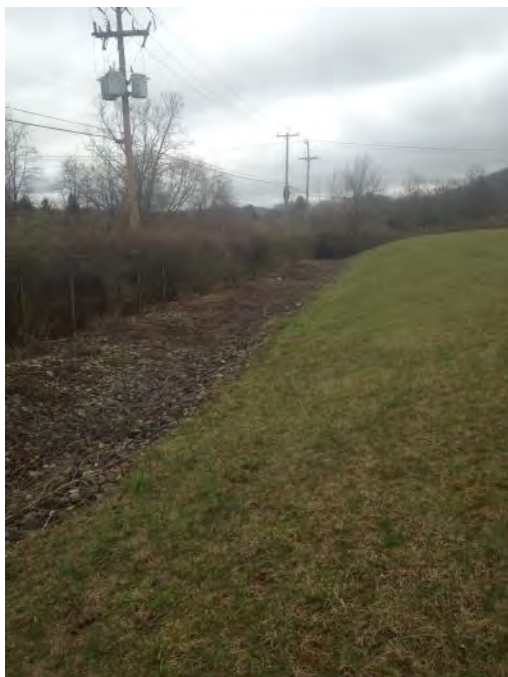
West edge of landfill – looking north

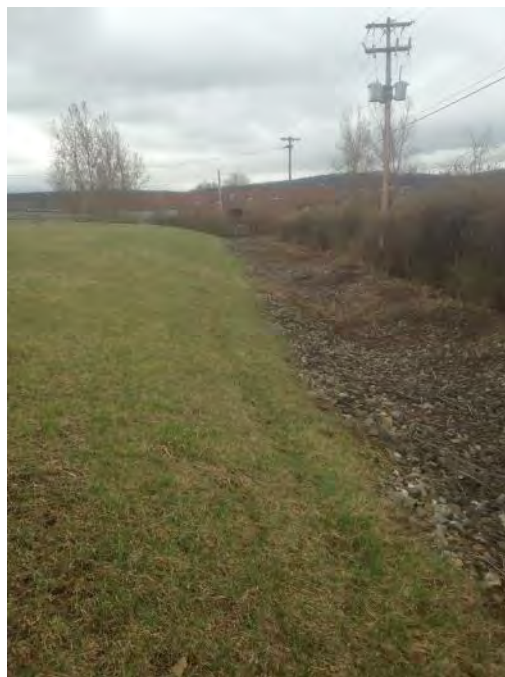
West edge of landfill – looking south

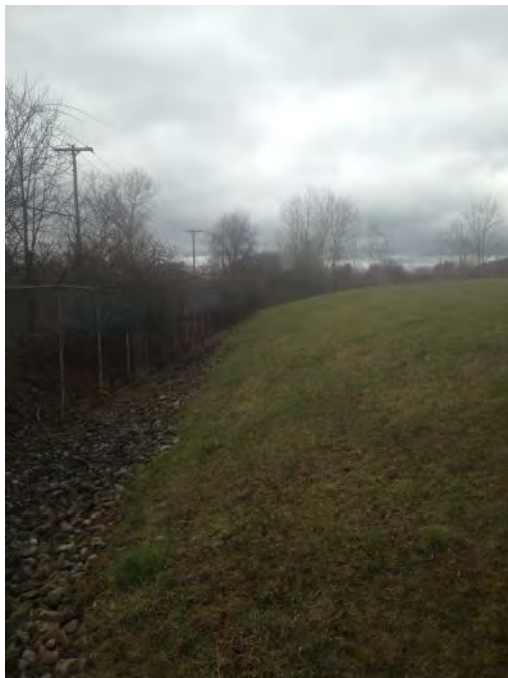
North edge of landfill – looking east

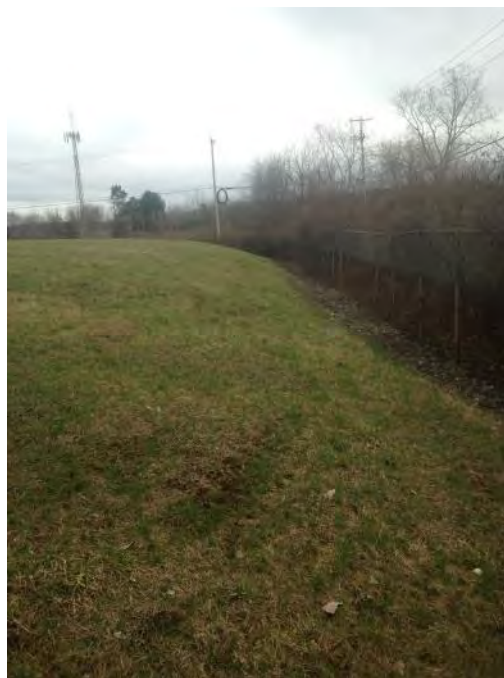
North edge of landfill – looking west

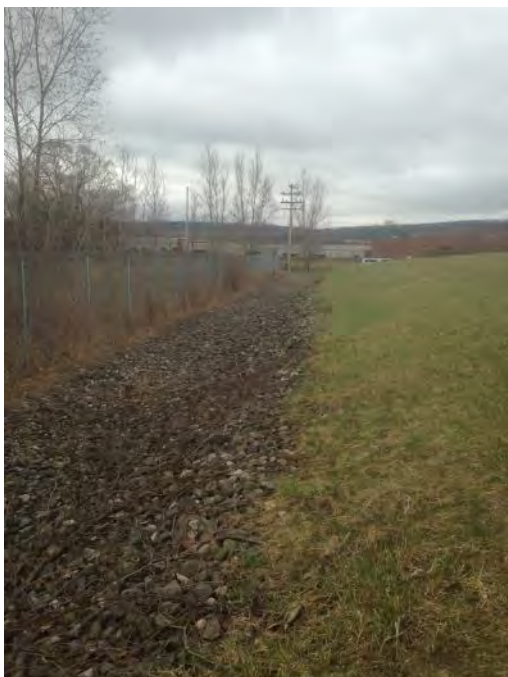
East edge of landfill – looking south

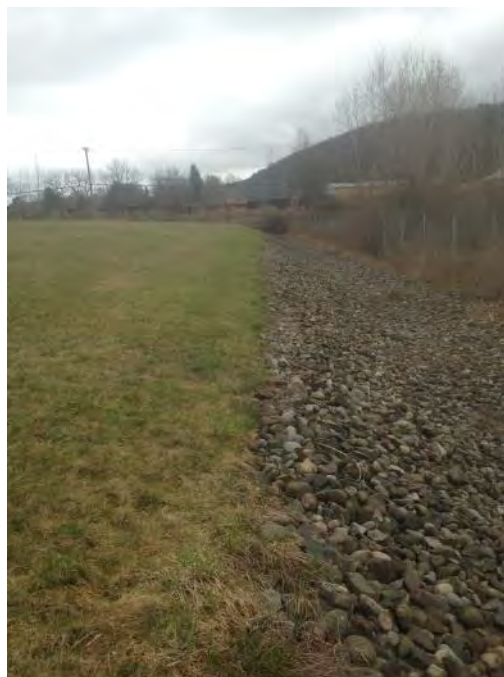
East edge of landfill – looking North

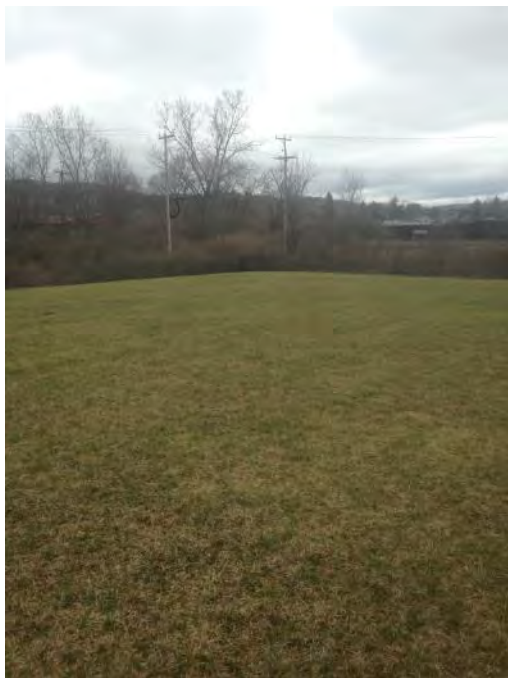
Central landfill – looking northwest

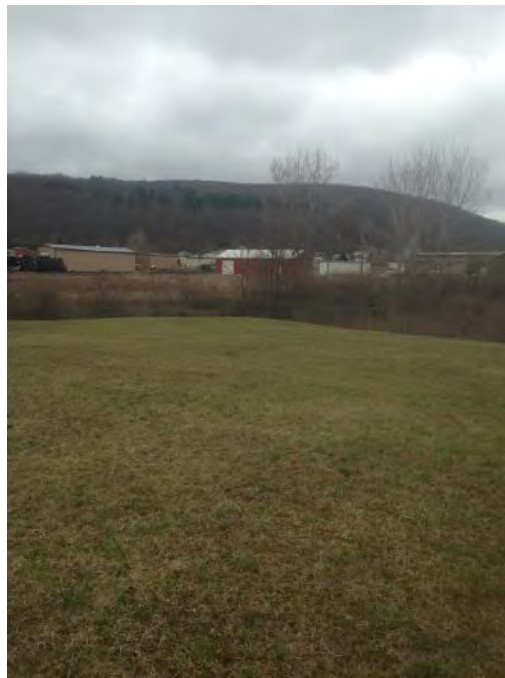
Central landfill – looking northeast

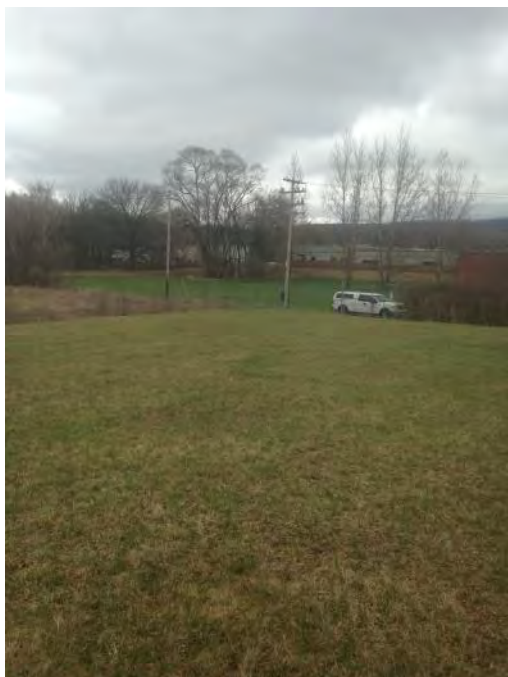
Central landfill – looking southeast

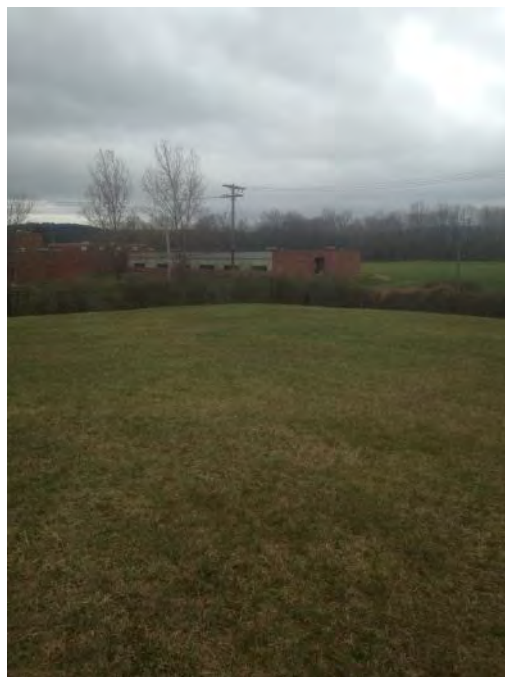
Central landfill – looking southwest

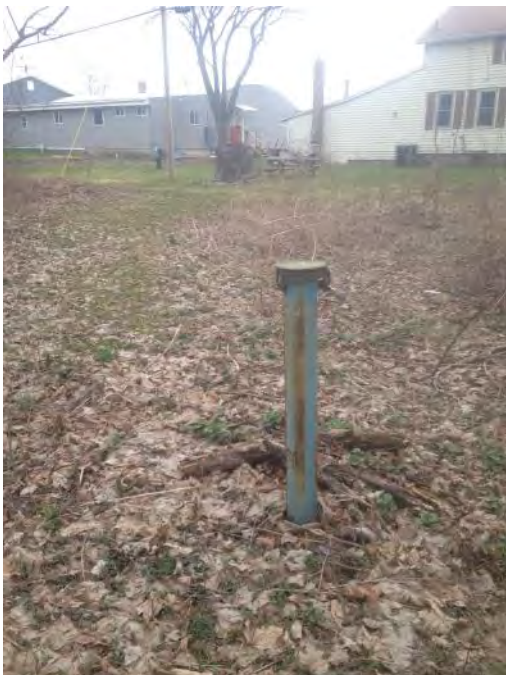
MW-1R

All other locks are corroded and should be replaced.

The locks at the remaining site wells are corroded and should be replaced.

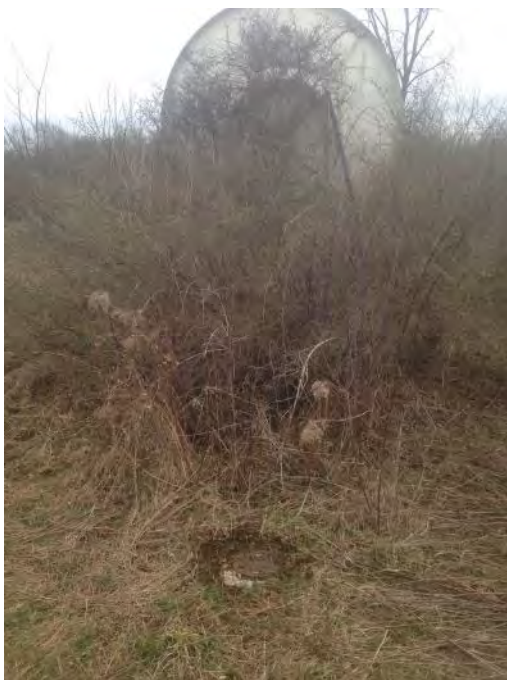
Concrete collar for MW-4 flushmount is deteriorated - flushmount should be replaced

The flush-mount protective casing at MW-4 should be replaced due to a deteriorated concrete collar and the cover can no longer be secured.

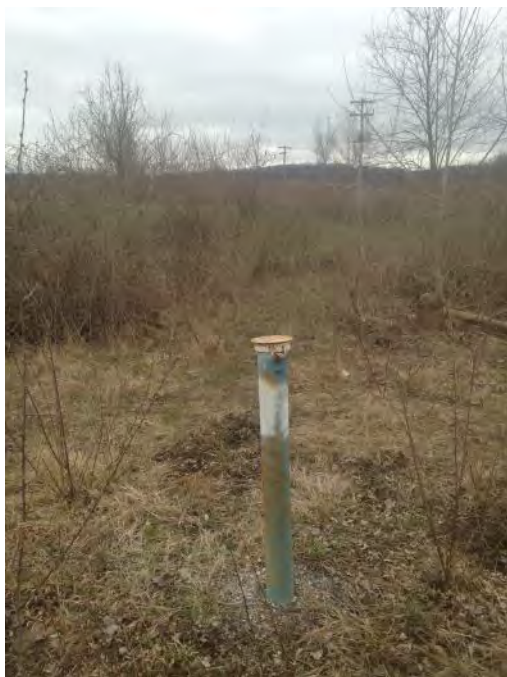
- The lock for MW-6 is seized and needs to be replaced.

Comments: MW-6 lock will not lock and needs replacement.

The lock for MW-6 is not operating and should be replaced.
