Tioga Castings Site Quarterly Report Third Quarter 2015

NYSDEC Site Number 7-54-012

January 2016

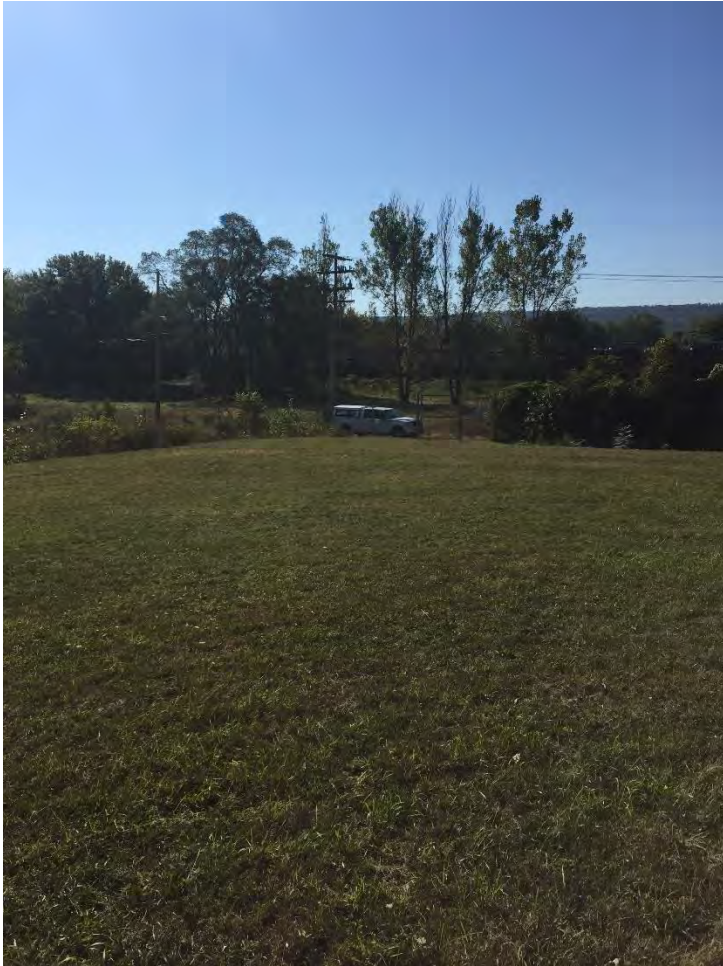
Facing southeast
corner, from center
of landfill

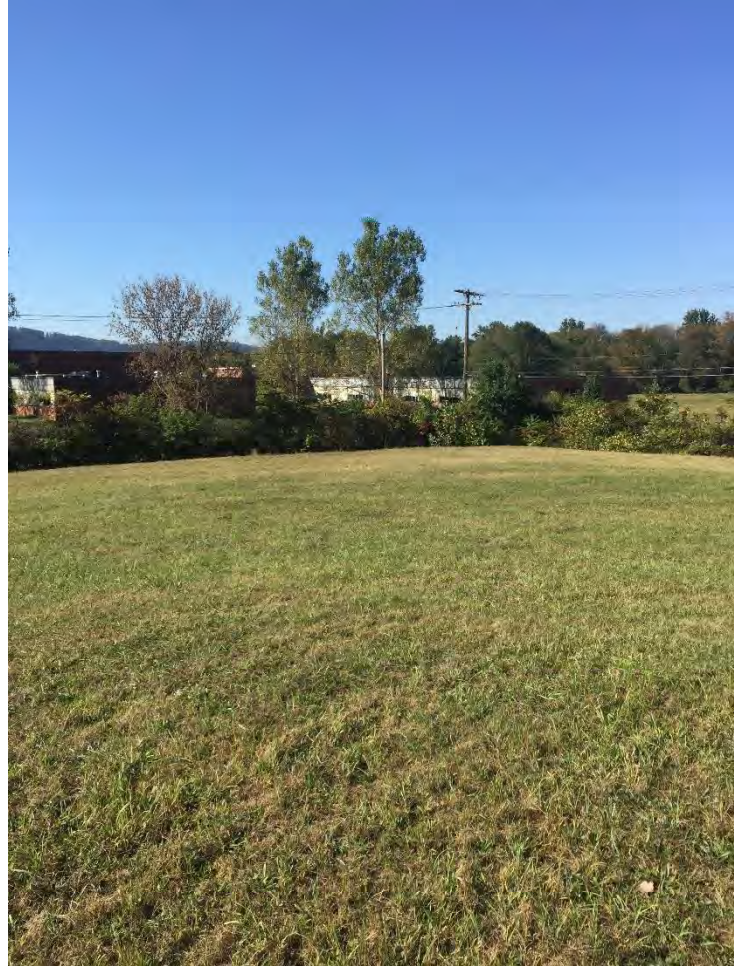
Facing southwest
corner, from center
of landfill

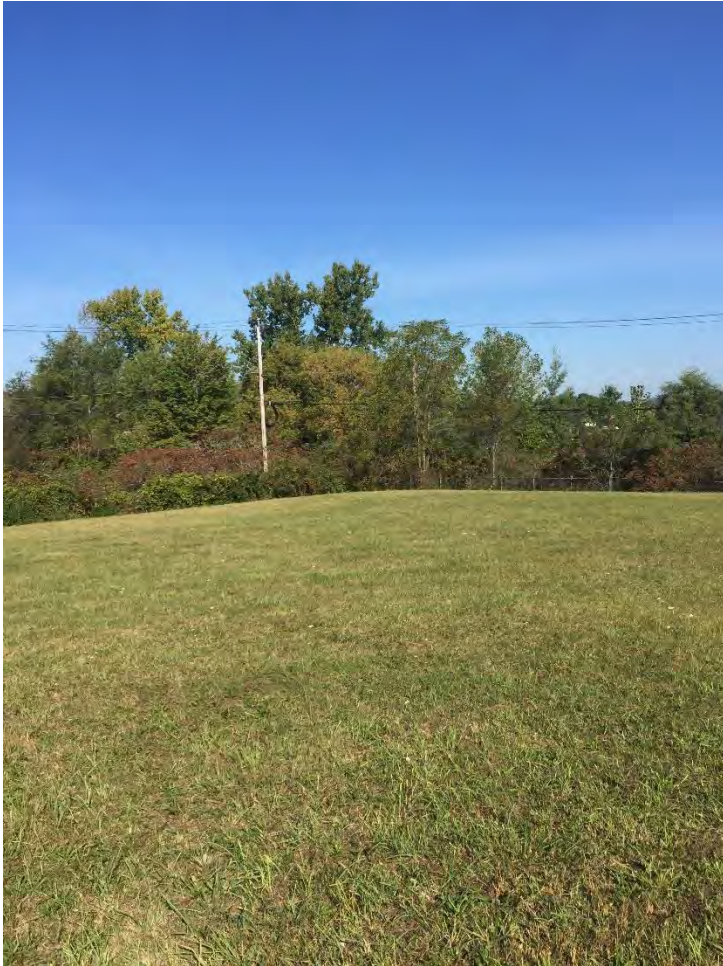
Facing northwest
corner, from center
of landfill

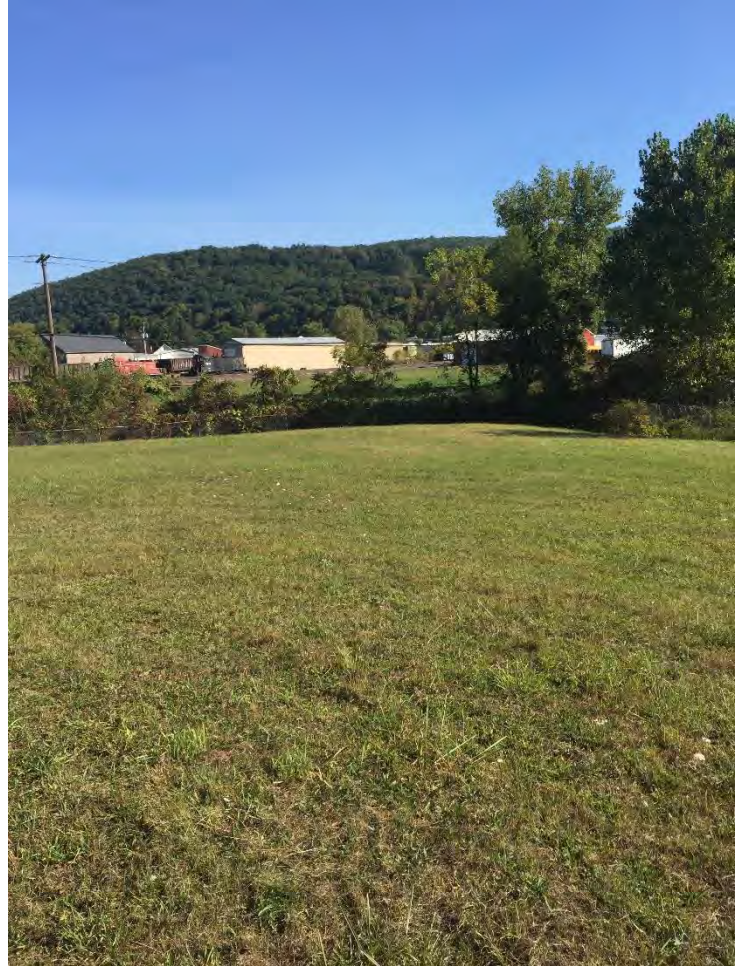
Facing northeast
corner, from center
of landfill

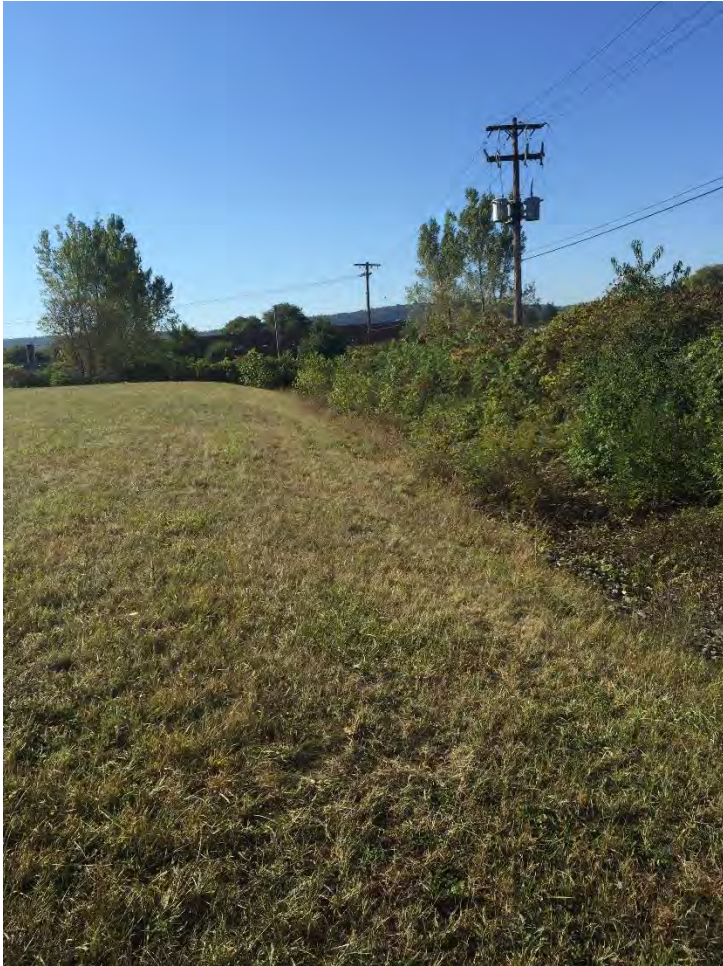
Facing south, from
northwest corner

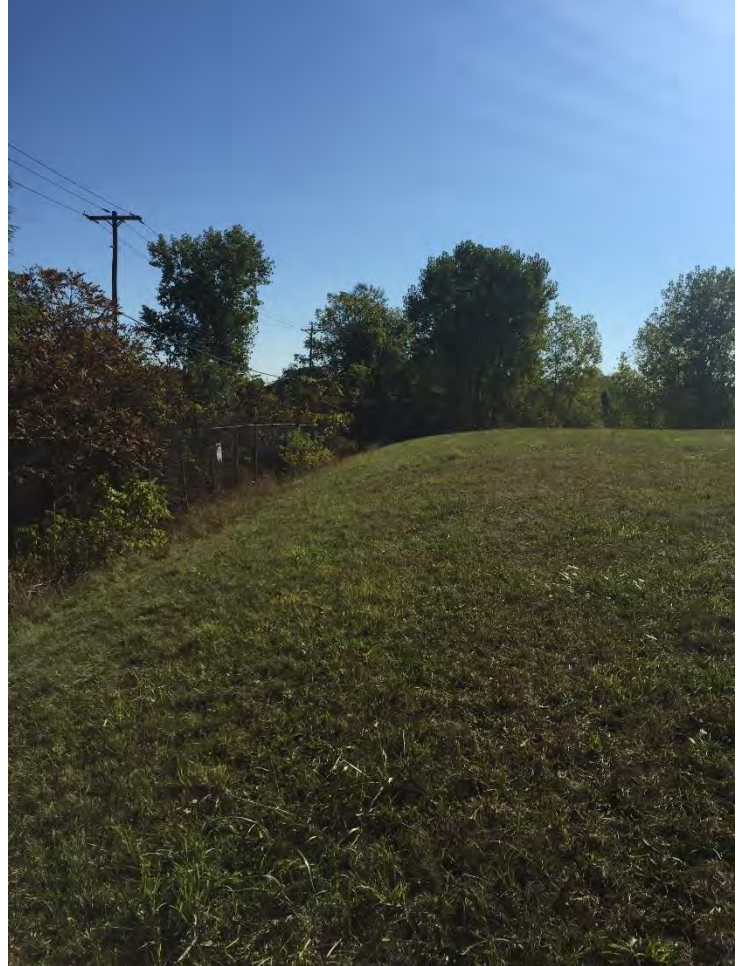
Facing east, from
northwest corner

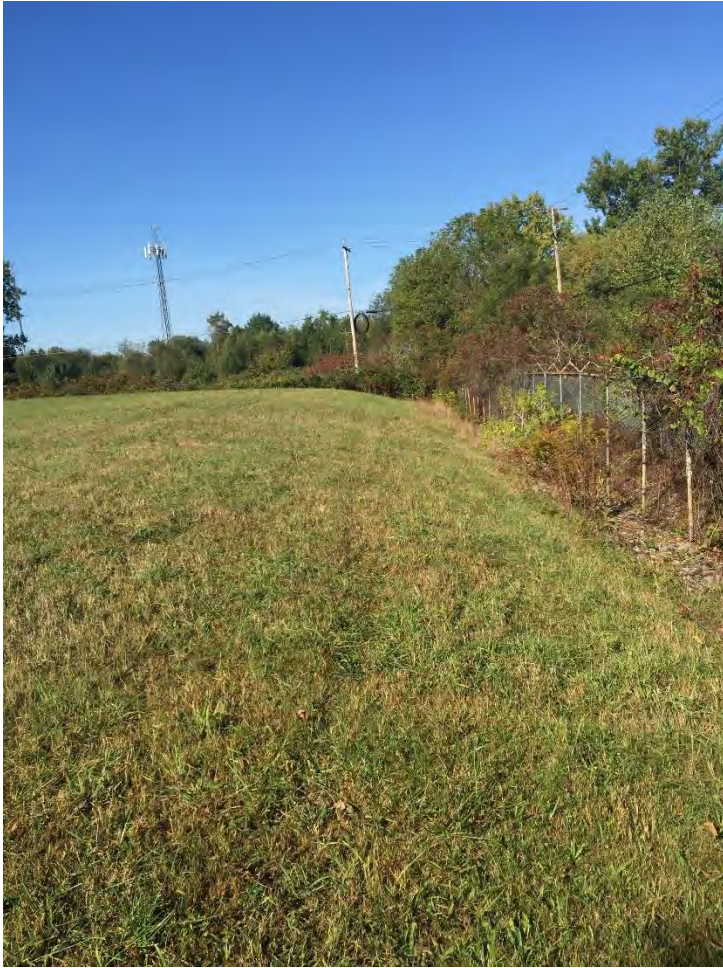
Facing west, from
northeast corner

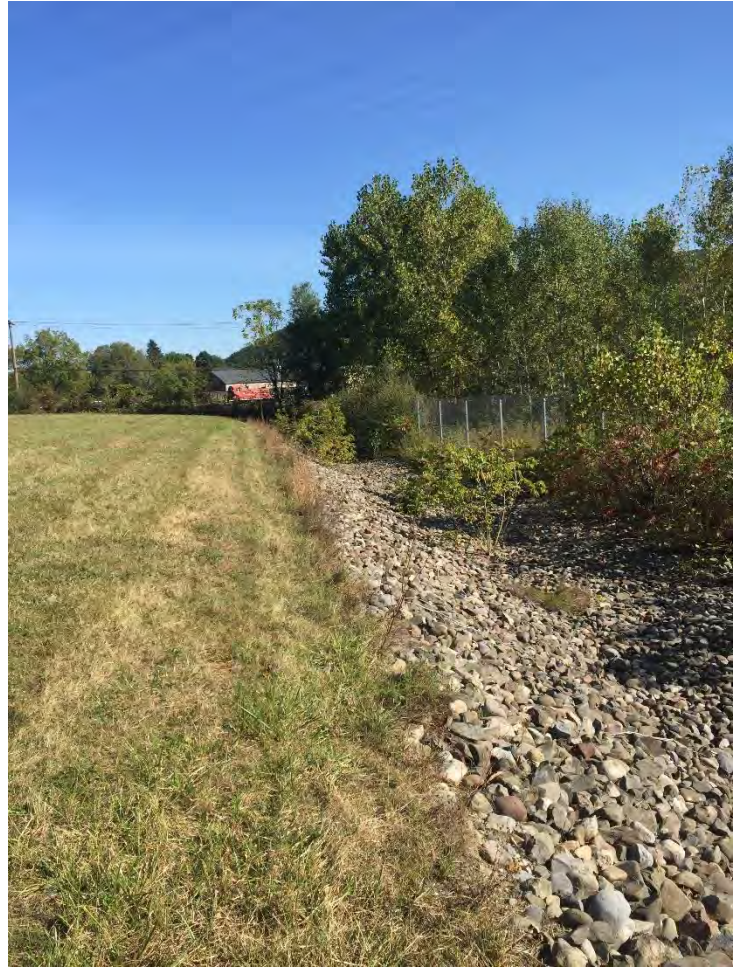
Facing north, from
southeast corner

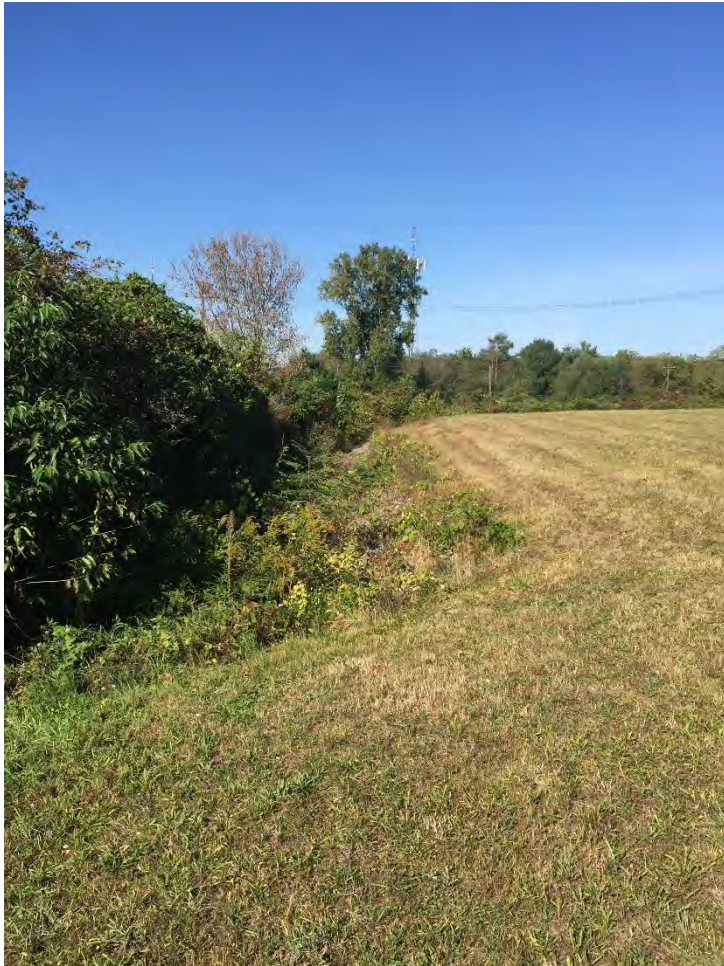
Facing west, from
southeast corner

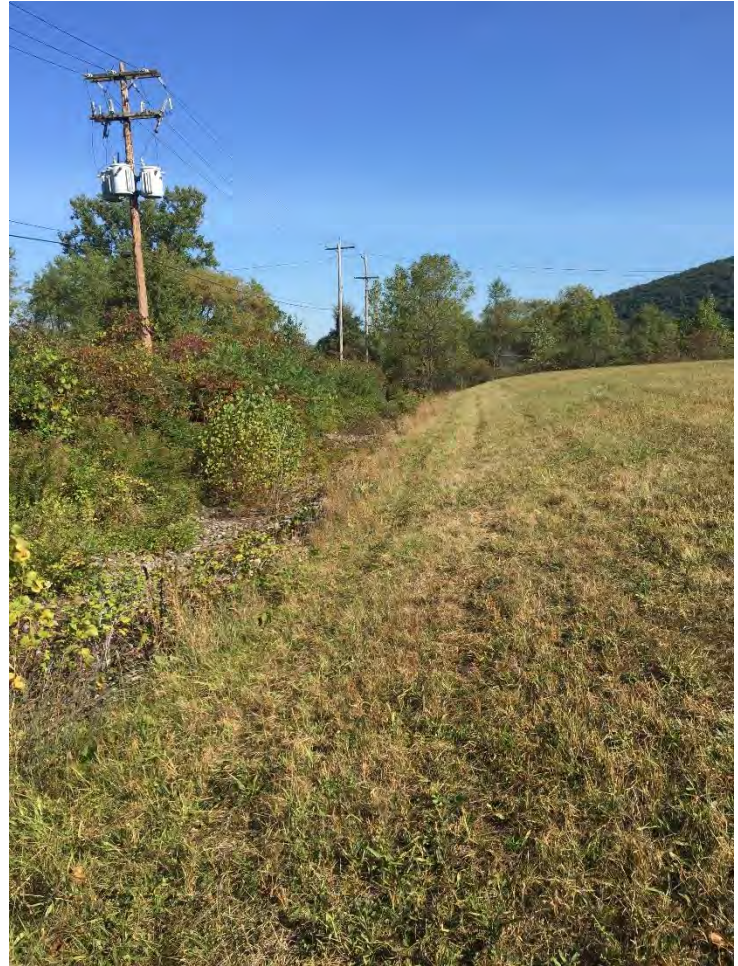
Facing north, from
southwest corner
