TIOGA CASTINGS SITE SEMI- ANNUAL REPORT

Second Quarter 2017

TIOGA CASTINGS SITE SEMI-ANNUAL REPORT

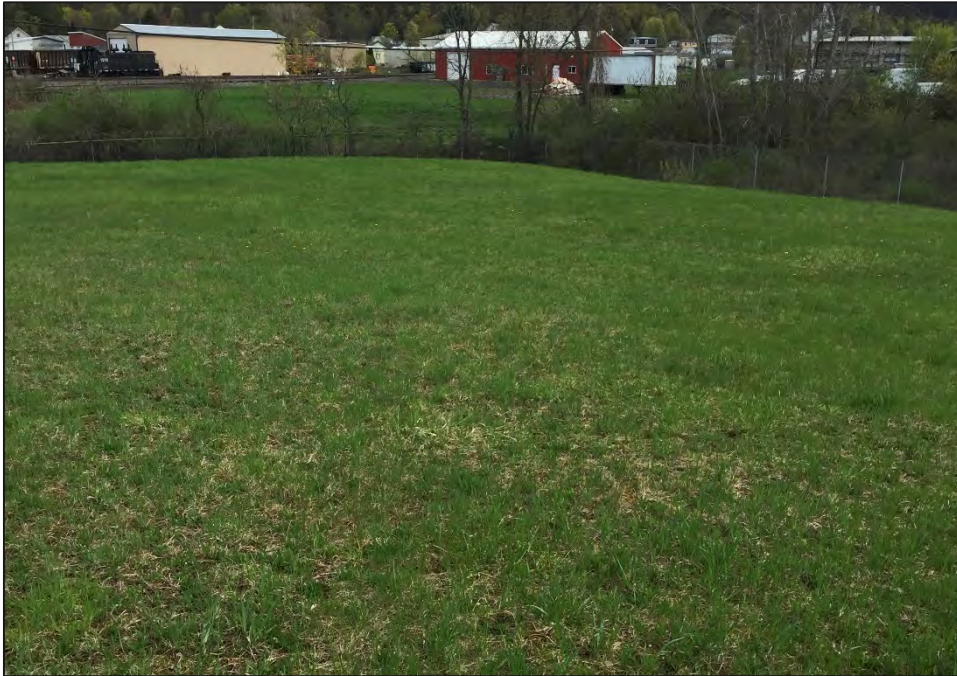
Photo: 1

Center of Landfill Cap – Facing
Northeast

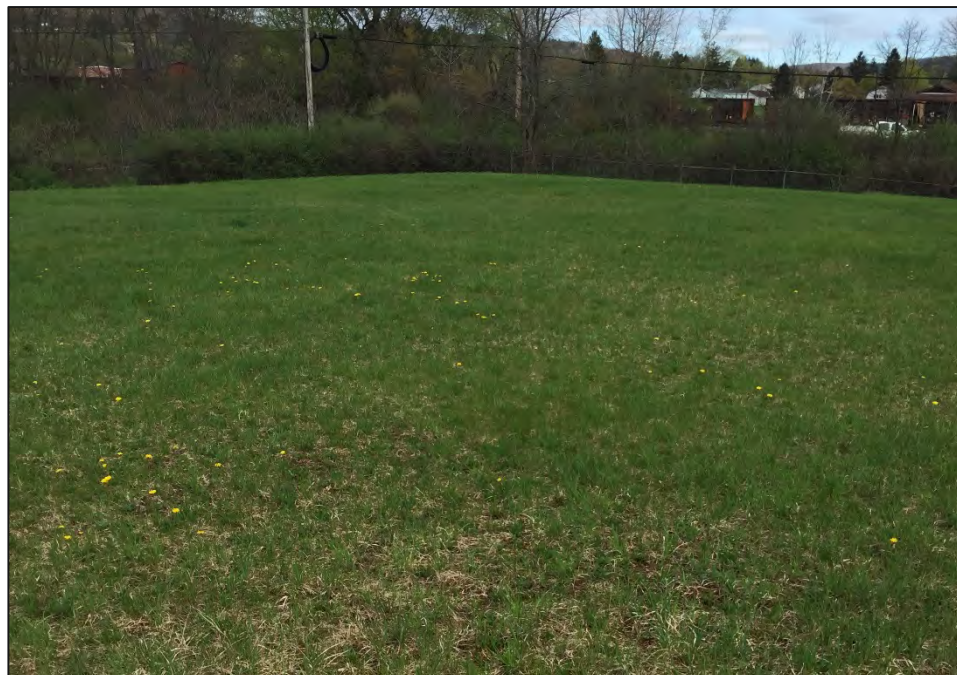
Photo: 2

Center of Landfill Cap – Facing
Northwest

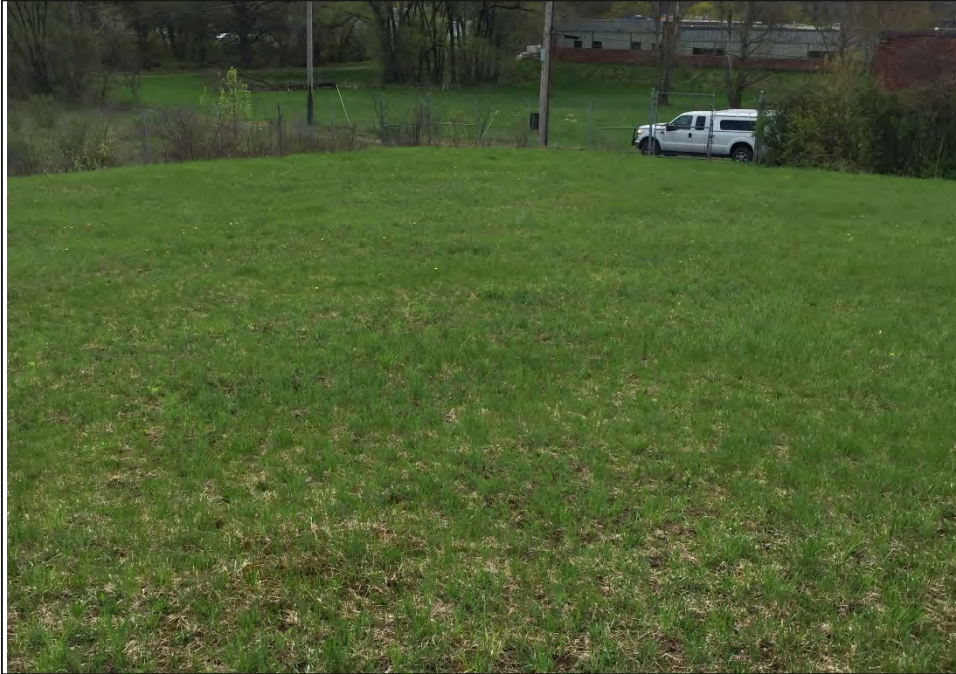
Photo: 3

Center of Landfill Cap – Facing
Southeast

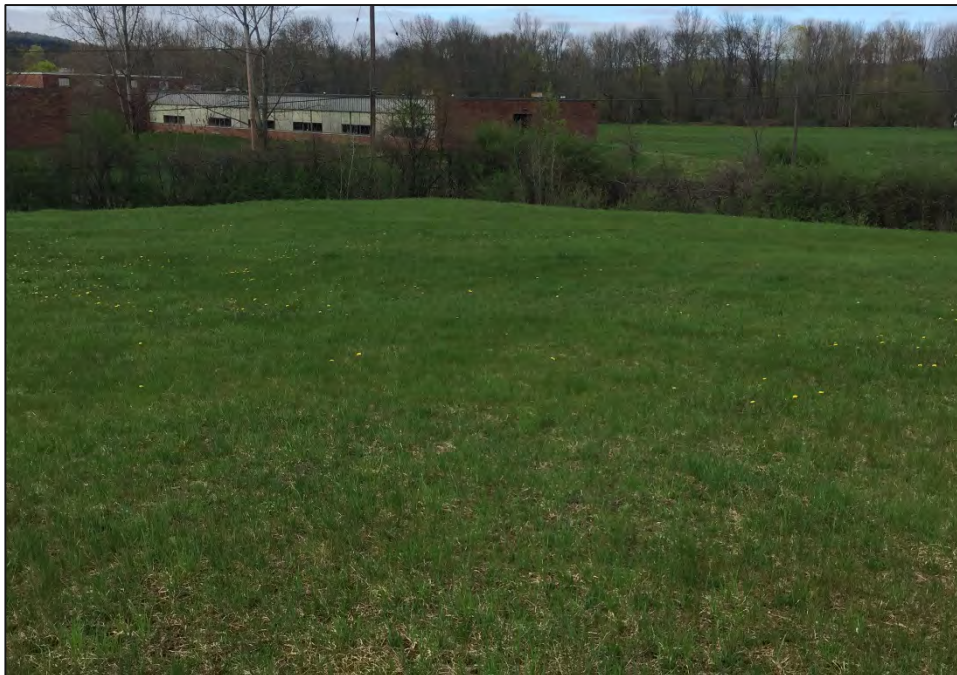
Photo: 4

Center of Landfill Cap – Facing
Southwest

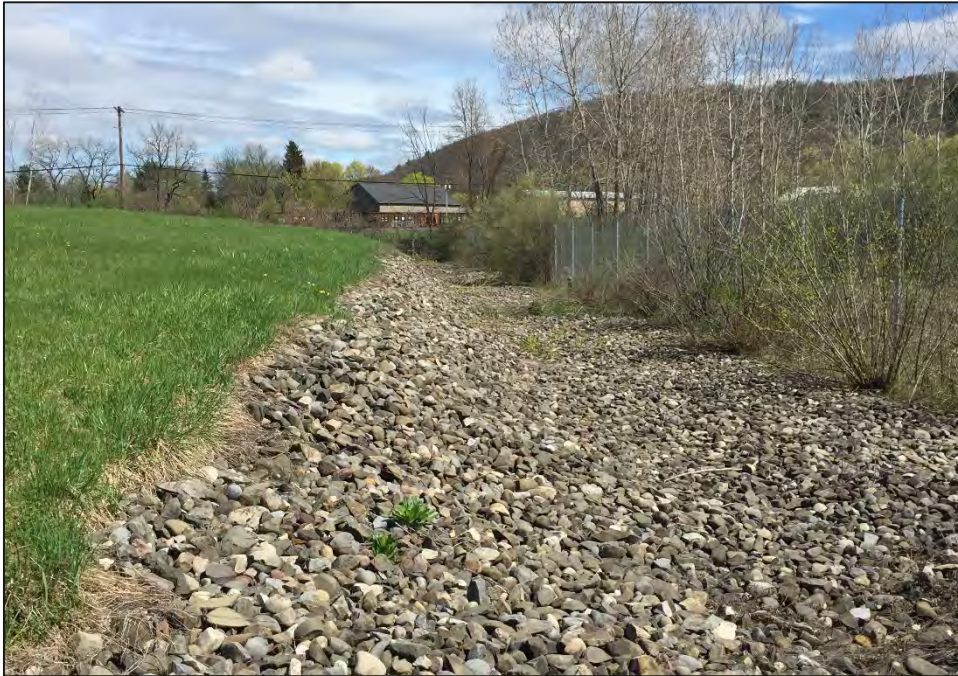
Photo: 5

East Side of Landfill – Facing
North

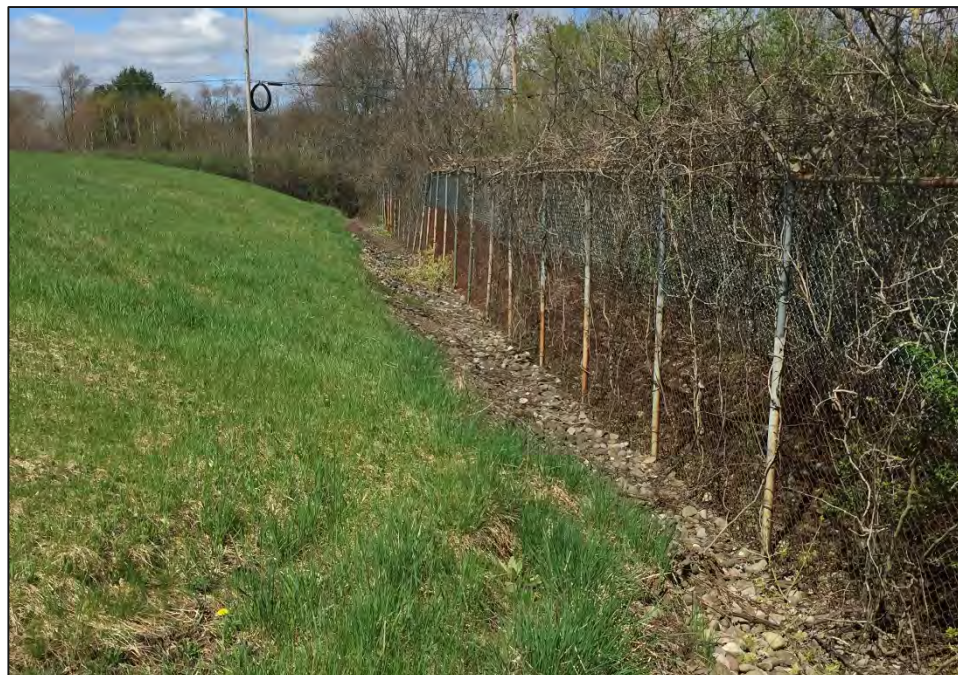
Photo: 6

North Side of Landfill – Facing
West

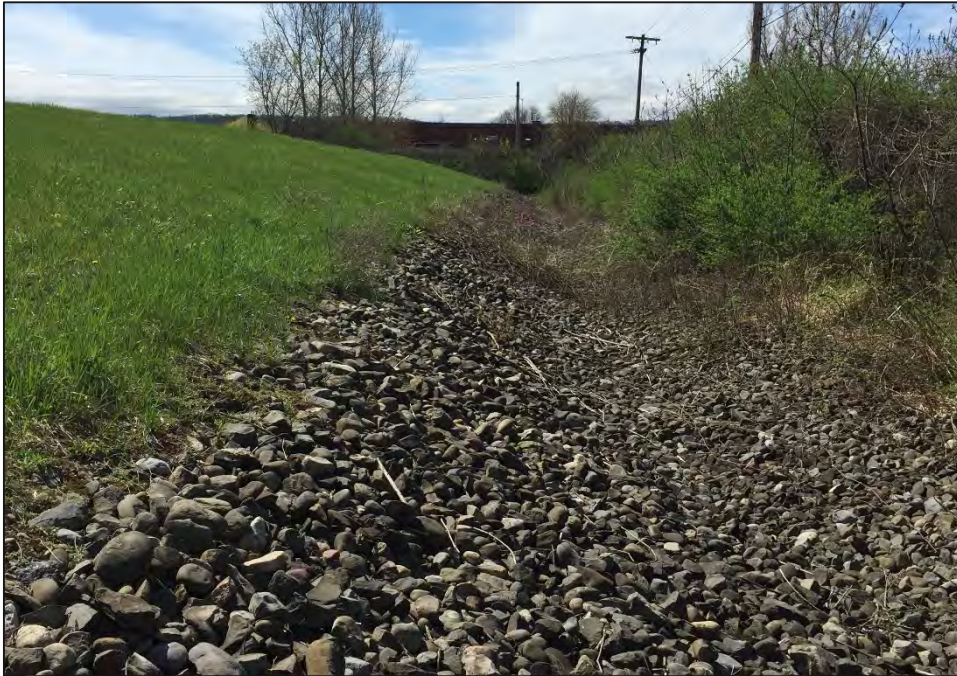
Photo: 7

West Side of Landfill – Facing South

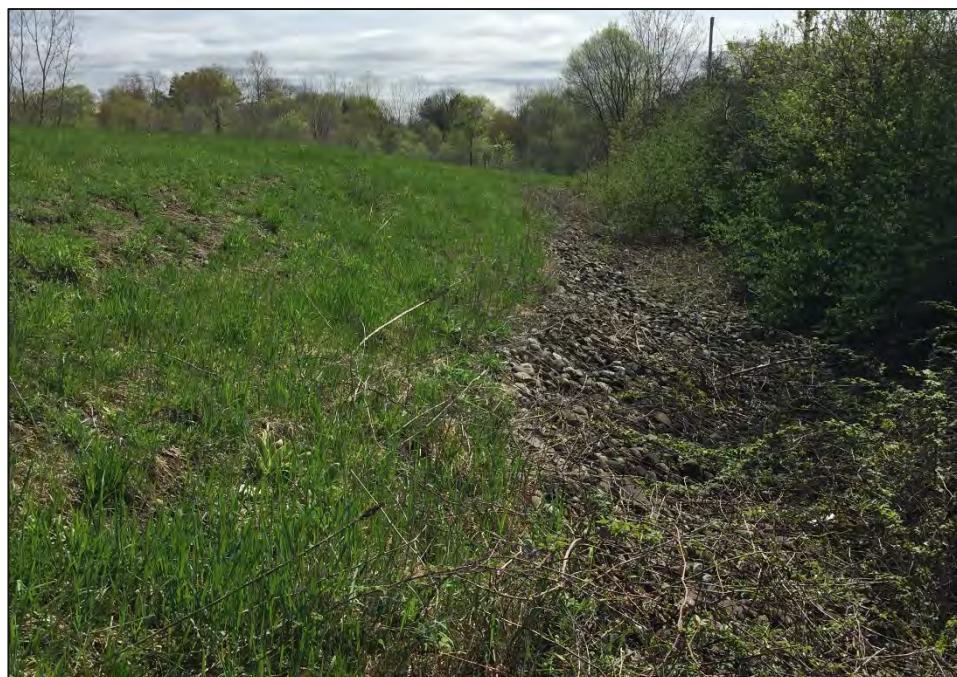
Photo: 8

South Side of Landfill – Facing East

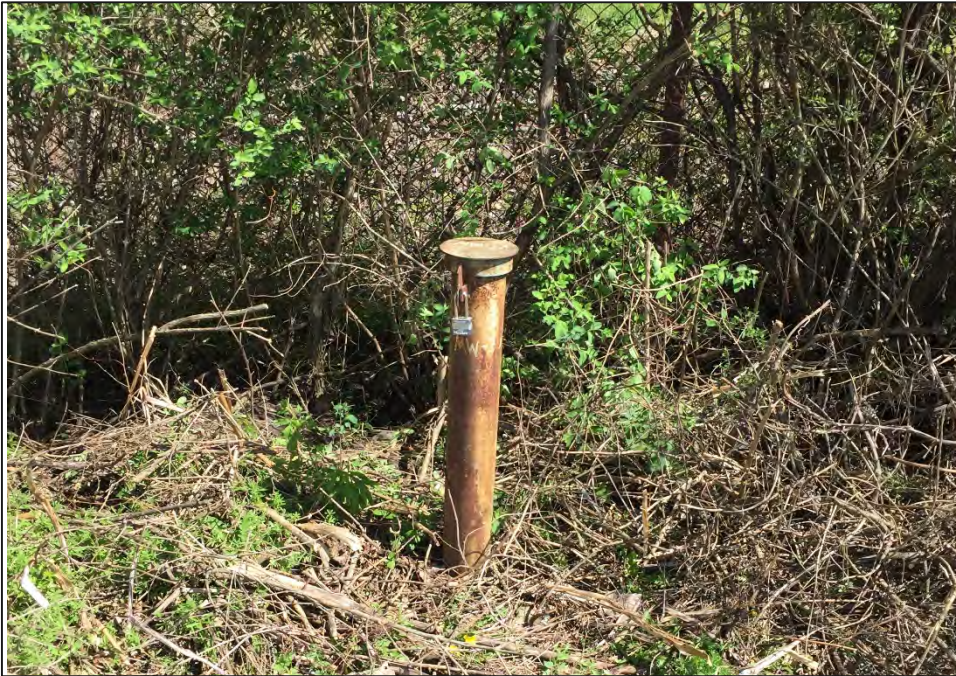
Photo: 9

Description:
MW-3D

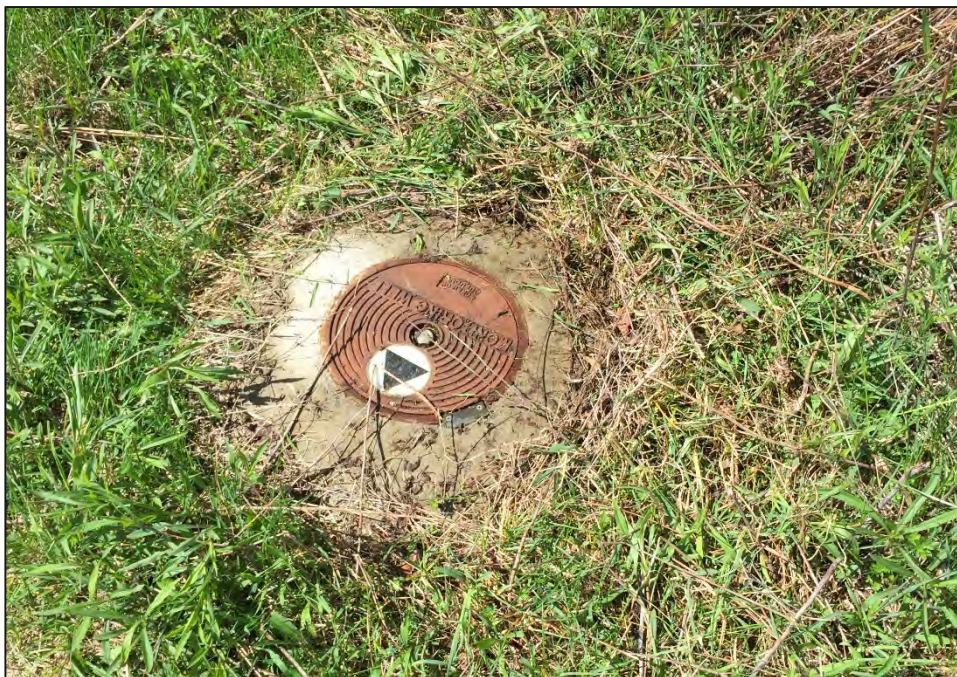
Photo: 10

Description:
MW-4

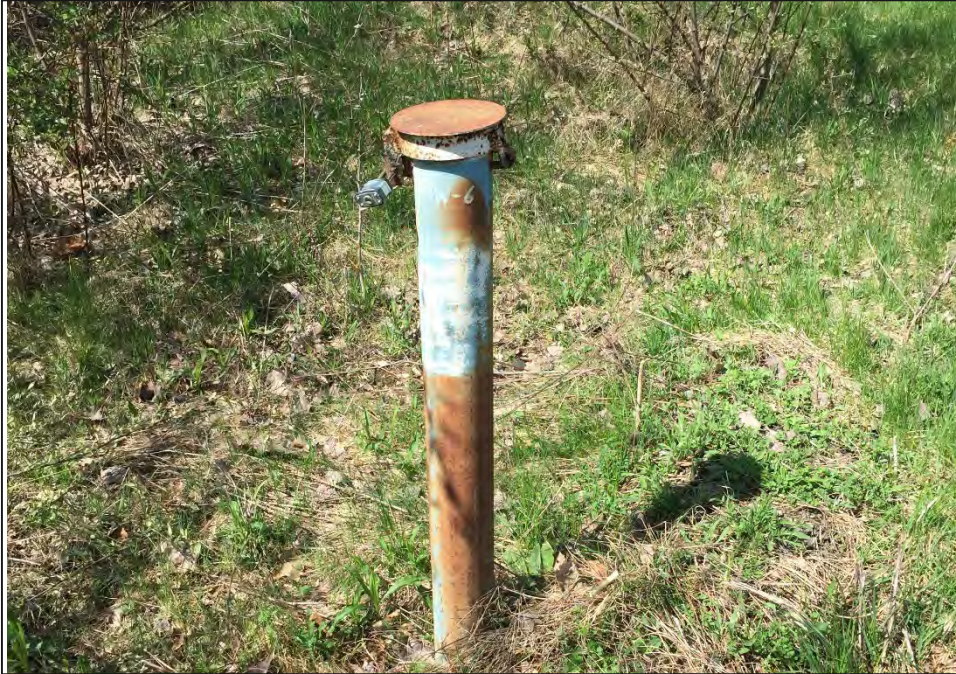
Photo: 11

Description:
MW-6

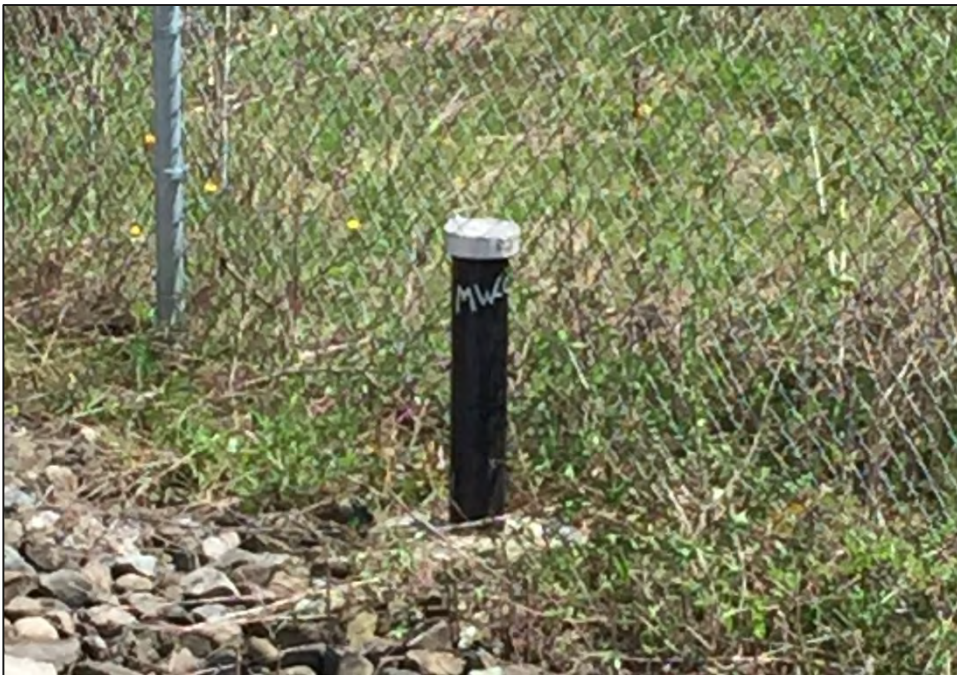
Photo: 12

Description:
MW-9
