TIOGA CASTINGS SITE SEMI- ANNUAL REPORT

Second Quarter 2018

July 2018

New York State Department of
Environmental Conservation
Division of Environmental Remediation
625 Broadway
Albany, New York 12233

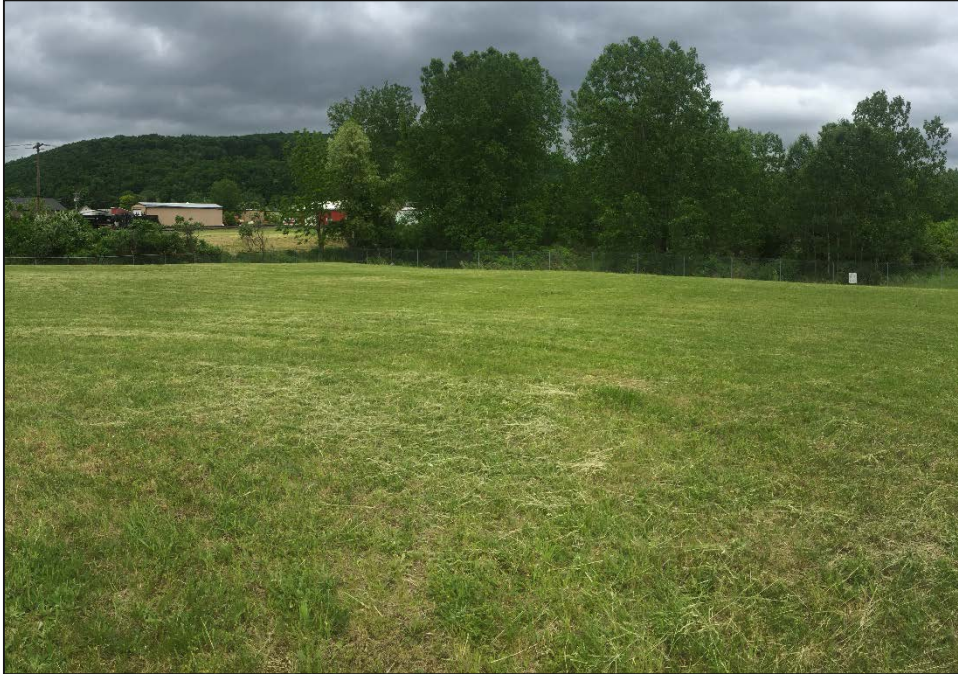
Photo: 1

Center of Landfill Cap – Facing
Northeast

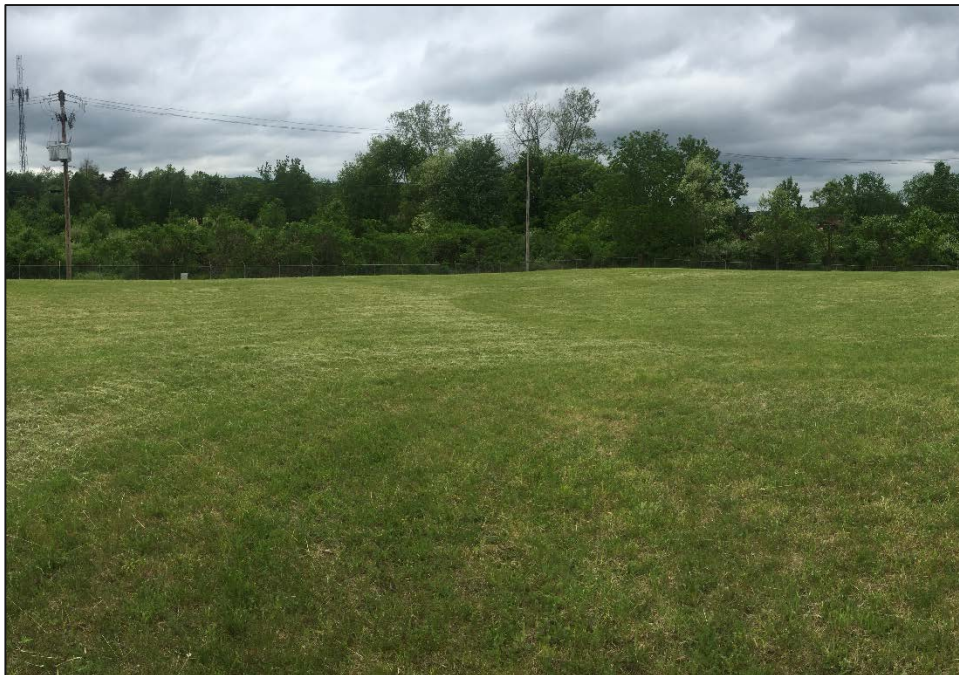
Photo: 2

Center of Landfill Cap – Facing
Northwest

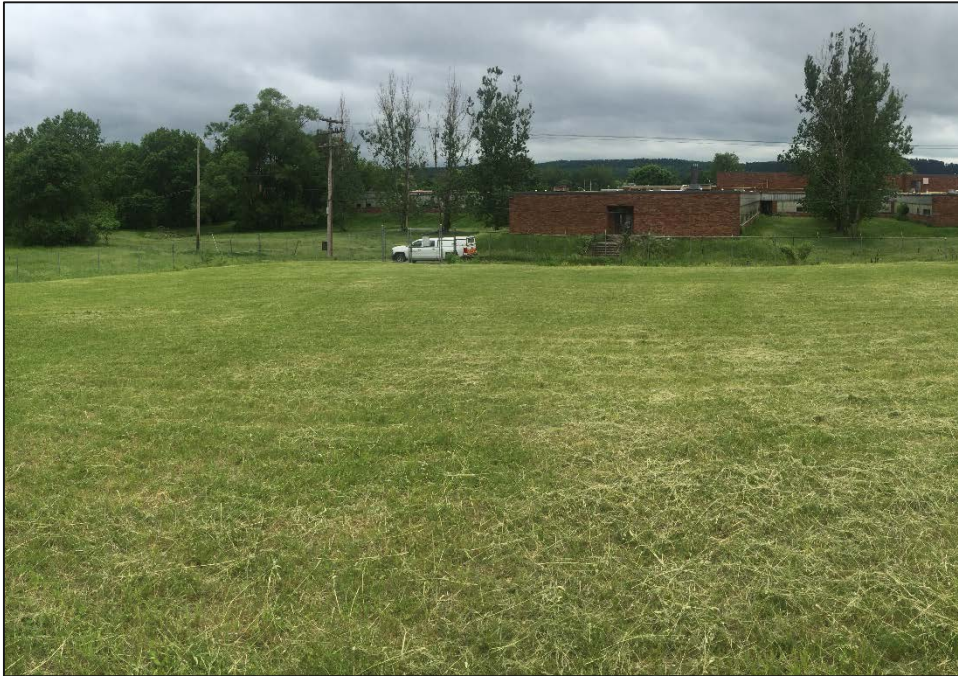
Photo: 3

Center of Landfill Cap – Facing
Southeast

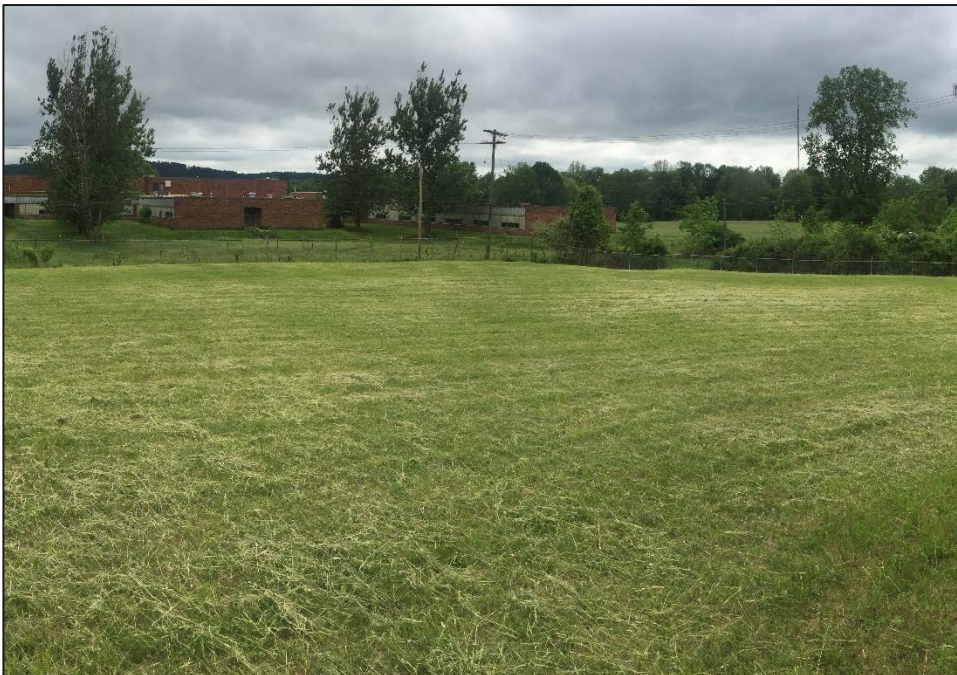
Photo: 4

Center of Landfill Cap – Facing
Southwest

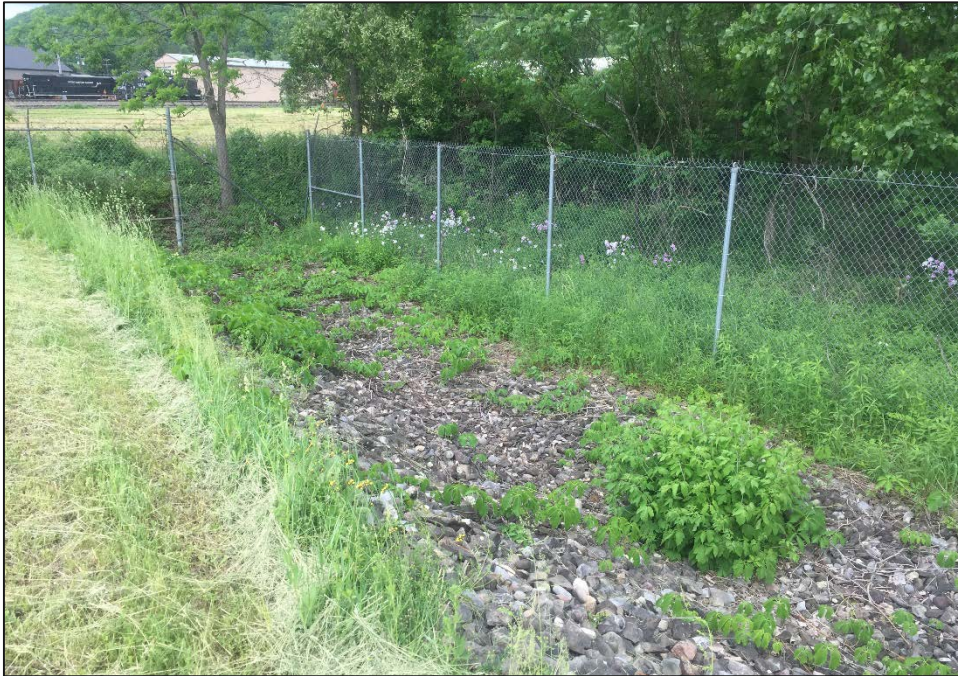
Photo: 5

East Side of Landfill – Facing
North

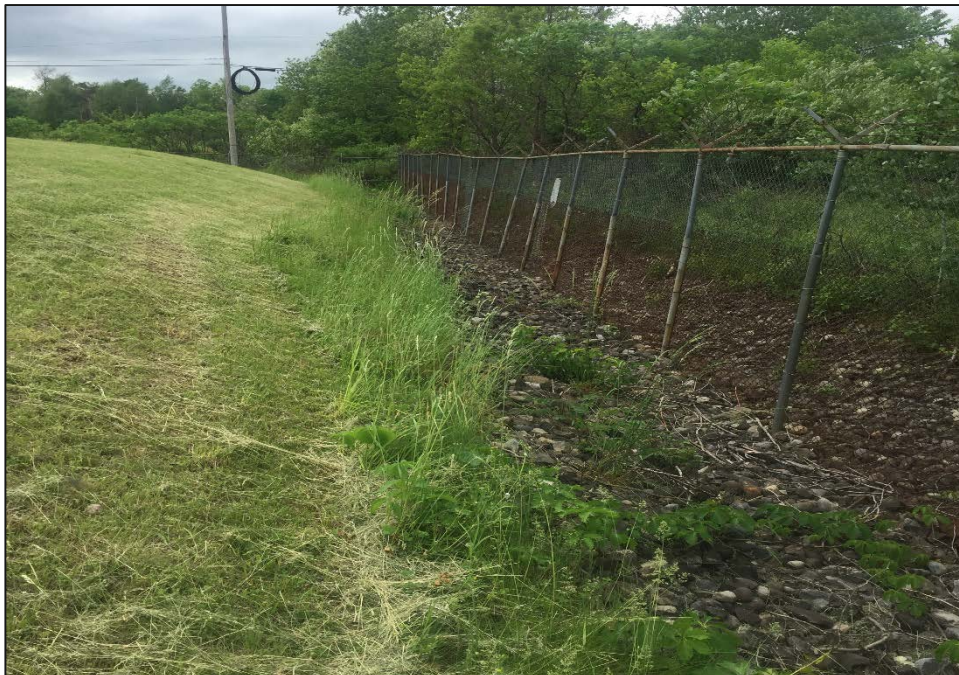
Photo: 6

North Side of Landfill – Facing
West

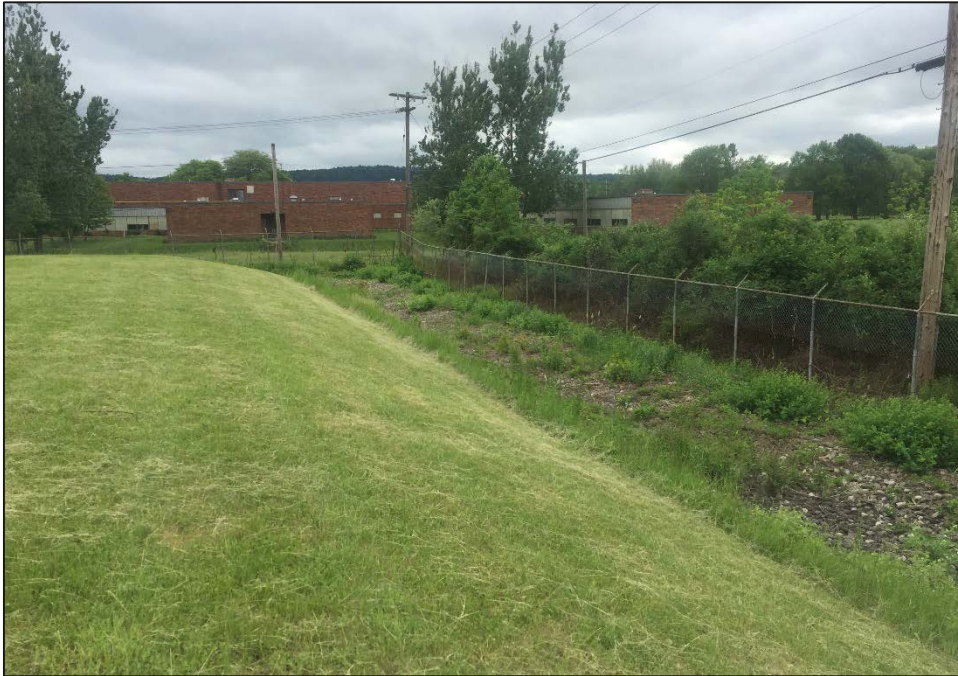
Photo: 7

West Side of Landfill – Facing
South

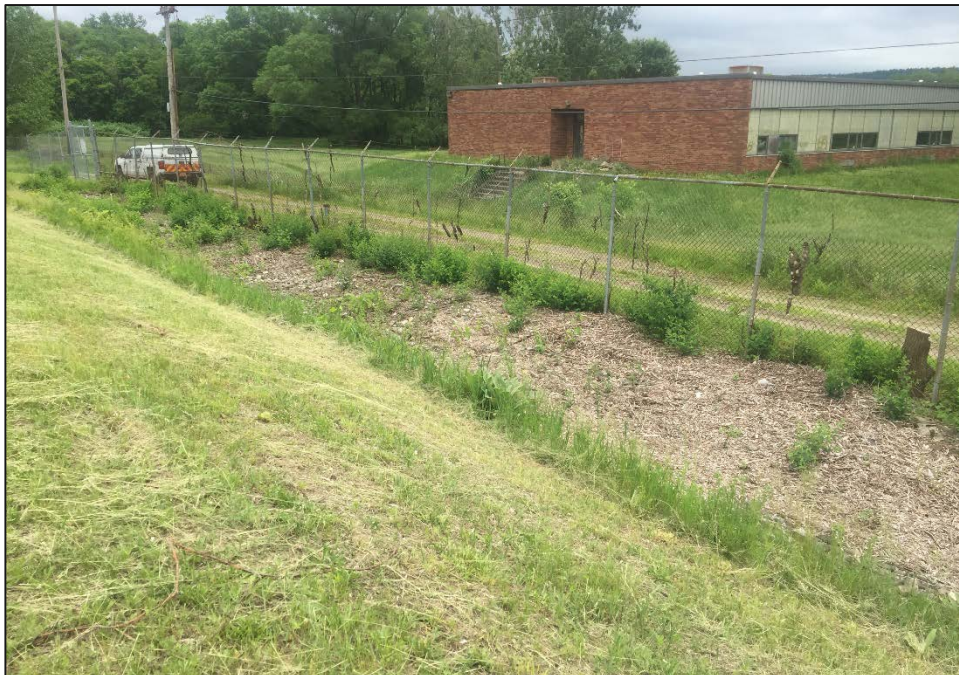
Photo: 8

South Side of Landfill – Facing
East

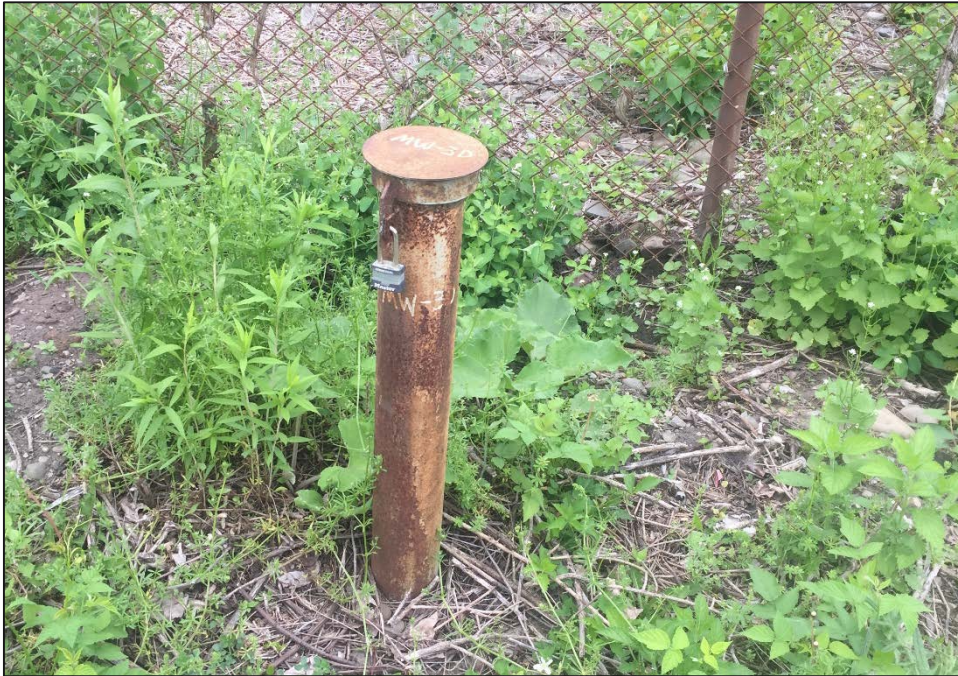
Photo: 9

MW-3D

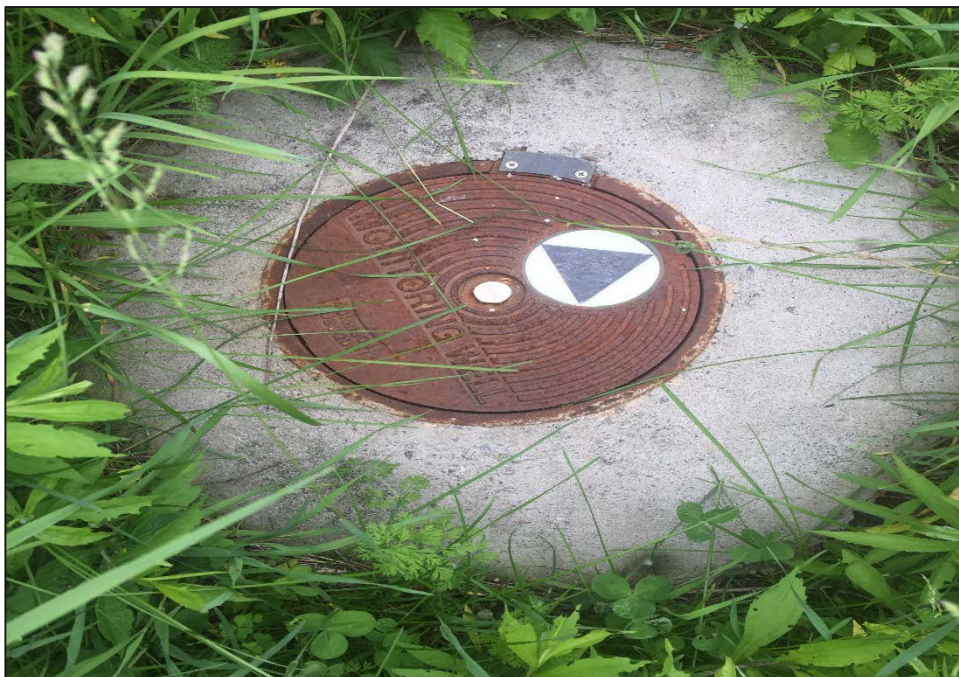
Photo: 10

MW-4

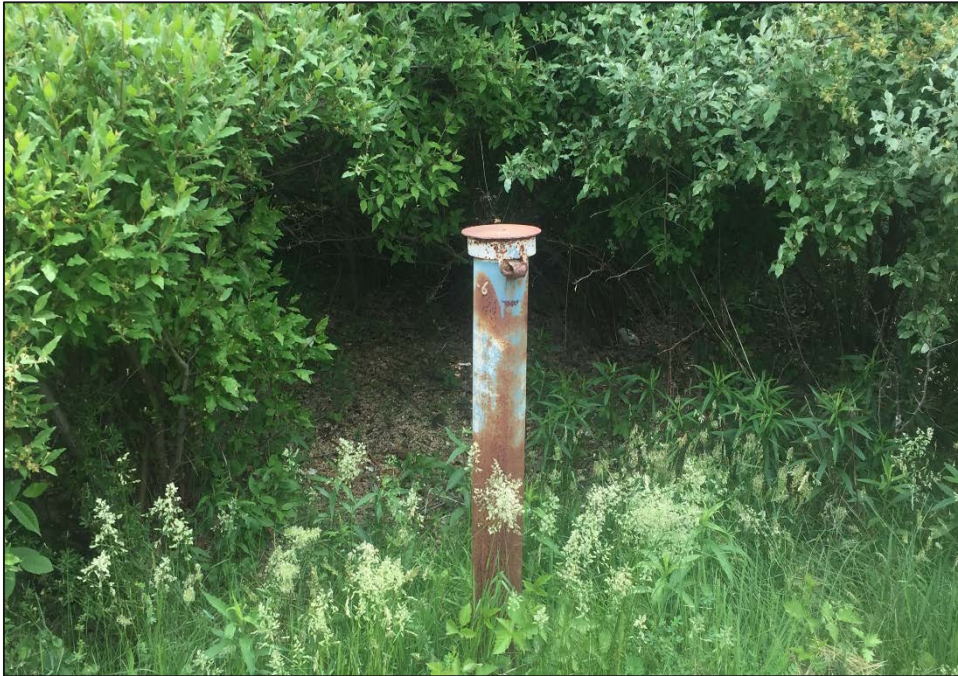
Photo: 11

Description:
MW-6

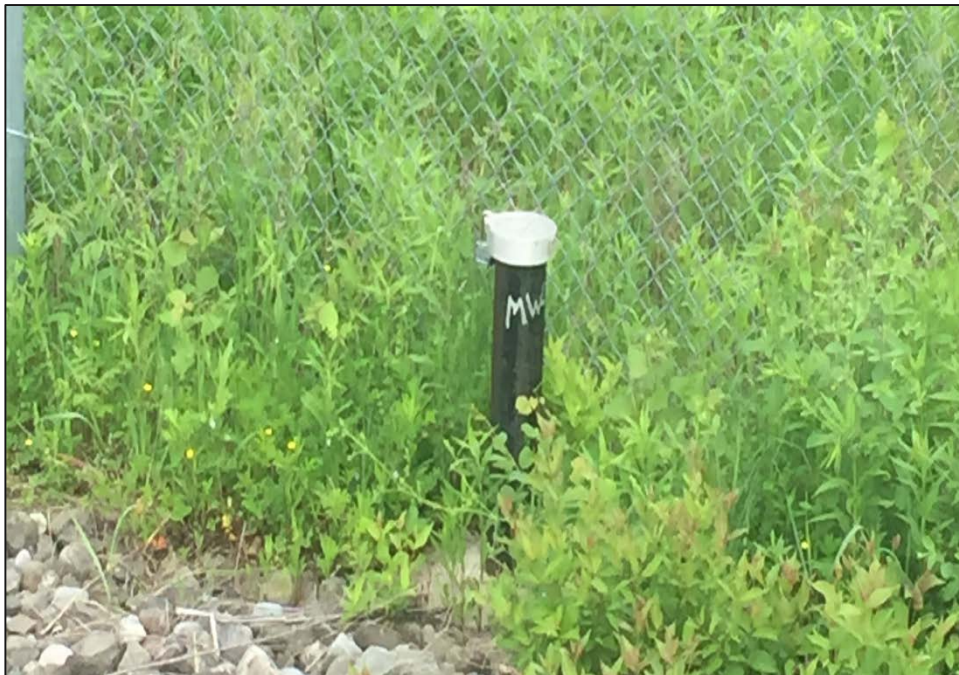
Photo: 12

Description:
MW-9
