New York State Department of Environmental
Conservation – Division of Environmental
Remediation

TIOGA CASTINGS SITE SEMI- ANNUAL REPORT

Third Quarter 2019

September 2019

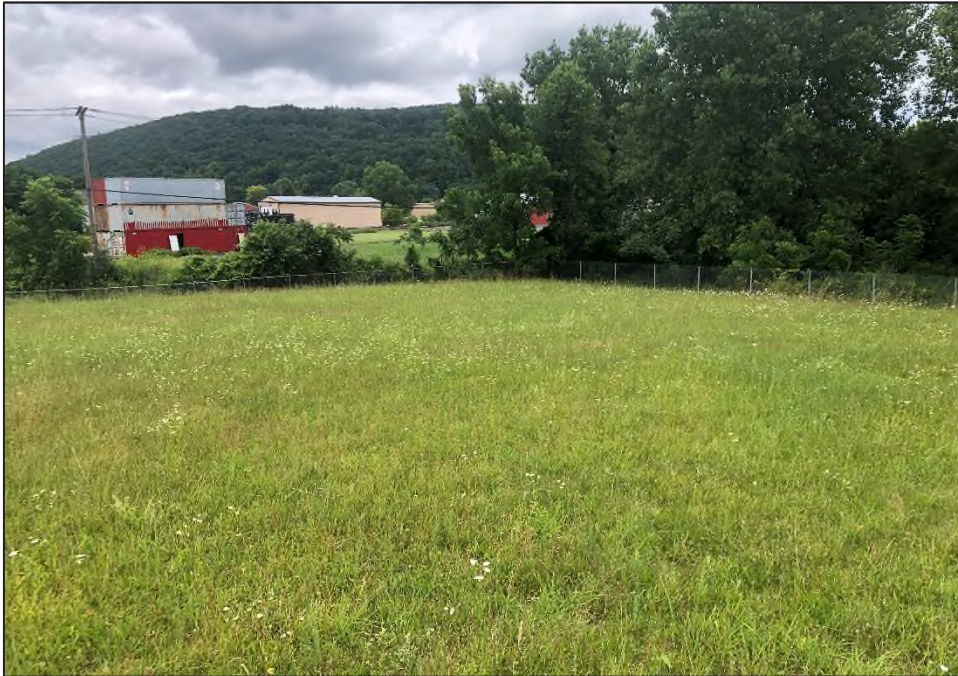
Photo: 1

Description:
Center of Landfill Cap – Facing
Northeast

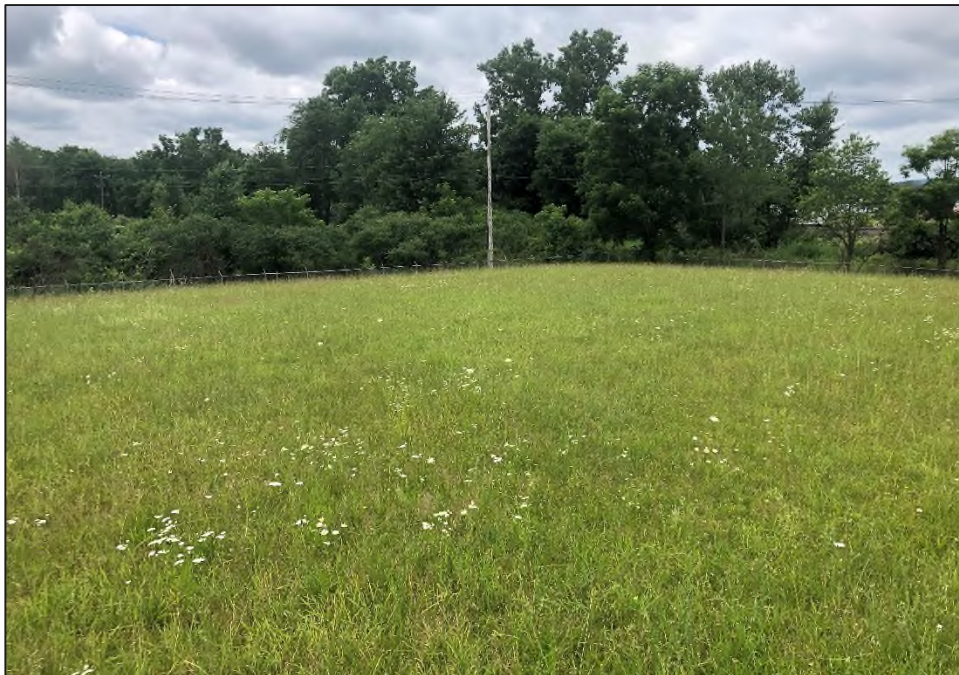
Photo: 2

Description:
Center of Landfill Cap – Facing
Northwest

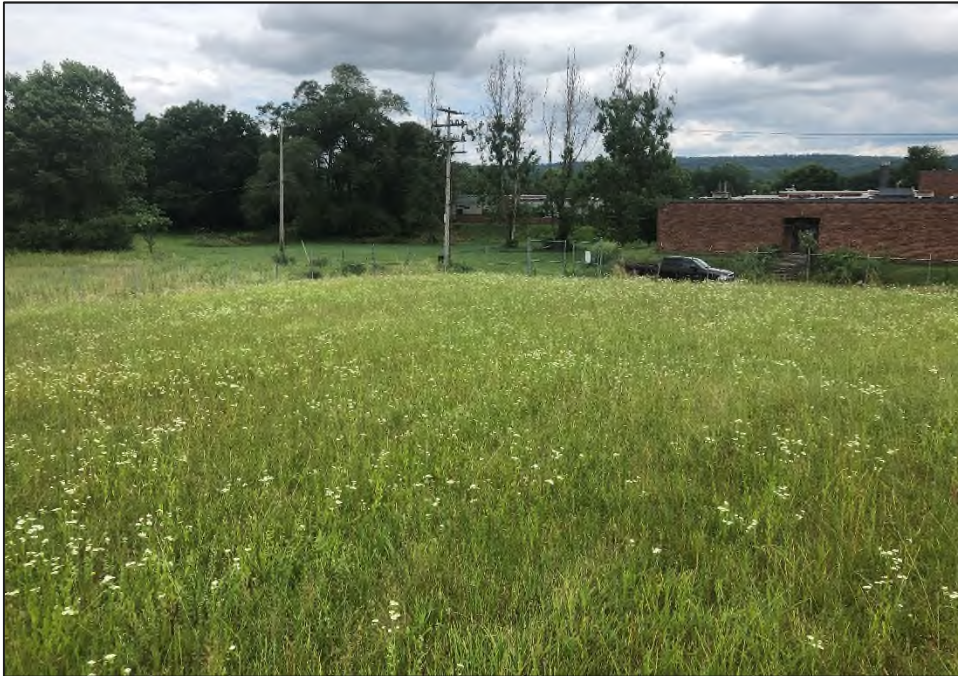
Photo: 3

Description:
Center of Landfill Cap – Facing
Southeast

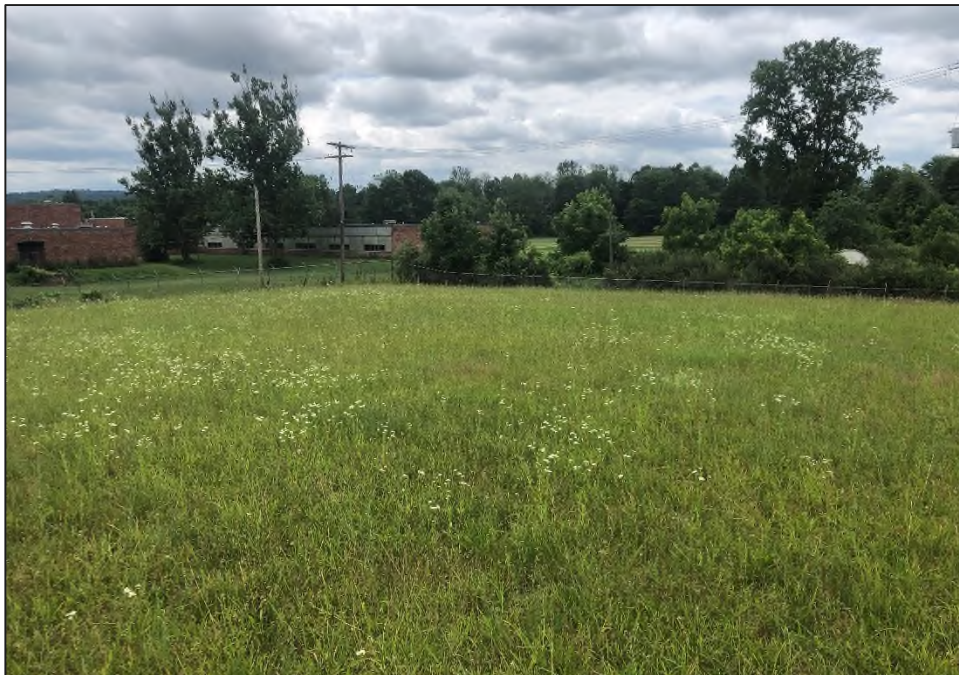
Photo: 4

Description:
Center of Landfill Cap – Facing
Southwest

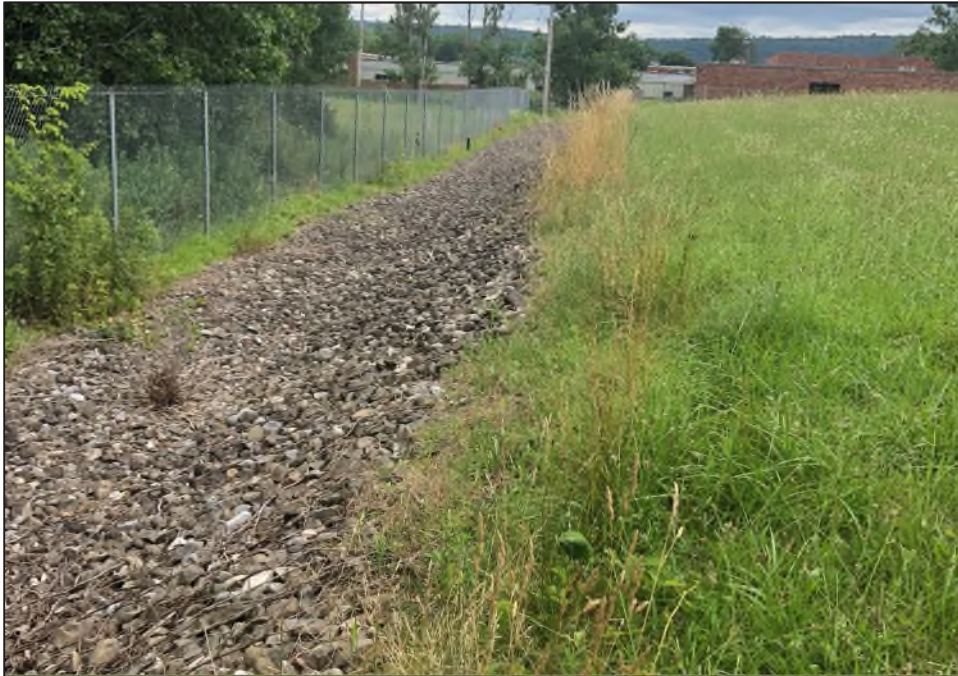
Photo: 5

Description:
East Side of Landfill – Facing
South

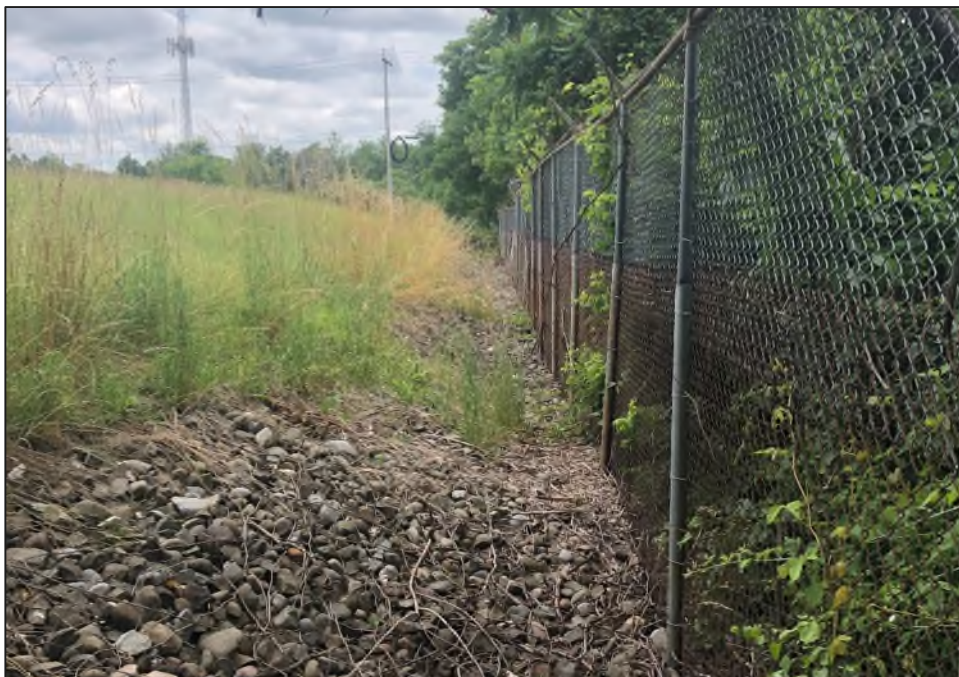
Photo: 6

Description:
North Side of Landfill – Facing
West

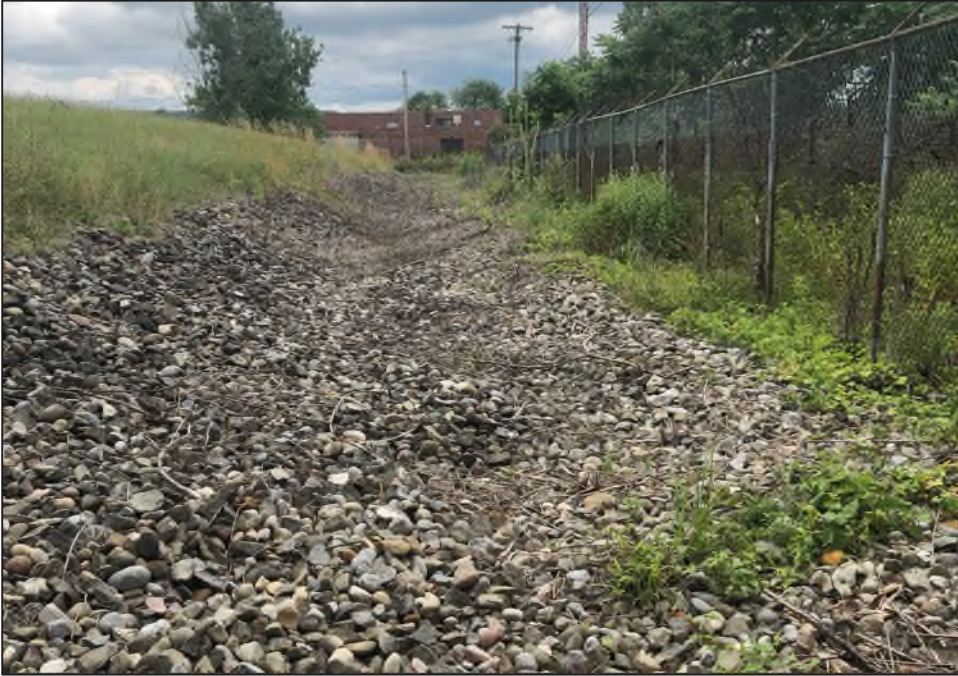
Photo: 7

West Side of Landfill – Facing
South

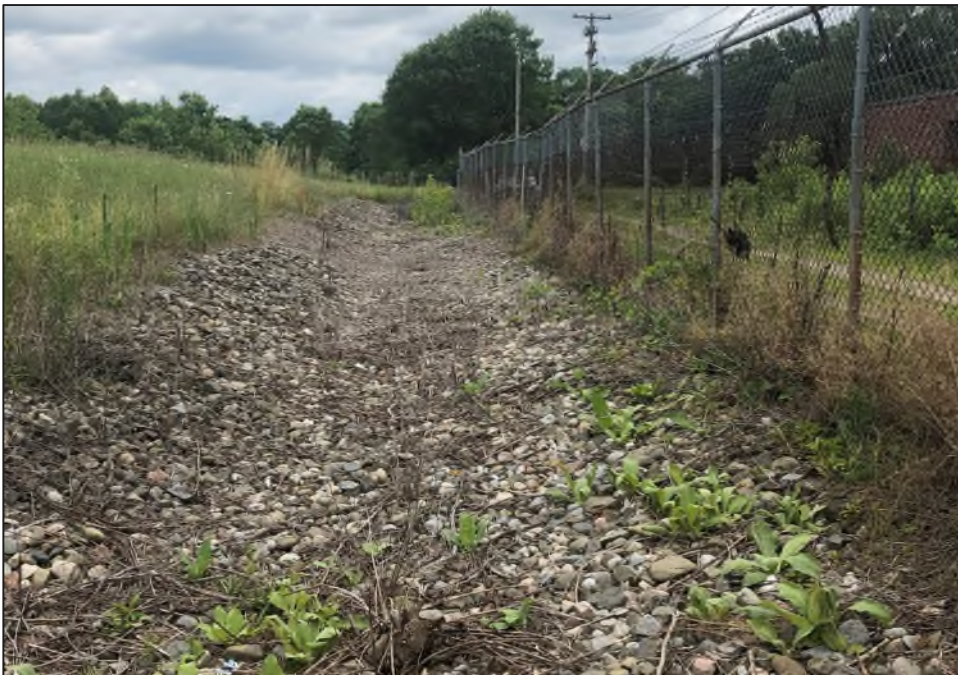
Photo: 8

South Side of Landfill – Facing
East

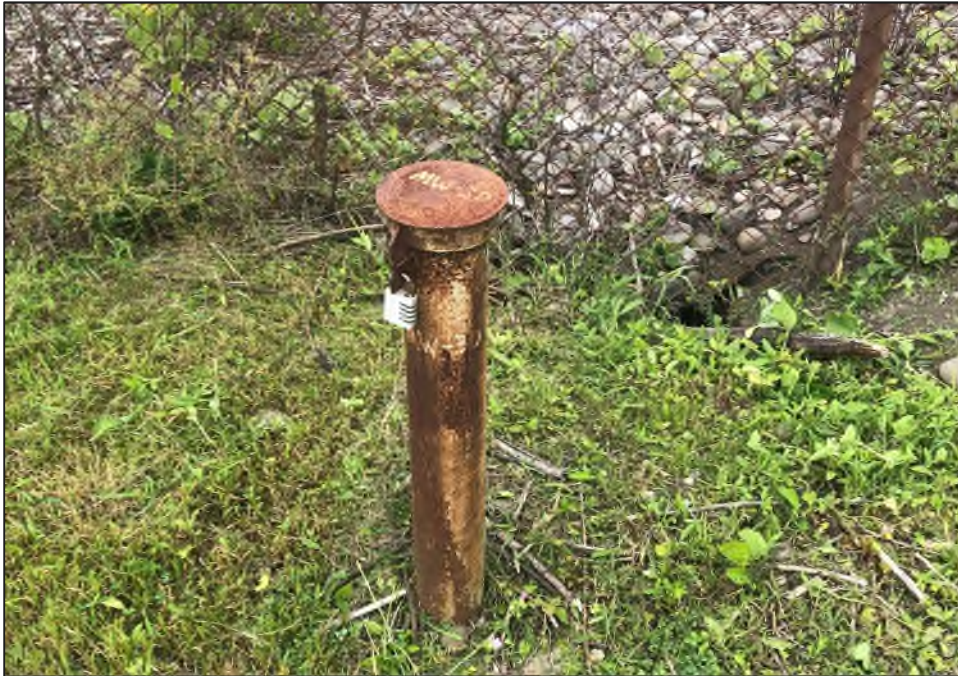
Photo: 9

Description:
MW-3D

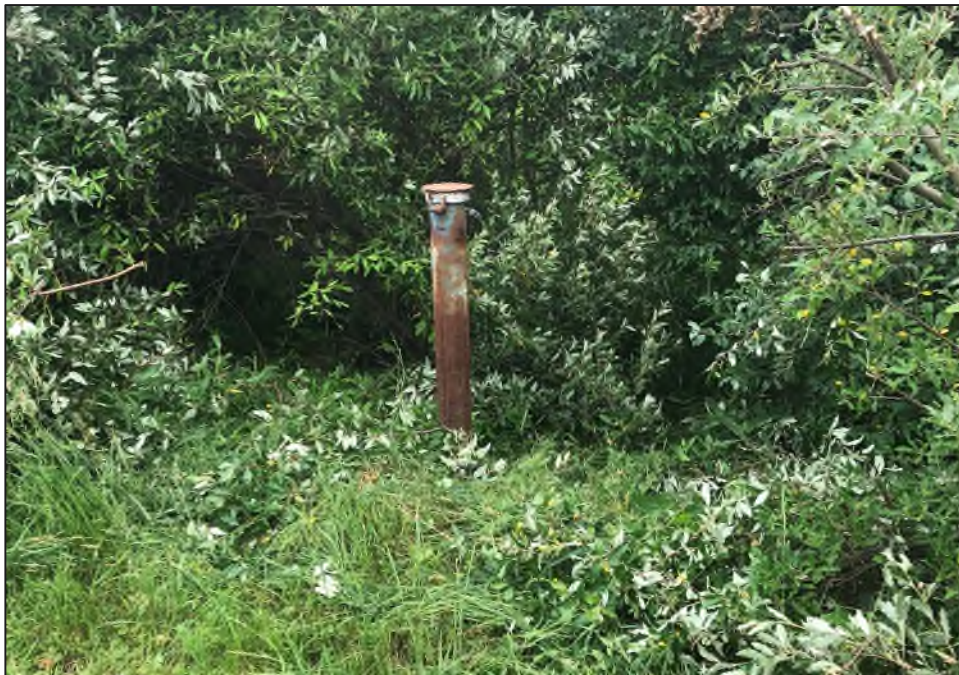
Photo: 10

Description:
MW-6

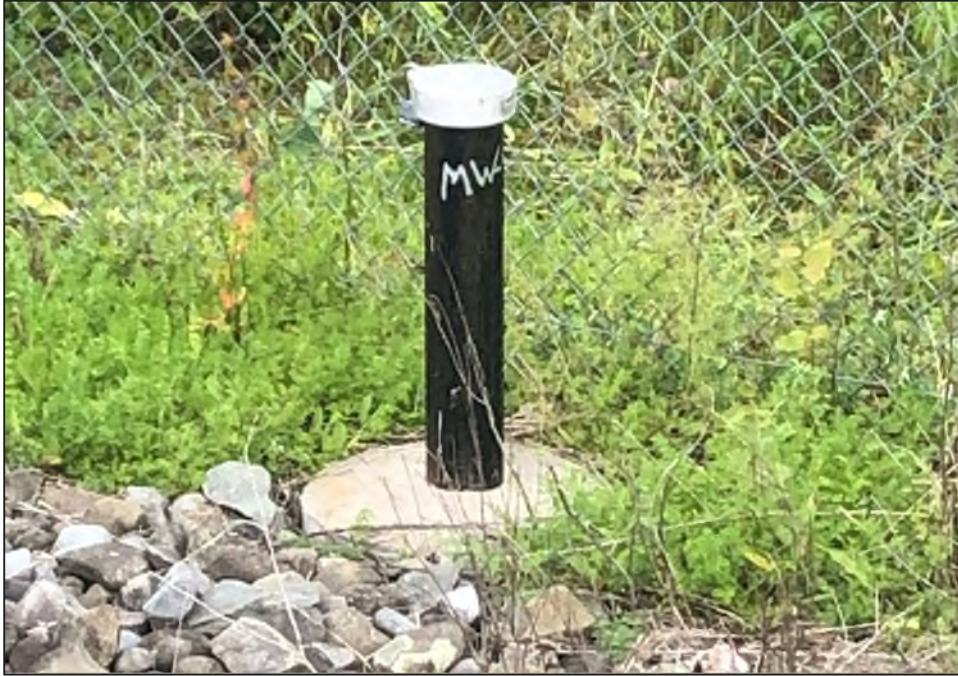
Photo: 11

MW-9
