**Remedial Investigation
Progress Report**

Ithaca Court Street MGP Site

Site No. 7-55-008

February 2002

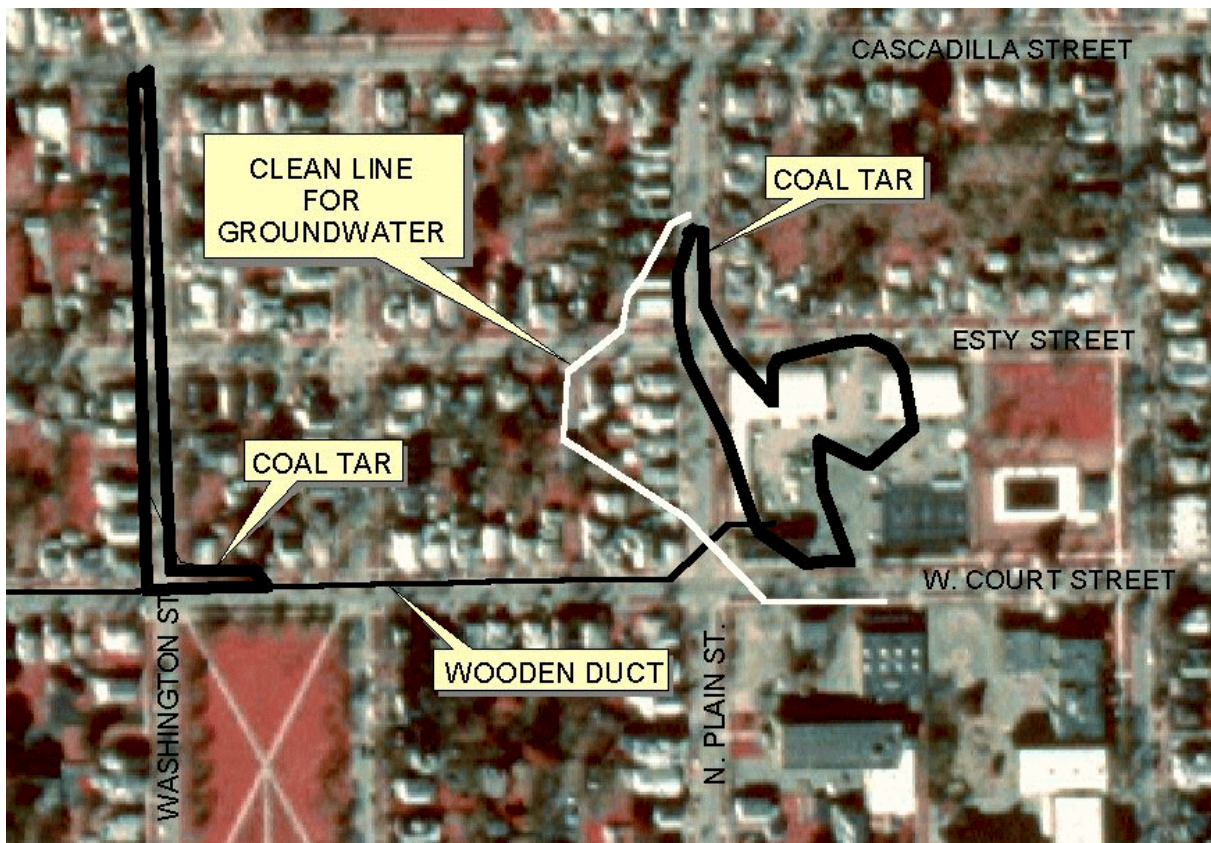
1. **Source investigation:** Soil borings were used to delineate where coal tar is present on and adjacent to the site. A rough sketch of the area where coal tar was visually identified is provided in the figure below.

3. **Shallow groundwater contamination:** Groundwater samples were collected from temporary borings down-gradient from the site to establish a “clean line” beyond which the groundwater does not appear to be impacted by this site. This line is shown on the figure below. Permanent monitoring wells are currently being installed along this clean line and elsewhere to allow continued monitoring of groundwater quality.

4. **Wooden Duct:** This duct was historically used to transport coal tar from the Court Street MGP to Cayuga Inlet. Coal tar was visually identified in borings along the wooden duct at Washington Street during this investigation. This area of contamination (shown on the figure below) appears to be very narrow, following the path of a storm sewer. Borings at other intersections and utility crossings did not detect any coal tar.
