SUPPLEMENTAL PRE-DESIGN INVESTIGATION

FIRE WATER RESERVOIR

EMERSON POWER TRANSMISSION FACILITY

June 30, 2011

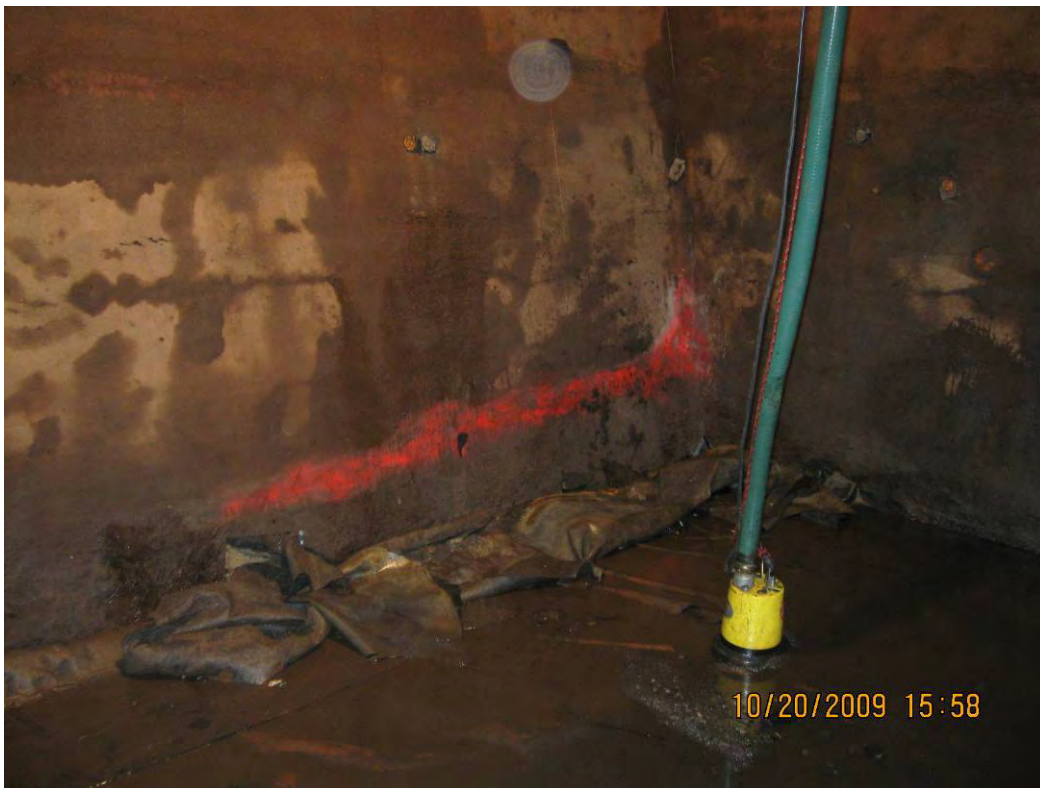
Photograph 4: Sealed crack that was painted.

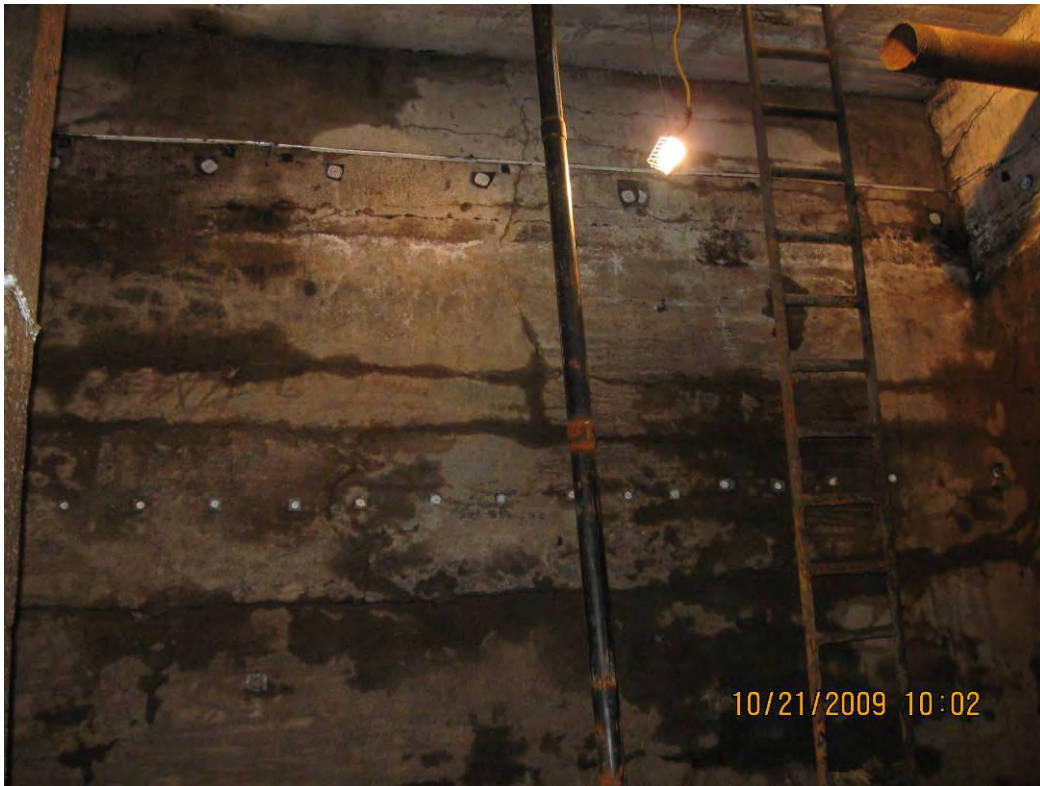
Photograph 6: West wall of the south tank after removal of the liner.

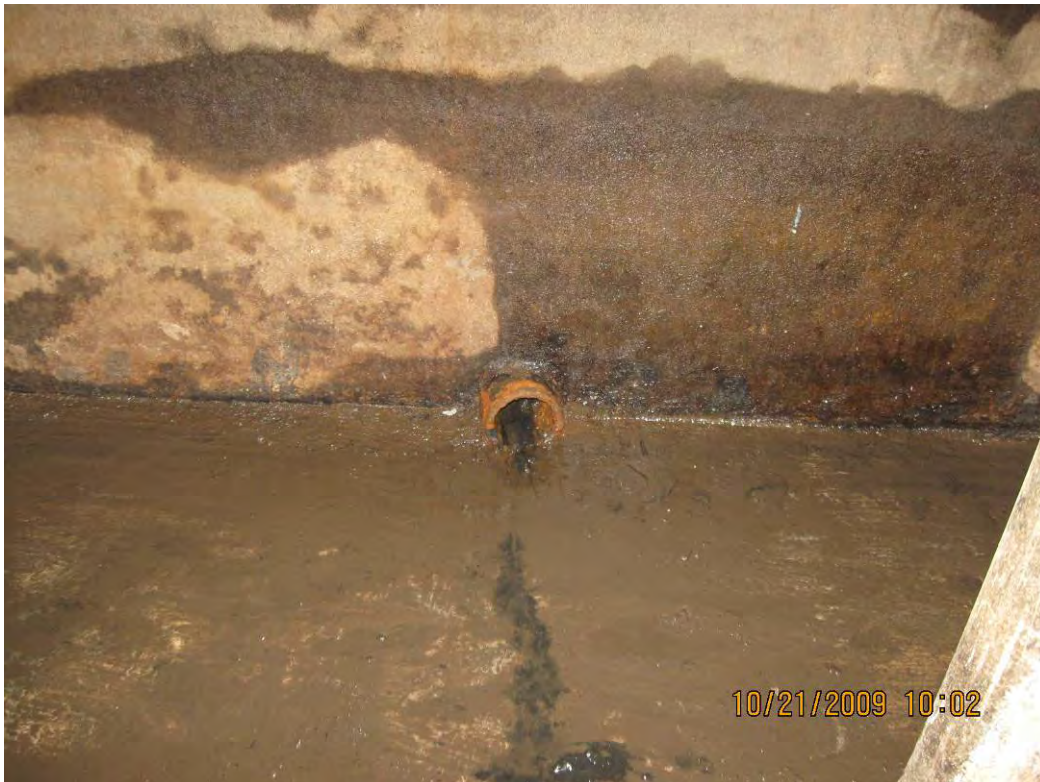
Photograph 7: Pipe exiting the south tank at the west wall.

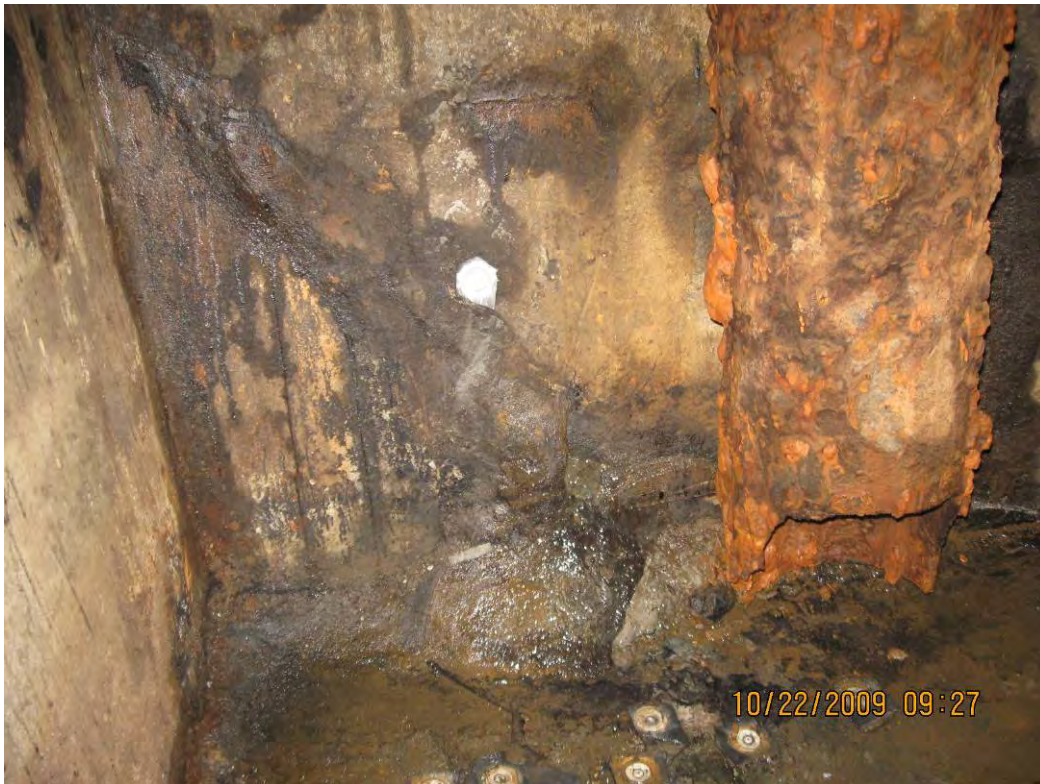
Photograph 10: Hole patched at the northern end of the eastern wall of the north tank.

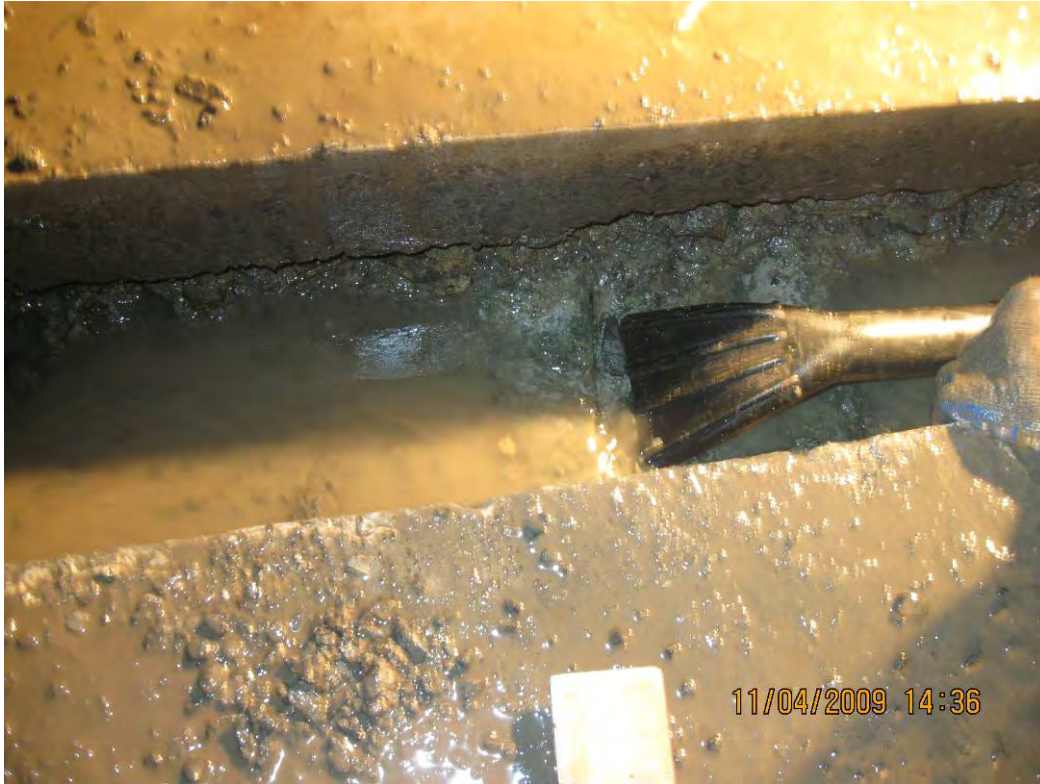
Trench-1 contained a single joint that trends N16W and a parallel joint set that trends N18W. Groundwater was observed discharging from the parallel joint set and a grab sample (T-1), was collected from the joint set and analyzed for VOCs using EPA Method 8260B (Table 4). Figure 4 shows the location at which grab samples of groundwater were collected and the bedrock fracture trends.

Photograph 15: Vacuuming water from a vertical joint located in T-1.

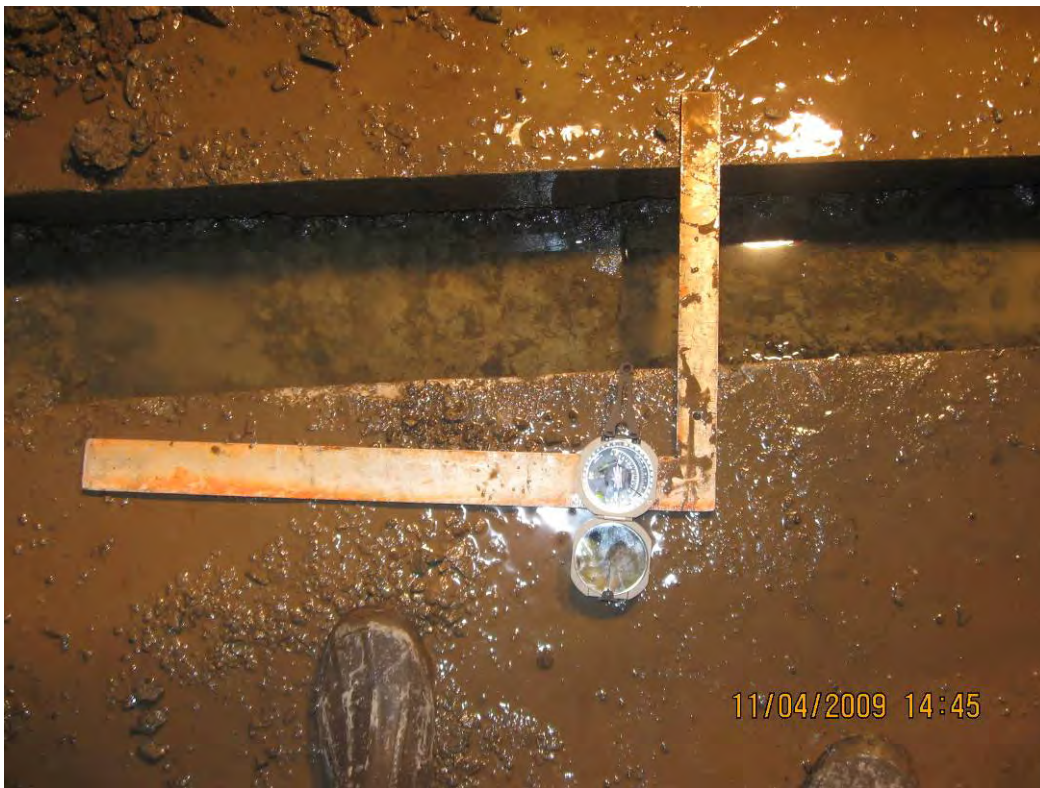
Photograph 16: Measuring the trend of a vertical joint in T-1 (N17W).

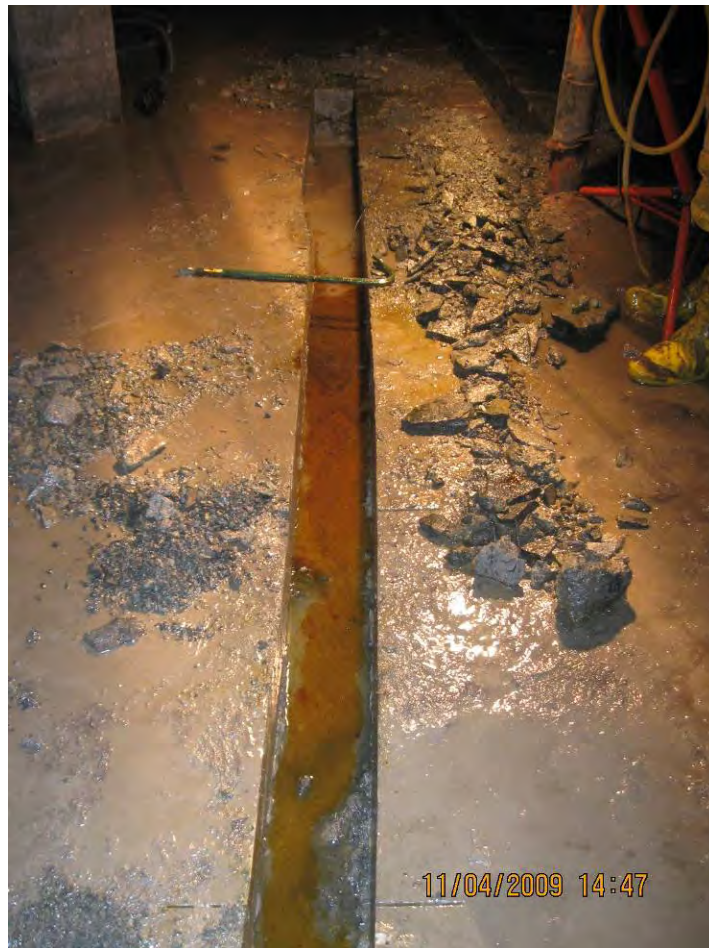
Trench-2 was intersected by three single joints (N15W, N2W, and N40W) and one parallel joint set (N17W), as shown in Figure 4. A sample (T-2) was collected near the parallel joint set towards the center of the trench cut and analyzed for VOCs using EPA Method 8260B (Table 4). A light-phase petroleum product sheen was observed seeping into the center of the trench cut near the location of sample (T-2). Photographs of trench cuts and observed petroleum product are provided in Appendix A.

Photograph 17: Petroleum product entering T-2 below floor slab.

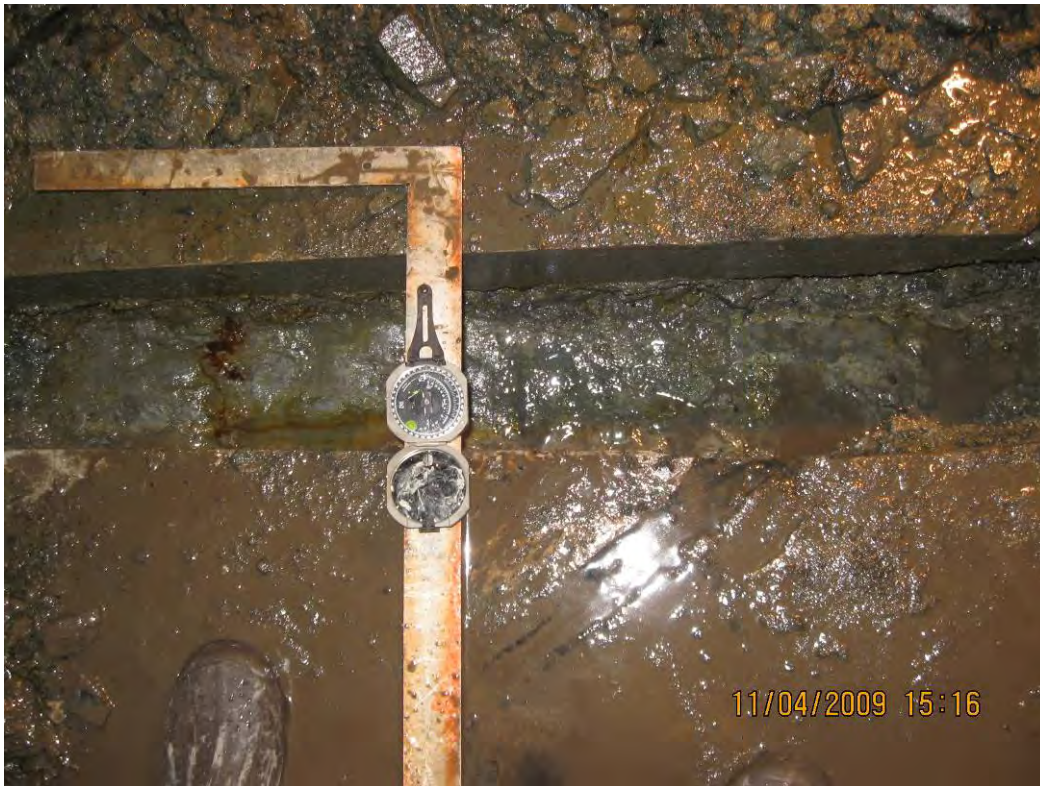
Photograph 19: Measuring the alignment of the vertical fracture producing petroleum product.

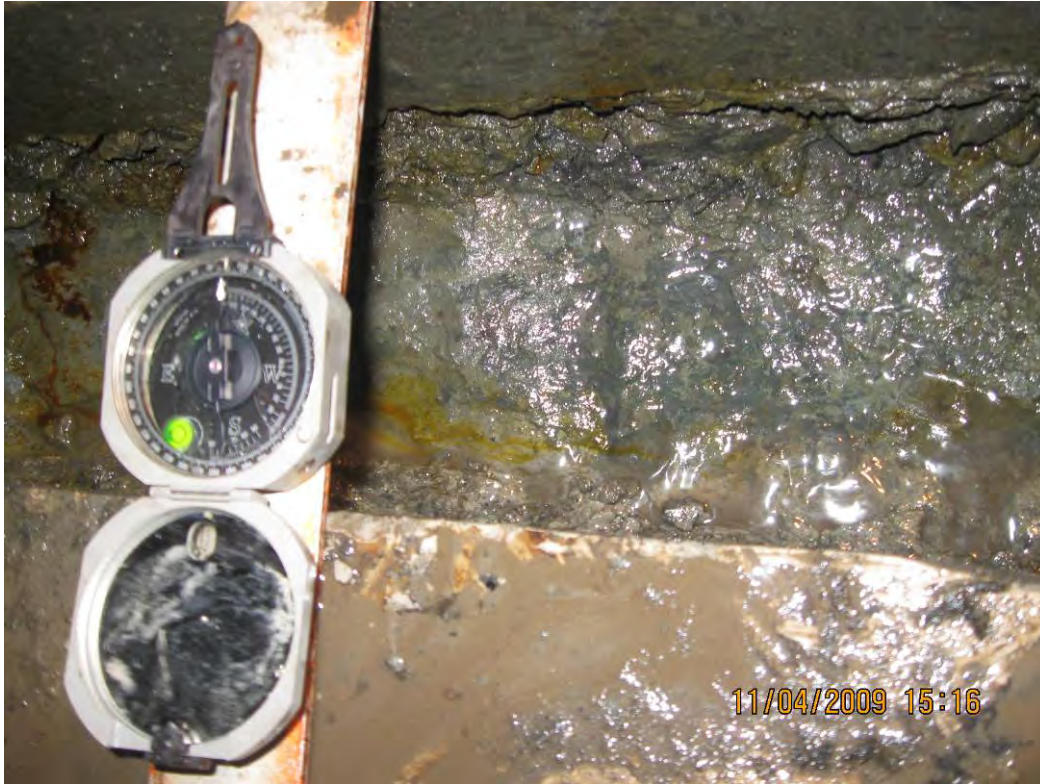
Photograph 20: Measuring the alignment of the vertical fracture producing petroleum product.

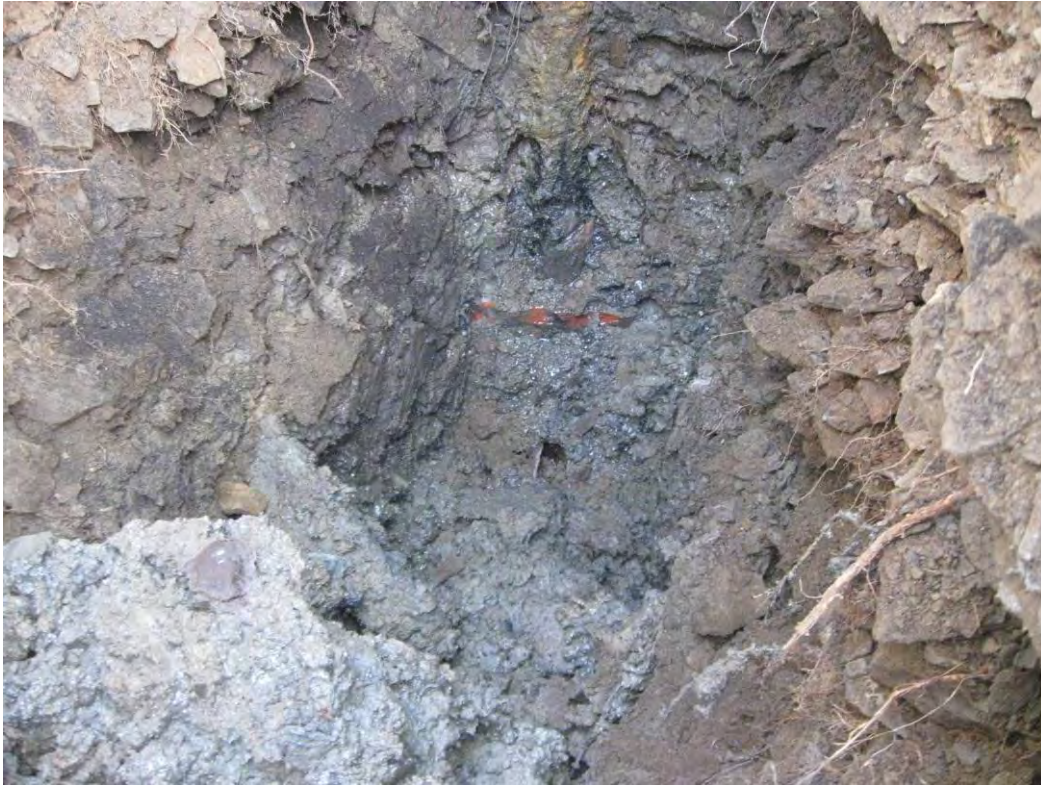
Photograph 25: Brick structure found at the base of the vertical stand pipe – the pipe exiting to the west is visible.

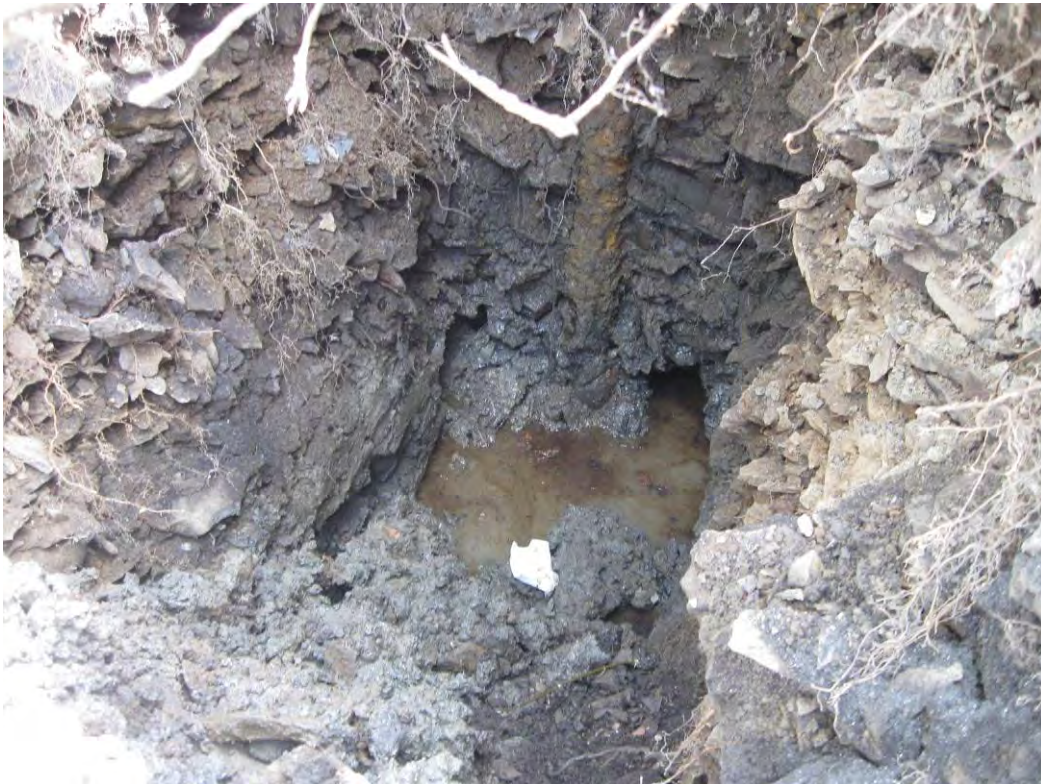
Photograph 26: Petroleum product and groundwater entering the open test pit.

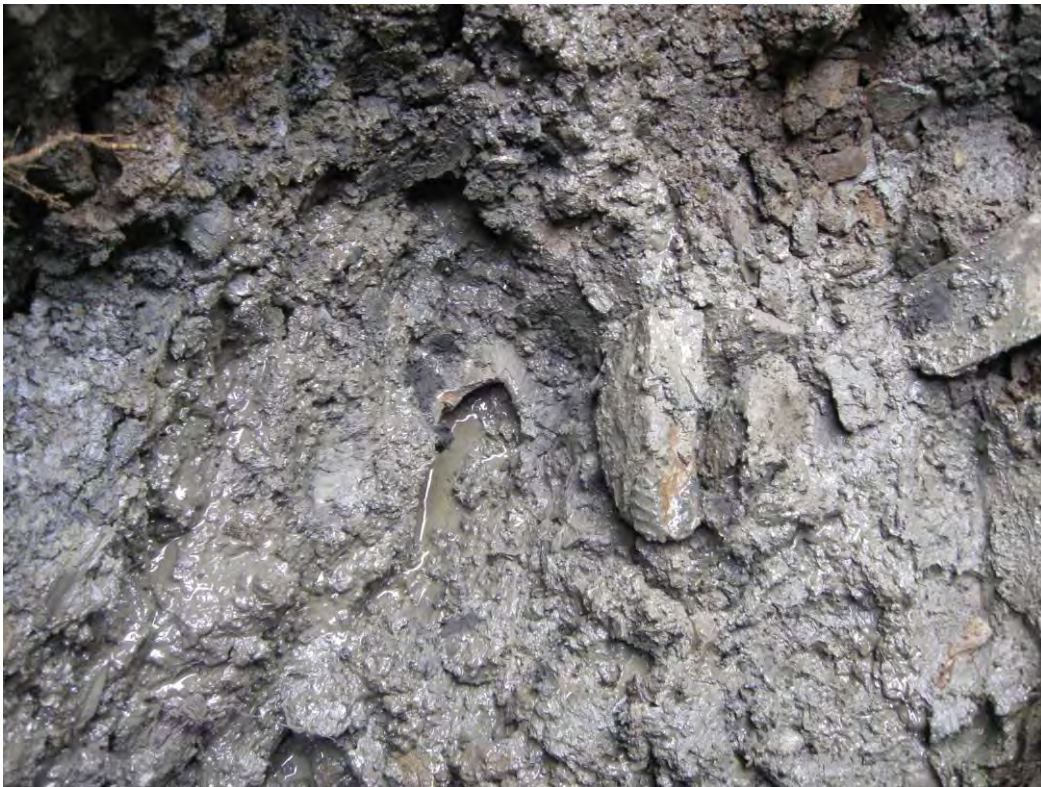
Photograph 27: Transition from cast-iron pipe to clay tile.

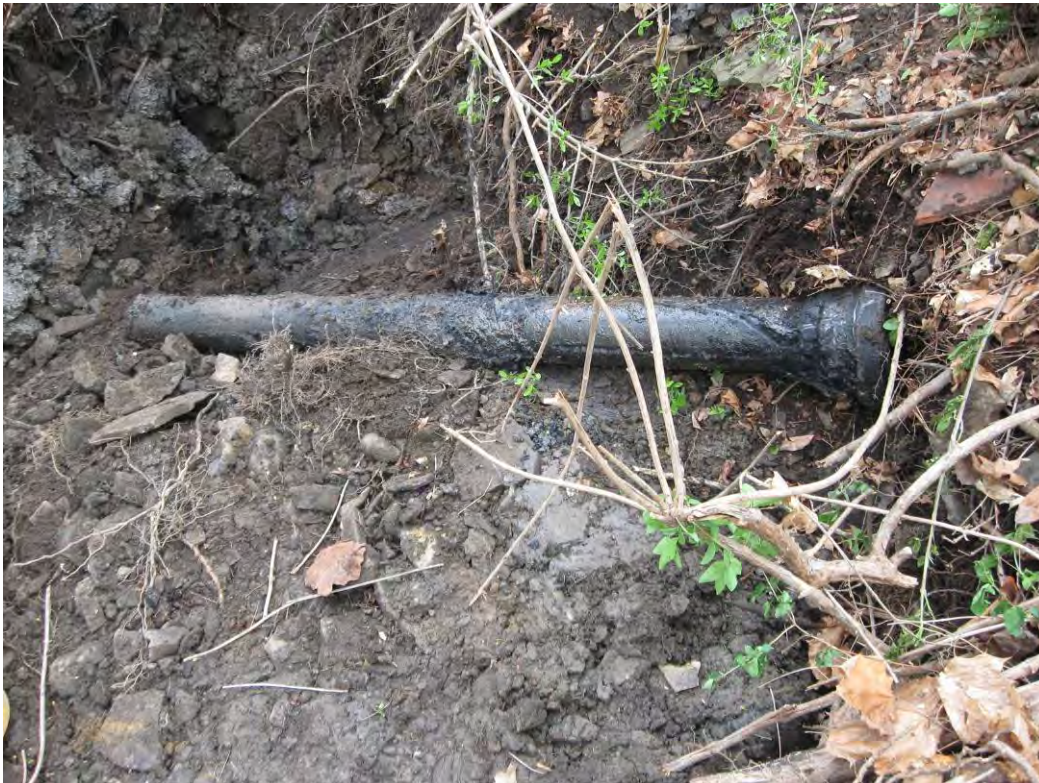
The section of cast-iron pipe was approximately 6 feet long, which correlated to the pipe terminating approximately 2 feet from the drainage ditch. A sample (Table 5) was collected from inside the pipe that remained in the hillside, where the 6-foot section was broken off (CIPipeSludge-5). This section was subsequently sealed with concrete. A sample (S5CIPipe-3) was also collected 5 feet south of where the 6-foot section was broken off (Table 5). Three additional test pits were installed and sampled (Table 5) southeast (TestPit1-5), northeast (TestPit2-6), and south (TestPit3-4) of the existing piping and near Outfall 001. Soil at TestPit3-4 was visually impacted by petroleum and, thus was sampled and analyzed using New York State Department of Health (NYSDOH) Method 310.13 for petroleum fingerprinting Table 6) and VOCs using EPA Method 8260B (Table 5). A test pit (WDitch-ST-5) installed northwest of the end of the cast-iron pipe filled with seepage water, and therefore, a soil sample could not be collected. A sample of the seepage water (WDitch-ST-5) was collected and analyzed for VOCs using Method EPA 8260B (Table 7).

Photograph 30: The end of the pipe (6-foot cast-iron pipe) removed at the edge of the drainage ditch.

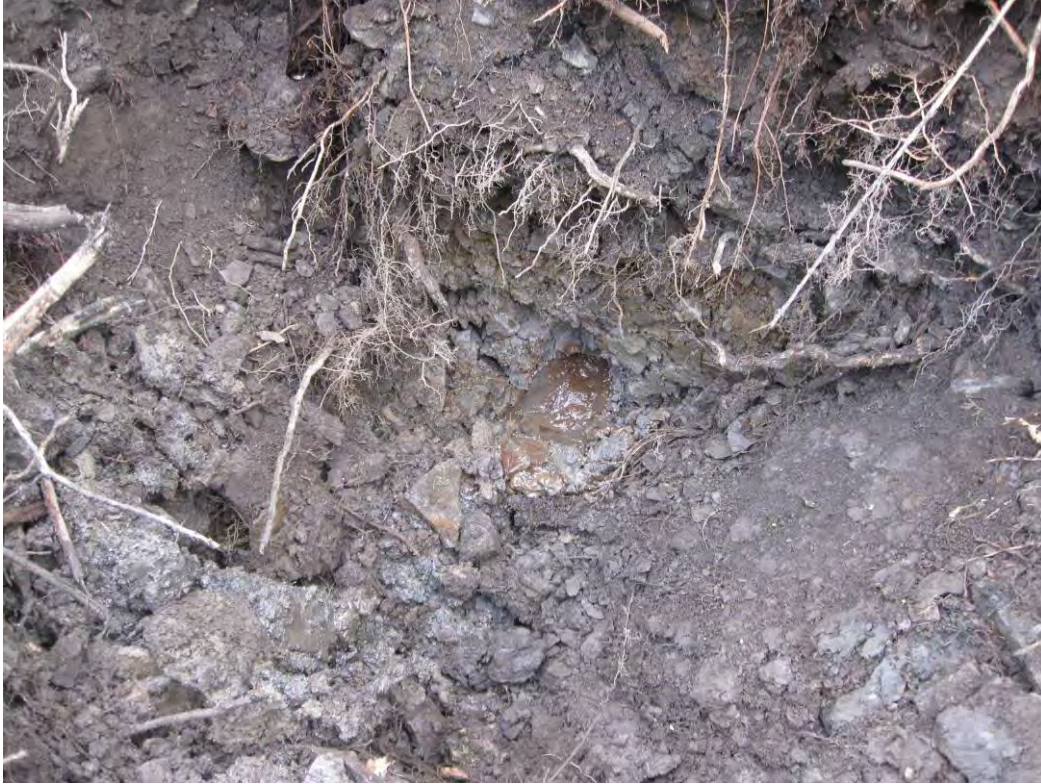
Soil samples collected from the test pits west of the reservoir (Figures 7 and 8) contained trace levels of VOCs, with total VOCs ranging from non-detect to 195 µg/kg (CIPipeSludge-5; Table 5). CIPipeSludge-5 had the highest detection of cis-1,2-DCE (101 µg/kg) and the only detection of TCE (94 µg/kg). The sample from TestPit3-4 was also analyzed for petroleum fingerprinting using the NYSDOH Method 310.13. The sample was found to contain primarily Lube Oil (3,180,000 µg/kg) and partially Diesel Fuel #2 (330,000 µg/kg; Table 6).

Photograph 31: Sample location – CI Pipe Sludge-5.
