**Subject: Phase I IRM Completion Report – Sanitary Sewers  
Former Emerson Power Transmission, Ithaca, New York**

**MANHOLE CLEANOUT**

FORMER EMERSON POWER TRANSMISSION  
ITHACA, NEW YORK

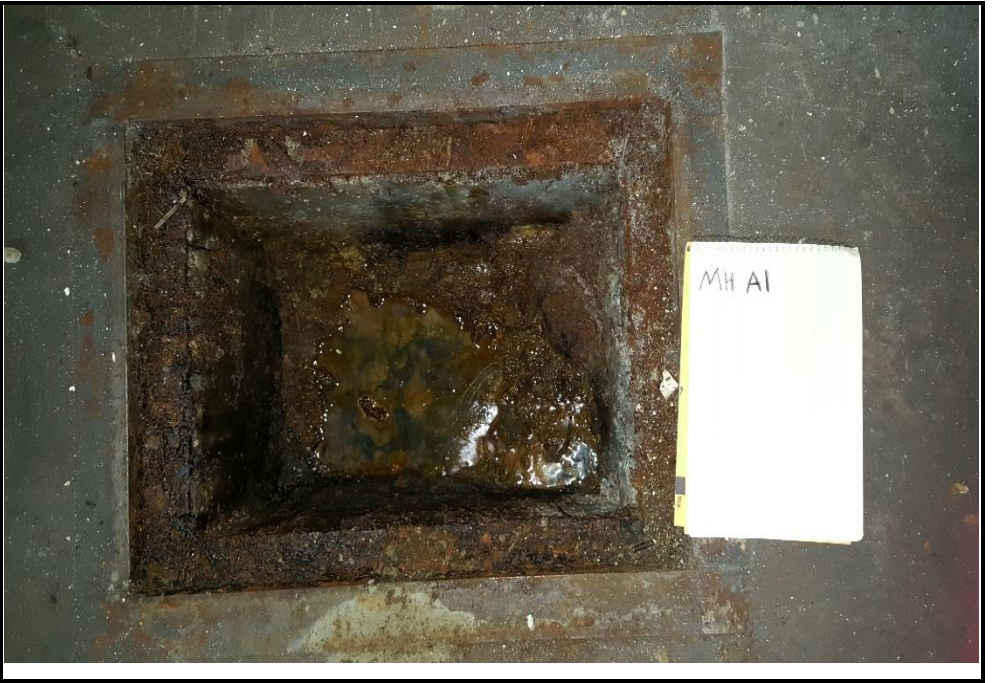
| Photo No. | Date | |
|---|---|---|
| 1 | 3/14/2017 | |

| Manhole (a,b) | Contents Description | Flow into Manhole Sides / Bottom (yes/no) | Flow into Manhole Through Pipes (yes/no) |
|---|---|---|---|
| MH-A1 | Approximately 1 inch of debris at bottom of manhole | No | No |

| Photo No. | Date | |
|---|---|---|
| MH-A1 before cleaning | | |

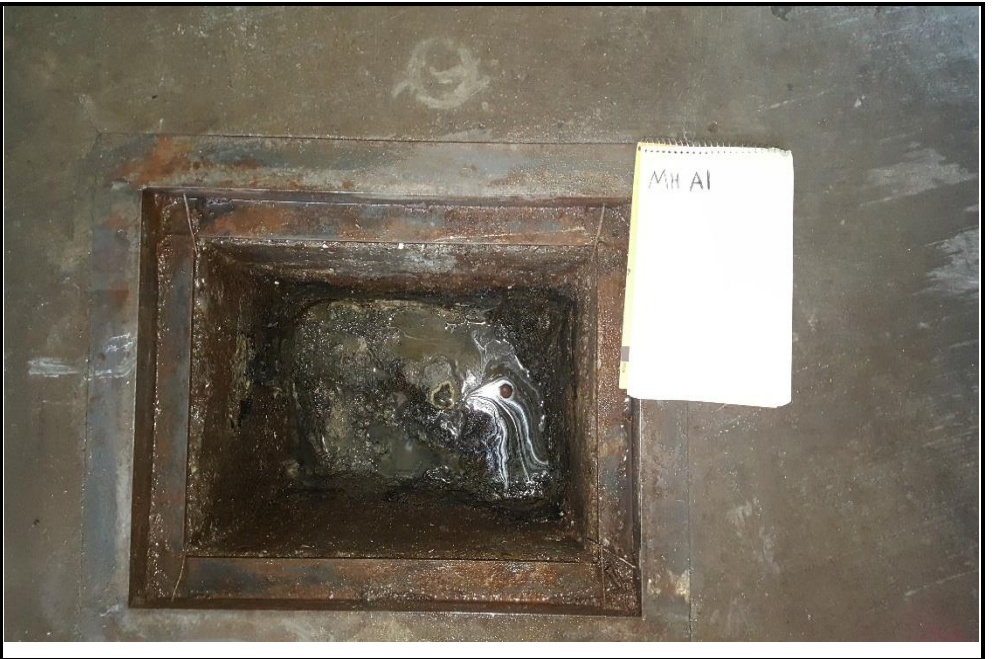
| Photo No. | Date | |
|---|---|---|
| 2 | 3/14/2017 | |

| Photo No. | Date | |
|---|---|---|
| MH-A1 after cleaning | | |

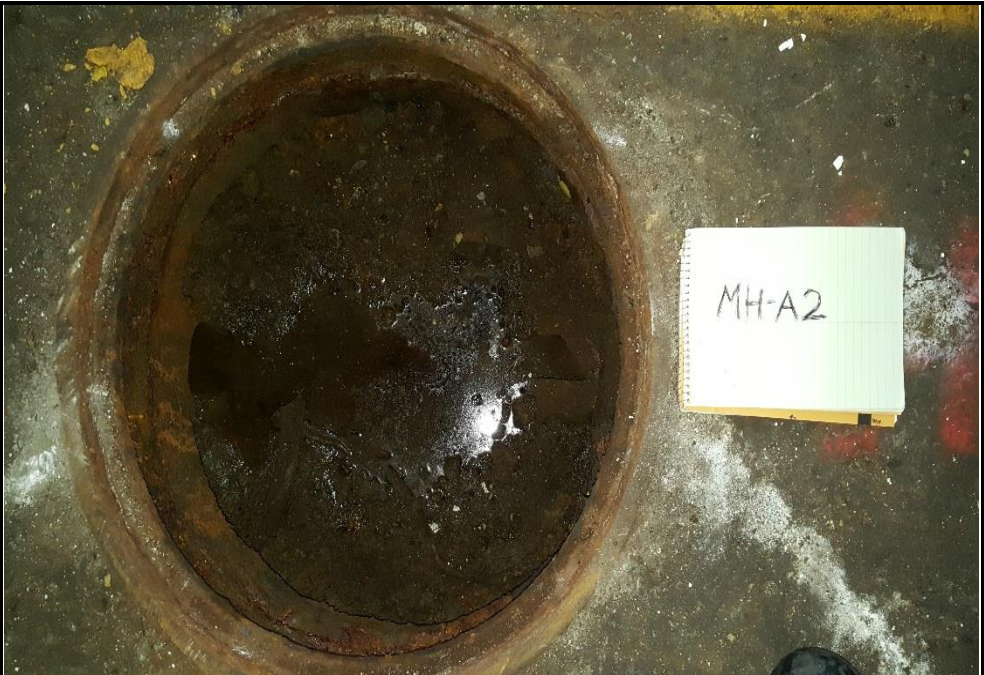
| Photo No. | Date | |
|---|---|---|
| 3 | 3/14/2017 | |

| Manhole (a,b) | Contents Description | Flow into Manhole Sides / Bottom (yes/no) | Flow into Manhole Through Pipes (yes/no) |
|---|---|---|---|
| MH-A2 | Bottom of manhole appears to be bedrock. Less than 1 gpm trickling into manhole from manhole walls. | Yes | No |

| Photo No. | Date | |
|---|---|---|
| MH-A2 before cleaning | | |

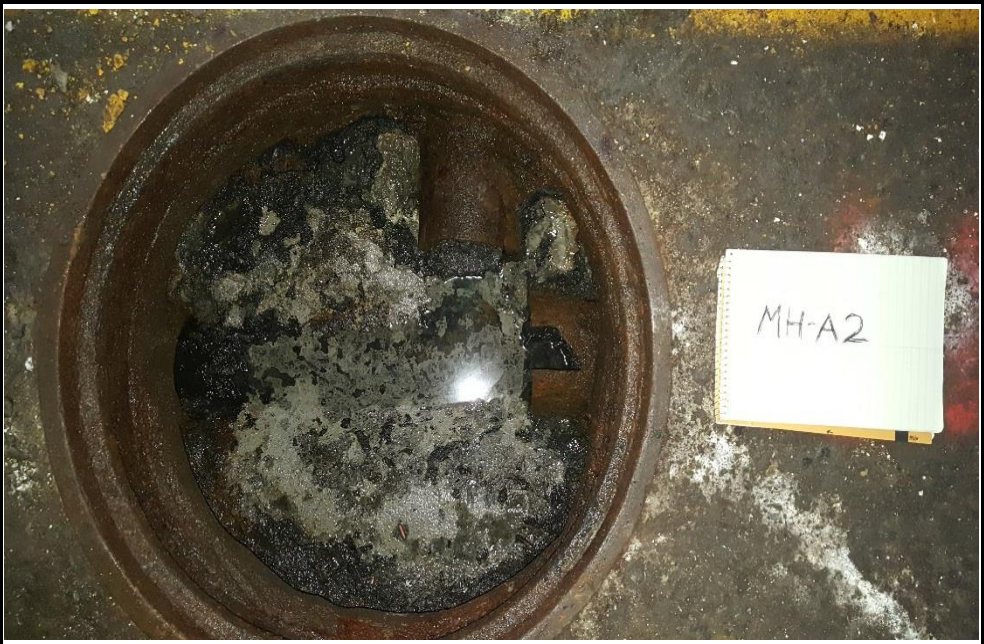
| Photo No. | Date | |
|---|---|---|
| 4 | 3/14/2017 | |

| Photo No. | Date | |
|---|---|---|
| MH-A2 after cleaning | | |

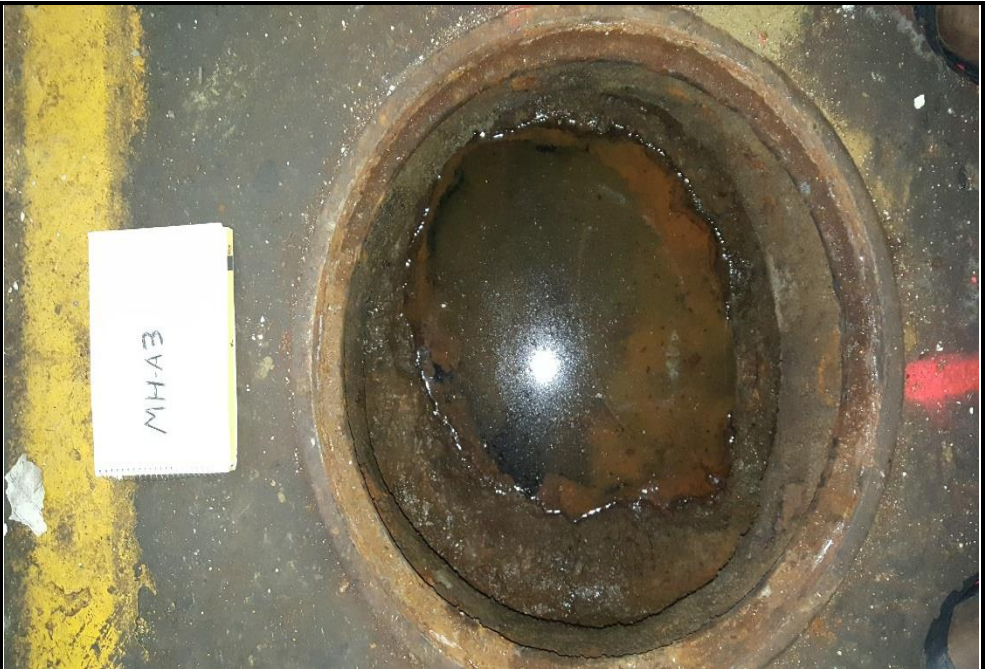
| Photo No. | Date | |
|---|---|---|
| 5 | 3/14/2017 | |

| Manhole (a,b) | Contents Description | Flow into Manhole Sides / Bottom (yes/no) | Flow into Manhole Through Pipes (yes/no) |
|---|---|---|---|
| MH-A3 | Very black cementitious material coating bottom of the manhole. Moderate odor, PID 0.0 ppm. | No | No |

| Photo No. | Date | |
|---|---|---|
| MH-A3 before cleaning | | |

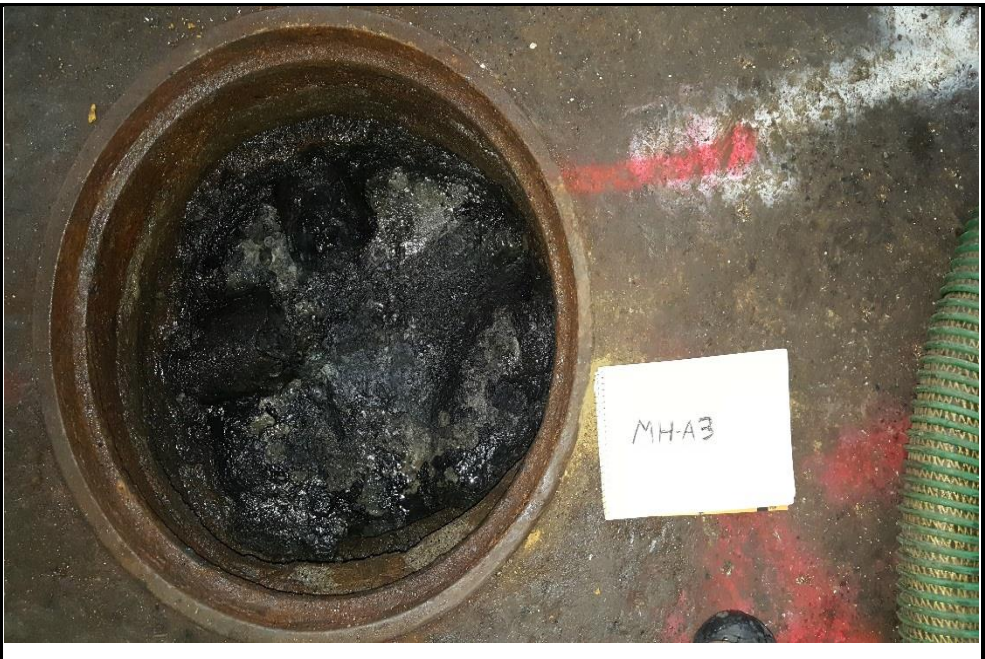
| Photo No. | Date | |
|---|---|---|
| 6 | 3/14/2017 | |

| Photo No. | Date | |
|---|---|---|
| MH-A3 after cleaning | | |

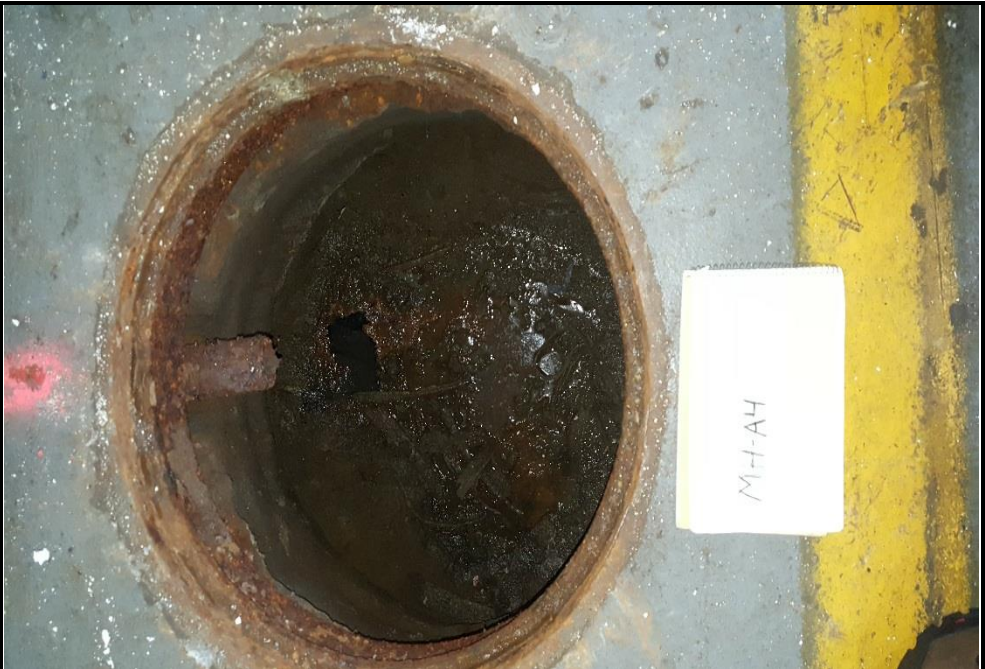
| Photo No. | Date | |
|---|---|---|
| 7 | 3/14/2017 | |

| Manhole (a,b) | Contents Description | Flow into Manhole Sides / Bottom (yes/no) | Flow into Manhole Through Pipes (yes/no) |
|---|---|---|---|
| MH-A4 | Approximately 6 inches of very black cementitious material. Small flow of water coming into manhole around perimeter/alongside of pipes. | Yes | No |

| Photo No. | Date | |
|---|---|---|
| MH-A4 before cleaning | | |

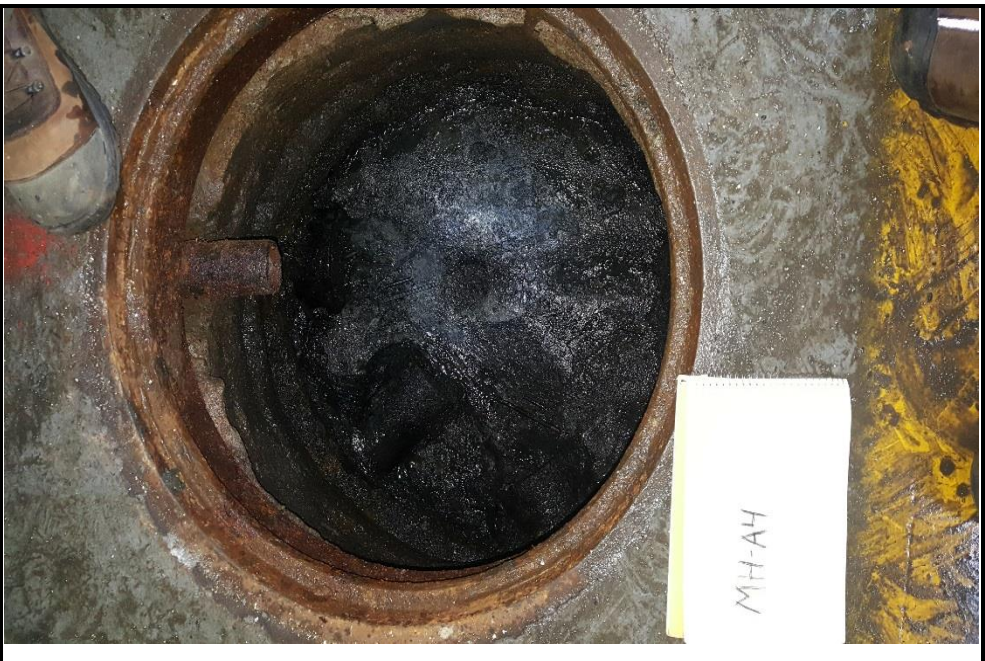
| Photo No. | Date | |
|---|---|---|
| 8 | 3/14/2017 | |

| Photo No. | Date | |
|---|---|---|
| MH-A4 after cleaning | | |

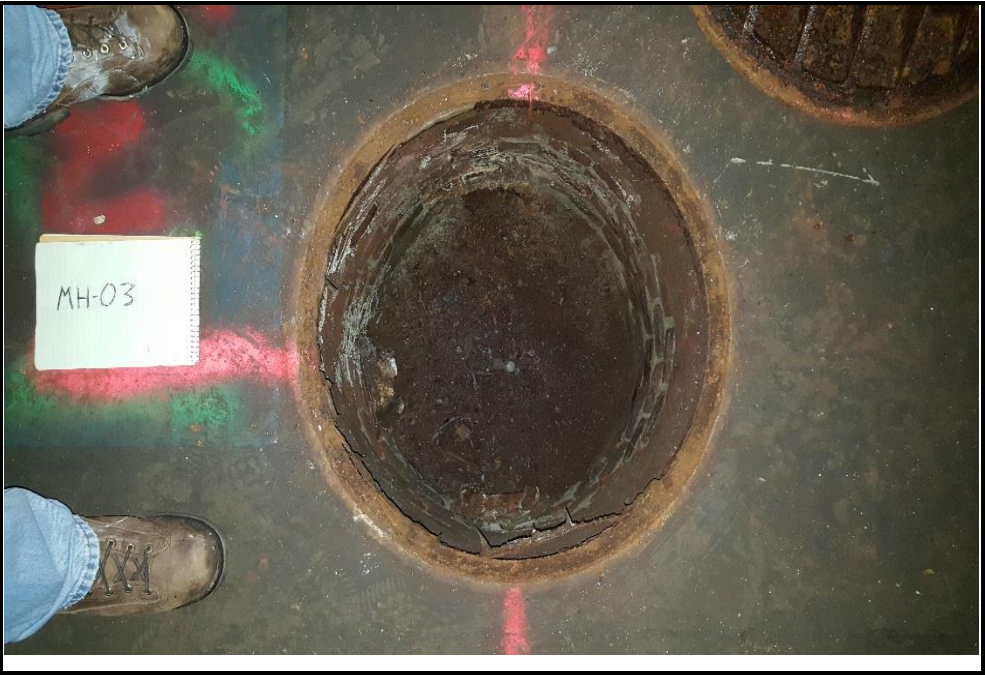
| Photo No. | Date | |
|---|---|---|
| 9 | 3/15/2017 | |

| Manhole (a,b) | Contents Description | Flow into Manhole Sides / Bottom (yes/no) | Flow into Manhole Through Pipes (yes/no) |
|---|---|---|---|
| MH-03 | Minimal material | No | No |

| Photo No. | Date | |
|---|---|---|
| MH-03 before cleaning | | |

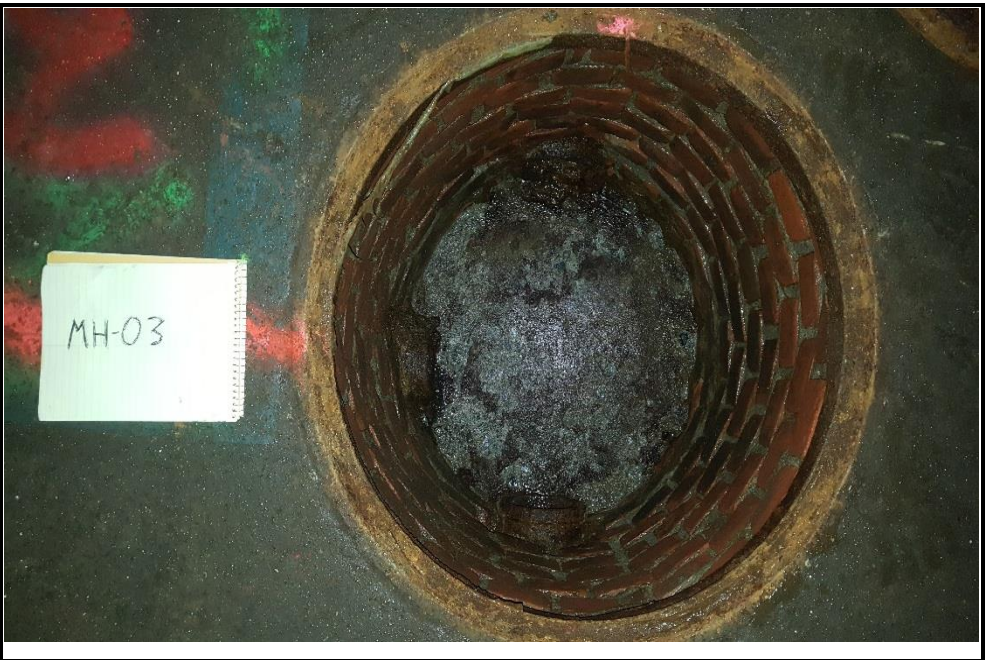
| Photo No. | Date | |
|---|---|---|
| 10 | 3/15/2017 | |

| Photo No. | Date | |
|---|---|---|
| MH-03 after cleaning | | |

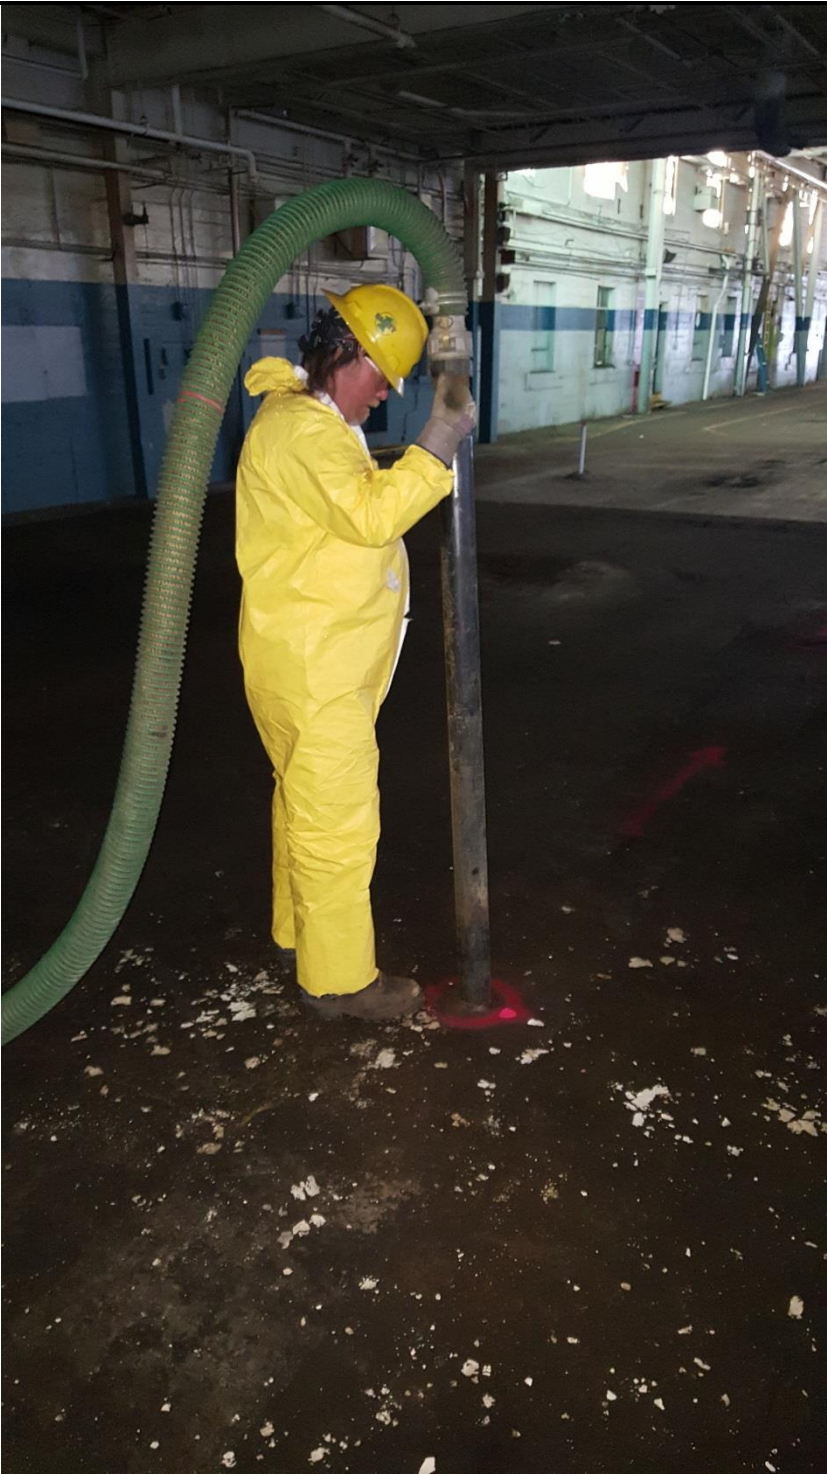
| Photo No. | Date | |
|---|---|---|
| 11 | 3/15/2017 | |

| Manhole (a,b) | Contents Description | Flow into Manhole Sides / Bottom (yes/no) | Flow into Manhole Through Pipes (yes/no) |
|---|---|---|---|
| Trench Network near MH-03 | Dry vacuum only through access holes. | No | No |

| Photo No. | Date | |
|---|---|---|
| Trench Network near MH-03<br>cleaning process | | |

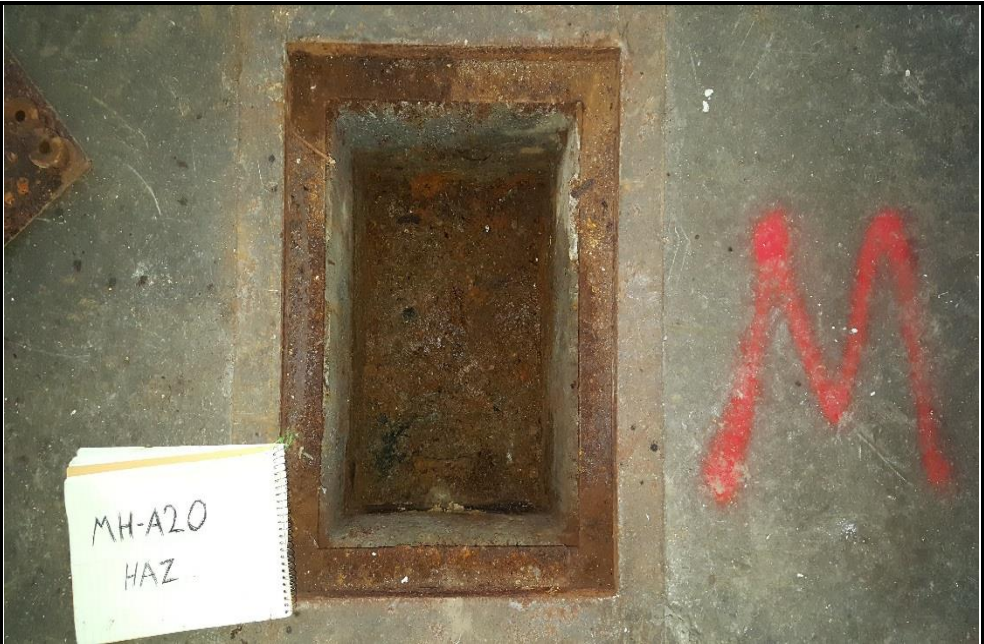
| Photo No. | Date | |
|---|---|---|
| 12 | 3/15/2017 | |

| Manhole (a,b) | Contents Description | Flow into Manhole Sides / Bottom (yes/no) | Flow into Manhole Through Pipes (yes/no) |
|---|---|---|---|
| MH-A20 | Minimal flow infiltrating from sidewalls of manhole. | Yes | No |

| Photo No. | Date | |
|---|---|---|
| MH-A20 before cleaning | | |

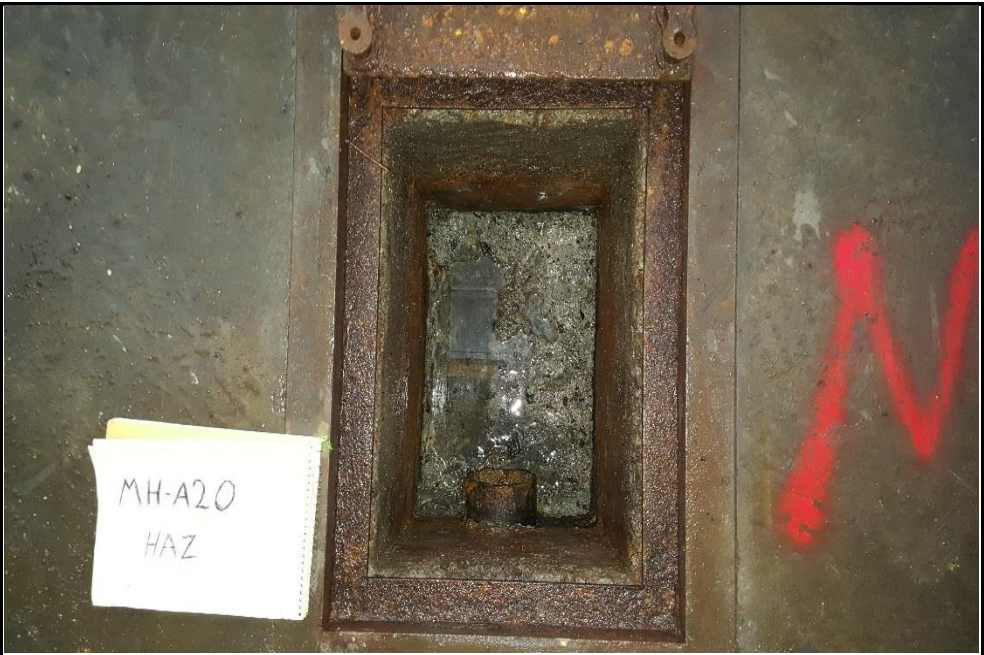
| Photo No. | Date | |
|---|---|---|
| 13 | 3/15/2017 | |

| Photo No. | Date | |
|---|---|---|
| MH-A20 after cleaning | | |

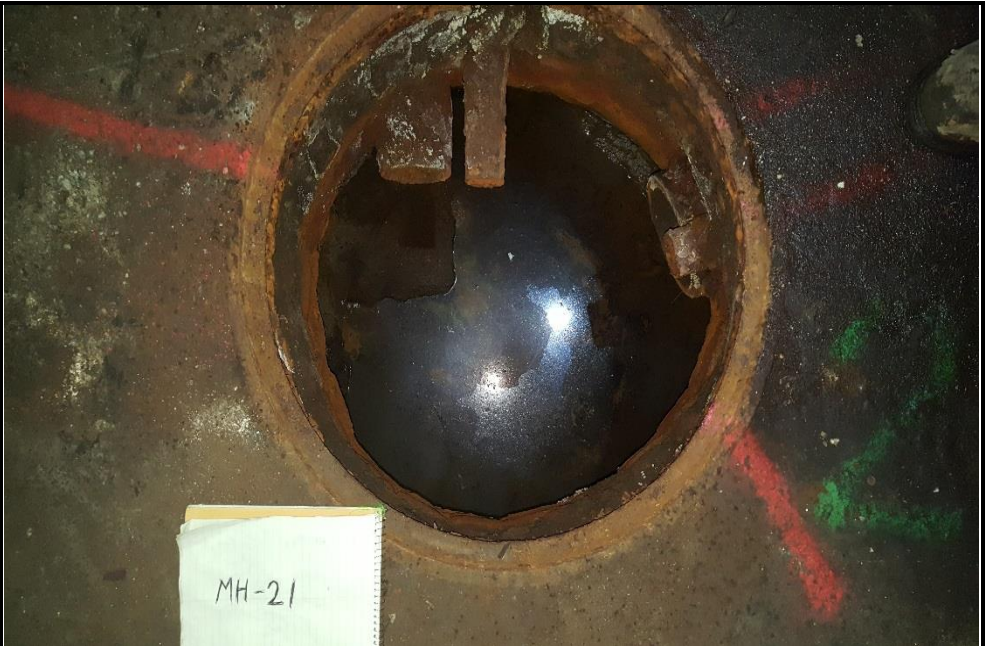
| Photo No. | Date | |
|---|---|---|
| 14 | 3/15/2017 | |

| Manhole (a,b) | Contents Description | Flow into Manhole Sides / Bottom (yes/no) | Flow into Manhole Through Pipes (yes/no) |
|---|---|---|---|
| MH-21 | Black sludge. Strong petroleum odor. PID 0.0 ppm. Room ventilated prior to work. Prior sampling indicates odor is from diesel range TPH cutting fluids. | No | No |

| Photo No. | Date | |
|---|---|---|
| MH-21 before cleaning | | |

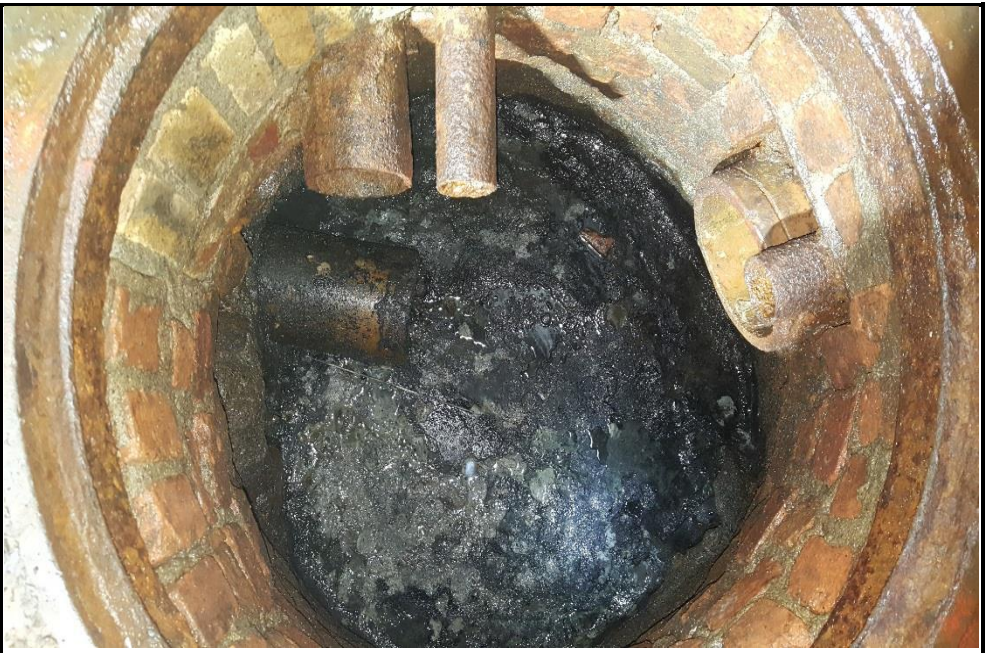
| Photo No. | Date | |
|---|---|---|
| 15 | 3/15/2017 | |

| Photo No. | Date | |
|---|---|---|
| MH-21 after cleaning | | |

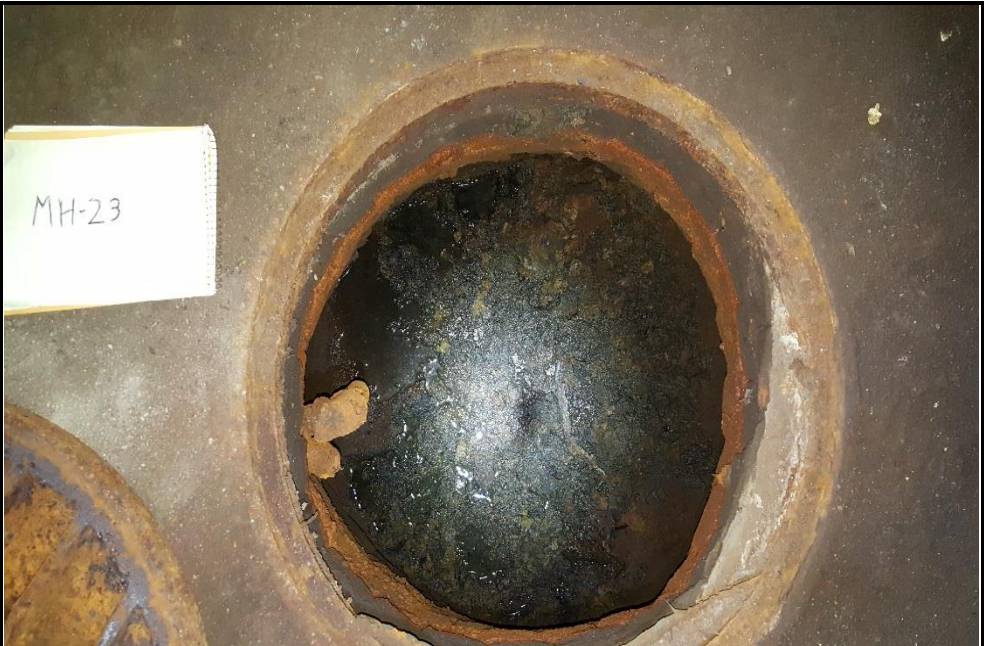
| Photo No. | Date | |
|---|---|---|
| 16 | 3/16/2017 | |

| Manhole (a,b) | Contents Description | Flow into Manhole Sides / Bottom (yes/no) | Flow into Manhole Through Pipes (yes/no) |
|---|---|---|---|
| MH-23 | Approximately 2 inches of standing water and 8 inches of soupy black sediment in bottom of manhole. Approximately 3 inches of very dense clay on the bottom required repeated pressure washing and hand tool cleaning to remove. Some cutting fluid odor, and a slight sheen on black sediment. Room ventilated prior to work. Manhole bottom is very rough, uneven concrete, an open 4 inch clay pipe runs the length of the bottom of the manhole, lines are plugged with dense clay. No flow, standing water is from the leaking roof. | No | No |

| Photo No. | Date | |
|---|---|---|
| MH-23 before cleaning | | |

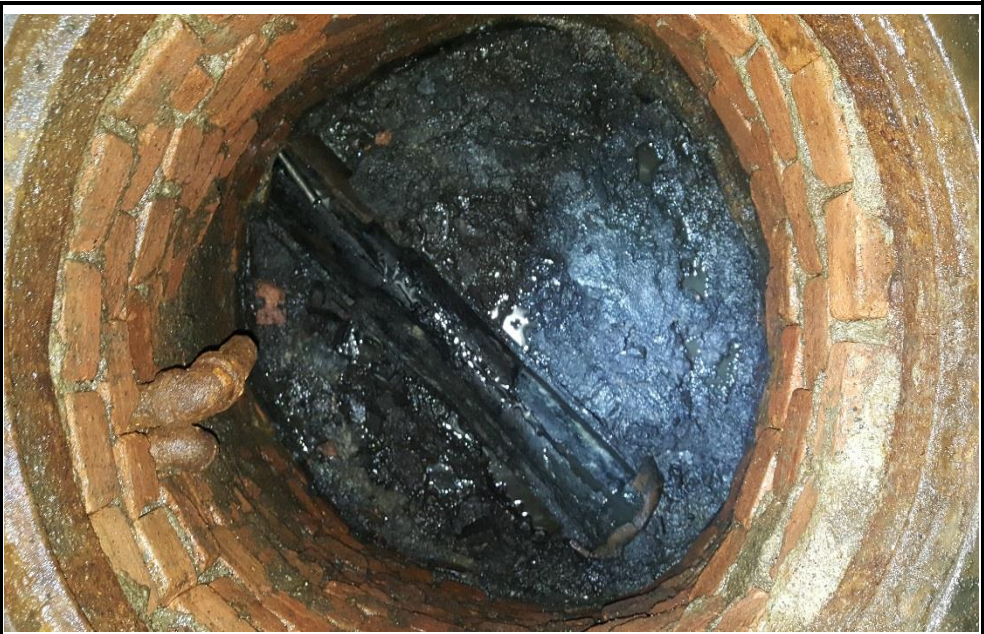
| Photo No. | Date | |
|---|---|---|
| 17 | 3/16/2017 | |

| Photo No. | Date | |
|---|---|---|
| MH-23 after cleaning | | |

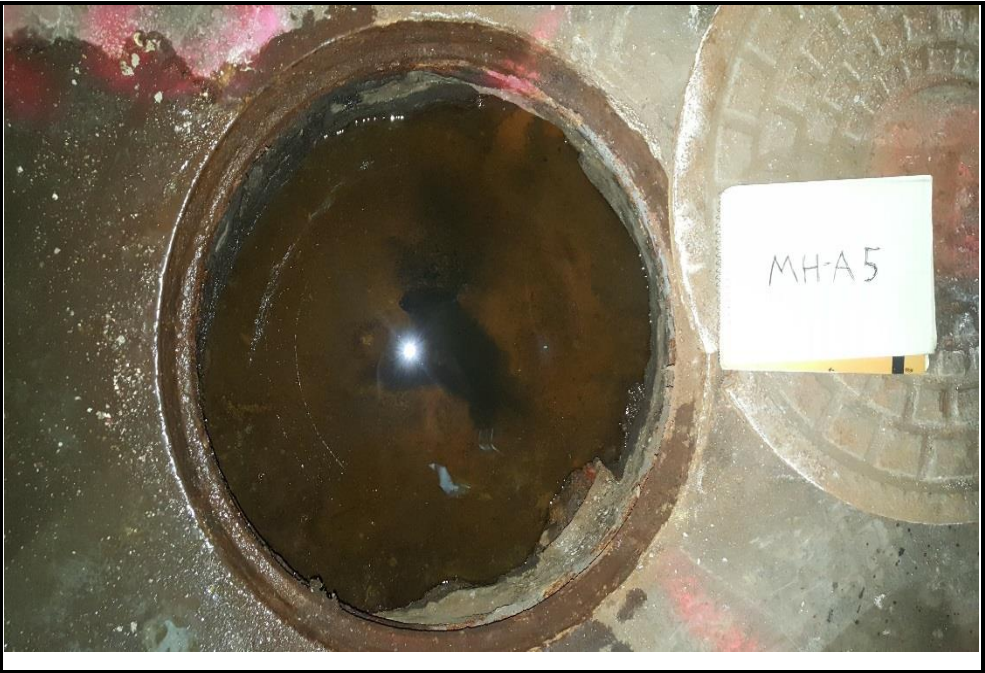
| Photo No. | Date | |
|---|---|---|
| 18 | 3/16/2017 | |

| Manhole (a,b) | Contents Description | Flow into Manhole Sides / Bottom (yes/no) | Flow into Manhole Through Pipes (yes/no) |
|---|---|---|---|
| MH-A5 | Approximately 2 inches of standing water and 2 inches of soupy sediment with oil sheen. No flow, standing water from the leaking roof. | No | No |

| Photo No. | Date | |
|---|---|---|
| MH-A5 before cleaning | | |

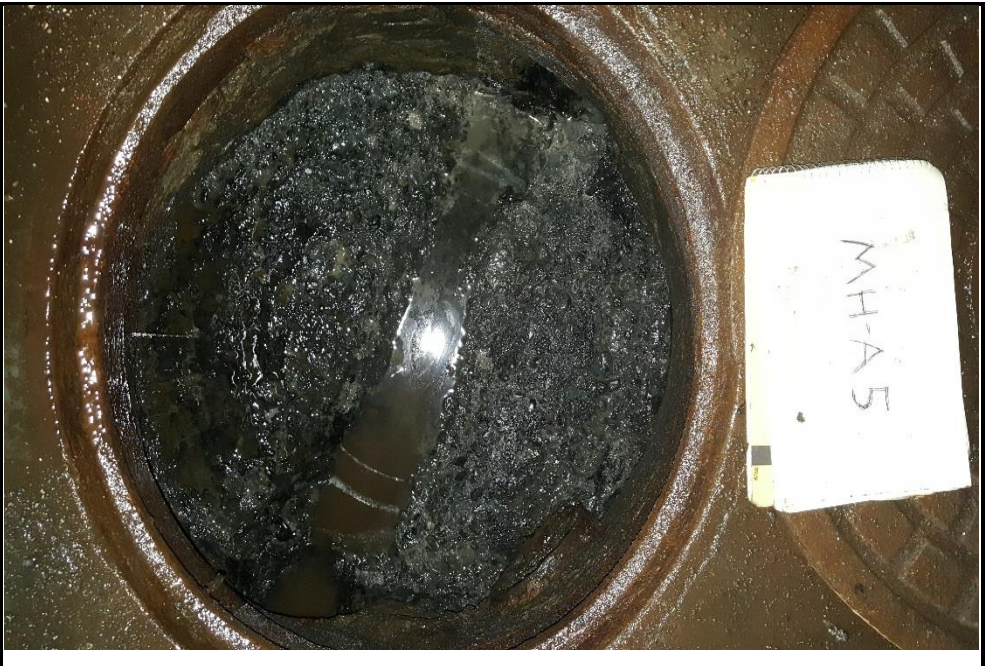
| Photo No. | Date | |
|---|---|---|
| 19 | 3/16/2017 | |

| Photo No. | Date | |
|---|---|---|
| MH-A5 after cleaning | | |

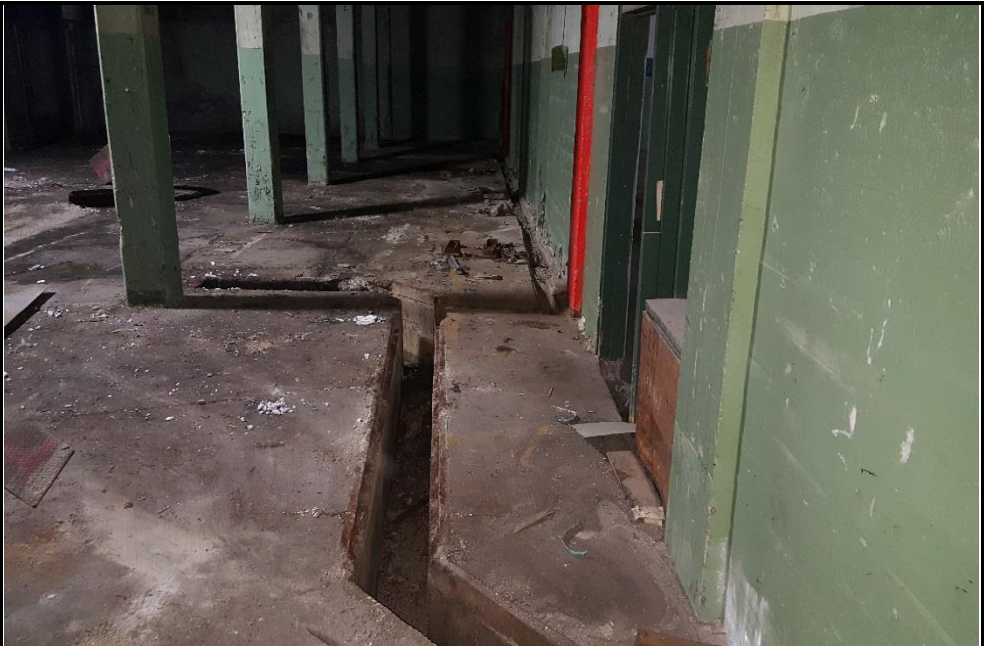
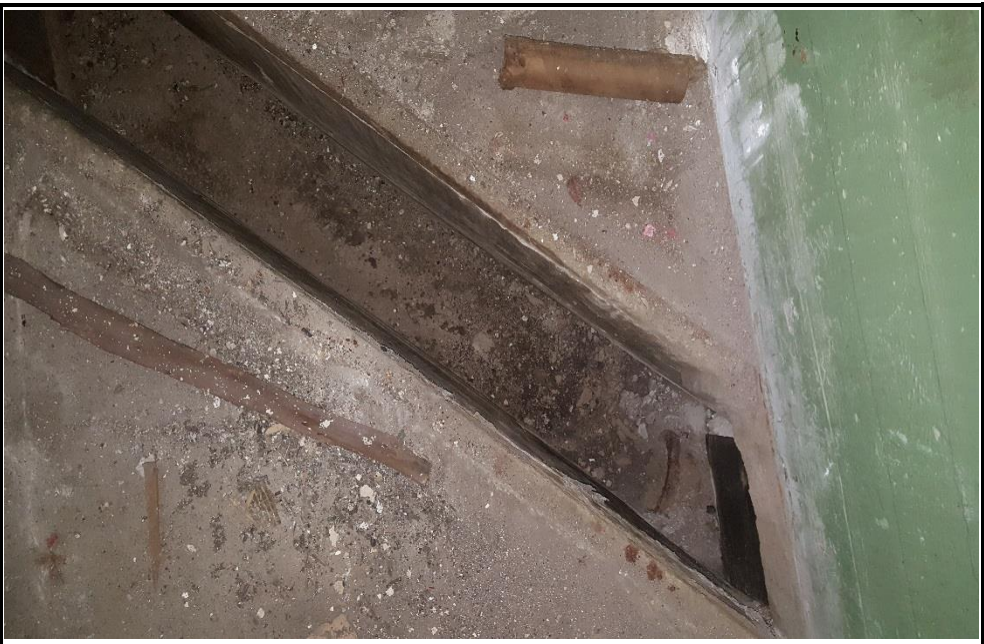
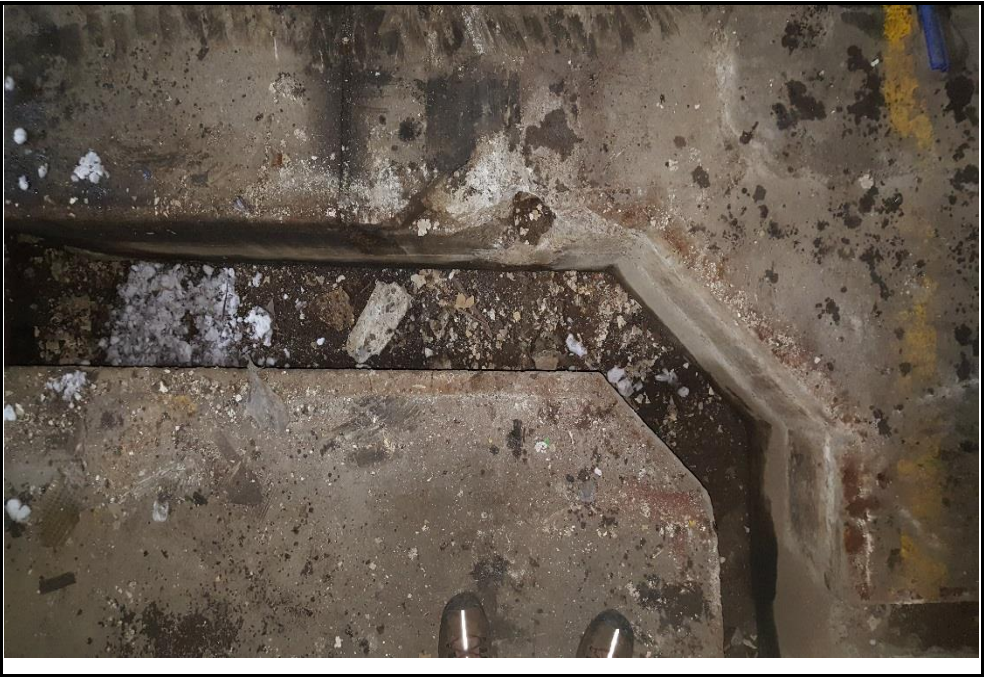
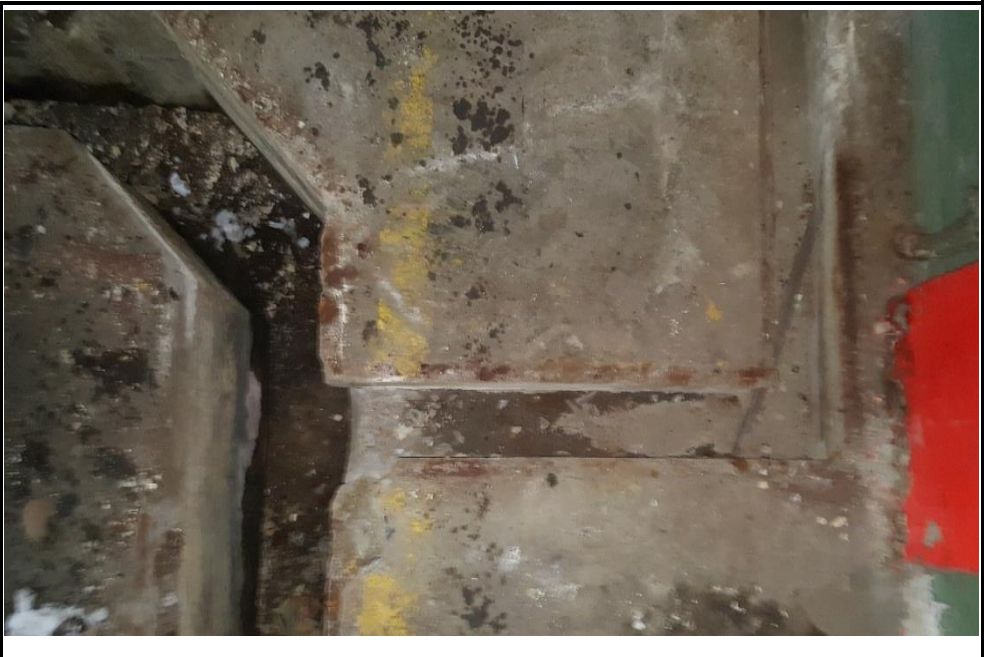
| Manhole (a,b) | Contents Description | Flow into Manhole Sides / Bottom (yes/no) | Flow into Manhole Through Pipes (yes/no) |
|---|---|---|---|
| BLDG 15 Trenches | Hard clay present in the trench bottom. No flow, dry. | No | No |

| Photo No. | Date | |
|---|---|---|
| BD 15 Trenches before cleanout | | |

| Photo No. | Date | |
|---|---|---|
| BD 15 Trenches before cleanout | | |

| Photo No. | Date | |
|---|---|---|
| BD 15 Trenches before cleanout | | |

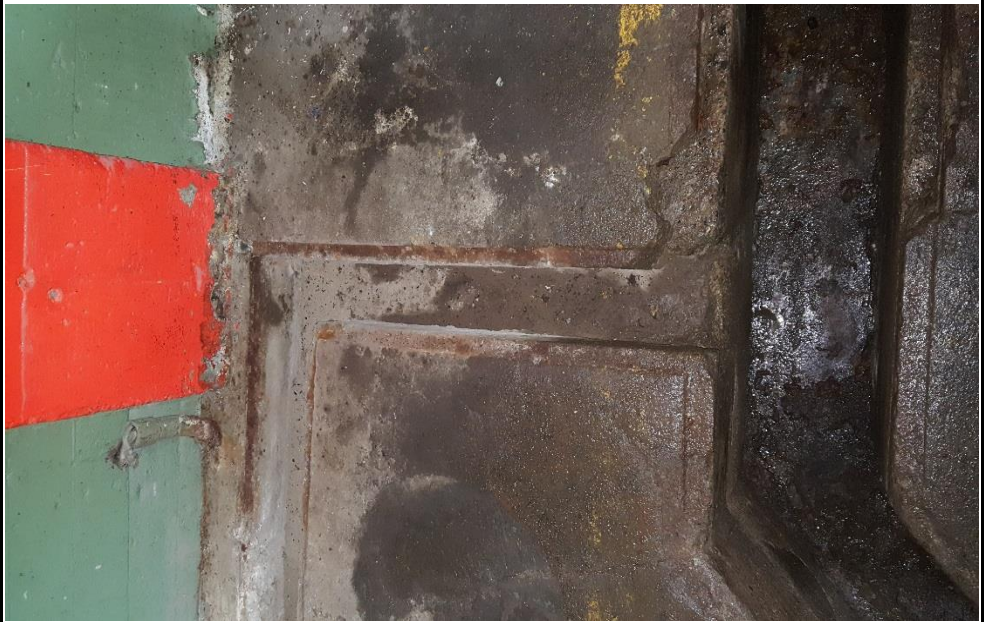
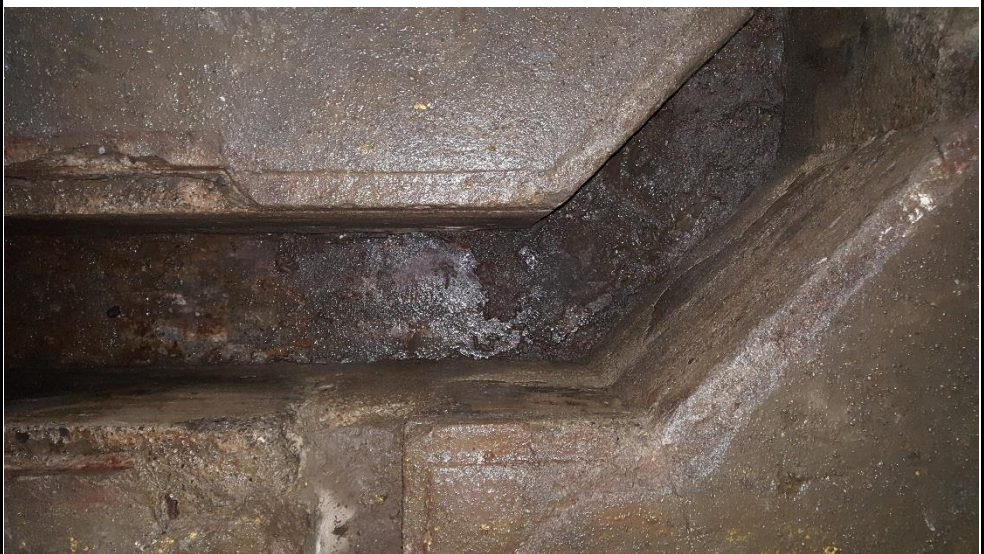
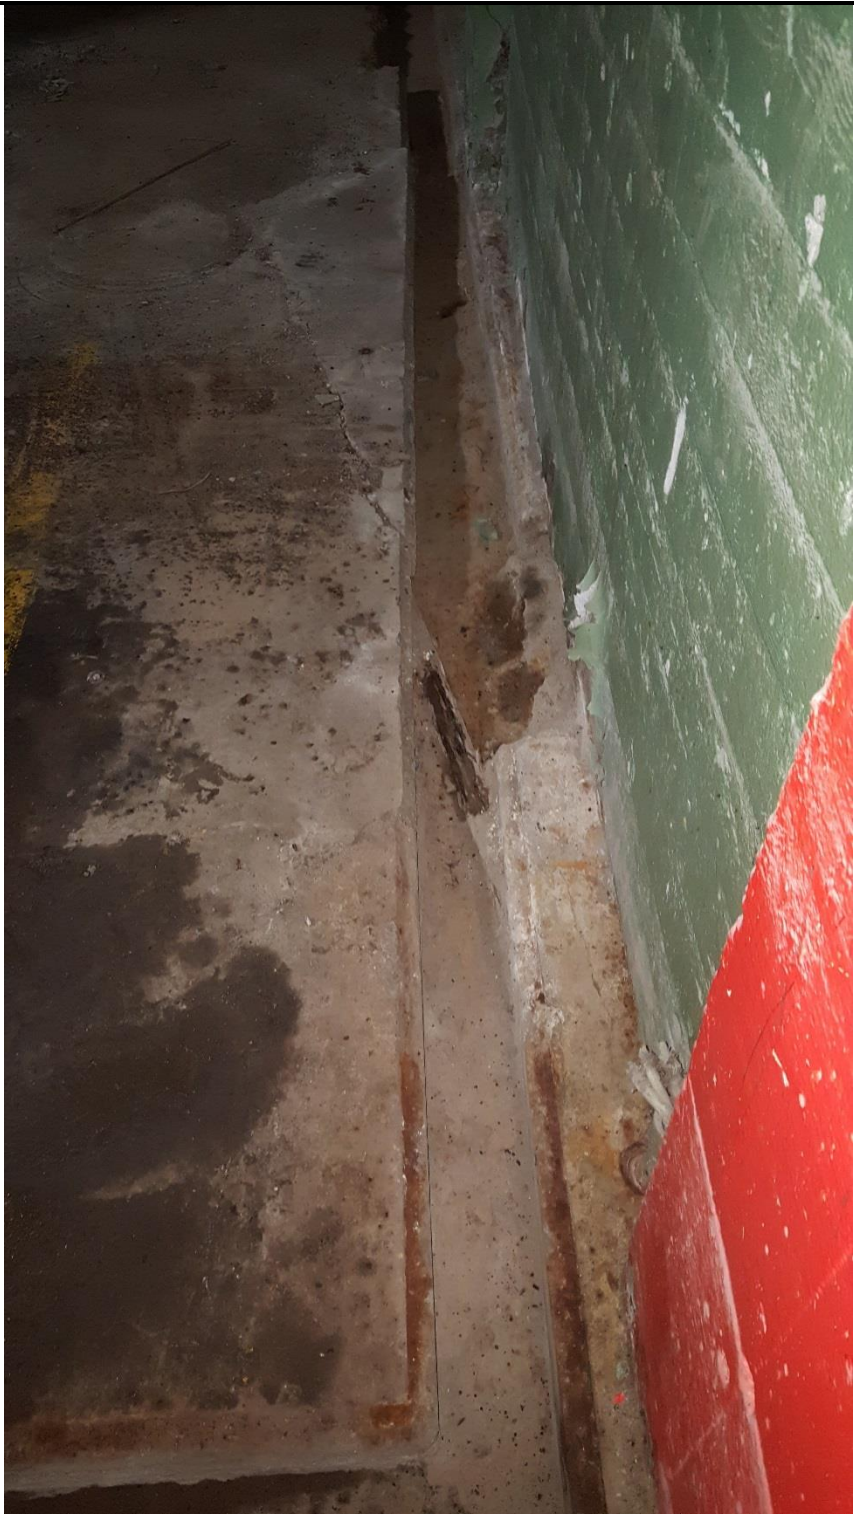
| Photo No. | Date | |
|---|---|---|
| BD 15 Trenches after cleanout | | |

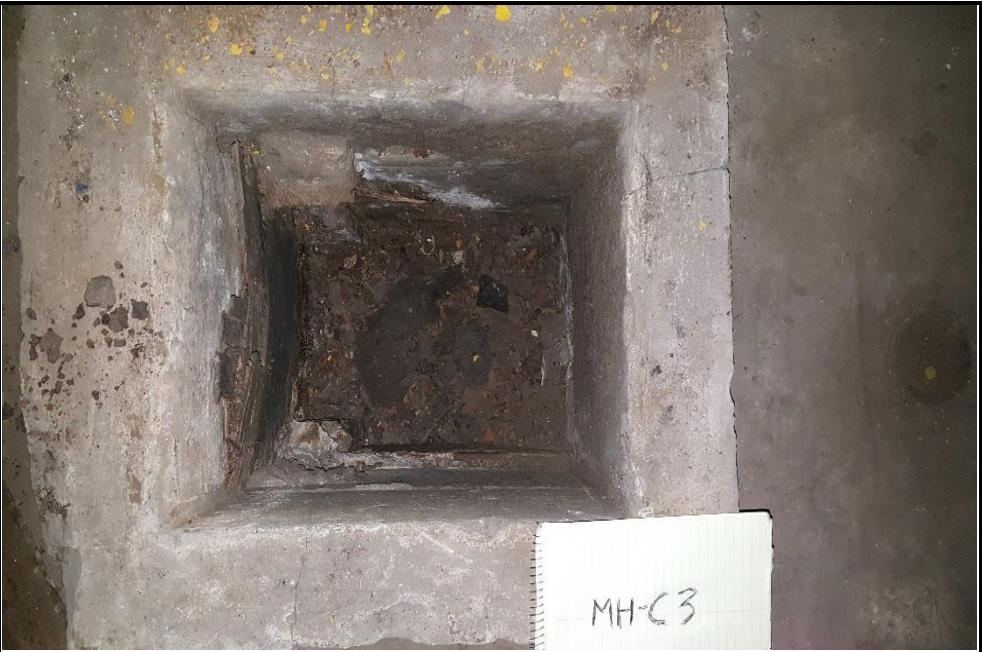
| Photo No. | Date | |
|---|---|---|
| 27 | 3/16/2017 | |

| Manhole (a,b) | Contents Description | Flow into Manhole Sides / Bottom (yes/no) | Flow into Manhole Through Pipes (yes/no) |
|---|---|---|---|
| MH-C3 | Approximately 6 inches of rusty debris in manhole bottom. No flow. Manhole bottom is rough concrete. | No | No |

| Photo No. | Date | |
|---|---|---|
| MH-C3 Before cleanout | | |

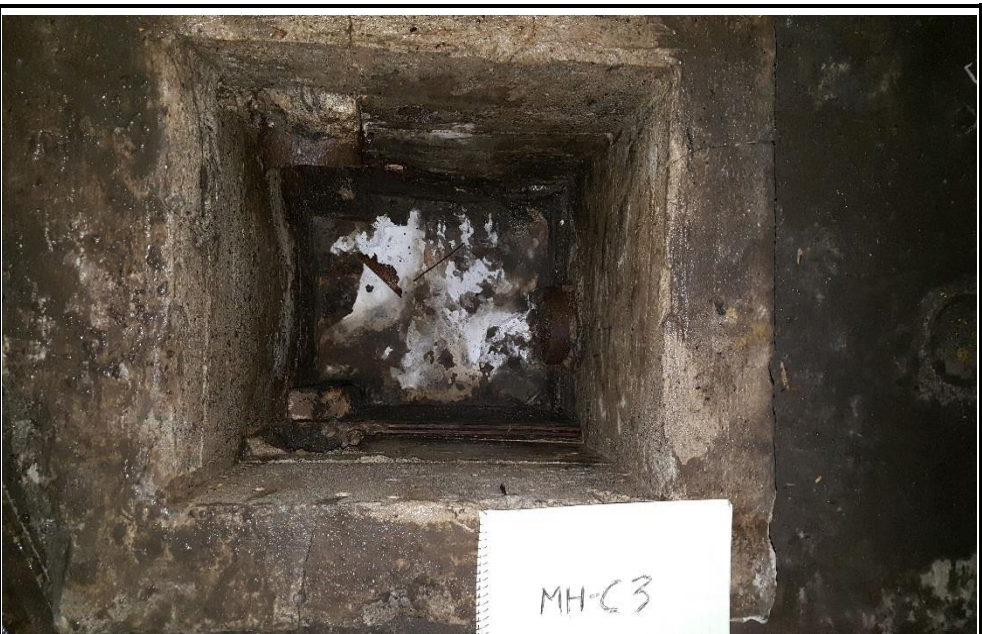
| Photo No. | Date | |
|---|---|---|
| 28 | 3/16/2017 | |

| Photo No. | Date | |
|---|---|---|
| MH-C3 after cleaning | | |

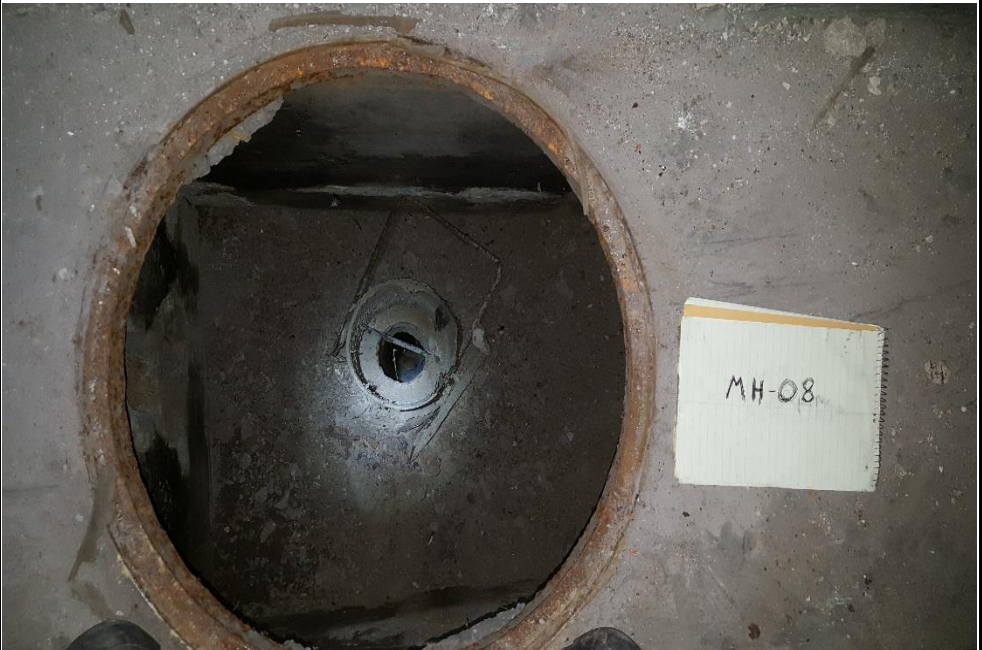
| Photo No. | Date | |
|---|---|---|
| 29 | 3/16/2017 | |

| Manhole (a,b) | Contents Description | Flow into Manhole Sides / Bottom (yes/no) | Flow into Manhole Through Pipes (yes/no) |
|---|---|---|---|
| MH-08 | Less than 1 inch of rusty debris. No flow, dry. | No | No |

| Photo No. | Date | |
|---|---|---|
| MH-08 Before cleanout | | |

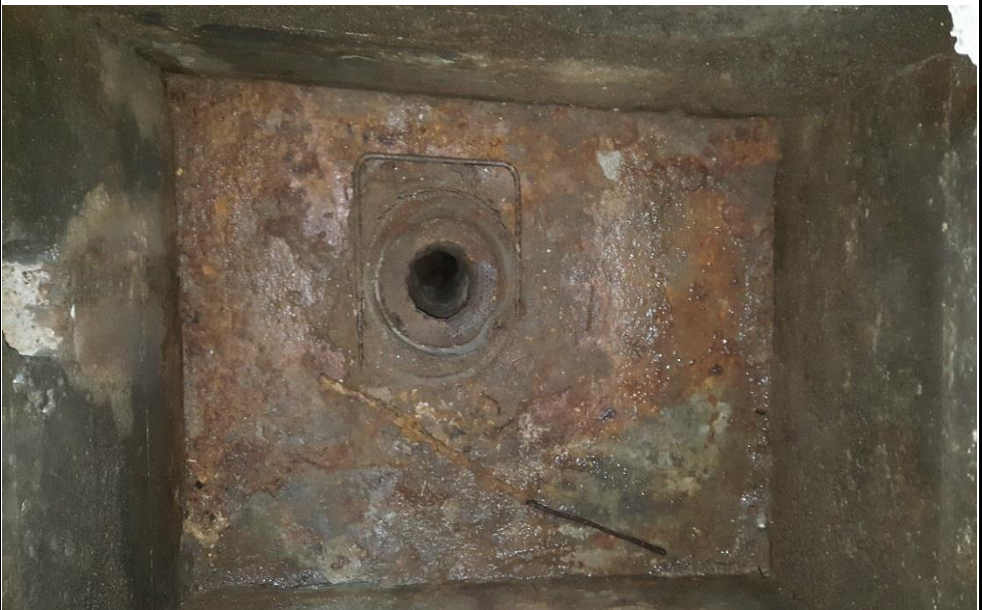
| Photo No. | Date | |
|---|---|---|
| 30 | 3/16/2017 | |

| Photo No. | Date | |
|---|---|---|
| MH-08 after cleanout | | |
