**Subject: Phase I IRM Completion Report – Sanitary Sewers  
Former Emerson Power Transmission, Ithaca, New York**

**MANHOLE CLEANOUT**

FORMER EMERSON POWER TRANSMISSION  
ITHACA, NEW YORK

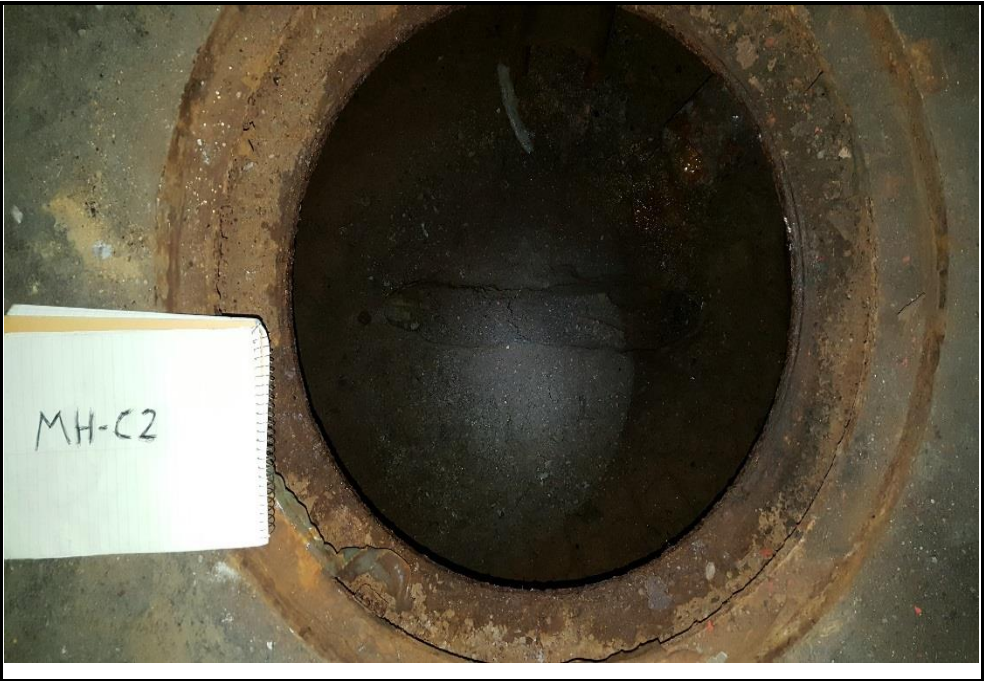
| Photo No. | Date | |
|---|---|---|
| 31 | 3/16/2017 | |

| Manhole (a,b) | Contents Description | Flow into Manhole Sides / Bottom (yes/no) | Flow into Manhole Through Pipes (yes/no) |
|---|---|---|---|
| MH-C2 | Approximately 2 inches of black clay coating bottom of manhole/pipe run. Thin coating of black greasy material on brick manhole walls. | No | No |

| Photo No. | Date | |
|---|---|---|
| MH-C2 Before cleanout | | |

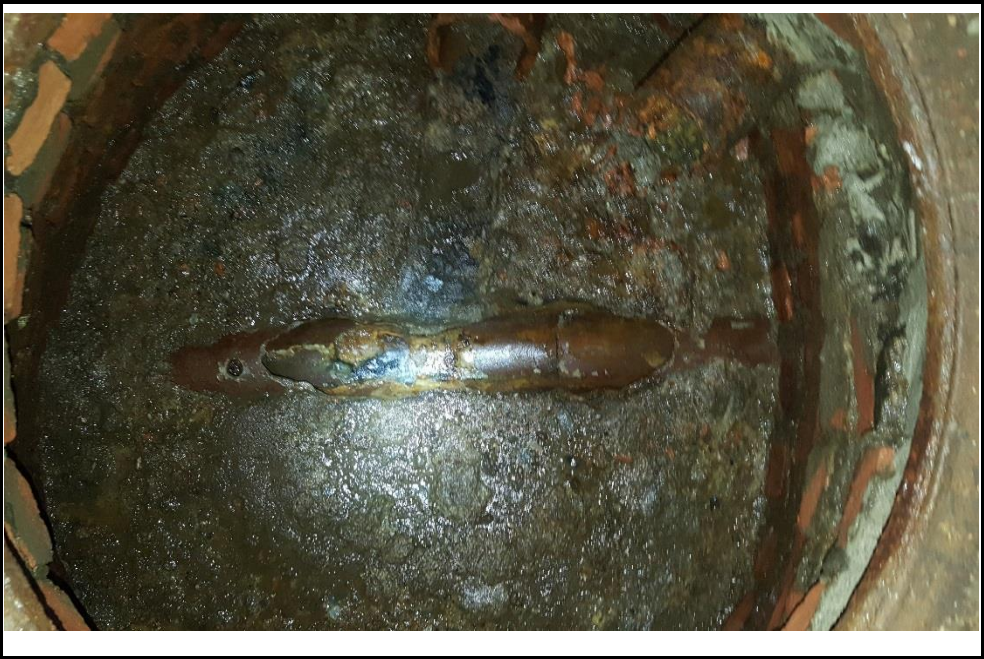
| Photo No. | Date | |
|---|---|---|
| 32 | 3/16/2017 | |

| Photo No. | Date | |
|---|---|---|
| MH-C2 after cleanout | | |

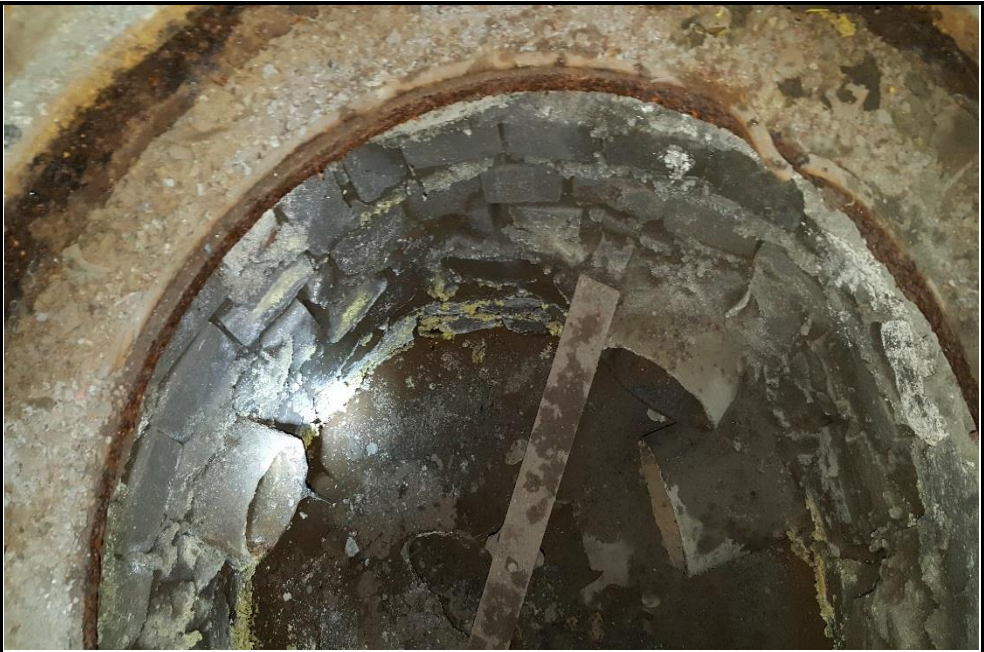
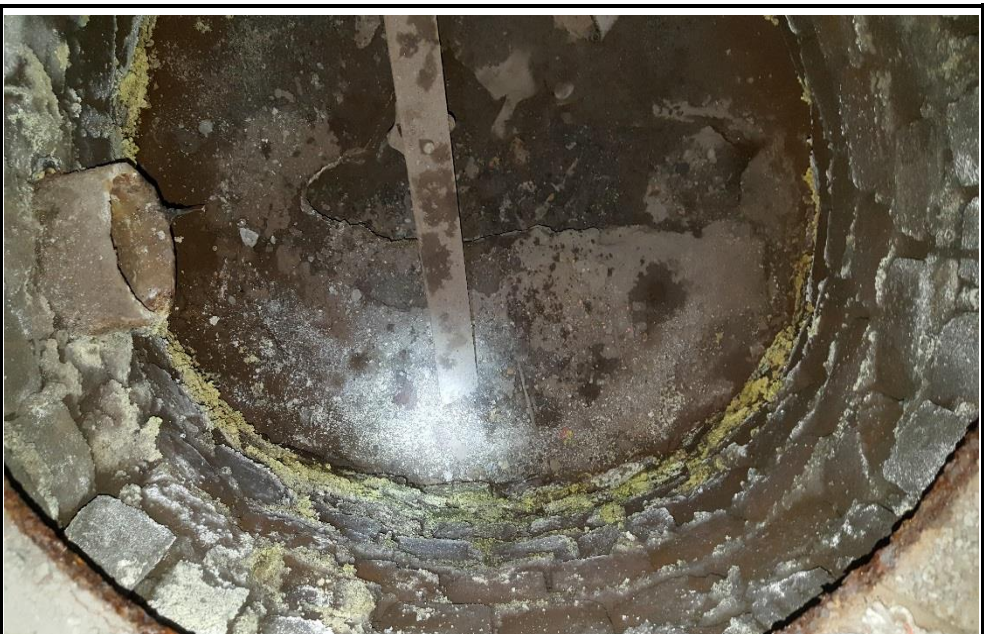
| Manhole (a,b) | Contents Description | Flow into Manhole Sides / Bottom (yes/no) | Flow into Manhole Through Pipes (yes/no) |
|---|---|---|---|
| MH-C1 | Approximately 4 inches of rusty debris at the bottom of the manhole. Visible yellow crystallization growing on manhole sidewalls. | No | No |

| Photo No. | Date | |
|---|---|---|
| MH-C1 Before cleanout | | |

| Photo No. | Date | |
|---|---|---|
| MH-C1 before cleanout | | |

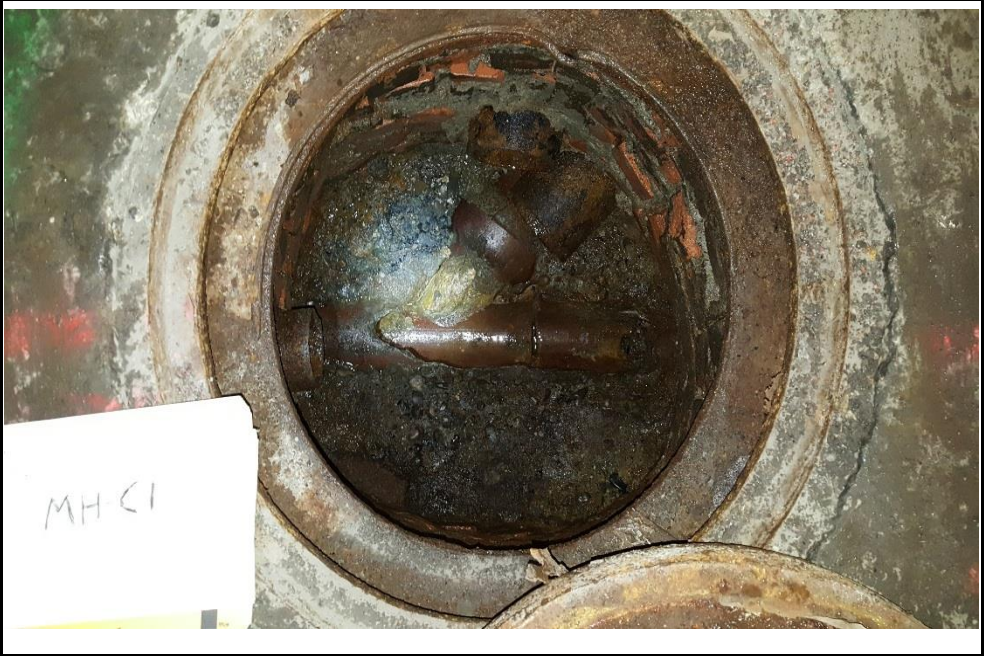
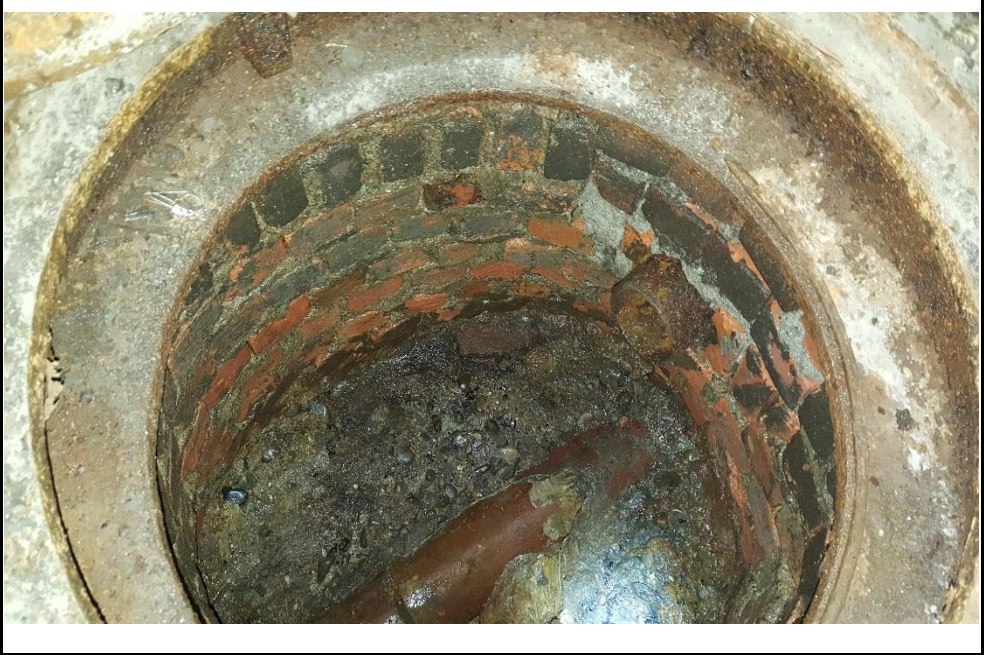
| Photo No. | Date | |
|---|---|---|
| MH-C1 after cleanout | | |

| Photo No. | Date | |
|---|---|---|
| MH-C1 after cleanout | | |

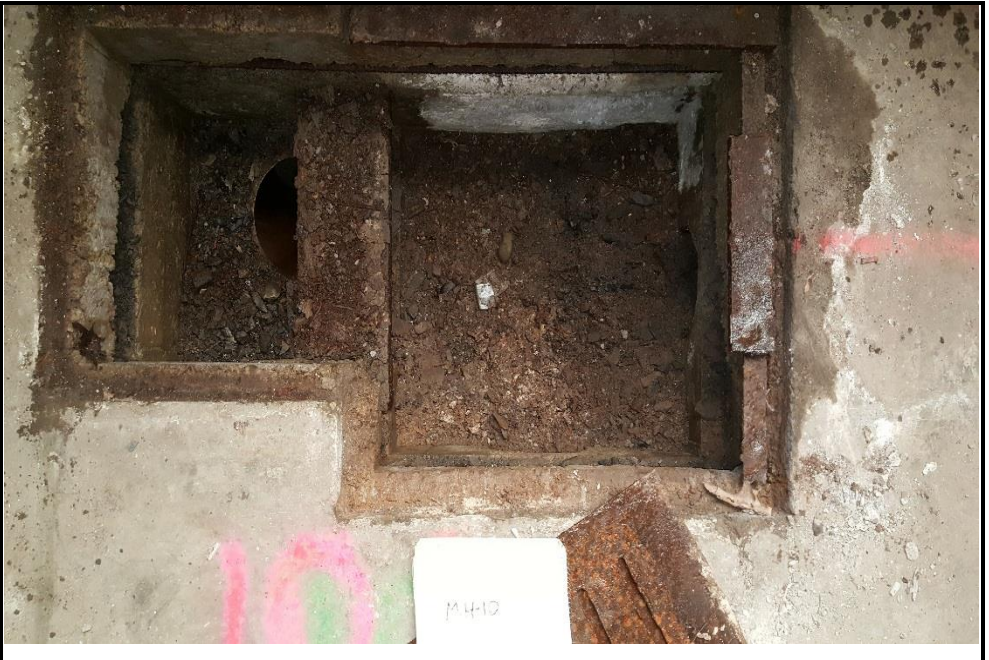
| Photo No. | Date | |
|---|---|---|
| 37 | 3/16/2017 | |

| Manhole (a,b) | Contents Description | Flow into Manhole Sides / Bottom (yes/no) | Flow into Manhole Through Pipes (yes/no) |
|---|---|---|---|
| MH-10 | 10-14 inches of loose loamy sediment with some rusty debris. | No | No |

| Photo No. | Date | |
|---|---|---|
| MH-10 Before Cleanout | | |

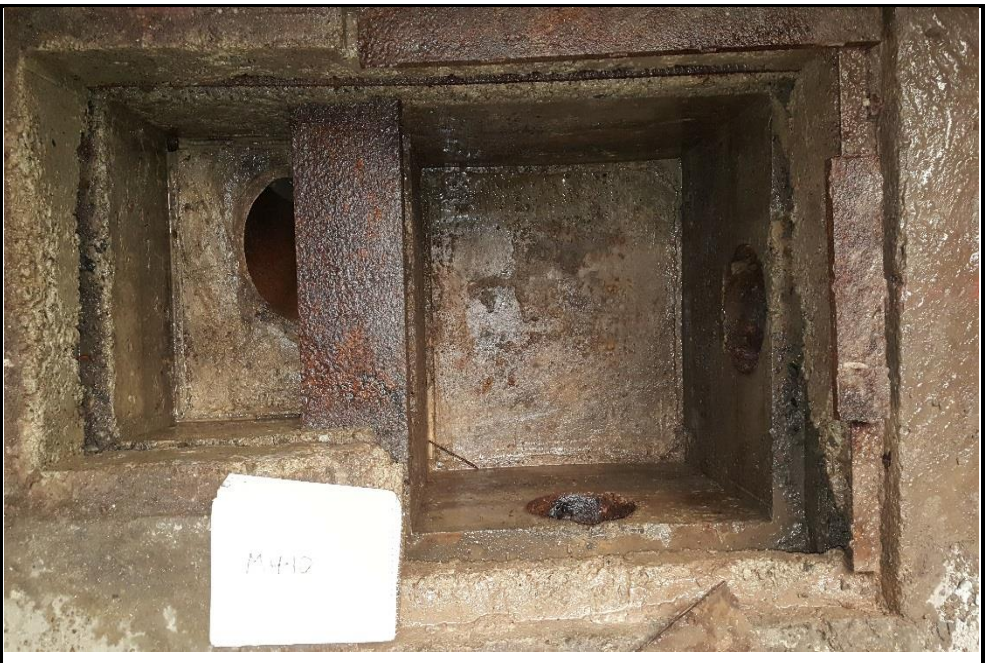
| Photo No. | Date | |
|---|---|---|
| 38 | 3/16/2017 | |

| Photo No. | Date | |
|---|---|---|
| MH-10 After cleanout | | |

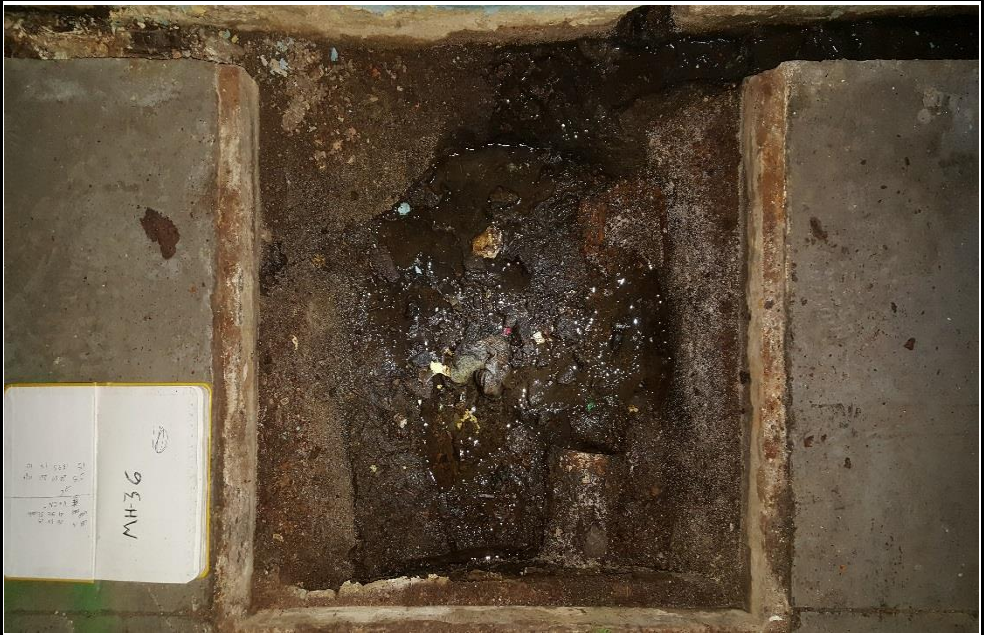
| Photo No. | Date | |
|---|---|---|
| 39 | 3/17/2017 | |

| Manhole (a,b) | Contents Description | Flow into Manhole Sides / Bottom (yes/no) | Flow into Manhole Through Pipes (yes/no) |
|---|---|---|---|
| MH-36 | 2-4 inches of loose wet sediment and rusty debris. Steady flow in/out of manhole. Bottom of manhole is very rough concrete. | No | Yes |

| Photo No. | Date | |
|---|---|---|
| MH-36 before cleanout | | |

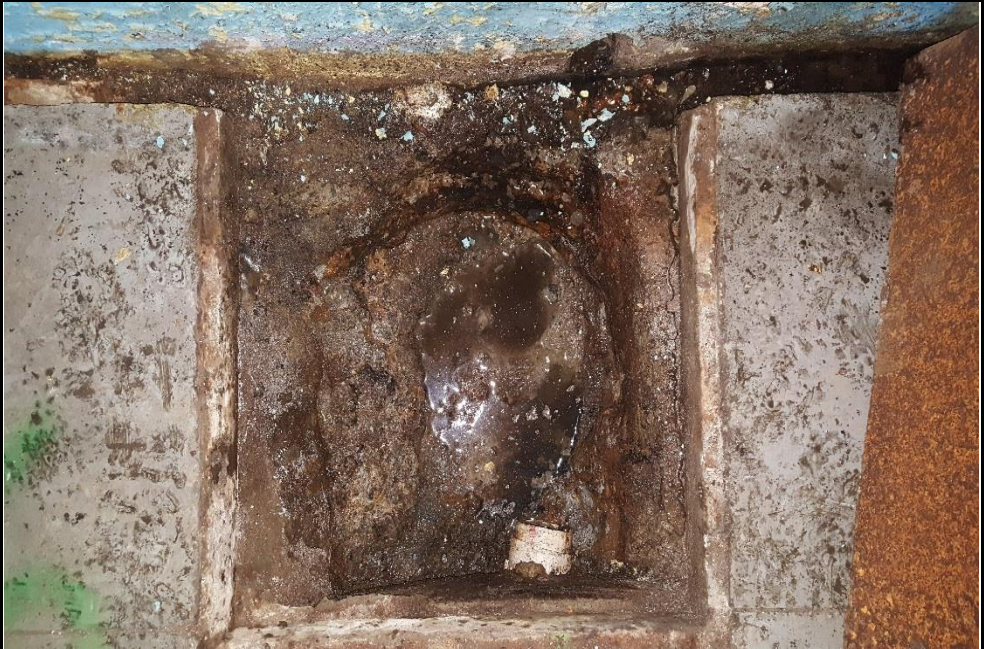
| Photo No. | Date | |
|---|---|---|
| 40 | 3/17/2017 | |

| Photo No. | Date | |
|---|---|---|
| MH-36 after cleanout | | |

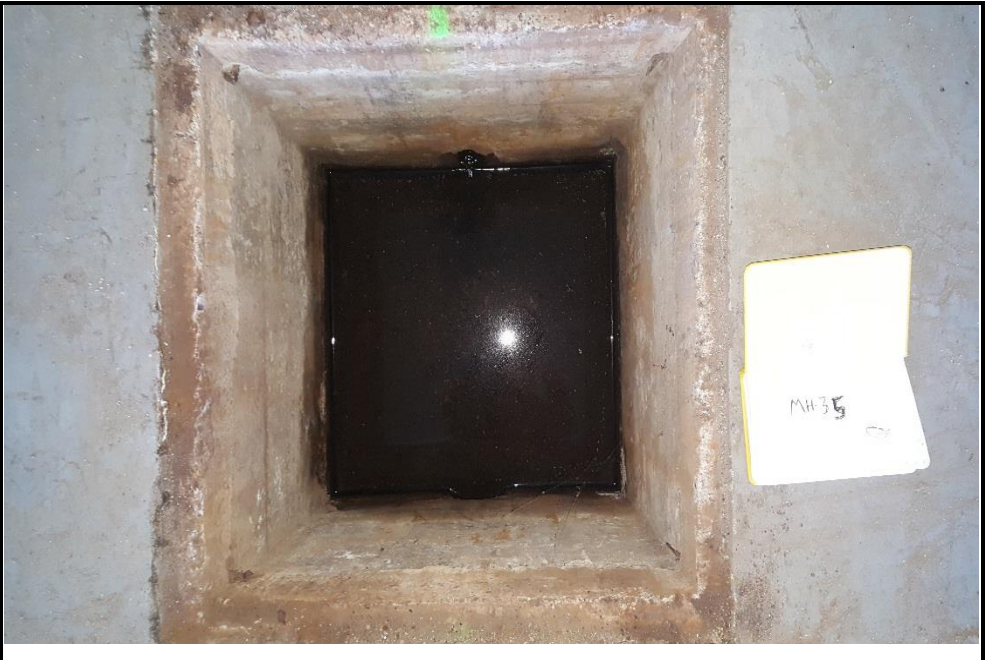
| Photo No. | Date | |
|---|---|---|
| 41 | 3/17/2017 | |

| Manhole (a,b) | Contents Description | Flow into Manhole Sides / Bottom (yes/no) | Flow into Manhole Through Pipes (yes/no) |
|---|---|---|---|
| MH-35 | 2-4 inches of black sludge and rusty debris at the bottom of the manhole. 6 inches of water present with 0.5 gpm flow in/out of manhole. | No | Yes |

| Photo No. | Date | |
|---|---|---|
| MH-35 before cleanout | | |

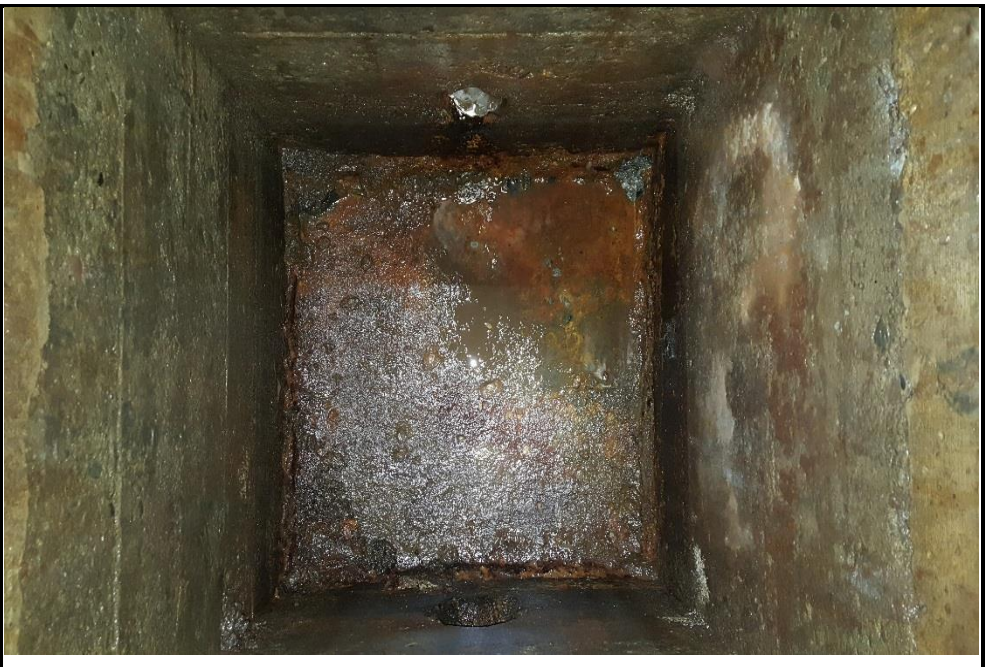
| Photo No. | Date | |
|---|---|---|
| 42 | 3/17/2017 | |

| Photo No. | Date | |
|---|---|---|
| MH-35 after cleanout | | |

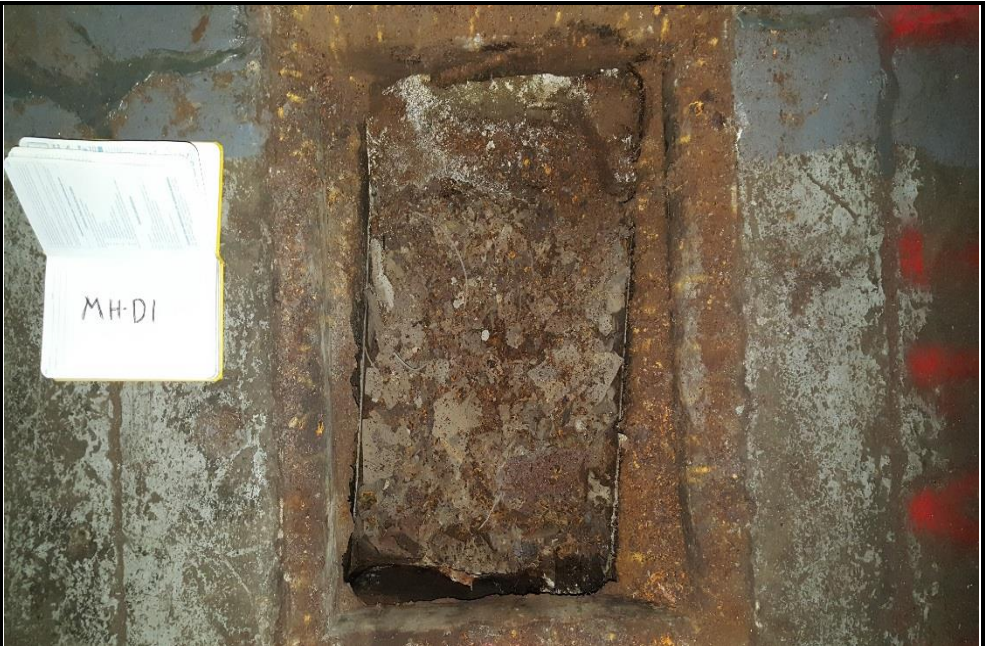
| Photo No. | Date | |
|---|---|---|
| 43 | 3/17/2017 | |

| Manhole (a,b) | Contents Description | Flow into Manhole Sides / Bottom (yes/no) | Flow into Manhole Through Pipes (yes/no) |
|---|---|---|---|
| MH-D1 | Approximately 8 inches of rusty metal fragments fused together at bottom of manhole. | No | No |

| Photo No. | Date | |
|---|---|---|
| MH-D1 before cleanout | | |

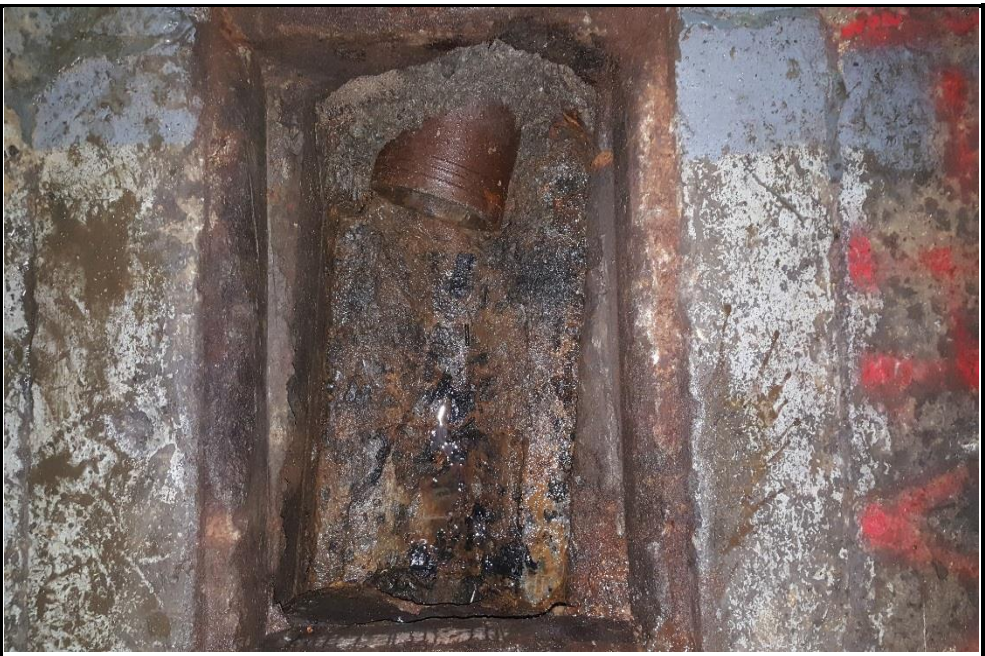
| Photo No. | Date | |
|---|---|---|
| 44 | 3/17/2017 | |

| Photo No. | Date | |
|---|---|---|
| MH-D1 after cleanout | | |
