Reference: As-Built Documentation
Sub-Slab Depression System
Tavern
219 Hoffman Street
Elmira, New York
NYSDEC Site No. 8-08-034

This letter documents the installation of a Sub-Slab Depression System (SSDS) at the above referenced site.

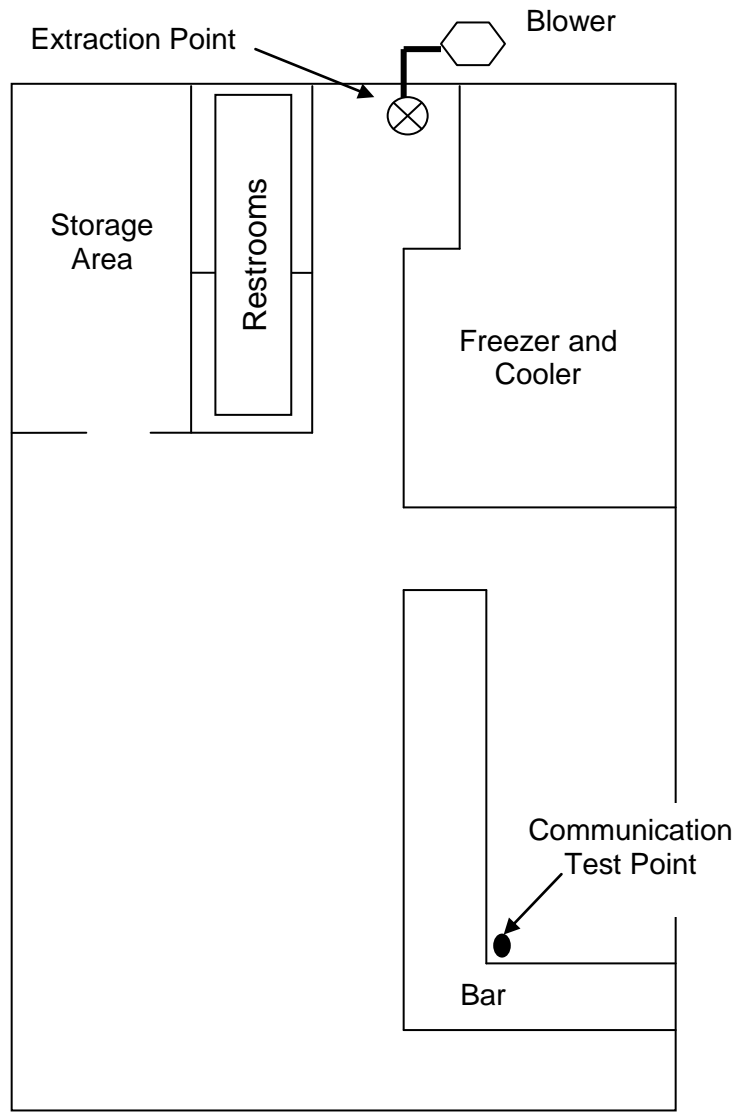
SITE SKETCH
SUB-SLAB DEPRESSION SYSTEM DIAGRAM
TAVERN
219 HOFFMAN ST., ELMIRA, NEW YORK
NYSDEC SITE NO. 8-08-034

A 4.25-inch hole was cored through the concrete floor at the middle of the rear wall near the back door (See attached Drawing No. 1). The location of the floor penetration was selected to minimize interference with business operation and to allow a negative pressure to be induced beneath the floor slab. To increase the extraction point surface area, the sub-base material below the hole was excavated to 10-inches deep and 6-inches in diameter.

A communication test was conducted after the system was completed and operational. One, 1 ½-Inch diameter hole was drilled through the concrete floor near the front of the building (See Drawing No. 1) and fitted with a magnehelic gauge. A vacuum of .025-inches of water was detected at the vacuum test point indicating air movement under the concrete floor.

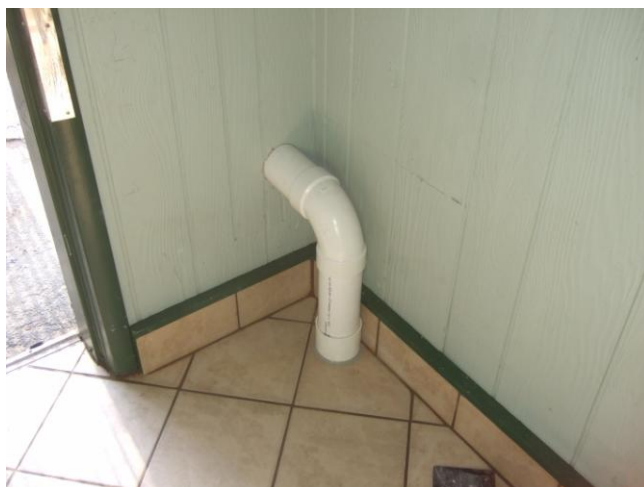
The ventilation pipe was installed into the drilled hole. The bottom of the pipe was located just below the concrete floor. System piping was constructed of 4-inch diameter schedule 40 PVC pipe. The pipe was sealed to the concrete floor (See Photo No. 1), and exits through the back wall of the building. On the outside of the building the piping was connected to a "RadonAway" blower, model number RP-265, which was mounted vertically (See Photo No. 2). The discharge pipe extends vertically from the blower to 24-inches above the eve. A rain cap was fitted at the top of the discharge pipe to prevent rain and snow from entering the system piping. The piping was pitched to allow condensation to drain back into the subsurface. A moisture bypass was installed around the blower to protect it from water condensing in the discharge stack.

Photo No. 1: Location of extraction point.

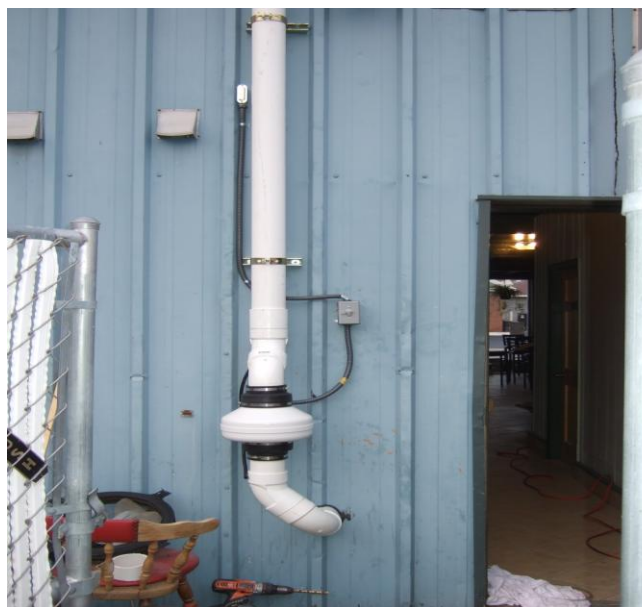
The mitigation system has an on-off switch, which is located outside near the blower.

Photo No. 2: Blower and on-off switch.

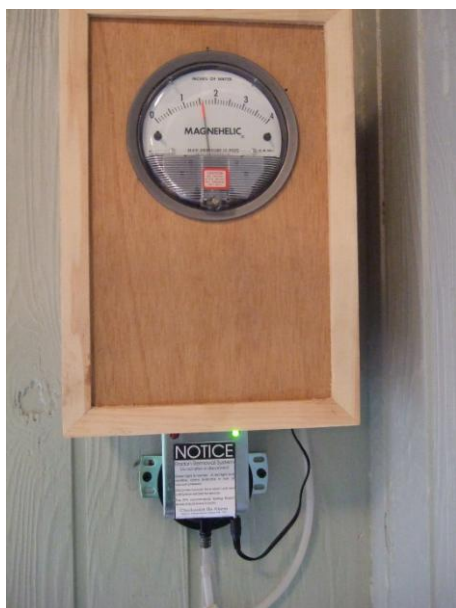
The system has visual and audio references to indicate proper operation (See Photo No. 3). The visual instruments are a magnehelic gauge and a negative pressure switch with a green LED indicating operation and red LED indicating failure. The magnehelic gauge reads 1.5-inches of water vacuum when operating properly. These system interlocks were tested and were operating properly at the time the system was installed.

Photo No. 3: Magnehelic gauge and vacuum switch with indicating LED.
