FORMER SPERRY REMINGTON SITE (NYSDEC SITE I.D. #808043)

REVISED INTERIM REMEDIAL MEASURE WORK PLAN

CITY OF ELMIRA, CHEMUNG COUNTY, NY

7 October 2019

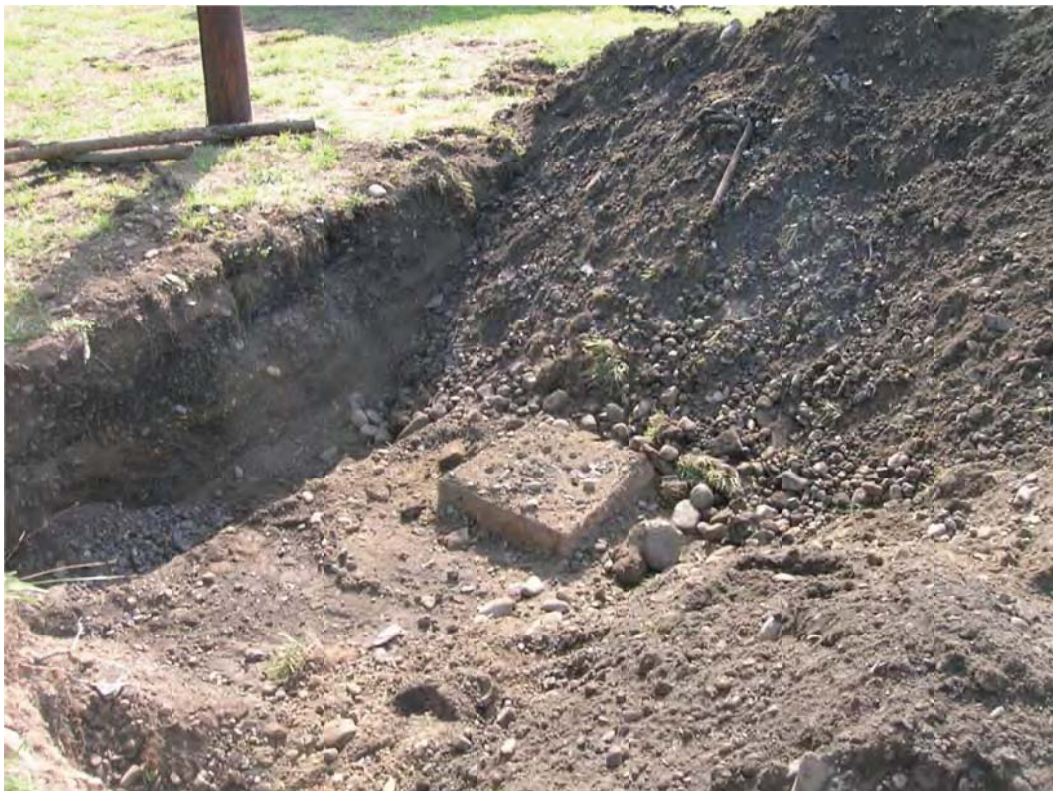
Picture #2- Oil Skimmer manhole uncovered

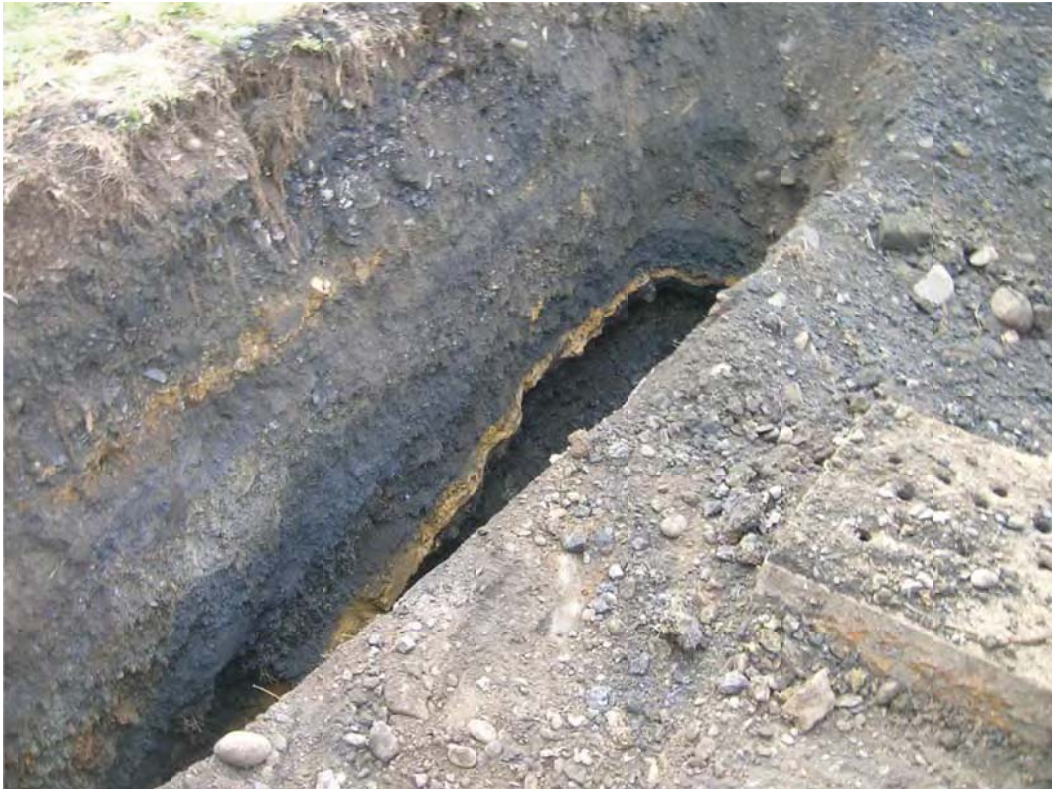
Picture #3- Test Pit #3, next to Oil Skimmer manhole

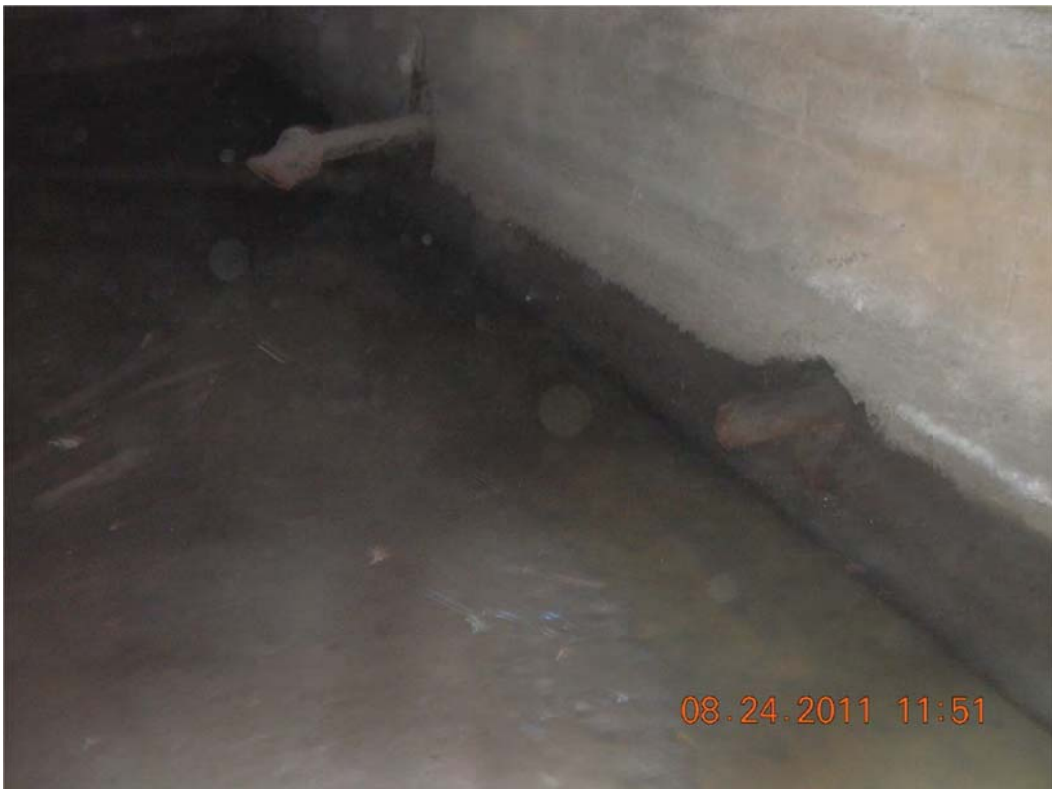
Picture #4- Inside Oil Skimmer from manhole looking NW at pipe penetrations

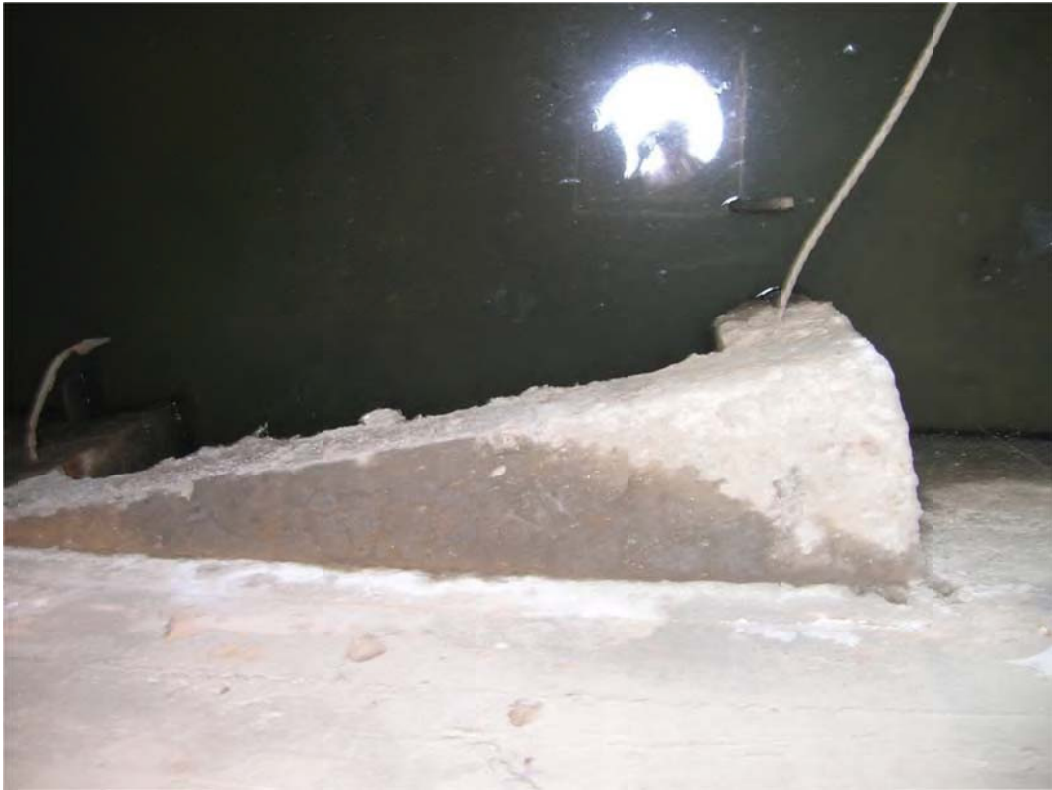
Picture #5- Looking down inside Oil Skimmer at ~5'wide influent culvert from east

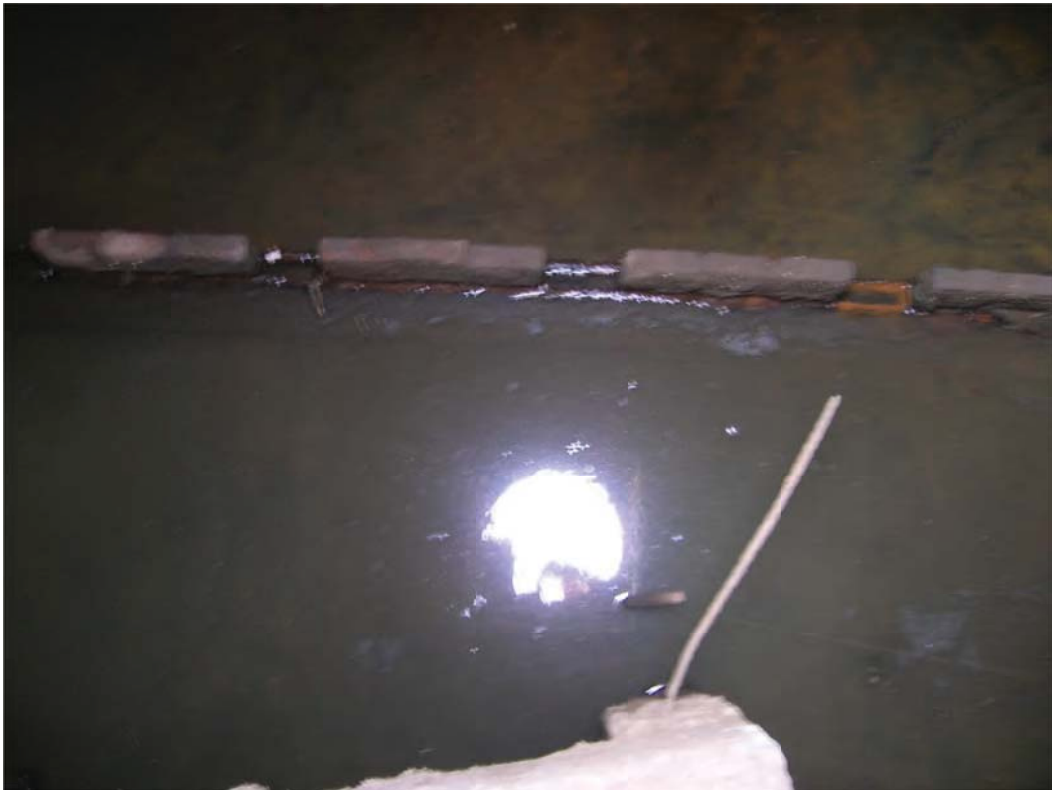
Picture #6- Looking down inside Oil Skimmer at internal baffles

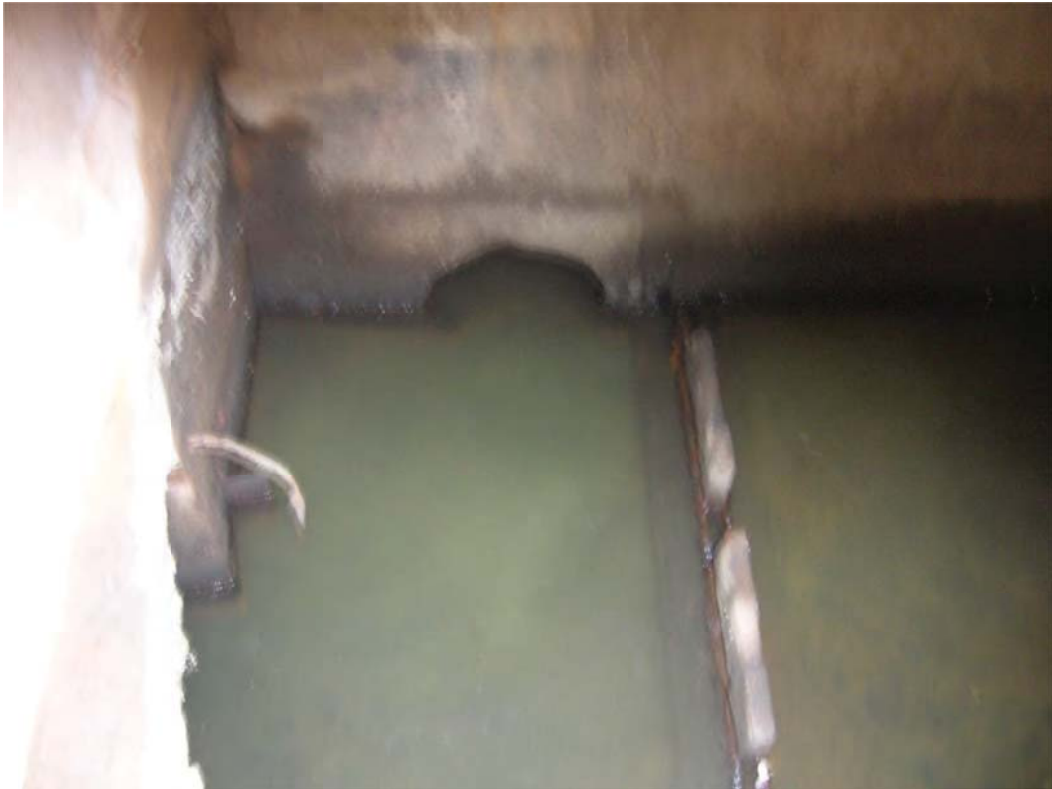
Picture #7- Inside Oil Skimmer looking south at pipe opening to south

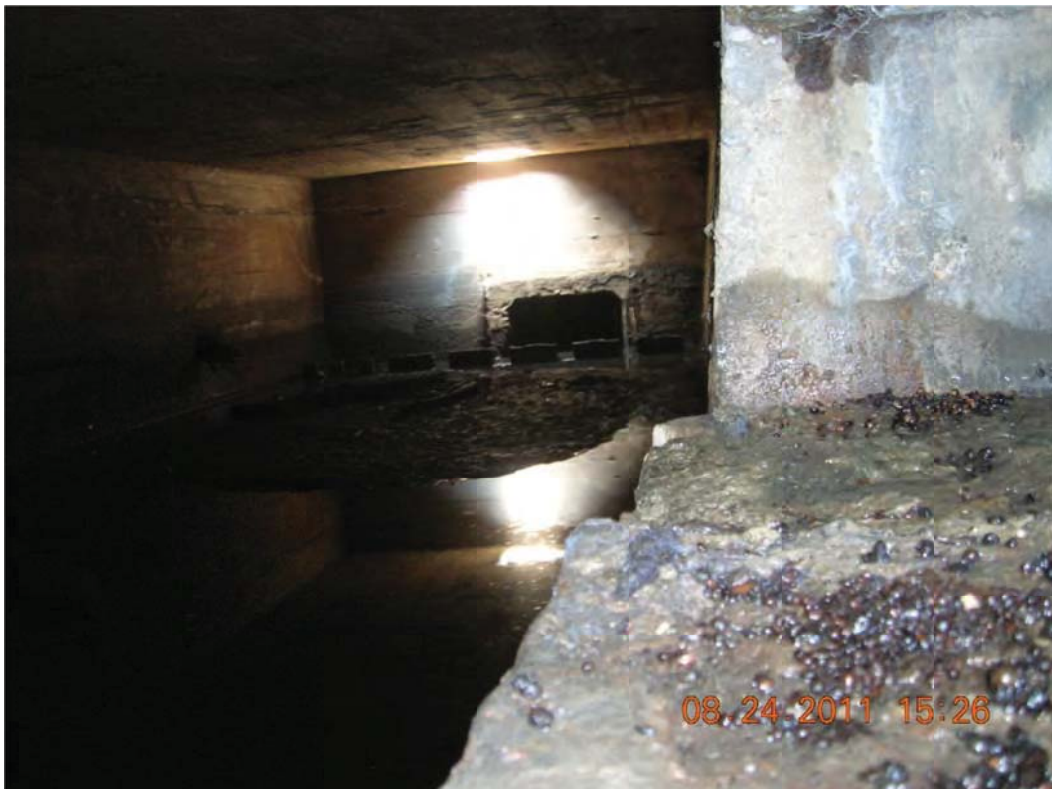
Picture #8- Inside Oil skimmer from Main Site Culvert looking east to ~5' wide culvert

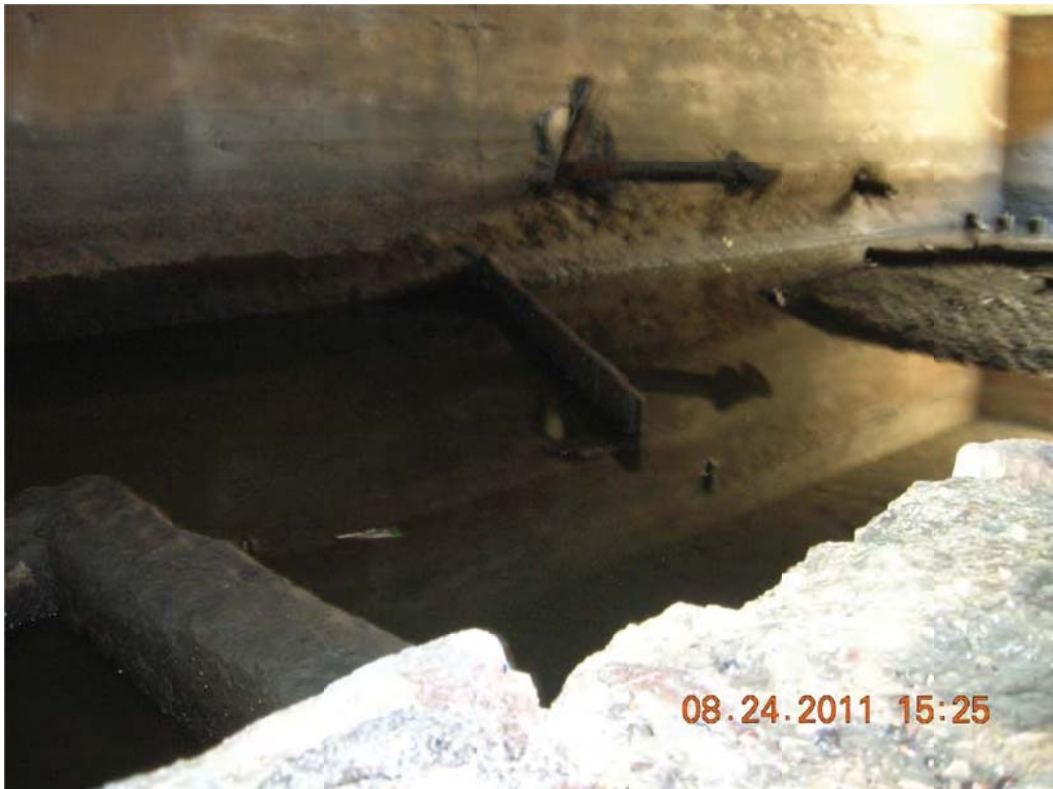
Picture #9- Inside Oil Skimmer looking NW at pipe penetrations and internal baffles

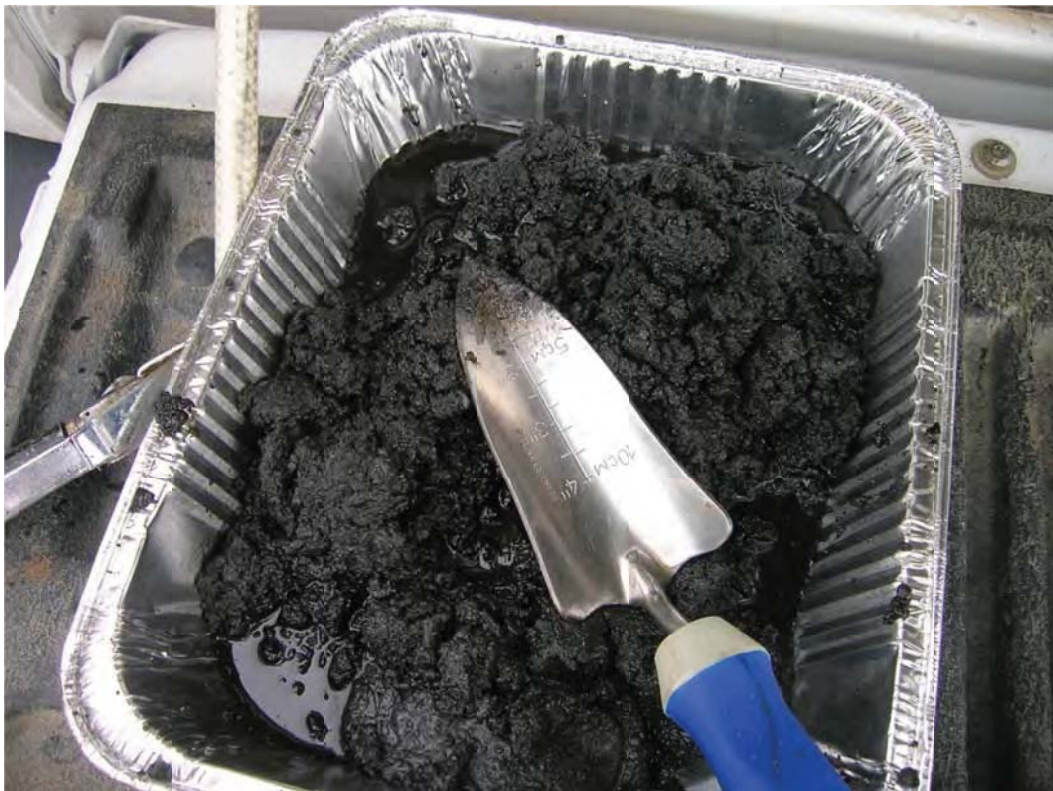
Picture #10- Sediment sample material from Oil Skimmer directly below manhole

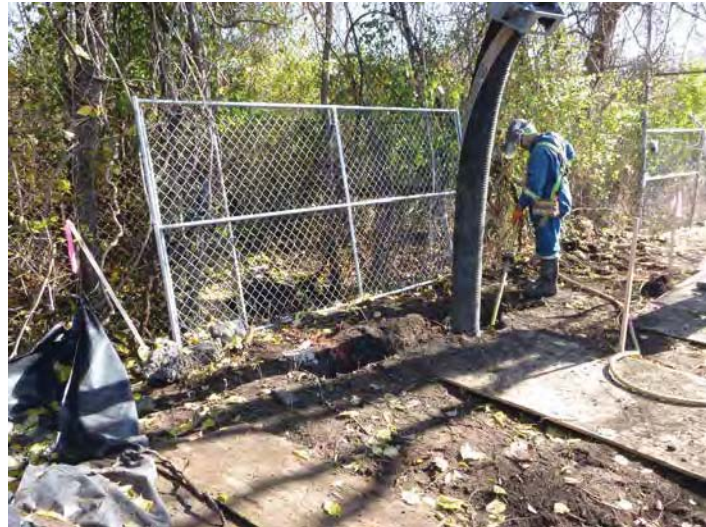
Comments: Test Pit-2.1 south of
CB-15, orange paint marks indicate
the edge of the 5 ft culvert.

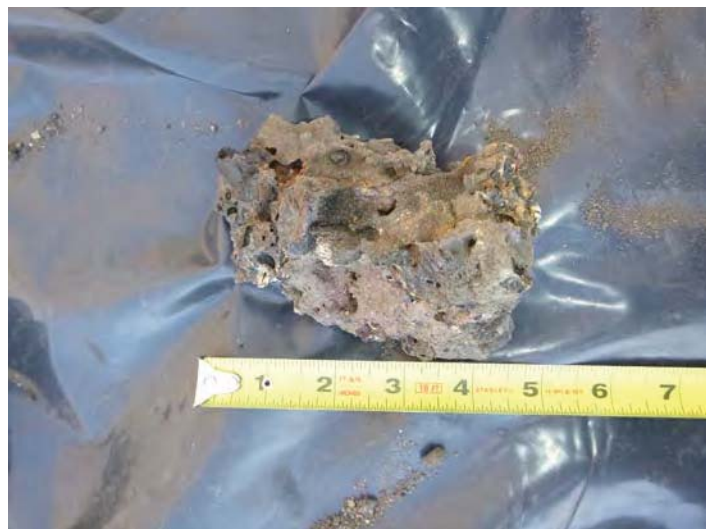
Photograph ID: 2

Comments: Slag material found in
TP-2.1 and in other test pits on site.

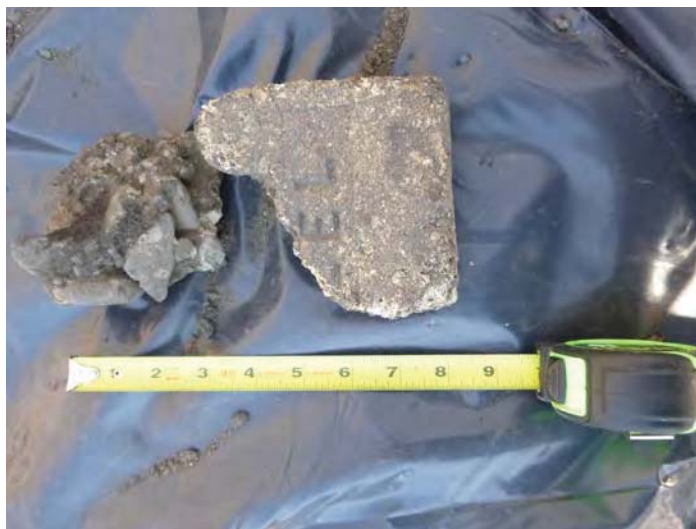
Comments: Sample fill fragments found in TP-2.1 and other soil spoils on site. On the right side is a yellow fragment of brick common in soils found in the Test pit areas 2, 3, and 4.

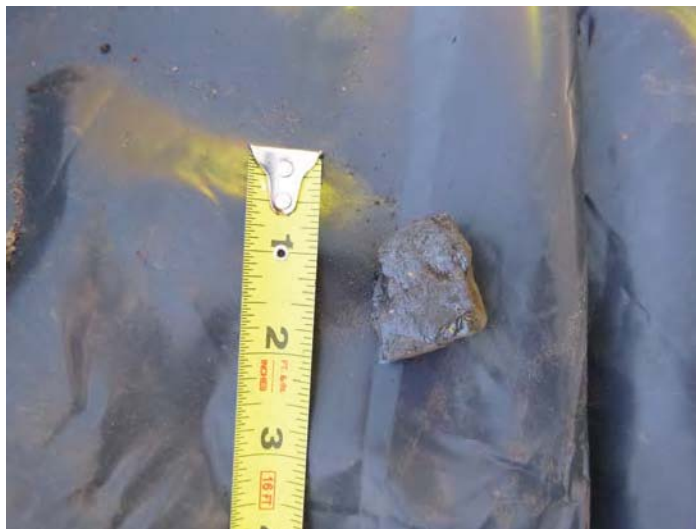
Photograph ID: 4

Comments: A fragment of coal collected from TP-2.1 soil spoils.

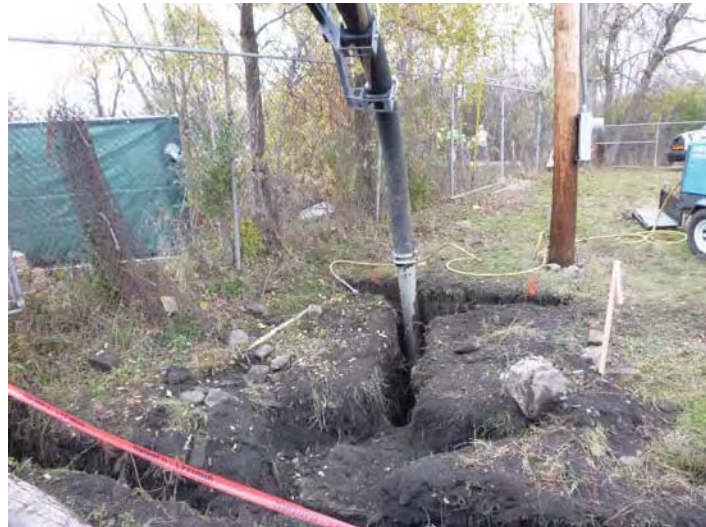
Comments: TP-2.2 investigated the northern and southern edges of OS2, the OS2 manhole, and the 5-ft box culvert headed northeast. Orange paint marks identify the edges of the 5-ft box culvert.

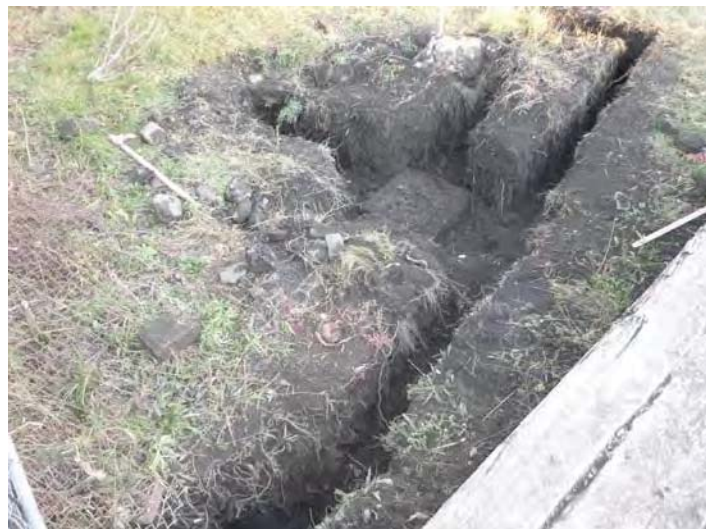
Photograph ID: 6

Comments: The OS-2-man hole was uncovered in TP-2.2 approximately 2 ft bgs.

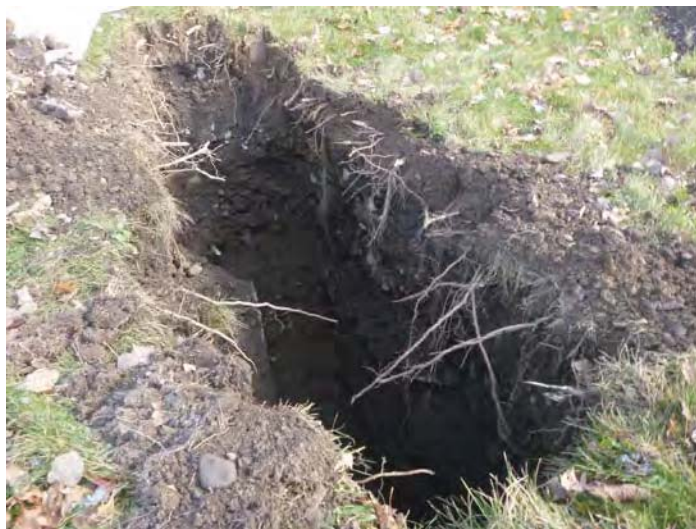
Comments: TP-3.1 reached dimensions of two (2) feet long, ten (10) feet wide, and eleven (11) feet deep. No structures were observed during TP-3.1 excavation.

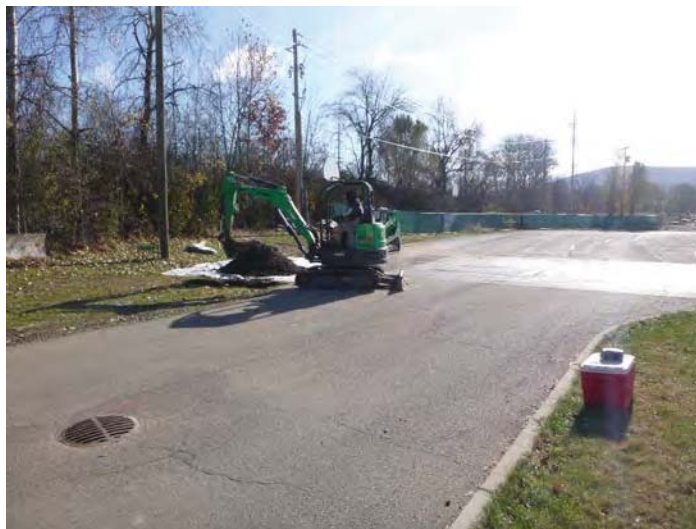
Comments: TP-3.2 was located closer to CB-6 (bottom left), at the location where the previous camera survey showed a sewer line take a sharp right turn. No structures were encountered.

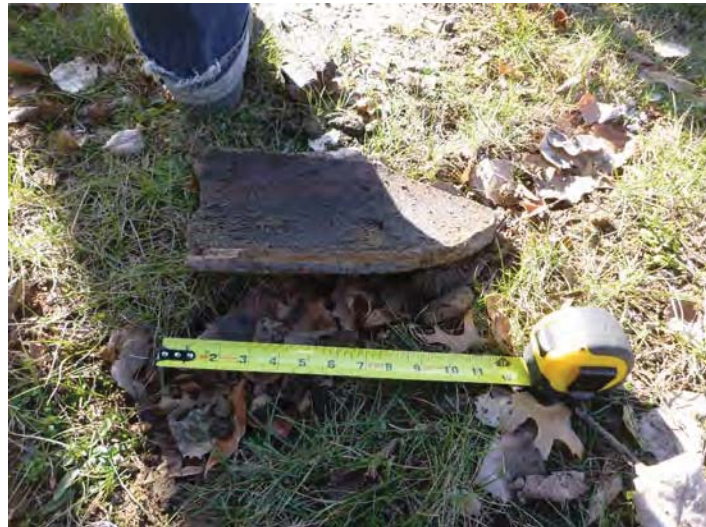
Comments: Clay pipe fragments
discovered in TP-3.2.

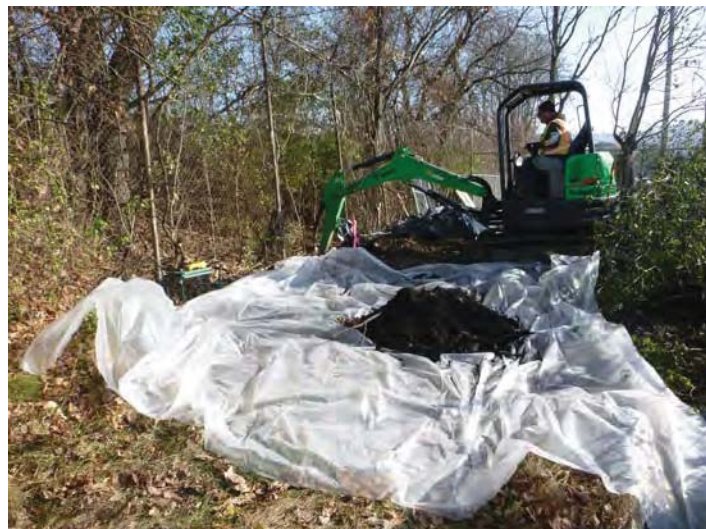
Photograph ID: 12

Comments: TP 4.1 was excavated
north-west of CB-15, perpendicular
to the EHS fence line.

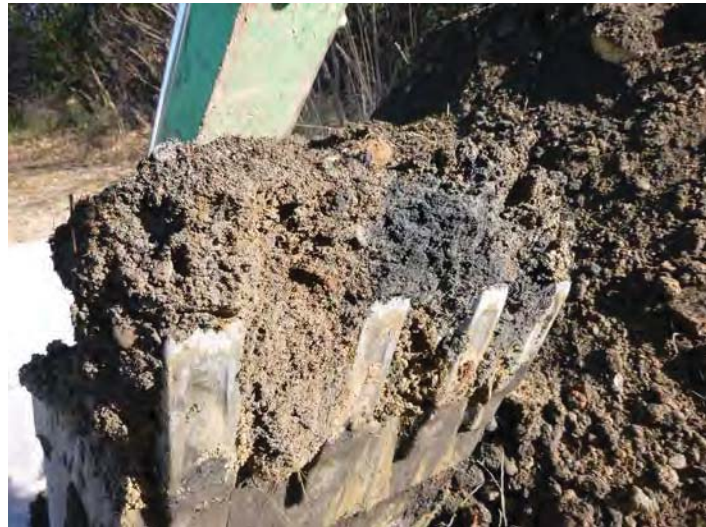
Comments: Soil spoils collected from approximately 11 ft bgs in TP-4.2. At 11 ft soil smelled like hydrocarbons and was visually stained.

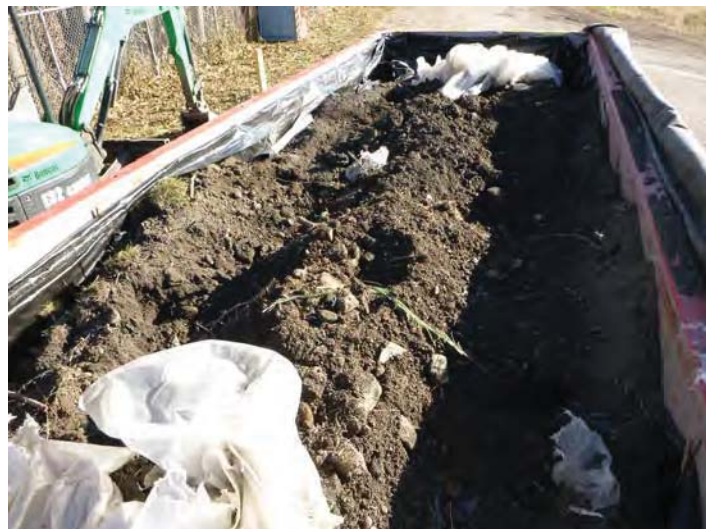
Photograph ID: 16

Comments: Excess soil spoils and plastic disposed of in the onsite Roll-off.

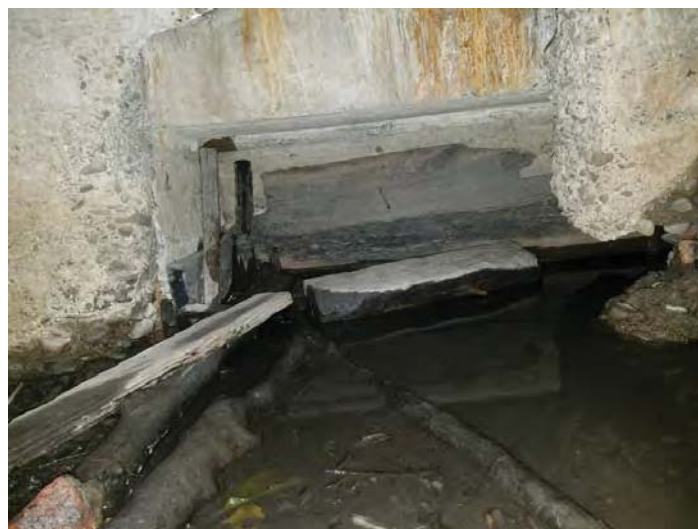
During the confined space entry, connections to CB-15 were visually inspected. A connection to the east toward the railroad tracks was observed to have been plugged with concrete. A connection to the northwest was constructed of clay tile and appeared to run parallel to the EHS property line. A connection to the southwest appeared to connect to OS2. A brick arch and 30-inch brick sewer line was observed (see photograph included in **Appendix F**) on the right side of this connection approximately ten (10) feet from CB-15.

Comments: CB-15's northeast connection, toward the railroad tracks, was observed to have been plugged with concrete.

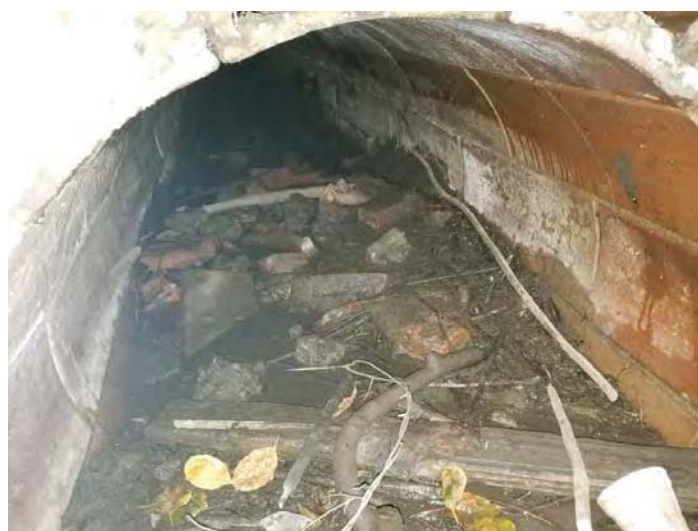
Photograph ID: 2

Comments: The connection leaving CB-15 headed northwest was constructed of clay tile and appeared to run parallel to the EHS property line.

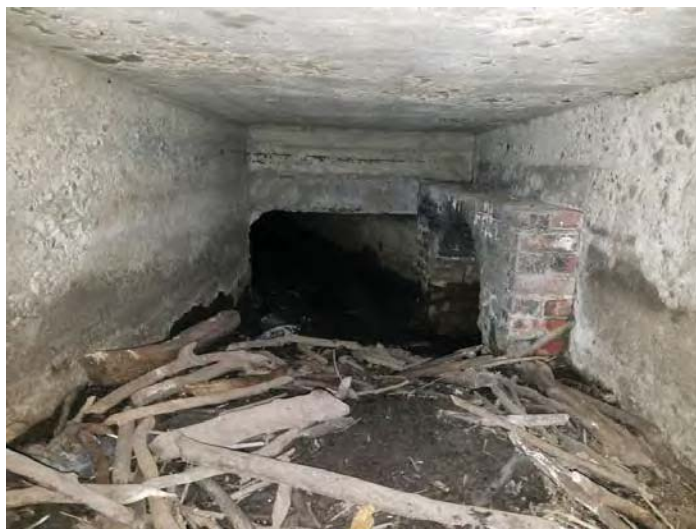
Comments: Looking from CB-15 toward OS-2, two connections were visible. The first connection to the southwest appeared to connect to OS2. A brick arch and 30-inch brick sewer line was observed on the right side of this connection approximately ten (10) feet southwest from CB-15.

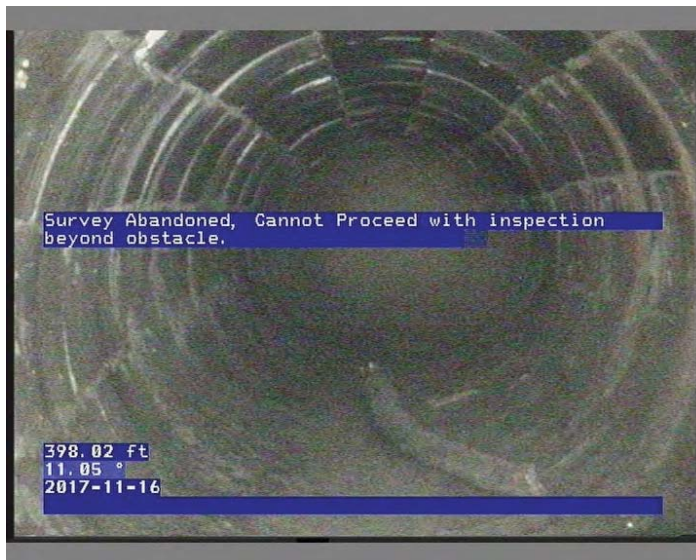
Photograph ID: 4

- A clay tile pipe connection connecting to CB-15 from the northwest extends approximately 395 feet. It was observed that this pipe had standing water and accumulated sludge in about ten 10 to twenty 20 percent (10-20%) of the pipe. Penetration by a two-inch PVC pipe and accumulated sand prevented further investigation at 395 ft. The structural compromise to the edge of the pipe at 395 ft is assumed to be piezometer MW-8 sand pack which obstructed further camera survey and flow. The location is consistent with a former

Comments: The thirty-six-inch (36-in) sewer line was surveyed from CB-15 to the northwest 398.02. The survey was abandoned because of blockage (sand).

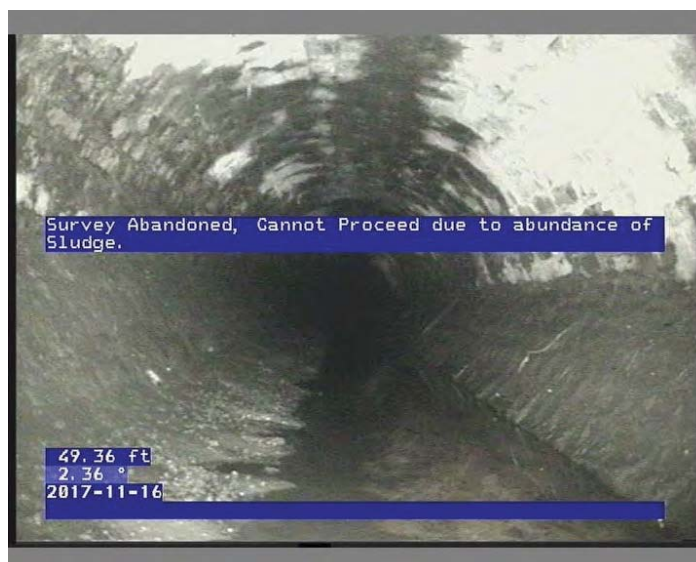
Comments: The 36-inch brick sewer line (10) feet southwest of CB-15 at a right angle to the 5-ft box culvert headed northwest. The survey was abandoned at 49.36 ft due to an abundance of sludge.

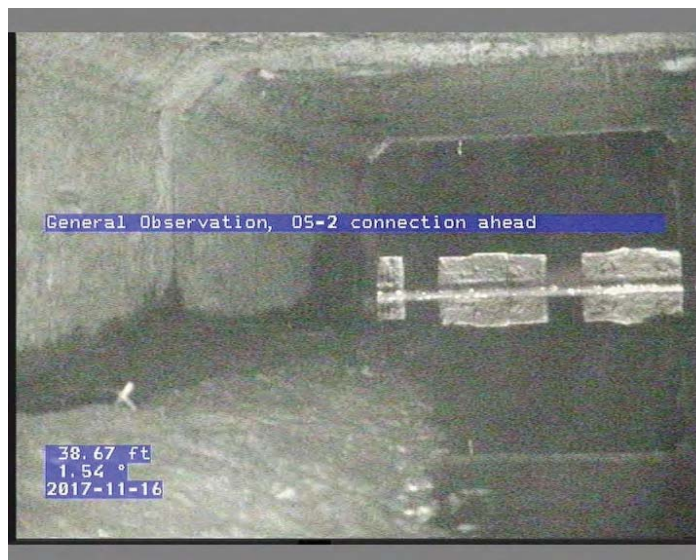
Photograph ID: 6

- The 5-ft box culvert connecting CB-15 to OS2 was surveyed to the southwest from CB-15. The culvert was wet with abundant fine-grained material, cobbles, wood, and standing water. The concrete culvert appears to be constructed of concrete segments. The survey extended a distance of approximately thirty-nine (39) ft until accumulated sludge prevented further progress and the survey was abandoned. The internal baffles at the northeast inlet to OS2 were observed. The connection to OS2 was confirmed by observation of an object that had been lowered through the OS2 manhole.

Comments: The 5-ft box culvert connecting CB-15 to OS2 was surveyed to the southwest from CB-15. The connection to OS2 was confirmed by a visual of the inlet weirs.

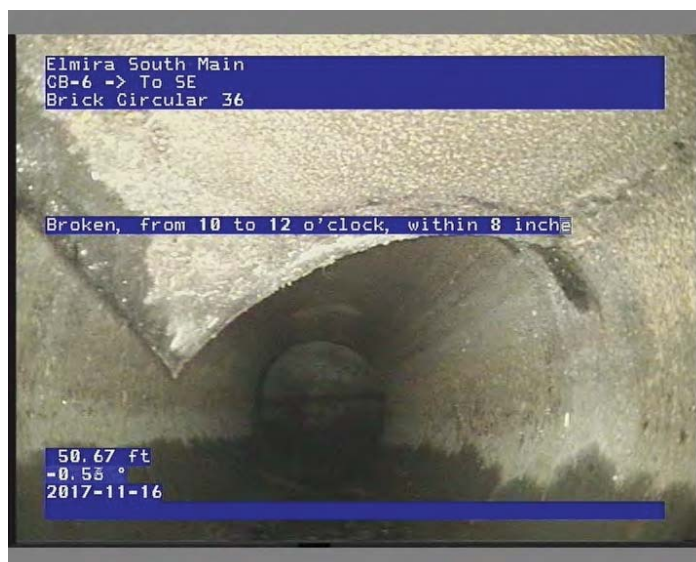
- The 36-inch circular brick pipe heading southeast from CB-6 was re-surveyed. The direction of stormwater flow is assumed to be to the southeast. Standing water, wood debris, rocks, and fine-grained material were observed in the line, making survey progress difficult. At a distance of approximately twenty-six (26) feet, two (2) connections are observed within a subsurface structure. The connection on the left (east) is sealed with brick and is not considered active. The connection to the right (west) continued straight. At a distance of approximately thirty-nine (39) feet from CB-6, the line transitions from brick to concrete and takes a right turn (between 30 and 80 degrees) to the southwest. At a linear distance of approximately forty-six (46) feet from CB-6, the line turns back to the left (east) at about the same angle as the previous turn. A structural fracture in the line was observed at 10-12 o'clock within eight (8) inches of the joint at a distance of approximately fifty (50) feet. At a distance of approximately sixty-seven (67) feet, the line again turns left (45 to 80 degrees) to the south and transitions to a clay tile built line. The survey ended at

Comments: The 36-inch circular brick pipe heading southeast from CB-6 was re-surveyed. A structural fracture in the line was observed at 10-12 o'clock within eight (8) inches of the joint at a distance of approximately fifty (50) feet.

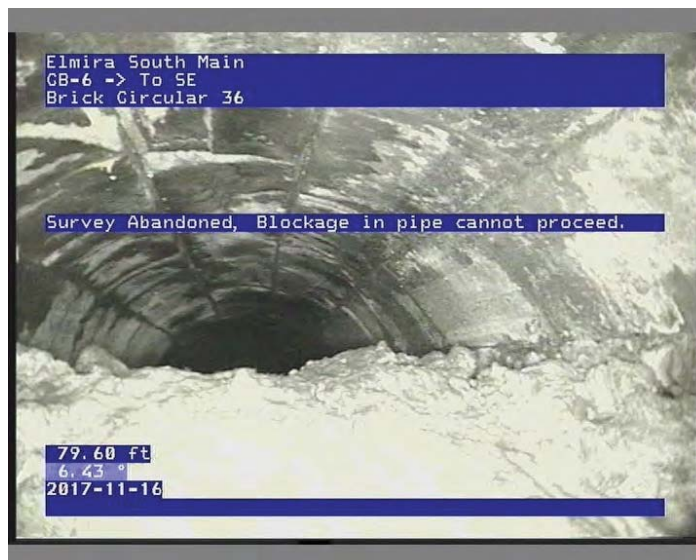
Photograph ID: 8

a linear distance of approximately eighty (80) feet at where approximately seventy-five 75 percent (75 %) of the connection was blocked by fine-grained material, wood, and rock. The survey of this connection was consistent with those from previous investigations while providing additional information regarding the condition of the western branch.

- A piping connection to the south southeast of CB-6 was observed to branch approximately twenty-six (26) feet downstream of CB-6 and observed to contain standing water and accumulated sludges. The eastern (left) branch is closed off with a brick bulkhead (i.e., a wall built to block flow). The western (right) branch continues for a linear distance of approximately sixty-four (64) feet until it becomes approximately seventy-five percent (75 %) blocked by heavy sludge. The line turns right at thirty-nine (39) feet with a transition to concrete then left at forty-six (46) feet and right at sixty-seven (67) feet with a transition to clay tile. The turns may be related to the bypass of an obsolete oil former oil skimmer, considered to be OS1, reported in a letter from Remington Rand to the Chemung County Health Department dated 15 August 1966. IRM PDI test pitting in the vicinity of the presumed location of OS1 confirmed its location in 2012. Observations made during test pitting along the exterior of that structure did not identify outlet pipes or demonstrate characteristics of non-native material and were, therefore, not sampled. No active connections from former OS1 to OS2 or the Site Culvert were identified. Former OS1 has been determined not to be a potential active source of COCs to OS2 or the Site Culvert. No evidence of pipe collapse or structural compromise. Structurally sound pipe continues to the southeast beyond the sludge obstruction. .

Comments: The survey ended at a linear distance of approximately eighty (80) feet at where approximately seventy-five (75 %) of the connection was blocked by fine-grained material, wood, and rock.

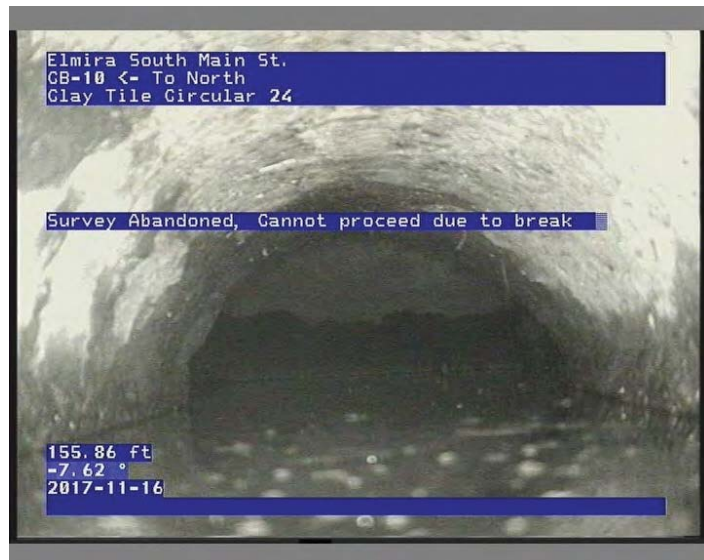
Comments: The connection heading northeast from CB-10 was re-surveyed in attempt to survey the entire line. An opening to another structure was observed at a distance of approximately one hundred fifty-seven (157) feet and the survey was ended. Based on distance and location, that structure is considered to be OS2.
