Subject: 2021 Annual Site Inspection Report

RG&E Pavilion Former MGP Site

NYSDEC Site No. 819024

SITE-WIDE INSPECTION FORM

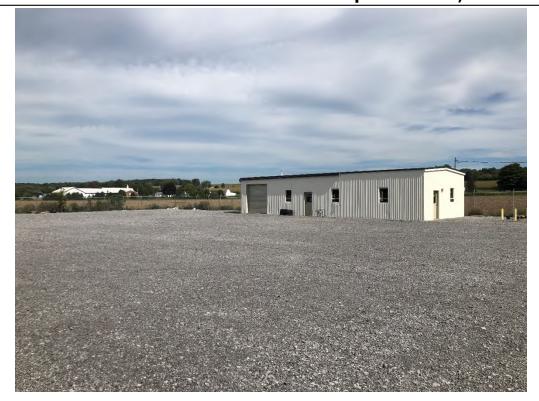
Training Building and the Northeastern Portion of the Site - Viewing Northeast

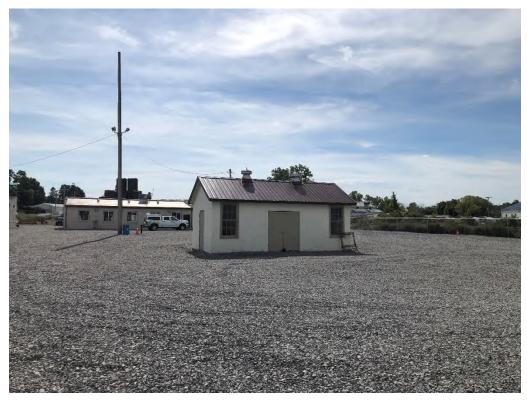
Gas Regulator Building and the Central Portion of the Site - Viewing South

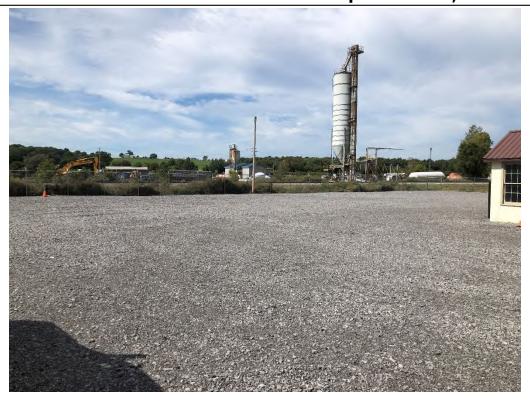
Northwestern Portion of the Site - Viewing Northwest

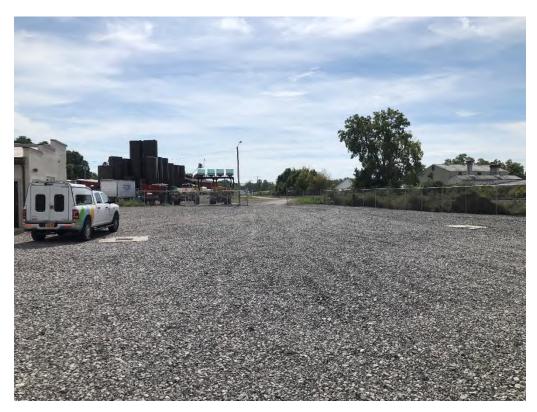
Western End of Office Building and Southwestern Portion of the Site - Viewing South

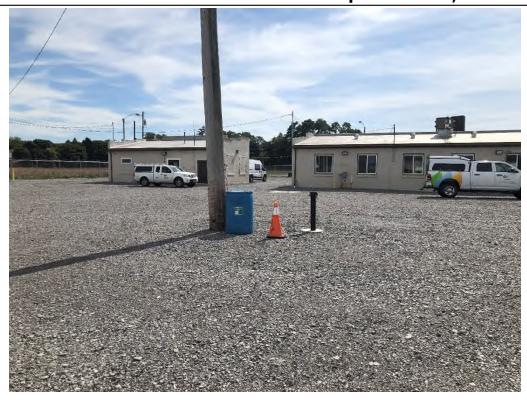
Locker Room Building, Eastern End of Office Building, and Plastic Drums Containing Purged Groundwater - Viewing Southeast

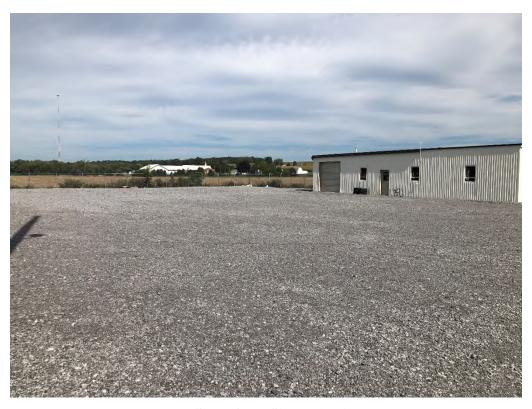
Northeastern Side of the Site - Viewing Northeast

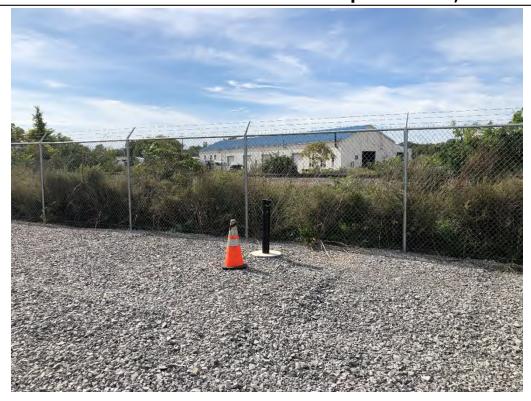
Typical "Stick Up" Groundwater Monitoring Well at the Site

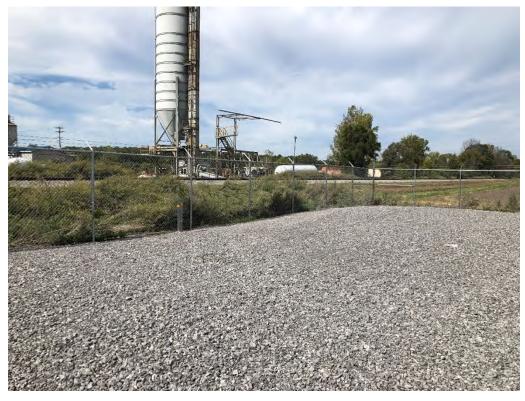
Northwestern Portion of the Site - Viewing North

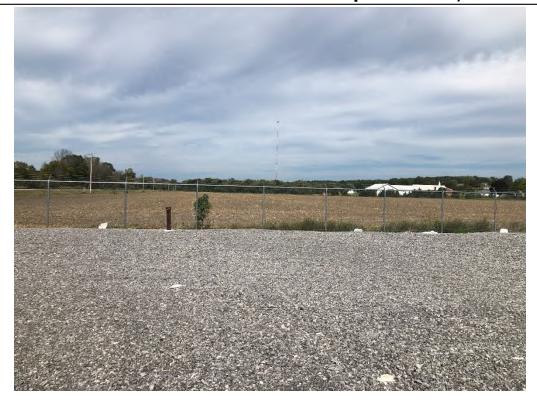
Northern Portion of the Site - Viewing North

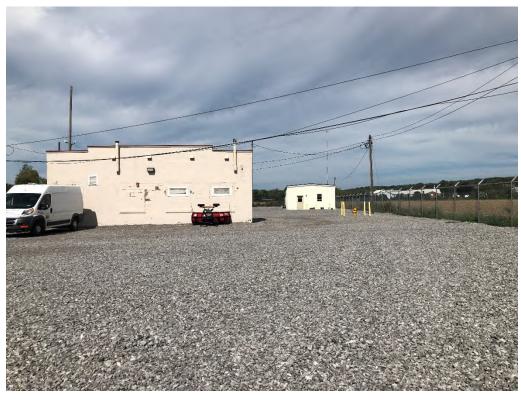
Southeastern Portion of the Site – Viewing Northeast
