FIELD INVESTIGATION TEAM ACTIVITIES AT UNCONTROLLED HAZARDOUS SUBSTANCES FACILITIES — ZONE I

**PRELIMINARY ASSESSMENT
NYSEG - DANVILLE GAS PLANT SITE
DANVILLE, NEW YORK**

02-8710-106-PA
Rev. No. 0

Date of Site Visit: Off-Site Reconnaissance conducted November 3, 1987

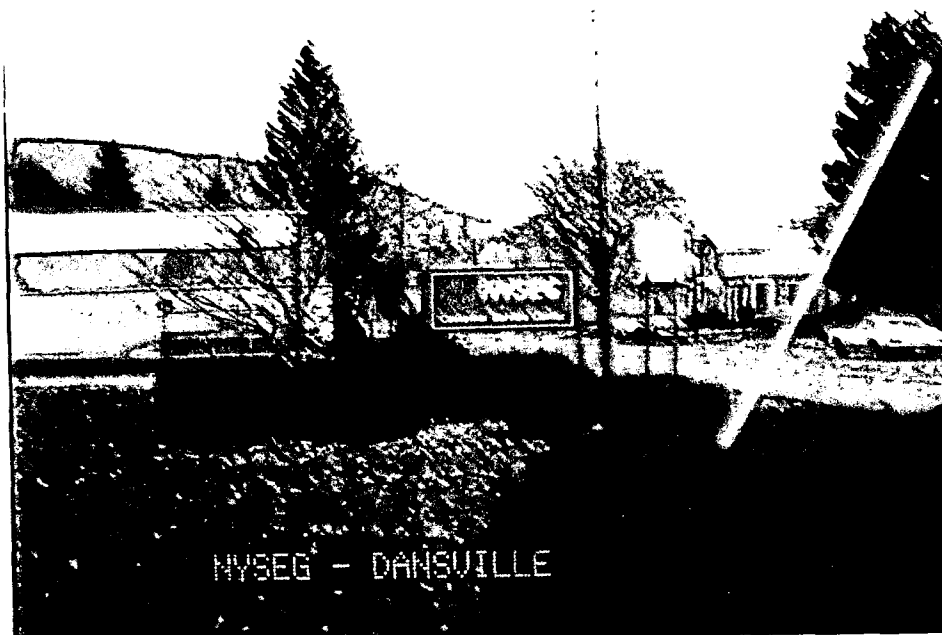
P-5

November 3, 1987
View looking east from access road.

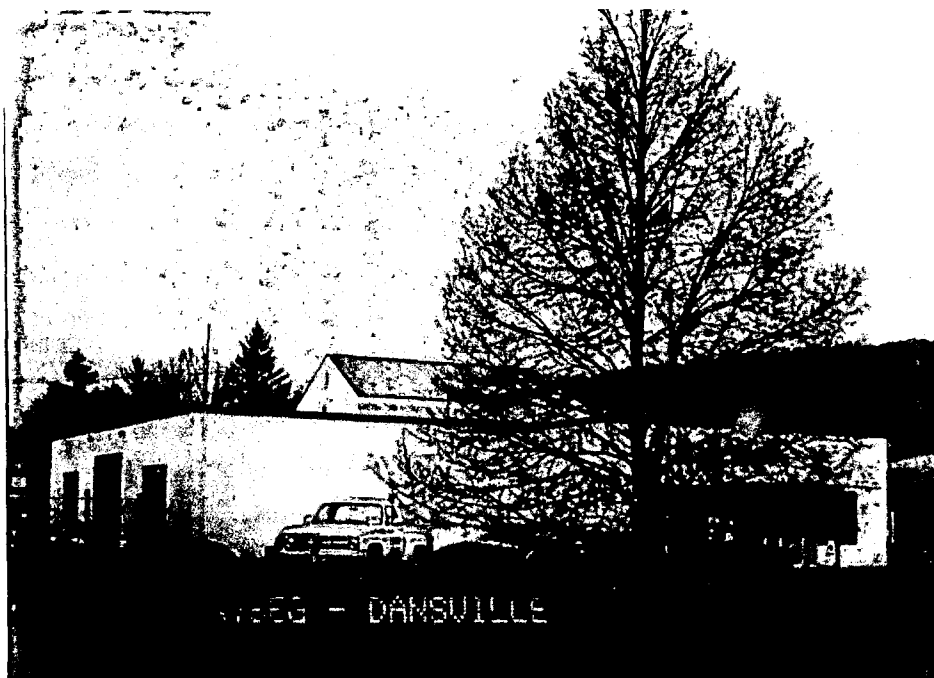
P-6

November 3, 1987
View looking north on access road-customer service center.

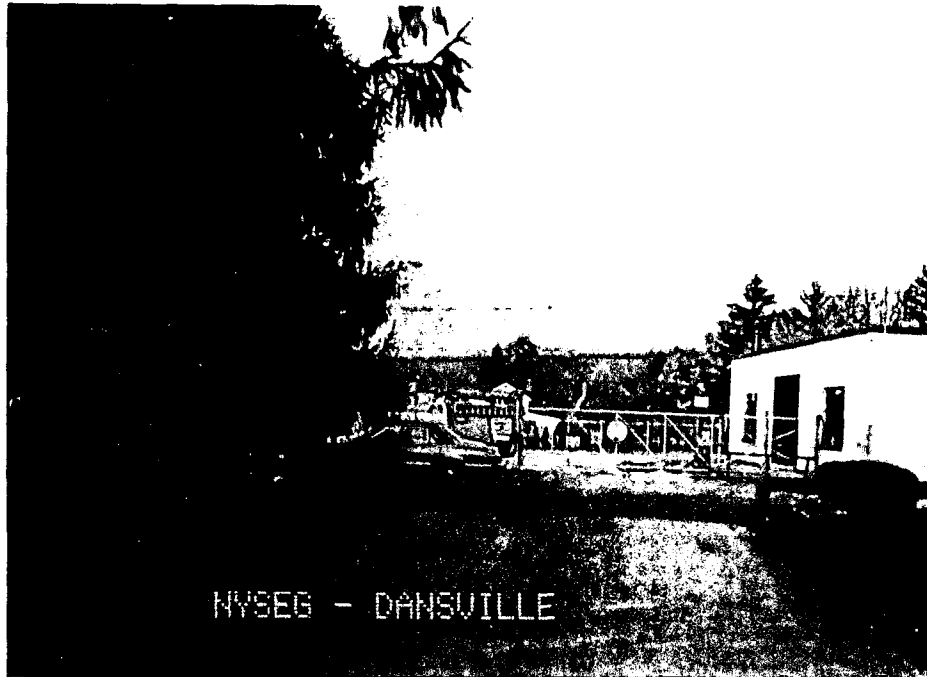
P-7

View looking north on access road into the site.
