Re: Former Jarl Extrusions Site Periodic Progress Report Site No. 828-005 Pittsford, NY File: 784/29706 #2

Periodic Progress Report Former Jarl Extrusions Site Site No. 828-005 Pittsford, NY File: 784/29706 #2

Asphalt Cover Inspection Photo Log

Asphalt Cover Inspection Photo Log - Repairs

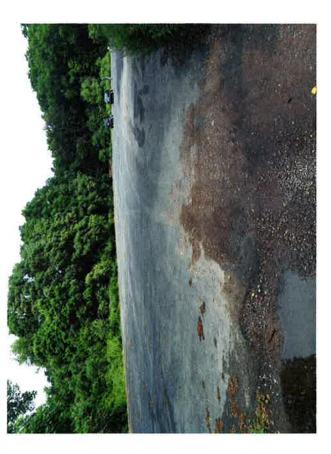
Photo 1- West side of property looking North.

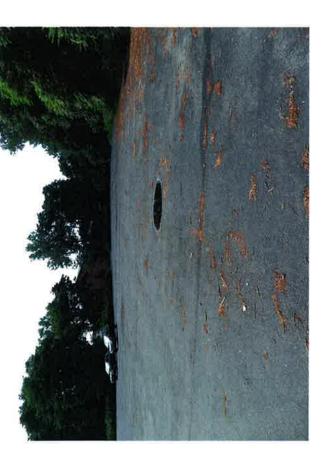
Photo 2 – West Side of property looking South

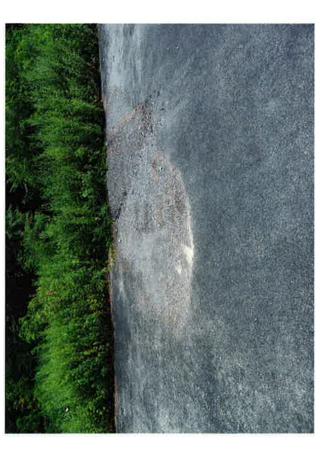
were no signs of erosion around the edges of the cover. Asphalt was disturbed in two approximately 8ft by 8 ft areas which had been backfilled with crushed stone (refer to photos #2 and #3). In addition, several minor joint cracks in the pavement seal were noted (refer to photo #8). Drainage appeared normal with no signs of erosion. There were several piles of yard type waste deposited on the sides of the asphalt cover (refer to photos #s 6 and 7).

Photo 2 – Repair required along Northern edge of property (approx 8ft by 8ft).

No evidence of vehicles being parked or stored on the asphalt cover was noted. Photos documenting site conditions and a site diagram can be found in the attached photo log. Repairs of this area have been scheduled to be completed during October 2011.

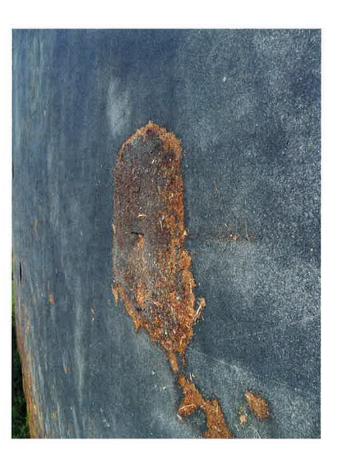
Photo 3 - Repair required on North-West side of property (approx. 8ft by 8ft).

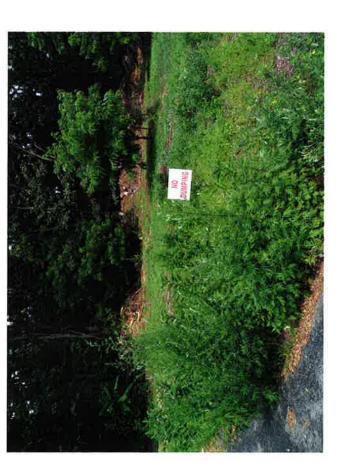
Photo 5 – Owner fill along Northwest edge of property.

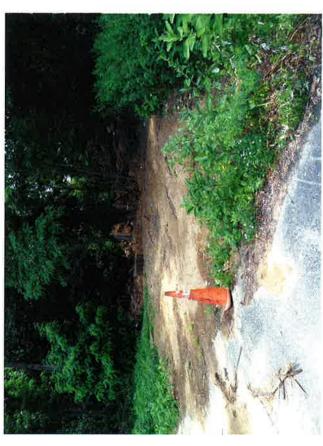
Photo 6 – Owner fill in Northwest corner of property.

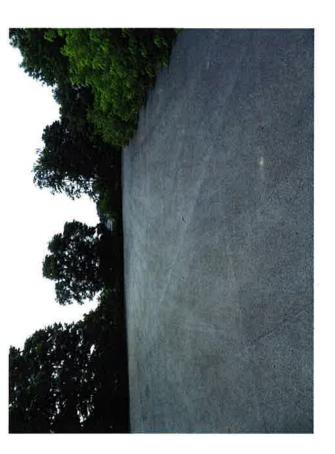
Photo 7- Looking West to East along property

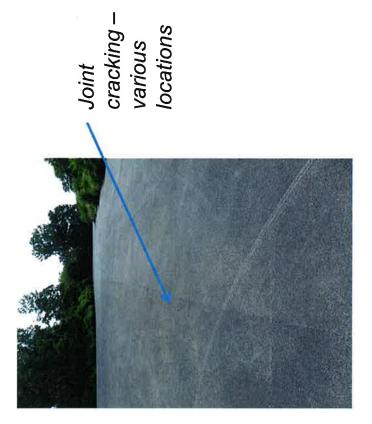
Photo 8 – Looking West to East along property

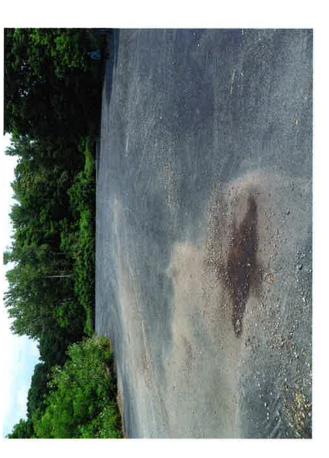
Photo 9- East side of property looking North

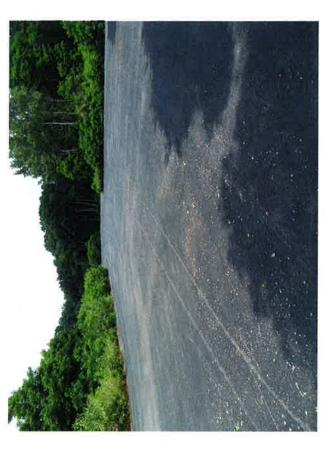
Photo 10 – East side of property looking Northwest

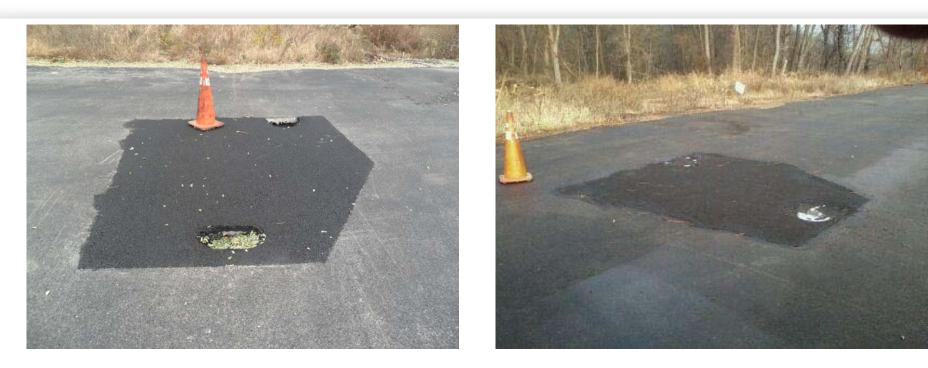
Patch repair – settlement occurred under patch repair – Settlement repaired again in Dec 2011 – see photo to right.

Patch repair – Filled with gravel and cold patch asphalt during week of December 9, 2011.
