Re: Former Jarl Extrusions Site 2020 Periodic Progress Report Site No. 828-005 Pittsford, NY

> Periodic Progress Report Former Jarl Extrusions Site Site No. 828-005 Pittsford, NY File: 784/29706 #2

Asphalt Cover Inspection Photo Log

FORMER JARL EXTRUSIONS SITE

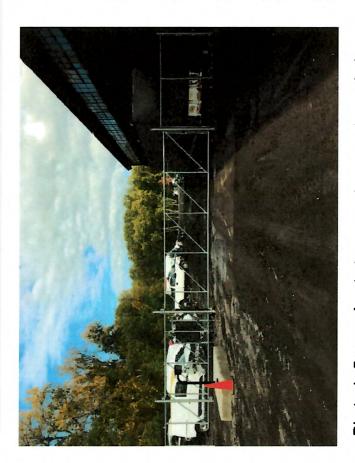
Photo 1: Secured gate to prevent access to asphalt cover

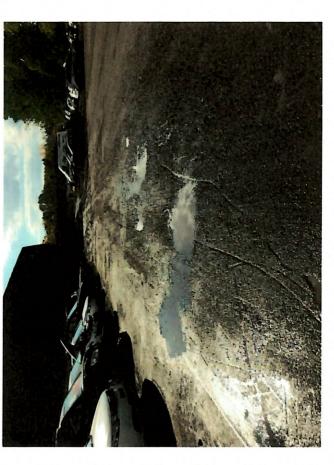
Photo 2: Surficial cracking, pooling of water on asphalt cover

III. Conclusions and Recommendations – The asphalt cap appears to be performing as intended. Recommendations are to repair surficial cracks and areas of settling and to continue inspections on a biannual basis.

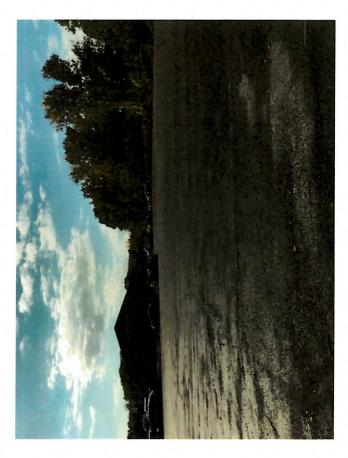
Photo 3: Surficial cracking throughout asphalt cap

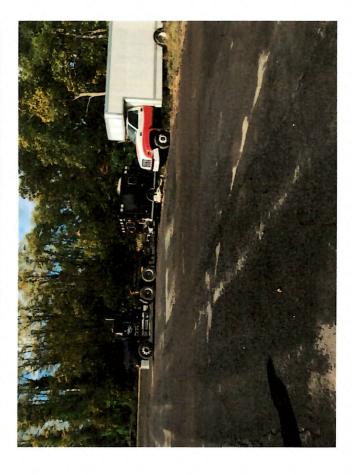
Photo 4: Equipment stored on and off of asphalt cover. Location of previous cap repair (box on ground in front of box truck).

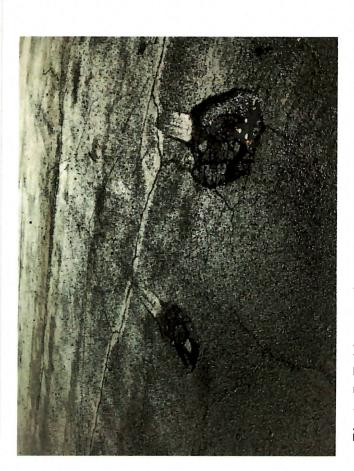
Photo 5: Evidence of parking heavy load on asphalt cap

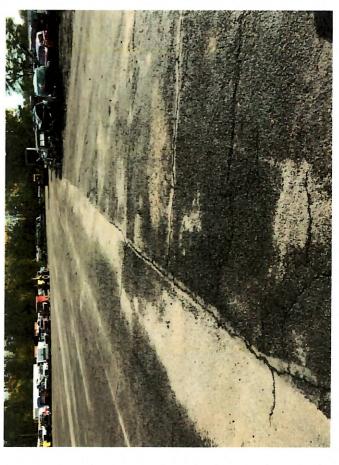
Photo 6: Surficial cracking observed along paving pass lines

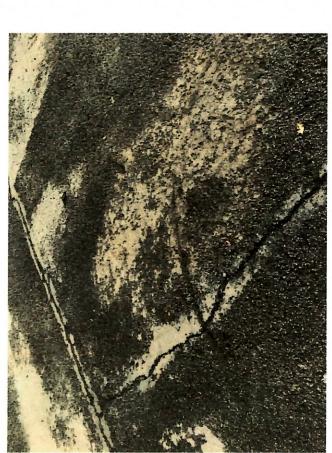
Photo 7: Close up of surficial cracking

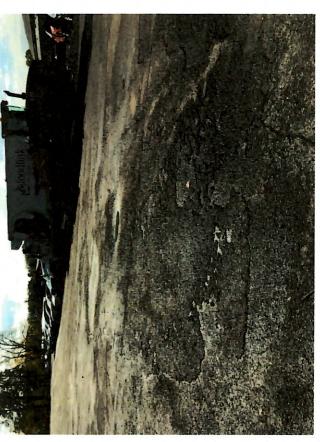
Photo 8: Cracking and spalling of surface. Deep settling observed in two areas.

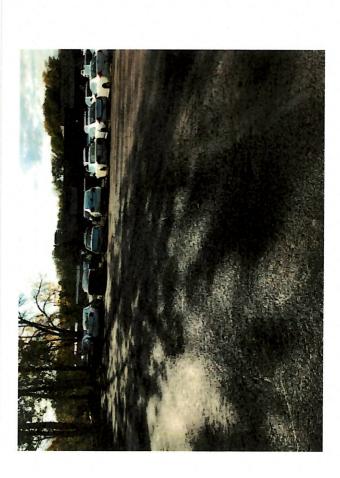
Photo 9: Southeast corner of cap in good condition

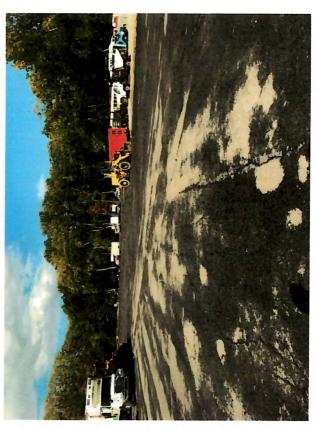
Photo 10: Some surficial cracking observed along pass lines
