CITY OF ROCHESTER
FORMER EMERSON STREET LANDFILL
SOIL VAPOR INTRUSION REPORT
Data Review, Site Screening, &
Prioritization Phase

FORMER EMERSON STREET
LANDFILL
ROCHESTER, NEW YORK

FORMER EMERSON STREET
LANDFILL SOIL VAPOR
INTRUSION INVESTIGATION

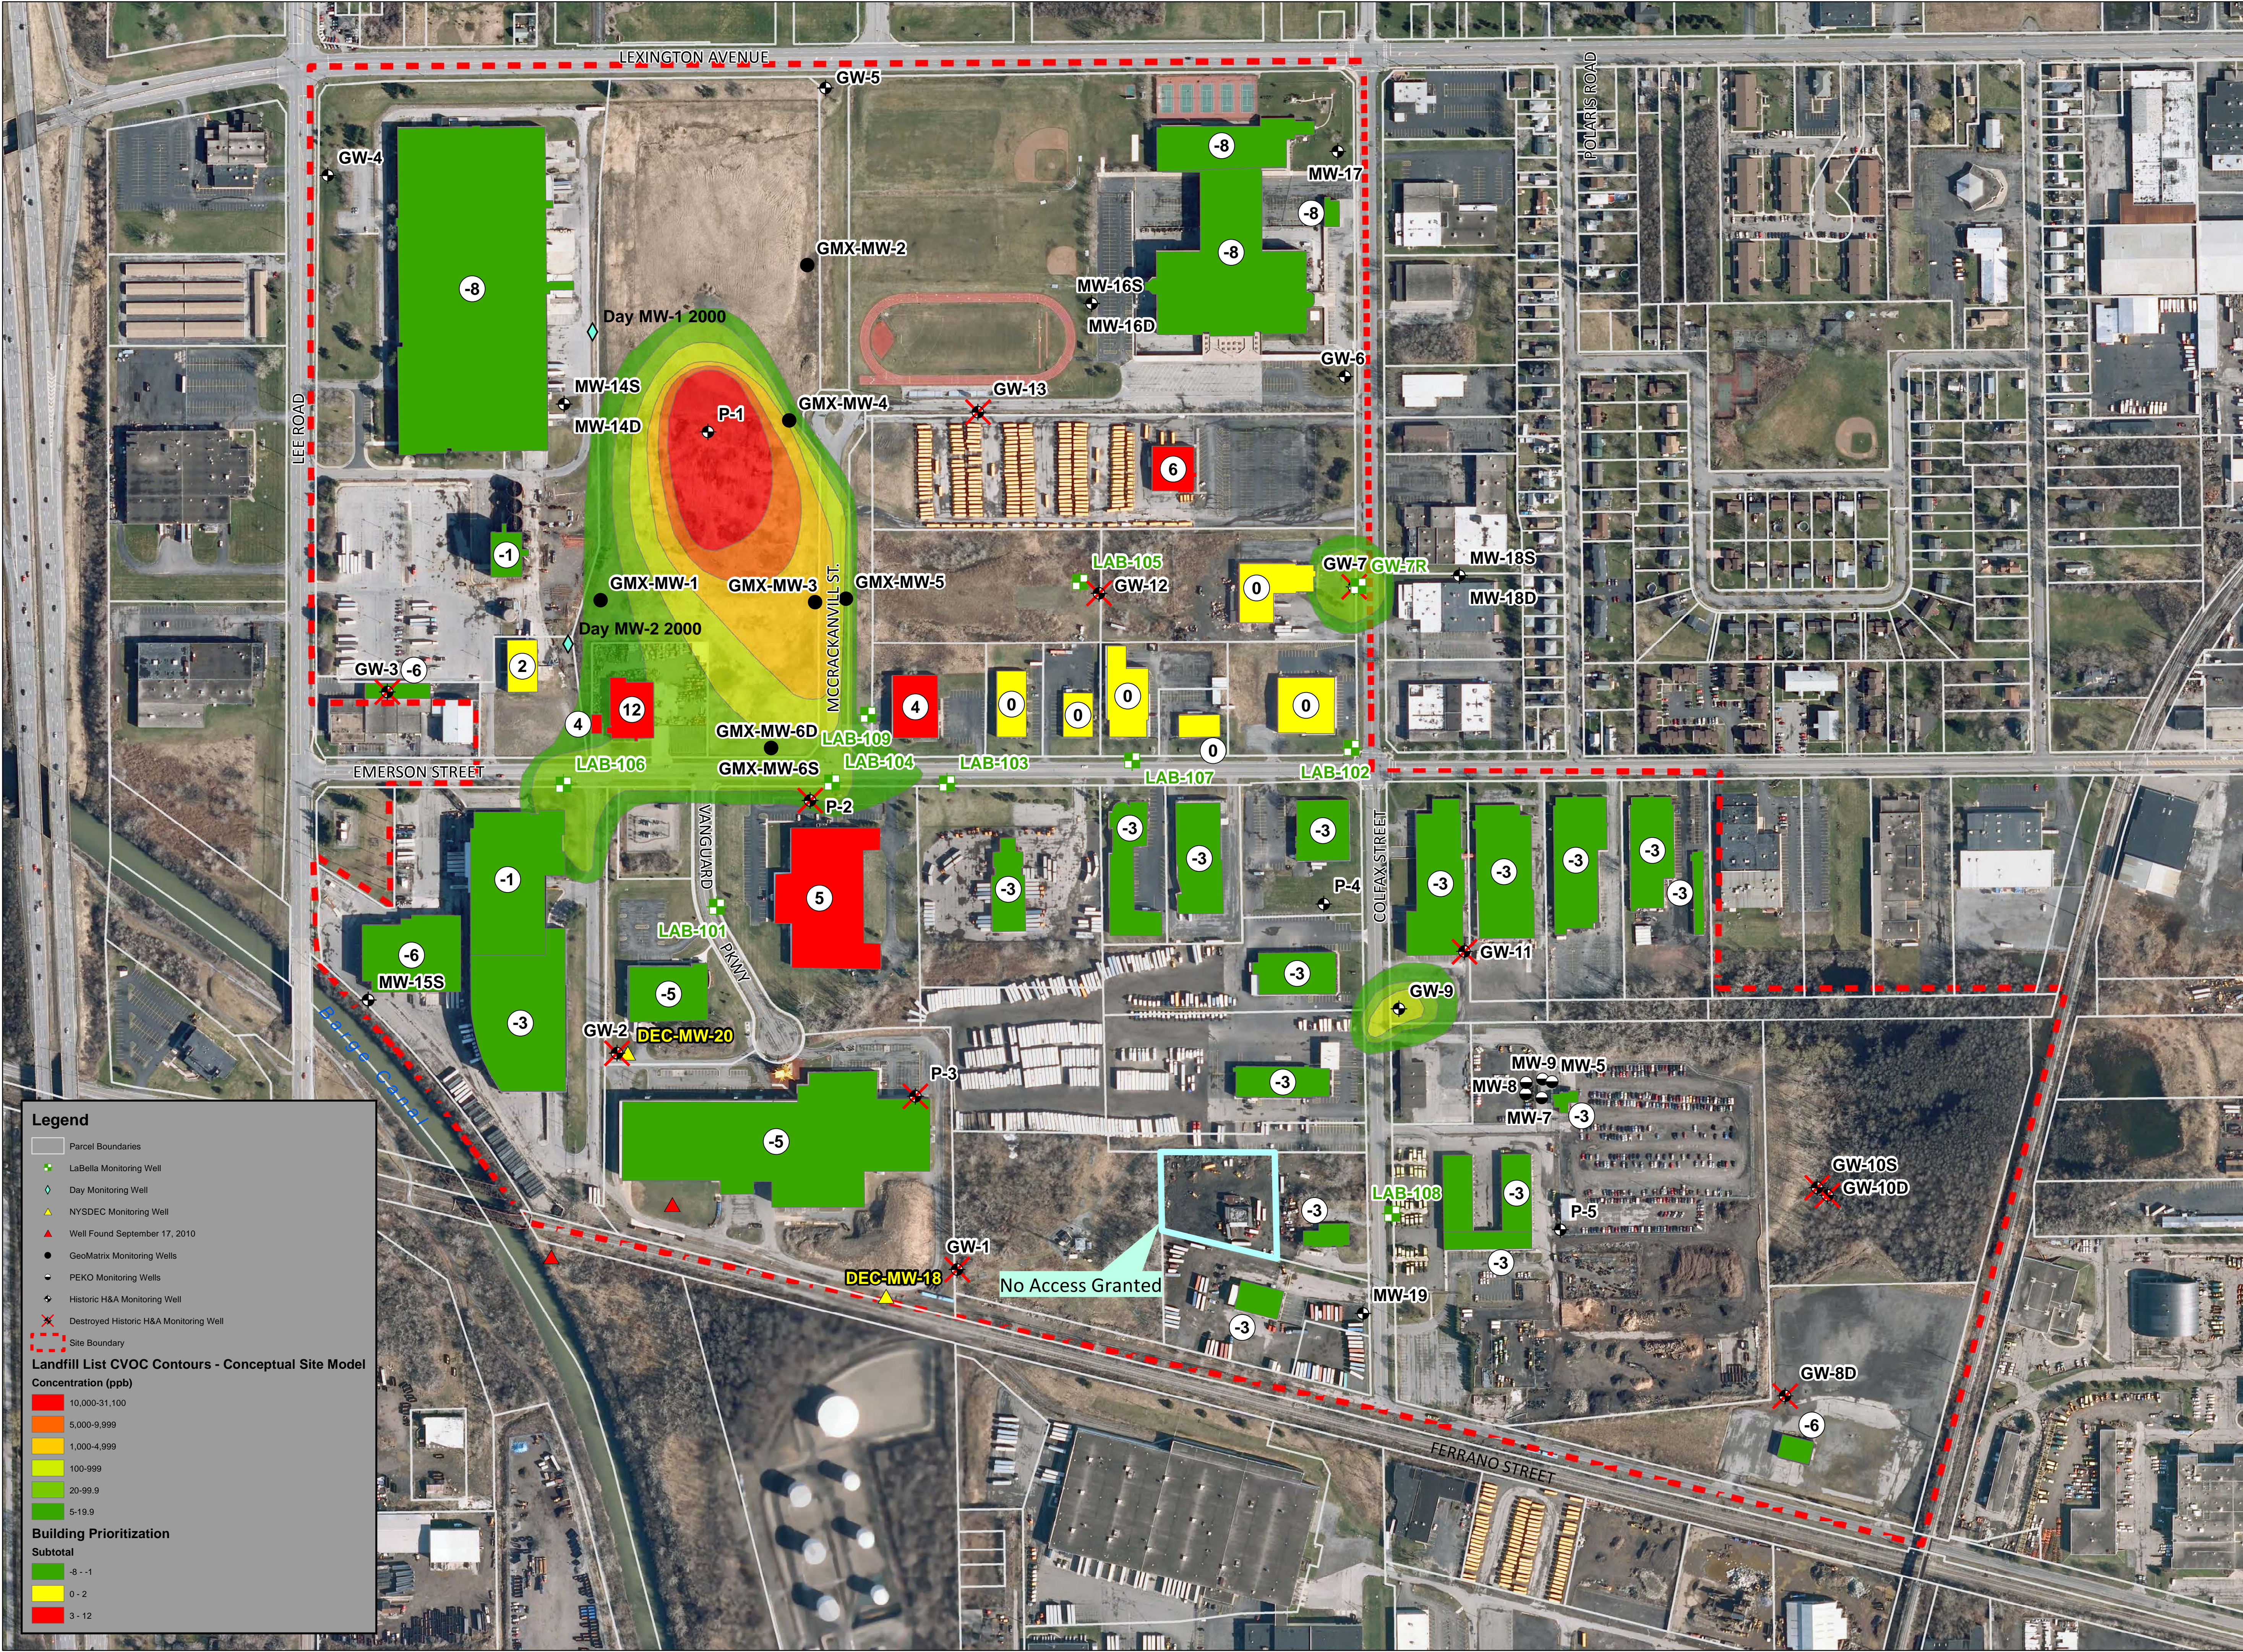
FIGURE 16

3) The CVOC plumes in proximity to GW-7R and GW-9 do not appear to be attributable to FESL and as such are not included in the prioritization factors. Refer to Section 4 and 5 of the report for details.

4) FESL prioritization scores are based on proximity to the P-1 plume area and site reconnaissance field meter readings that appear attributable to FESL. Section 7 of the report provides information on the methodology used and Appendix 14 "Property Summaries" provides details on the work completed at each facility.

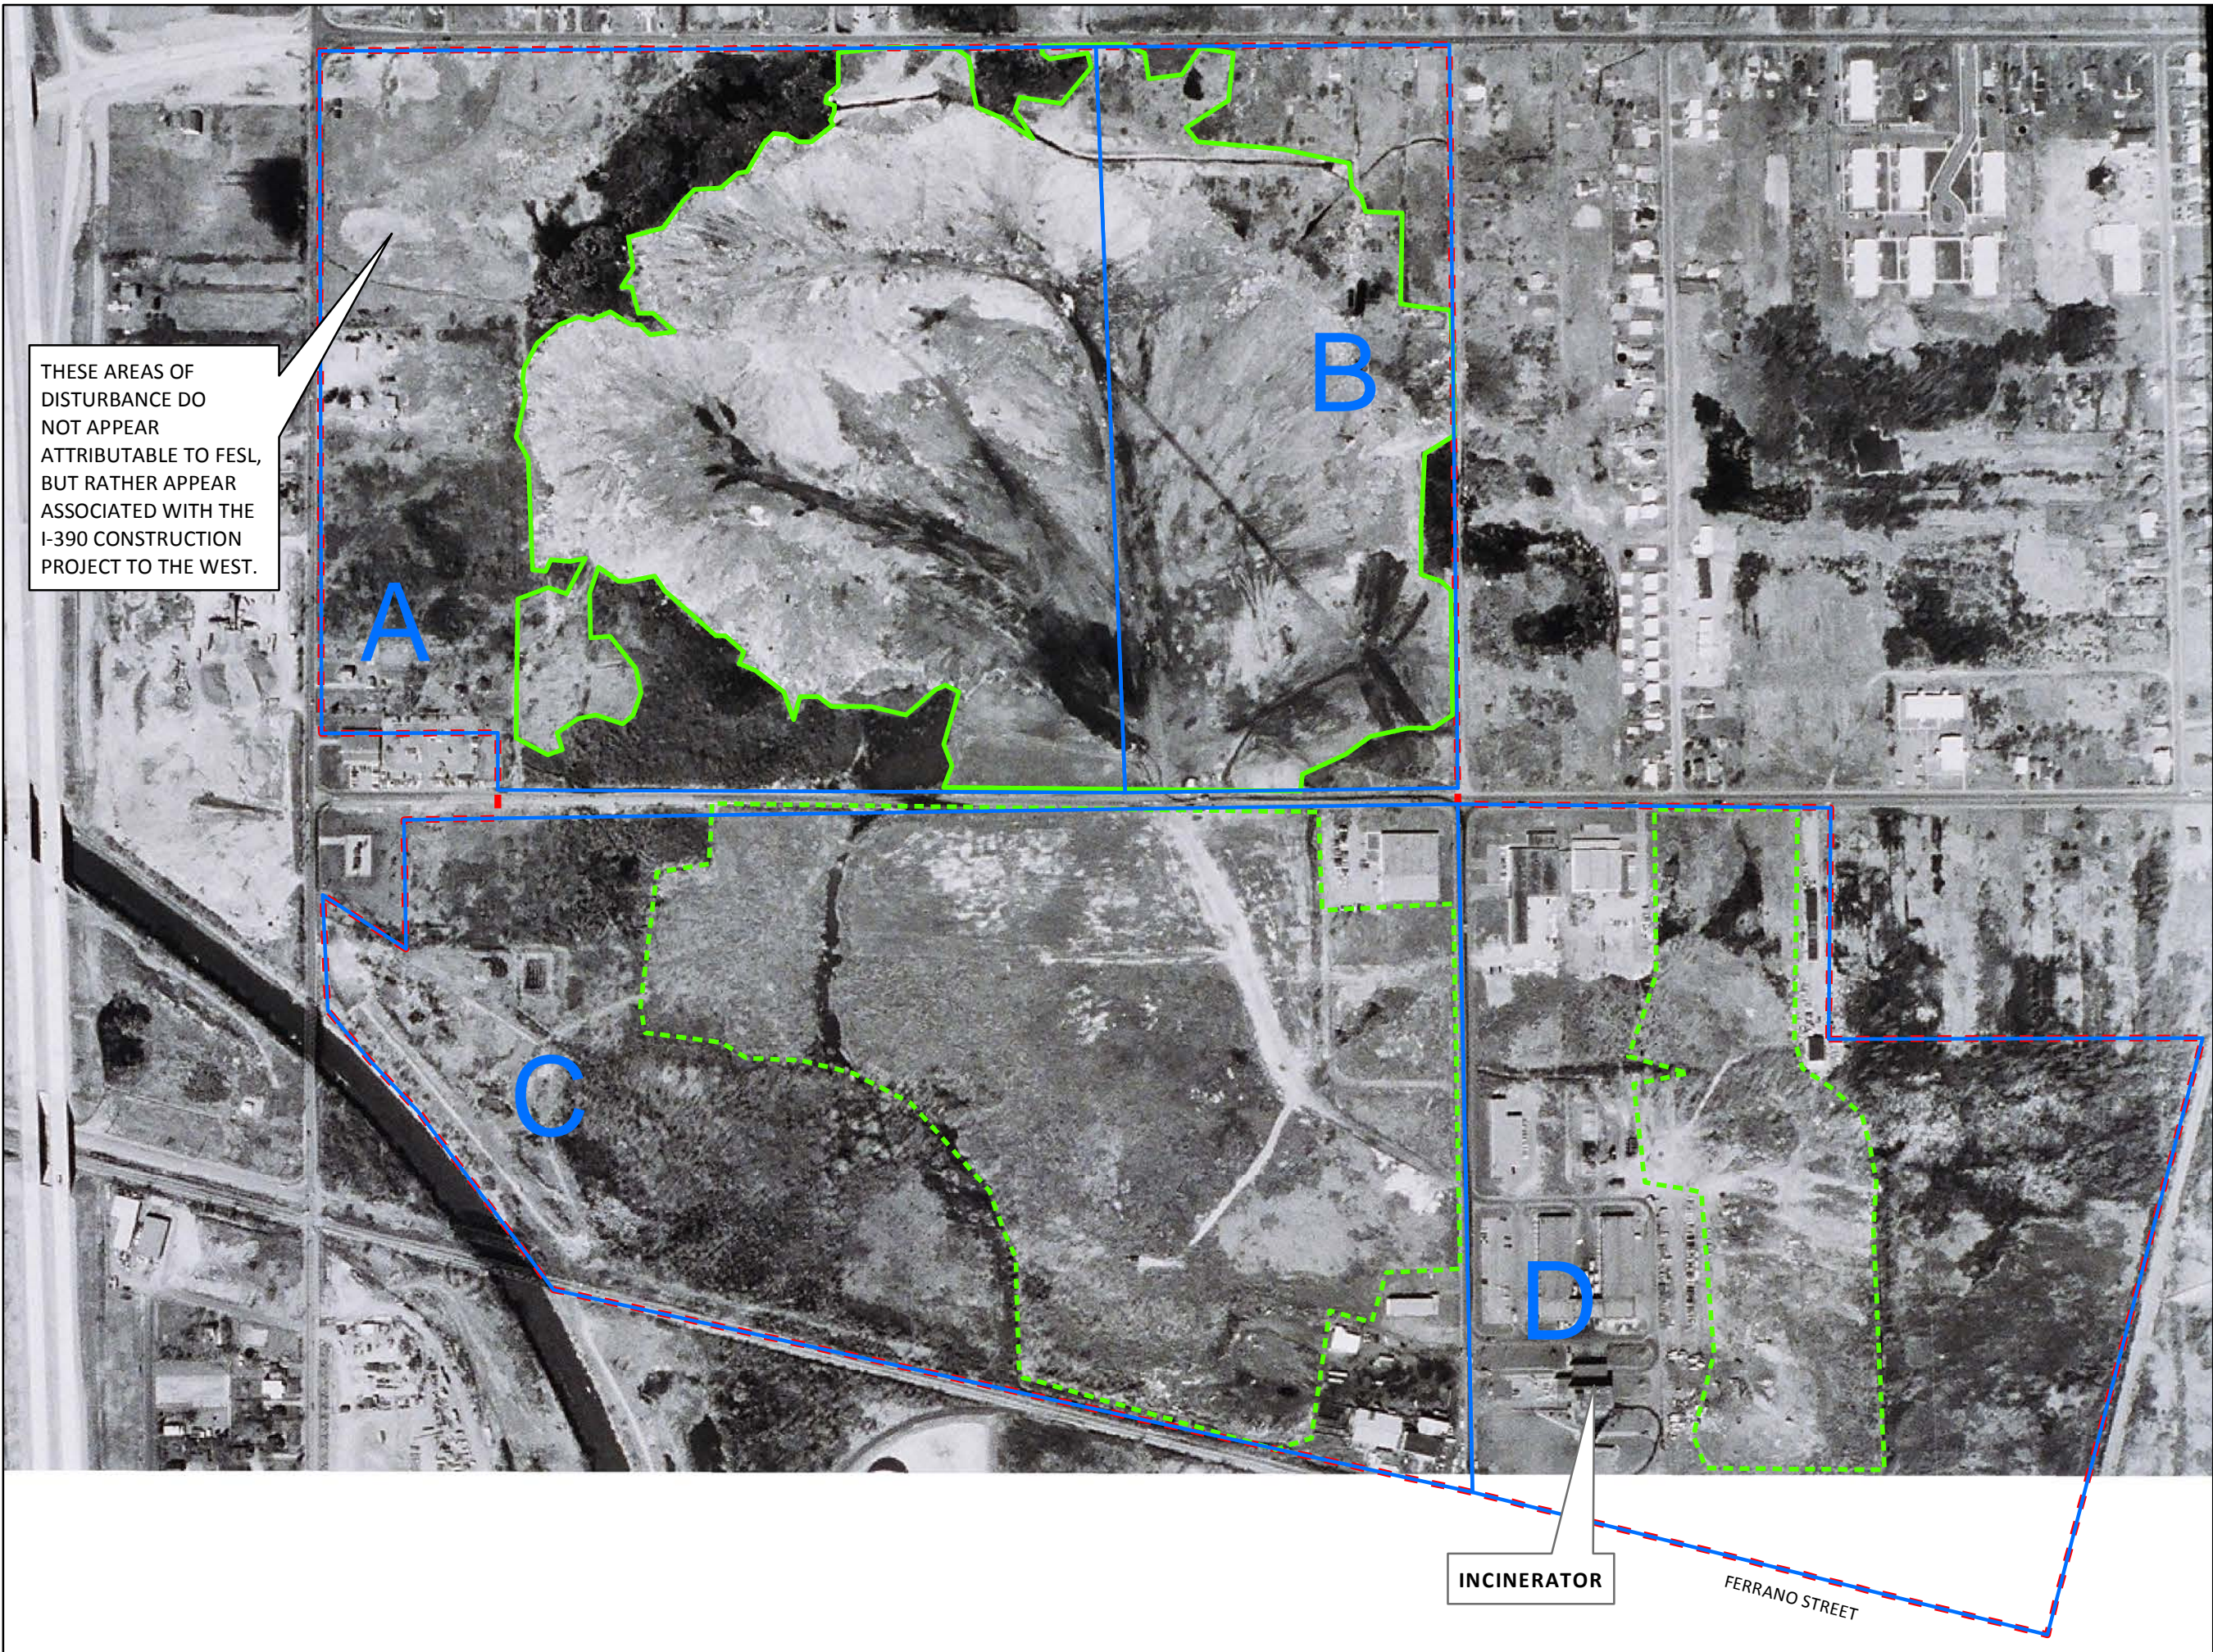
[FIGURE 4f]

THESE AREAS OF
DISTURBANCE DO
NOT APPEAR
ATTRIBUTABLE TO FESL,
BUT RATHER APPEAR
ASSOCIATED WITH THE
I-390 CONSTRUCTION
PROJECT TO THE WEST.

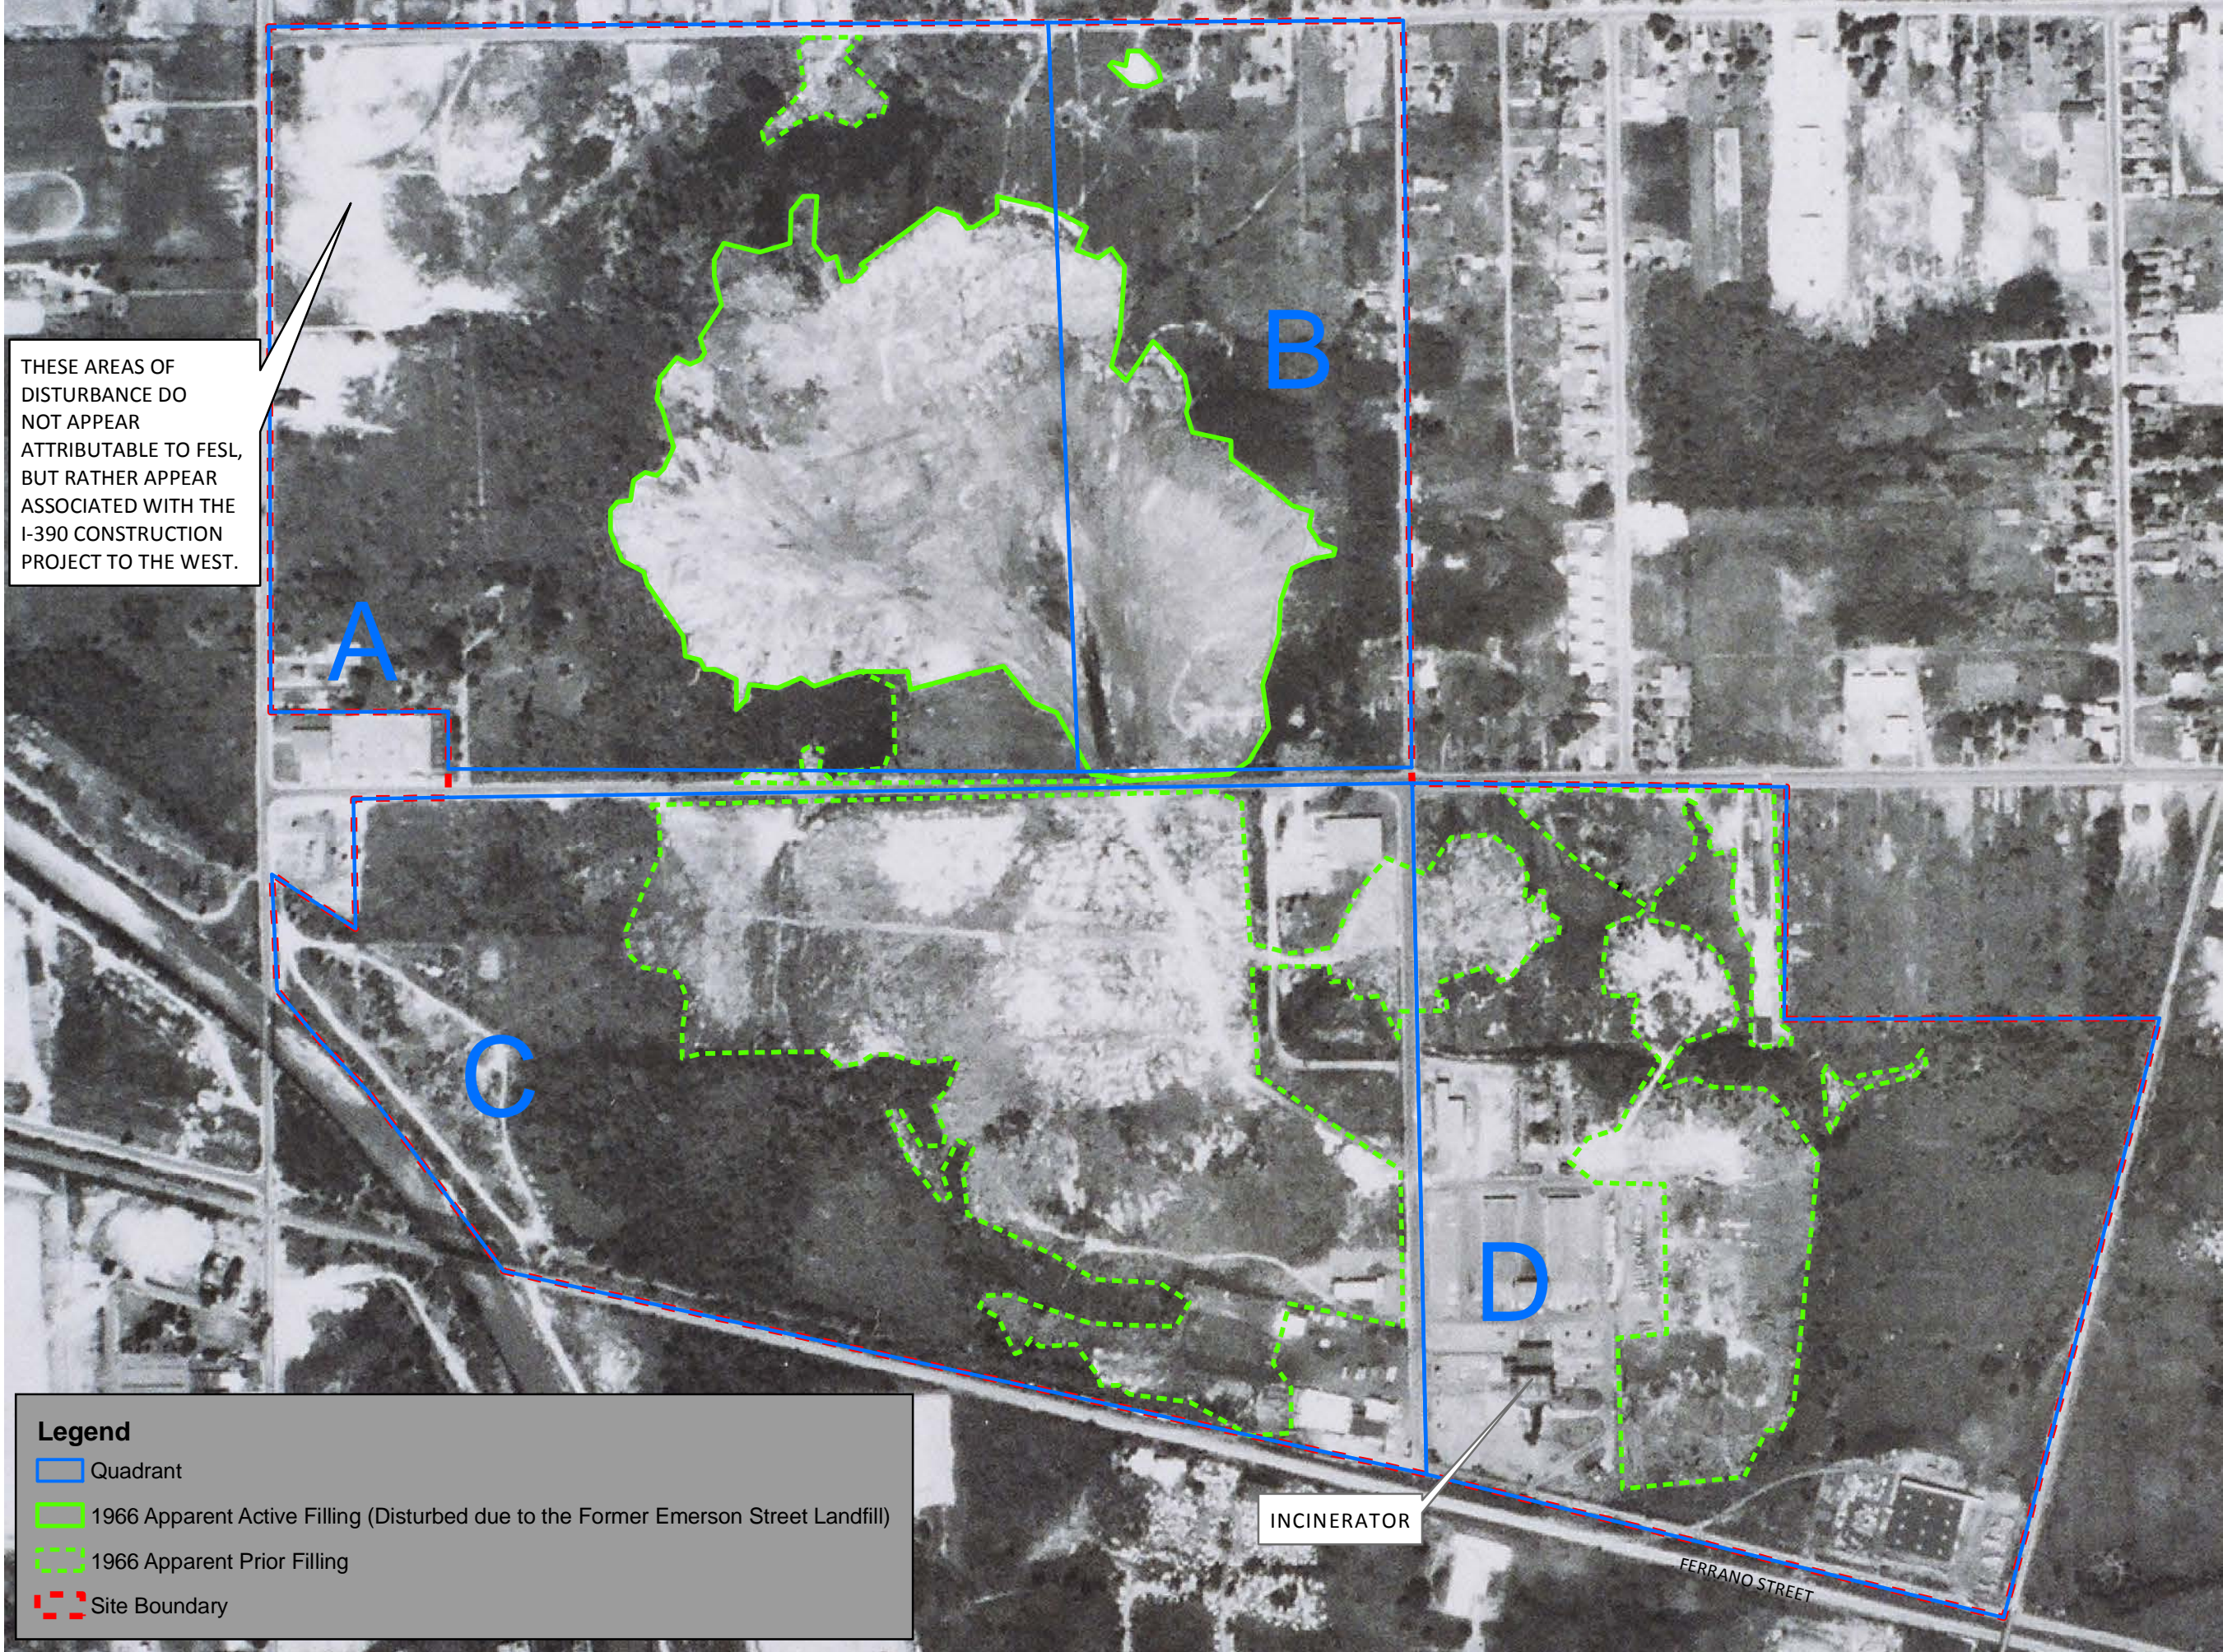
[FIGURE 4e]

THESE AREAS OF DISTURBANCE DO NOT APPEAR ATTRIBUTABLE TO FESL, BUT RATHER APPEAR ASSOCIATED WITH THE I-390 CONSTRUCTION PROJECT TO THE WEST.
