## Site: 655 Colfax Avenue

## Site Recon Dates: August 31st and September 1st, 2010 Consultant: O'Brien & Gere & LaBella Associates, P.C.

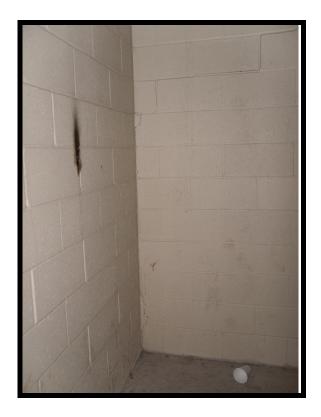
Location	Description	Background (ppb)	Reading (ppb)
49	Corner of wall in stairwell [Note: A large box of cosmetology materials (i.e., mannequin heads, wigs, etc.) was observed in the vicinity of this location. As such, this reading is likely attributable to site operations.]	30	82
87	Pipe penetrating the wall in boiler room*	27	327
89	Crack in concrete floor in boiler room*	28	201
90	Crack at base of wall in boiler room*	28	217

Location #49 – Corner of wall in stairwell

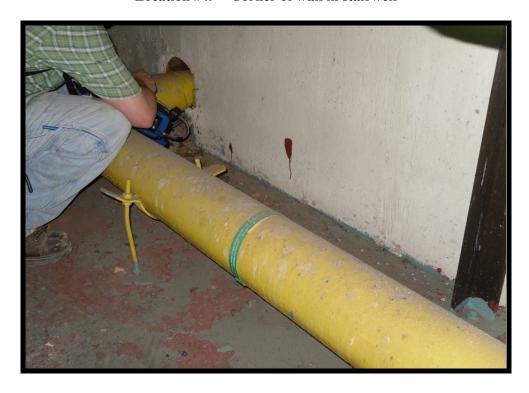
**Location #87 – Pipe wall penetration**

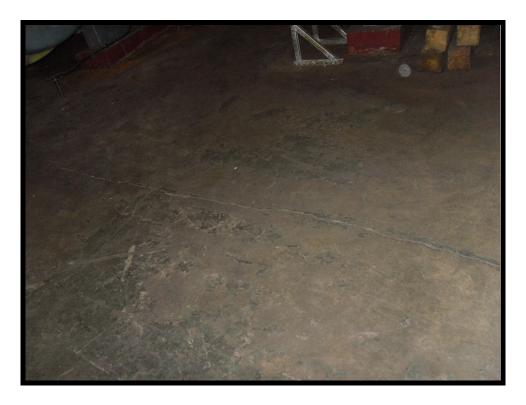
Location #89 – Floor crack in boiler room
