02-8710-102-PA  
REV. NO. 0

PRELIMINARY ASSESSMENT  
TAYLOR INSTRUMENT/DIVISION OF SYBRON

MARCH 11, 1988

NUS CORPORATION  
SUPERFUND DIVISION

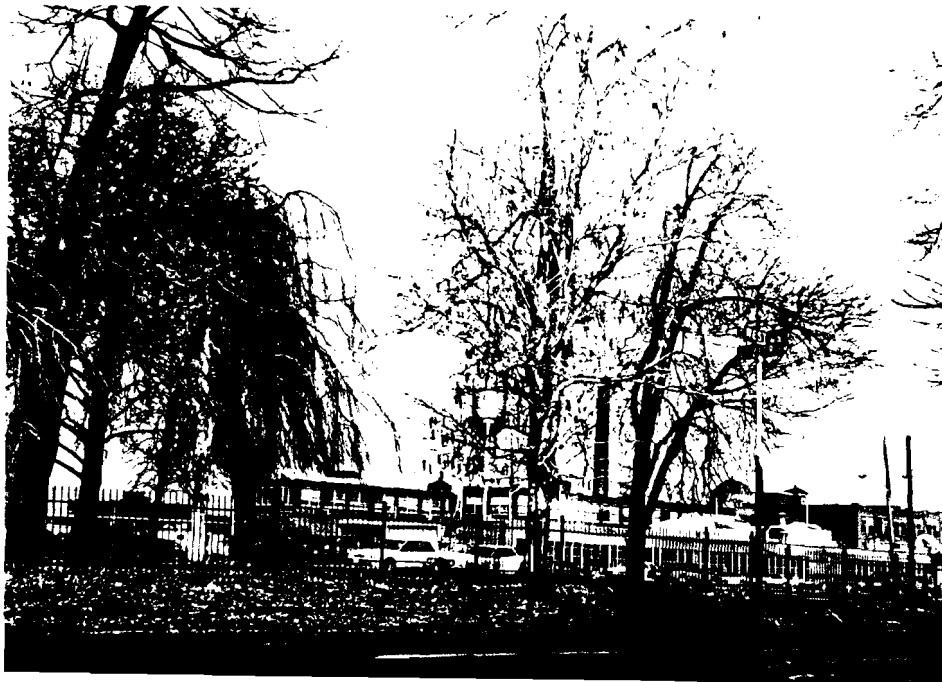
1P-24

View of facility looking north from West Street.

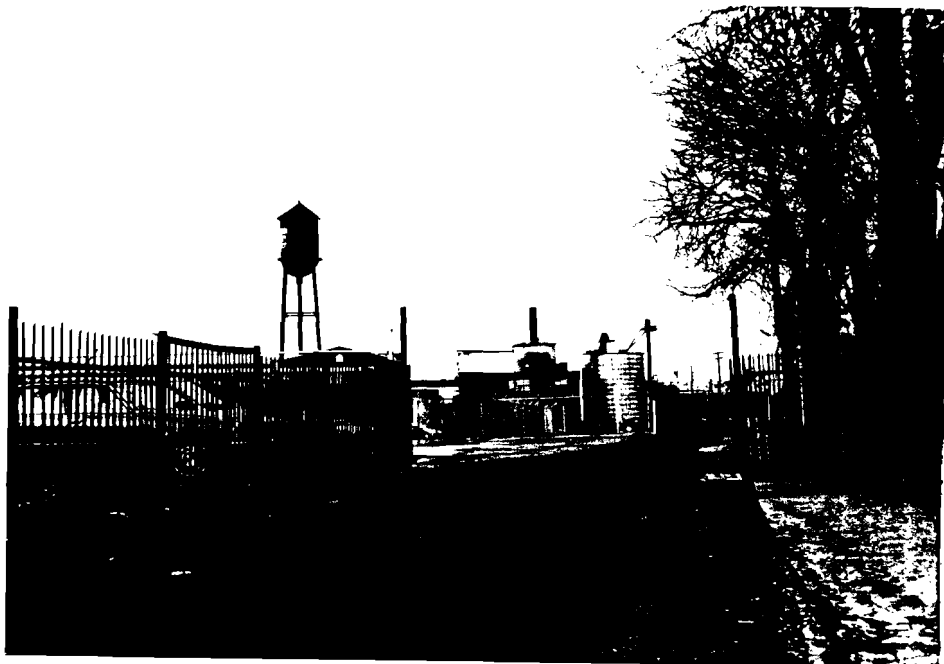
1P-22

View of one of the facility gate, looking north from West Street.
