MONROE COUNTY  
DEPARTMENT OF HEALTH

Re: Identification and Testing of Chemical Dump Sites

## THE LOWER FALLS

Several chemical seeps have been discharging from the Lower Falls of the Genesee River since the early 1970's. This paper discusses the problem, recent findings, and makes recommendations.

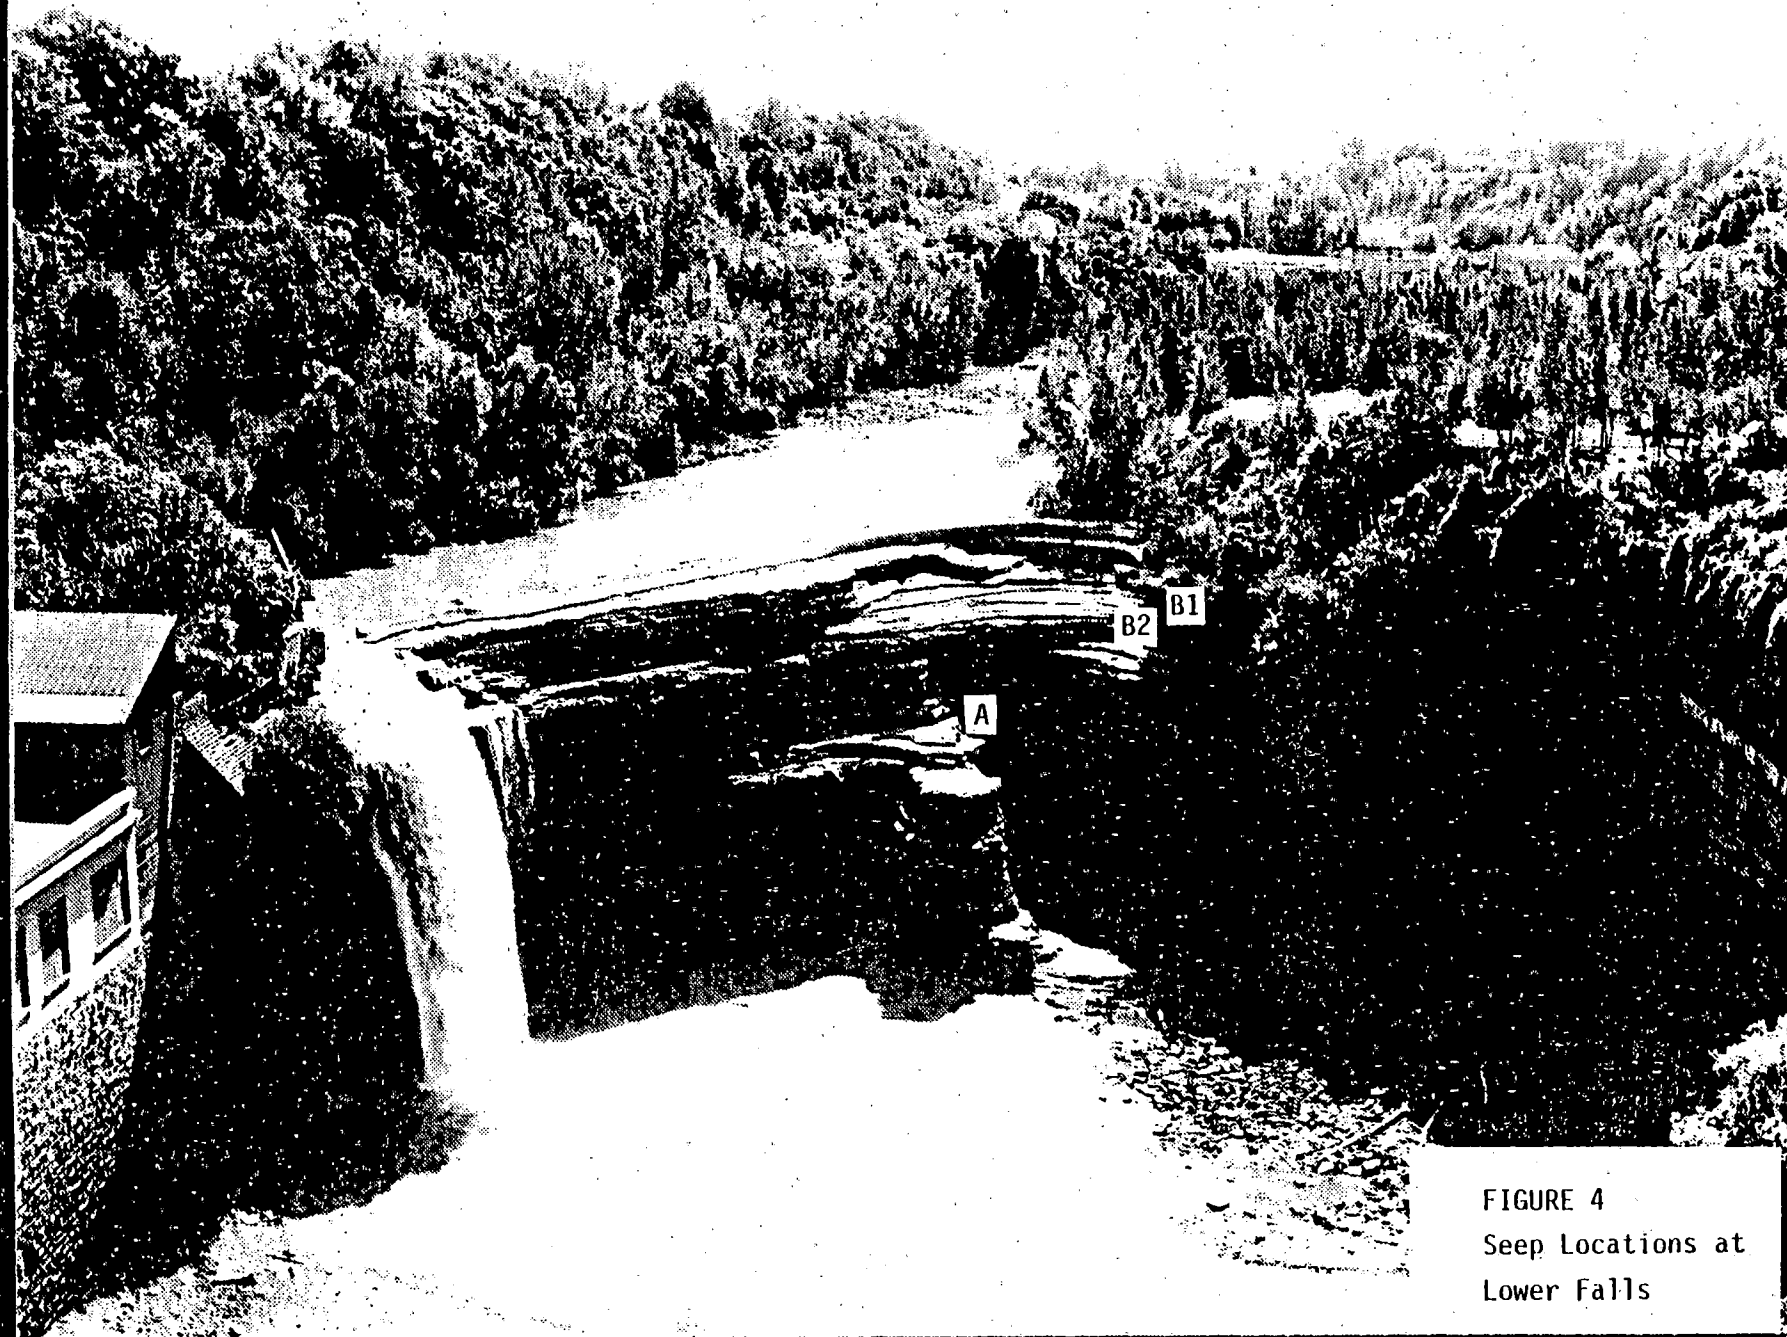
FIGURE 4  
Seep Locations at  
Lower Falls

The presence of chemical seepage on the face of the Lower Falls has been reported since the early 1970's. The Monroe County Health Department has investigated these reports since 1974 (Appendix C). The approximate location of the seeps is shown in Figure 4.

Seep A can best be described as a diffused seep which appears at several points. The seep is believed to be creosote which has leached from timbers used to shore up the hydropower tunnel constructed between the dam at the Middle Falls and Power Station 5 at the Lower Falls. Rochester Gas and Electric Corporation has reported a similar seepage problem within the tunnel itself. The tunnel and creosoted timber areas are shown in Figures 5 and 6. A geologist's report (Appendix D) points out that creosote from the tunnel timbers could move through interconnected natural jointing in the rocks to the face of the falls where it spreads out along horizontal planes in the weathered rock.

Seep B1 is continuous; chemical analysis show benzene, xylene, and toluene in concentrations greater than 10 ppm (Appendix E). Seep B2, which is located approximately 20 feet east and 3 feet below Seep B1, has an intermittent flow. Lab analysis indicates concentrations of benzene and xylene

at 8 ppm and toluene at 20 ppm. It is the conclusion of the Monroe County Health Department staff that Seep B2 is a dilution of Seep B1.

- (1) Additional samples should be taken by the Monroe County Health Department and sent to the New York State Health Lab for chemical identification. The NYS Department of Environmental Conservation and the Monroe County Health Department should determine if the creosote levels pose a hazard to fish and fishermen.
- (2) The Rochester Gas and Electric Corporation should evaluate the feasibility of collecting and disposing of any excess creosote in the tunnel headspace during its scheduled 1980 maintenance program and report its findings to the Monroe County Health Department.
- (3) RG&E should flush the residual creosote seeping at the face of the falls by distributing the normally released flow of the Genesee River over the entire face of the falls.

- (1) Additional samples should be taken by the Monroe County Health Department and sent to the New York State Health Lab for quantification of chemicals in the B1 Seep. NYS Department of Environmental Conservation and the Monroe County Health Department should determine if the chemical levels pose a hazard to fish or fishermen.

- (2) The Monroe County Pure Waters Division should determine if the sewer siphons at the point of mill race traverse are intact. If a leak is found, the siphons should be repaired.
- (3) If a pipe break is not found and if the chemical levels are determined to be a hazard, the City of Rochester, as the landowner, should evaluate methods for collecting and properly disposing of the material and identify the appropriate agency to carry out the corrective measures.

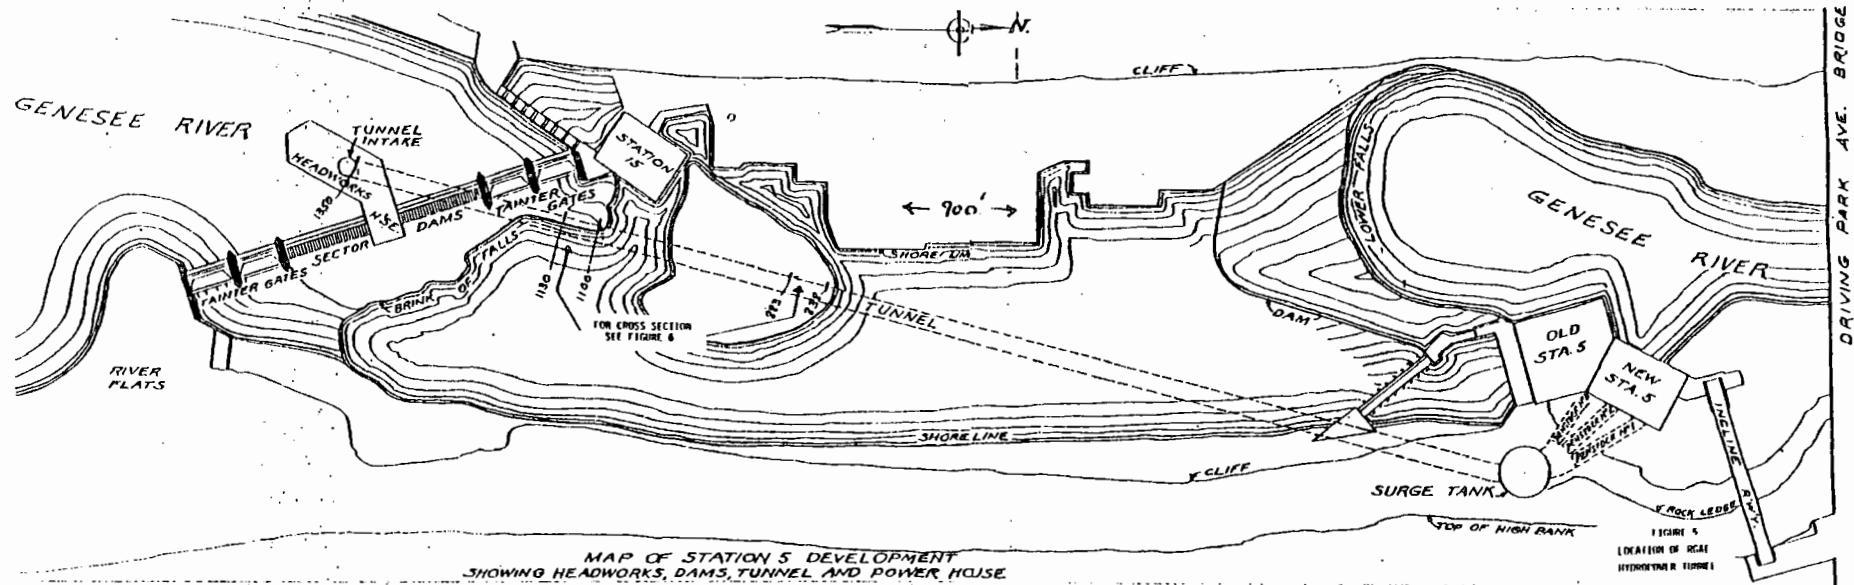
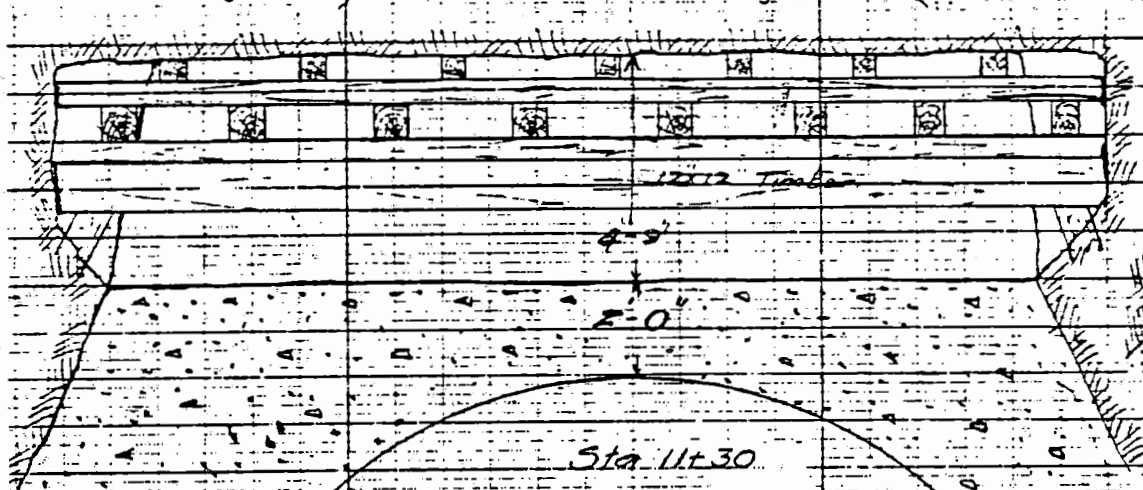
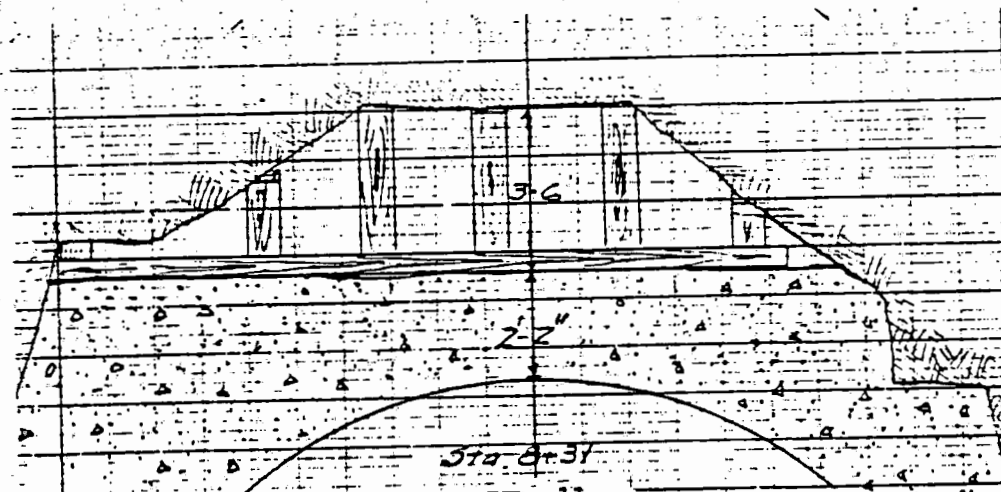
FIGURE 6  
Construction Drawing of  
Creosoted Timber  
Areas in RG&E  
Hydropower Tunnel

Roof dropped April 14 - 7:45 AM, broke timbers & cracked concrete along & over from sta. 11+58 to 12+18 and back from 11+00 a distance of

Packed with timber above 12"x12" and grouted later.

Longitudinal section of tunnel showing timbers

cross section of tunnel at Sta. 11 + 30 (see Figure 5)

cross section of tunnel at Sta. 8 + 31 (see Figure 5)
