Subject: Sub-Slab Depressurization System As-Built Engineering Report
Xerox Building 801 - Henrietta, NY (NYSDEC Site No. 828069)

**SUB-SLAB DEPRESSURIZATION SYSTEM
AS-BUILT ENGINEERING REPORT
XEROX BUILDING 801
(NYSDEC SITE NO. 828069)
HENRIETTA, NEW YORK**

**File No. 32077-104
6 July 2009**

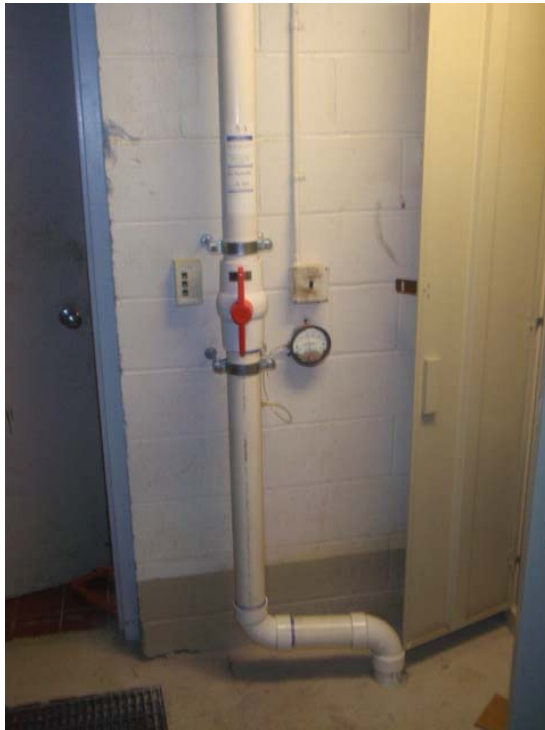
Vacuum Monitoring –Manometer

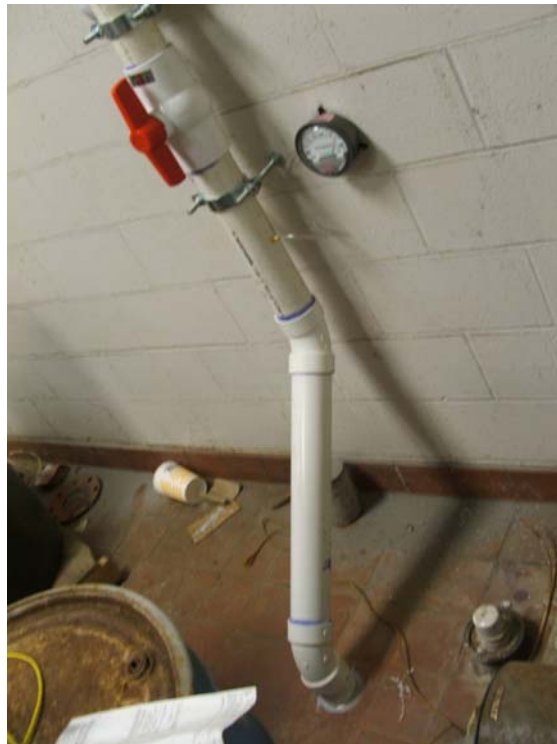
SSD – Typical Stack to Fan with Manometer

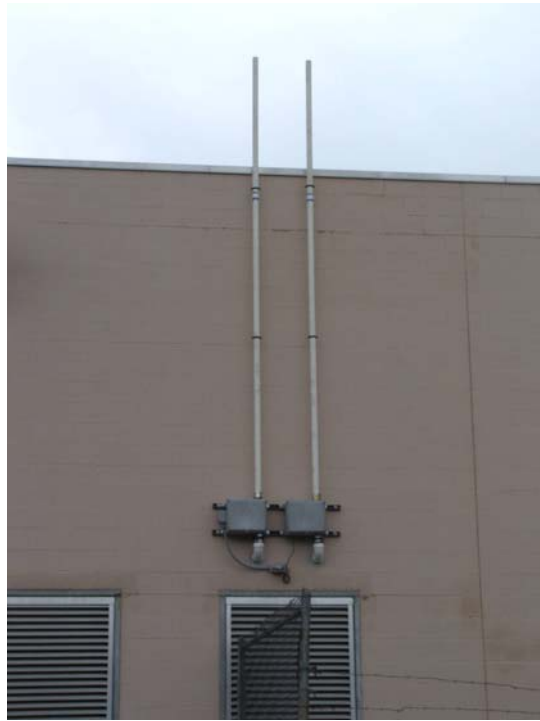
Northern Exterior Wall – SSD Fans and Exhaust

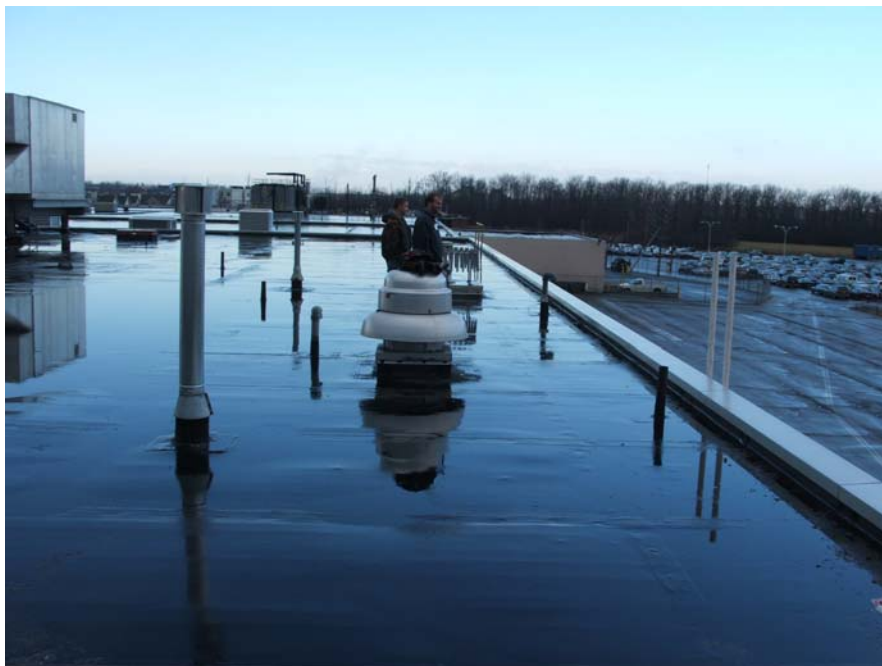
Roof – Location of Exhaust Relative to Other Roof Exhausts
