# KPX INDUSTRIAL SEWER RCRA FACILITY INVESTIGATION AND PRESUMPTIVE REMEDY REPORT – KODAK PARK CORRECTIVE ACTION PROGRAM

Eastman Kodak Company  
Rochester, New York

May 17, 2011

113-89261

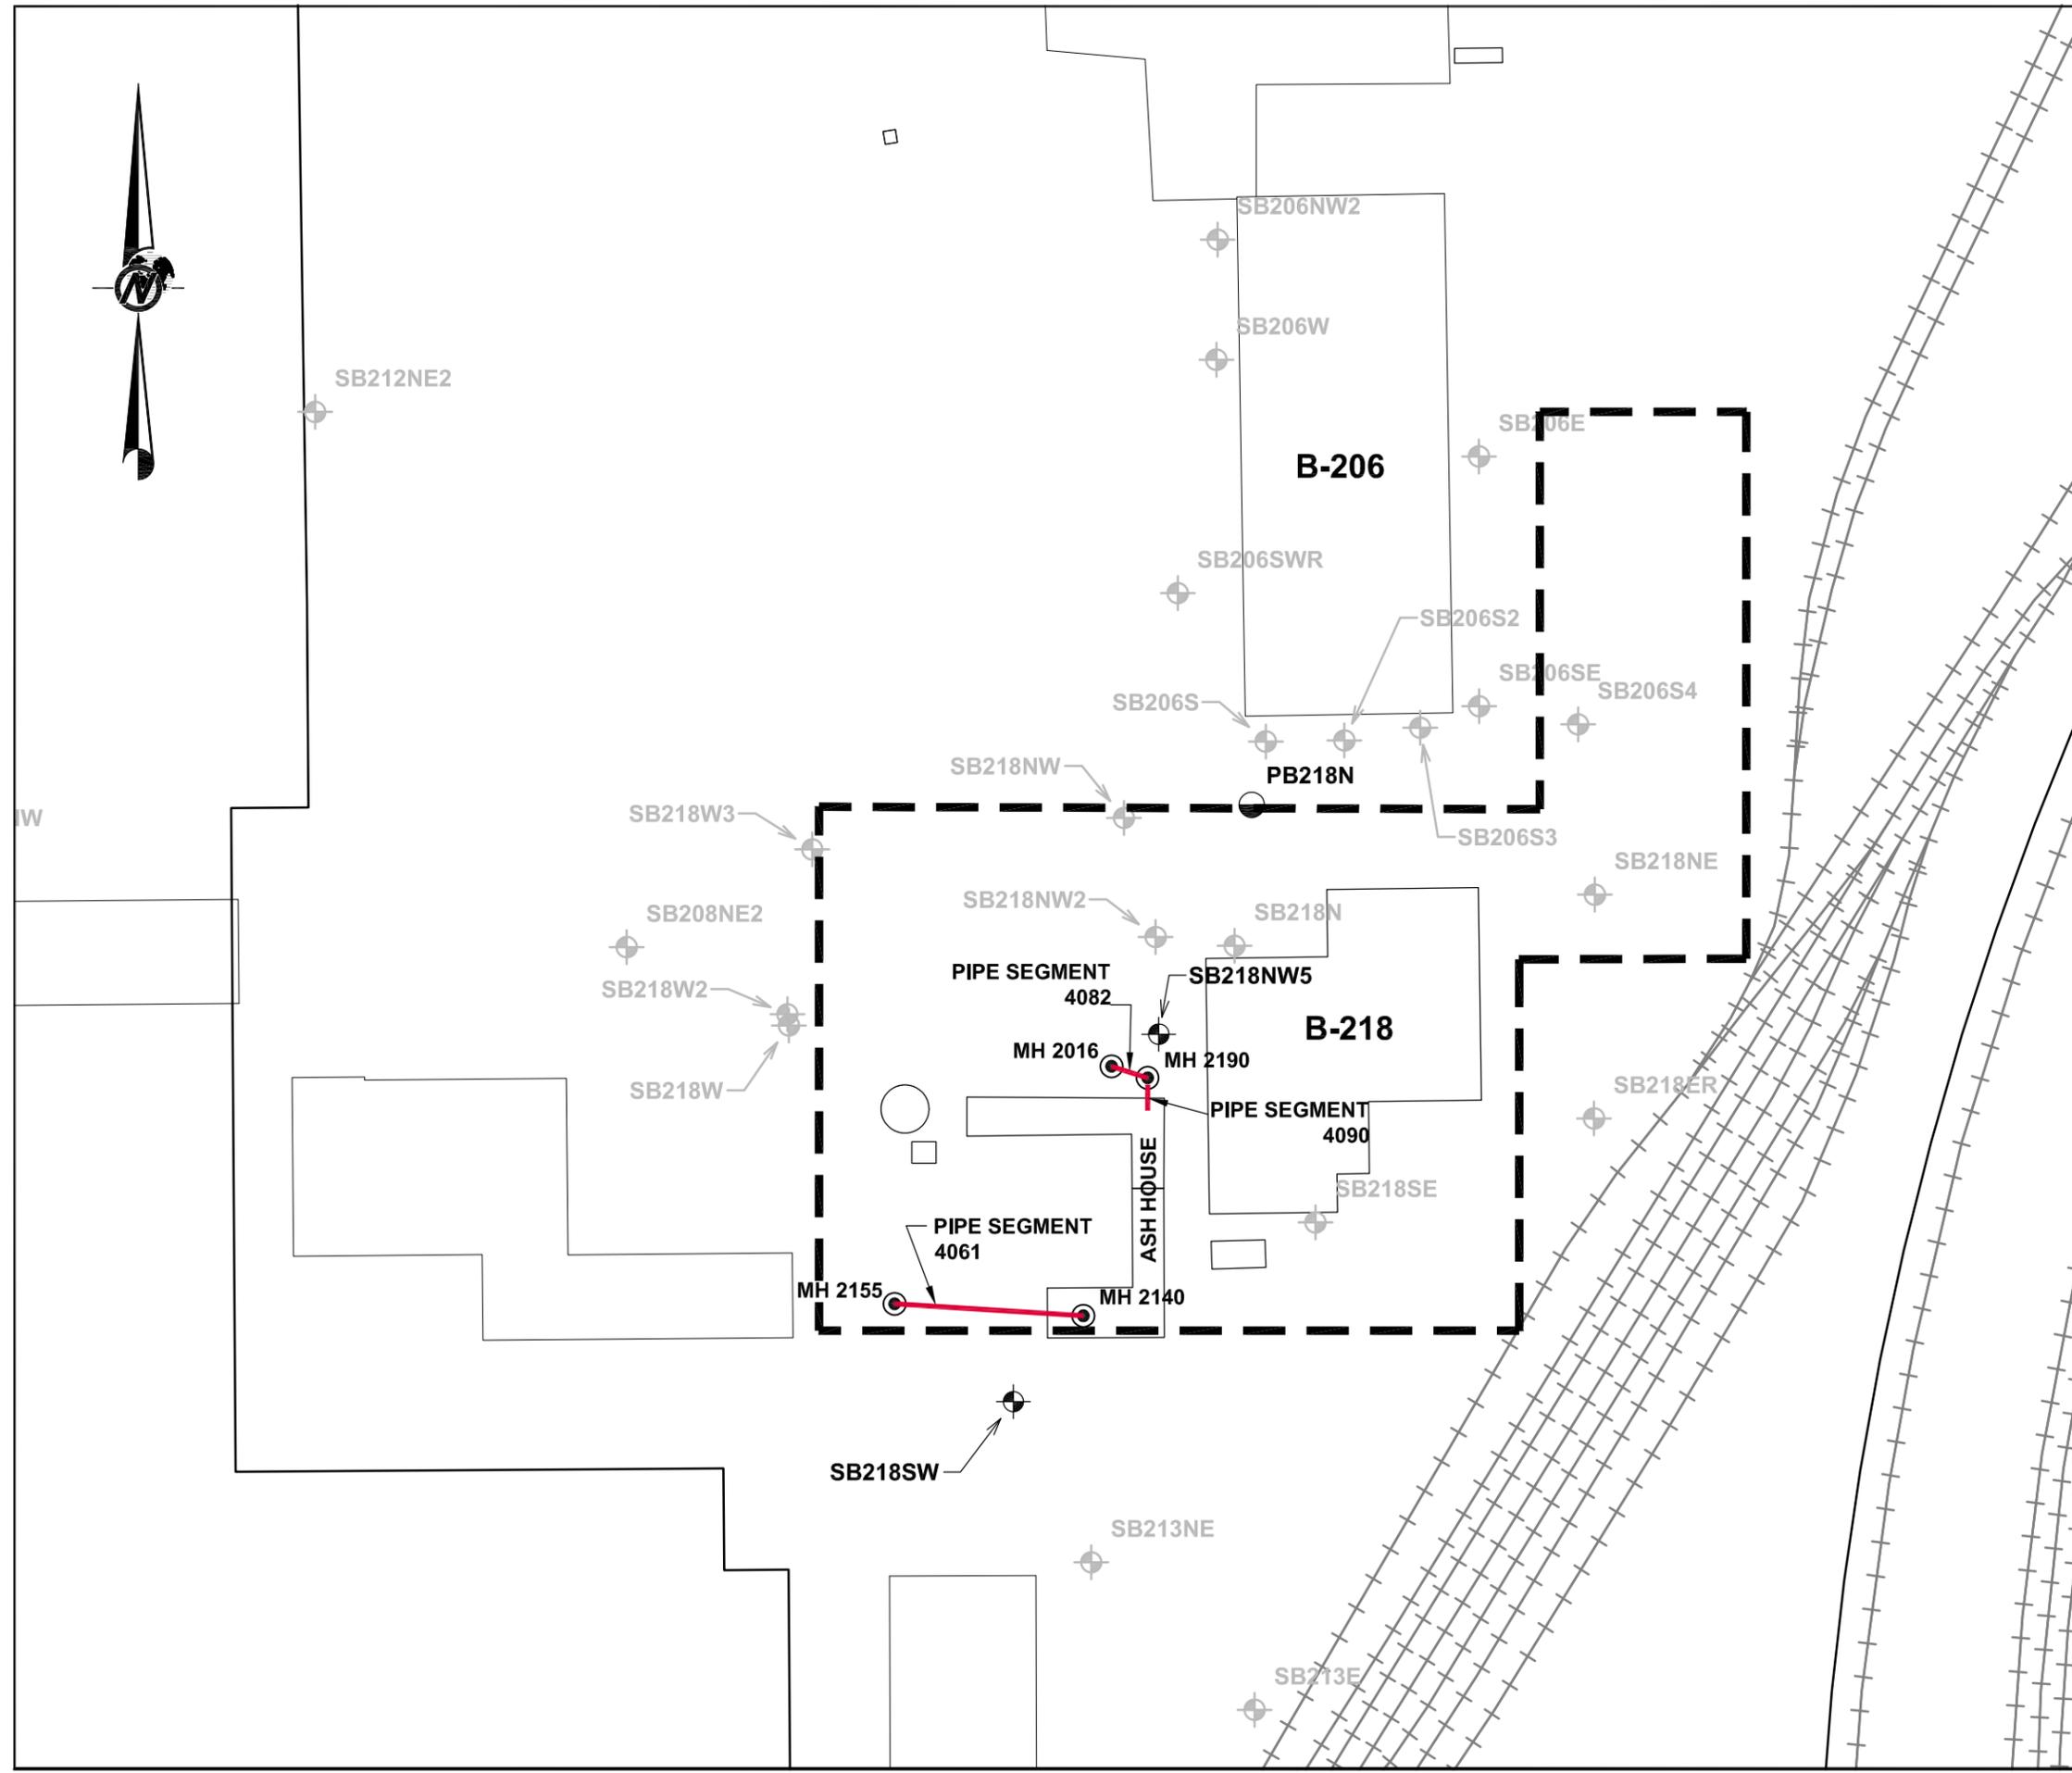
**FIGURE 2**

The three (3) NFFU pipe segments (PS) in KPX are designated as PS4082, PS4090, and PS4061, and are shown on Figure 2. PS4061 had two faults which caused the segment to be deemed NFFU. The investigation found a moderately broken joint along PS4082 which is a 12-inch pipe that runs between manholes 2016 and 2190. The investigation also found a severely misaligned/offset joint in PS4090 which is a 6-inch pipe that runs between manhole 2190 and the Ash House. The two issues that the investigation discovered within PS4061 (a 10-inch pipe that runs between manholes 2140 and 2155) were a section of moderate circumference cracks and a severe hole. All of these pipe segments were associated with water discharges from the Rotary Kiln Incinerator (RKI) Ash House shown on Figure 2 (conveying post incineration process water containing inorganics). With approved closure of the RKI, the pipes currently convey water/rainwater with no process discharges.

All of these issues were discovered between 1996 and 2001. The pipes were repaired per the EPA Consent Decree that Kodak entered into in 1994, which required Kodak to repair pipes prior to placing them back into service upon discovery of a break.

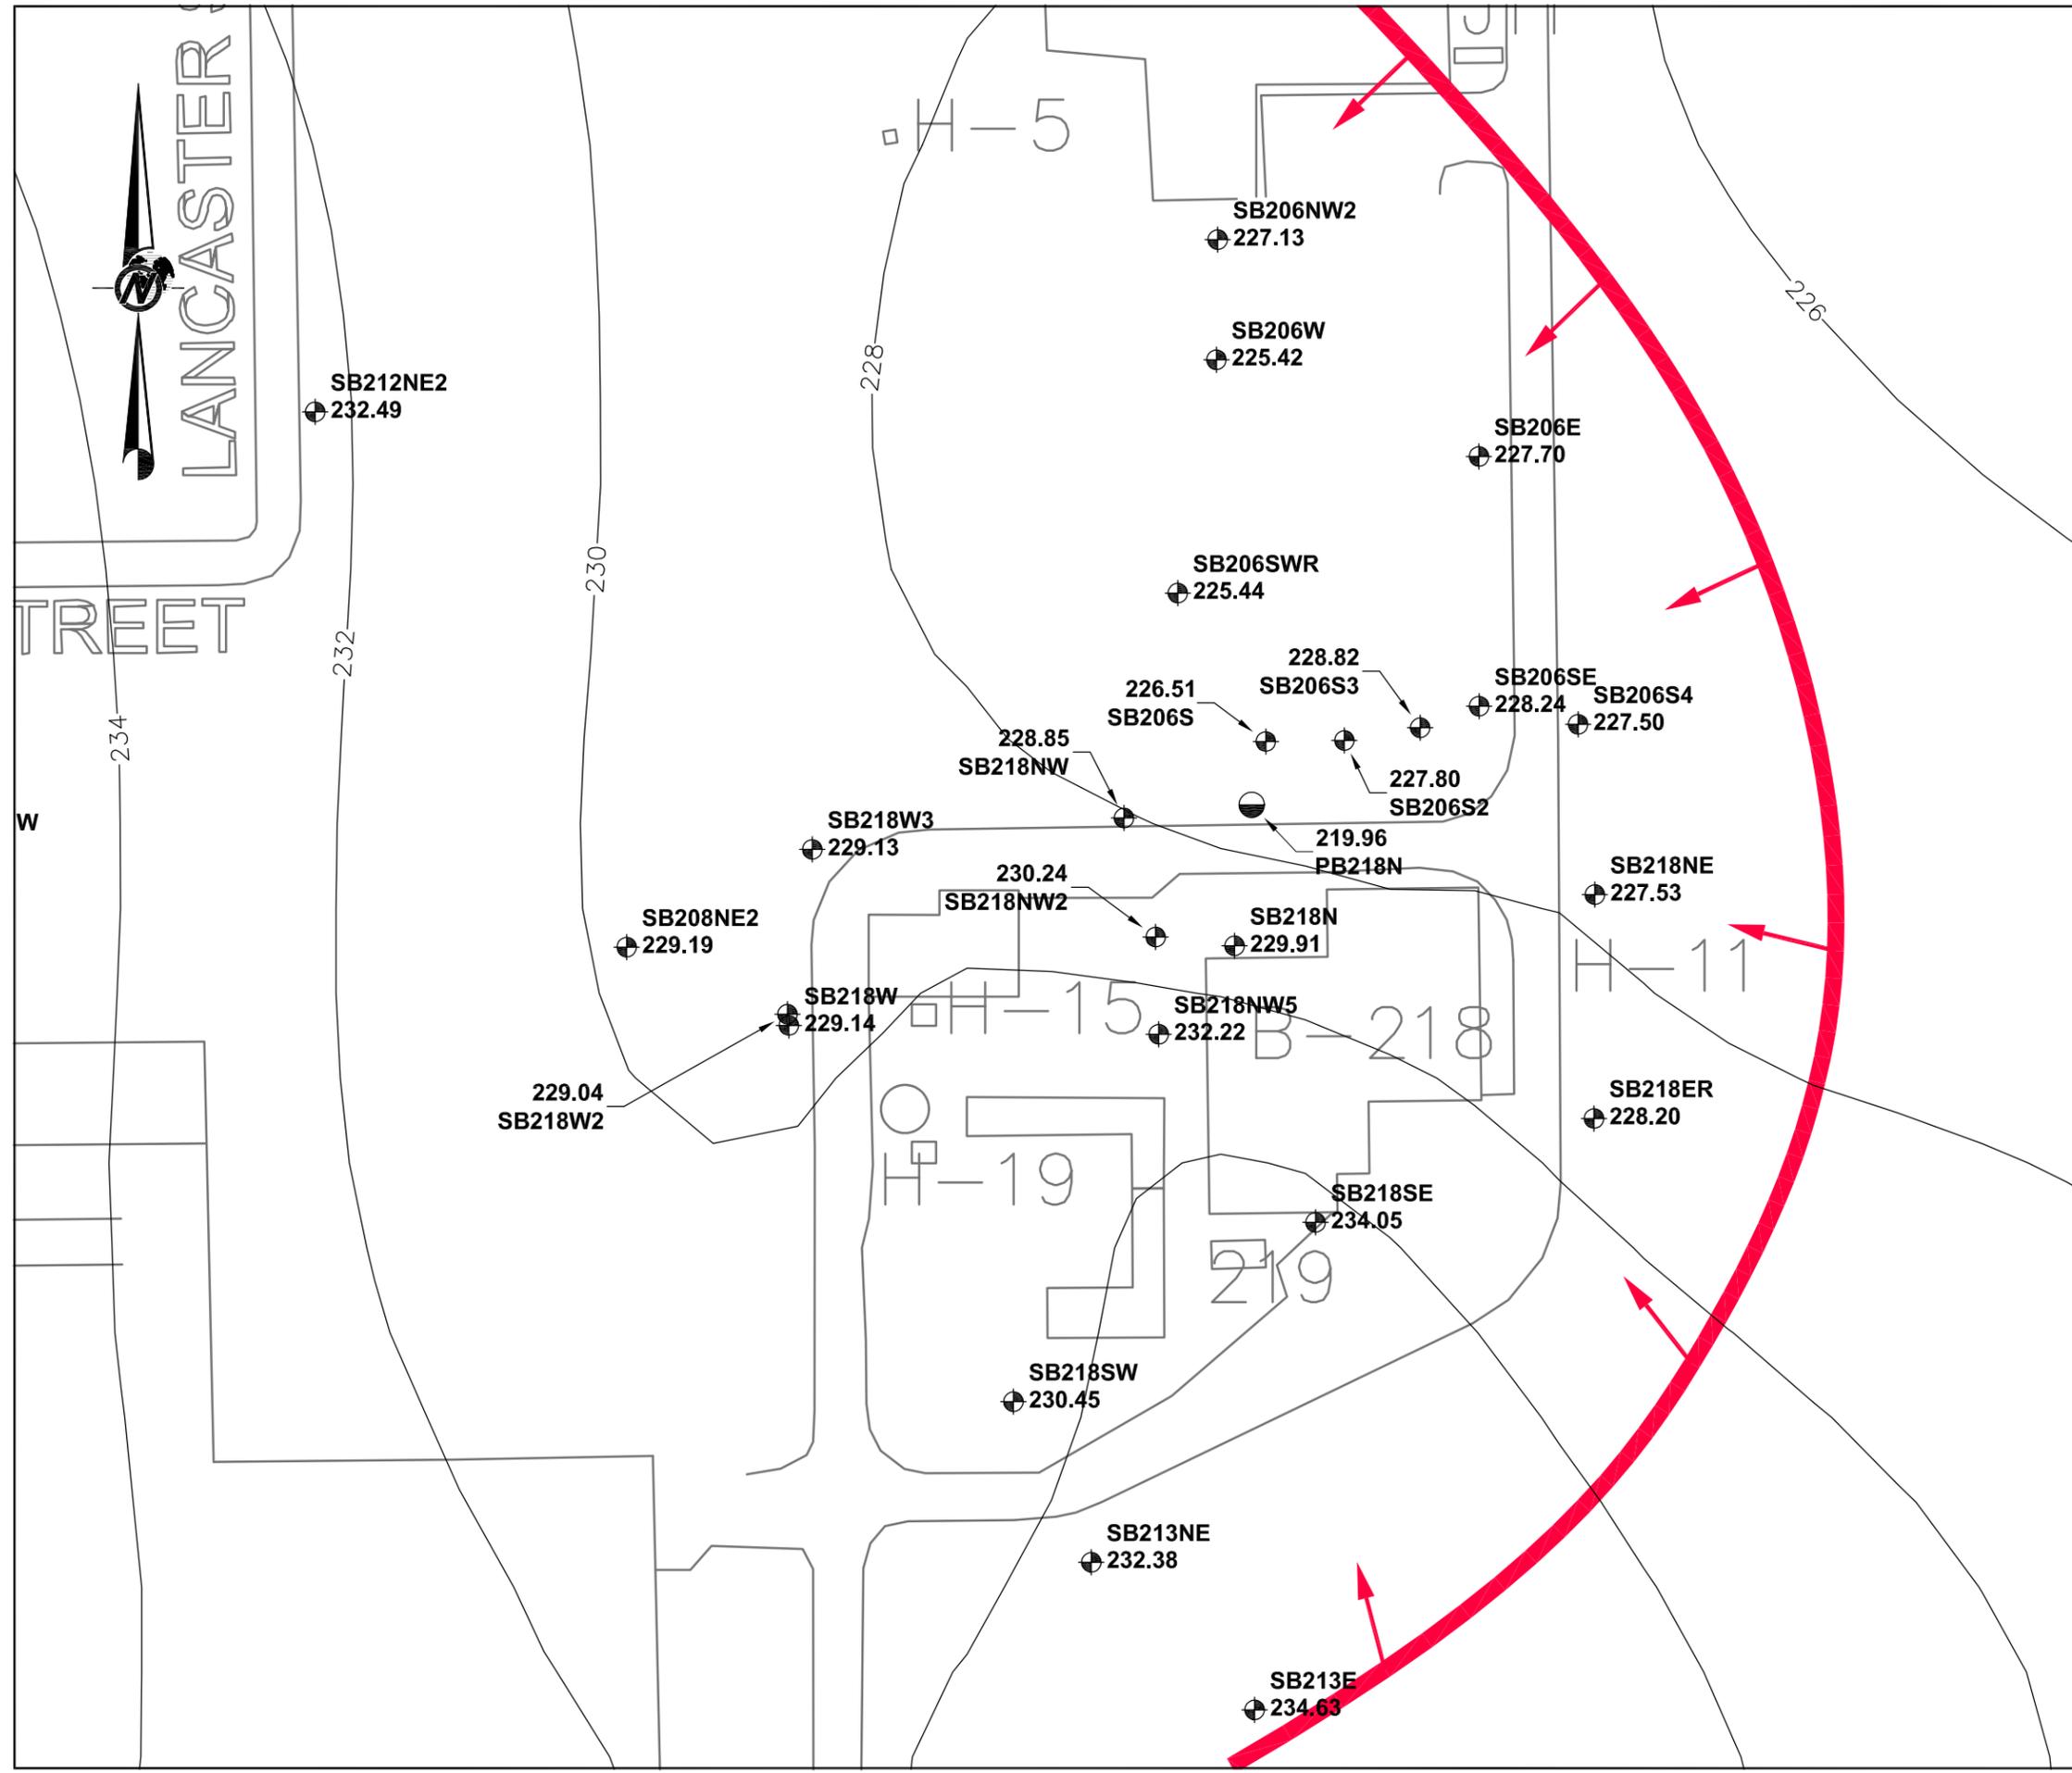
**FIGURE 3**

As shown in Appendix A-2, the average water elevations are above all the NFFU pipe segments. Since the water table is higher than the pipe segments in most cases, infiltration would occur primarily, rather than a release, thus reducing the potential for contamination of the surrounding soils and groundwater from the sewer. In the few instances where groundwater elevations were below the pipe elevations, however, the KPX MCS would capture any leakage from the pipe segments.
