December 21, 2018

RE: WA 31, Former Erwin Cleaners Project

TEST PIT LOCATIONS
ROCHESTER, NY

FORMER ERWIN CLEANERS

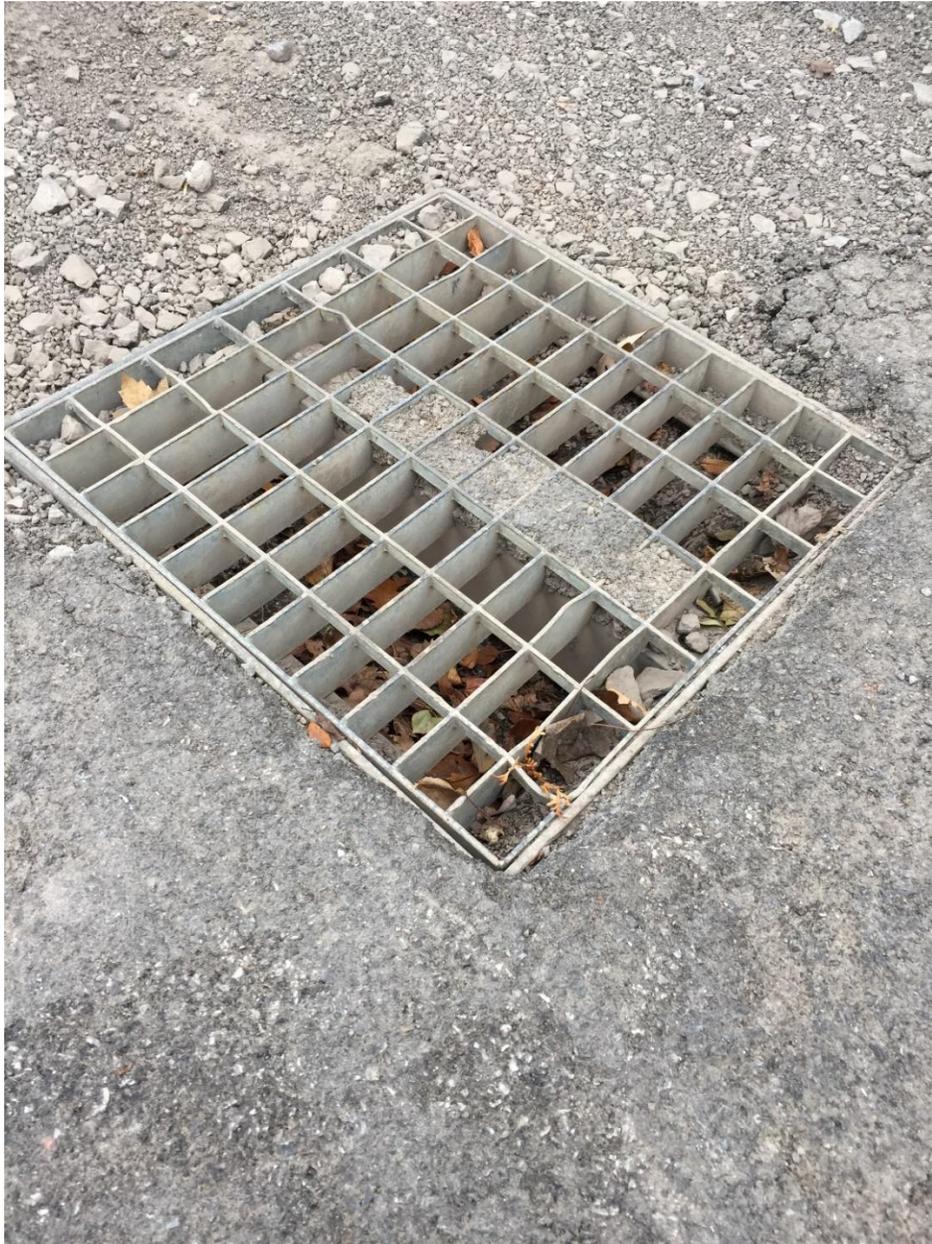
Upon arrival, initial site inspection found the drainage basin almost entirely full of sediment, which was within 6-9 inches from the top of the basin's grate. The parking lot of the neighboring property also showed evidence of significant erosion, with a large number of pot holes throughout. The original area of excavation on the Erwin property had similar erosion as well, though it was not as significant.

Photo #1: Drainage Basin upon arriving on site, filled with sediment.
Former Erwin Cleaners
December 18, 2018

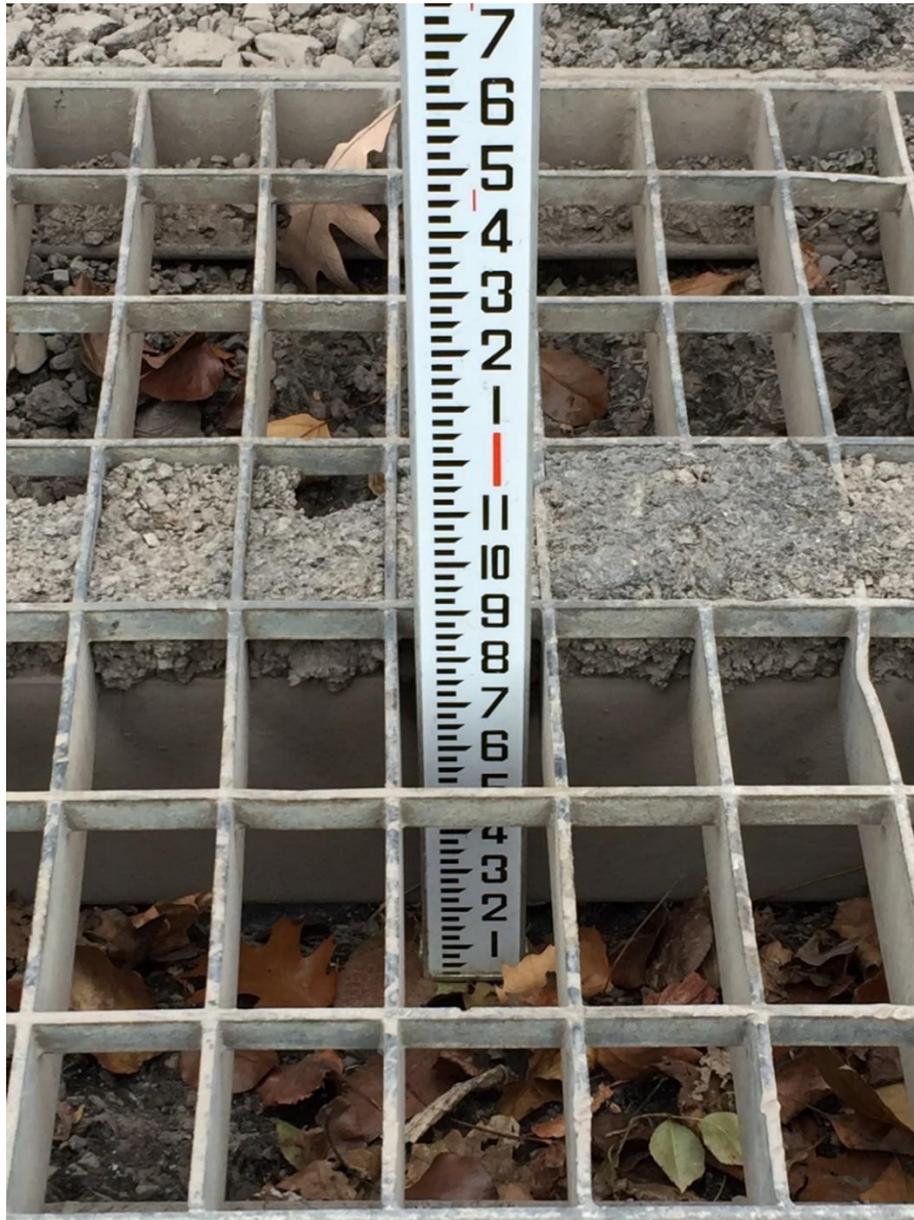
Photo #2: Depth of sediment within the Drainage Basin.
Former Erwin Cleaners
December 18, 2018

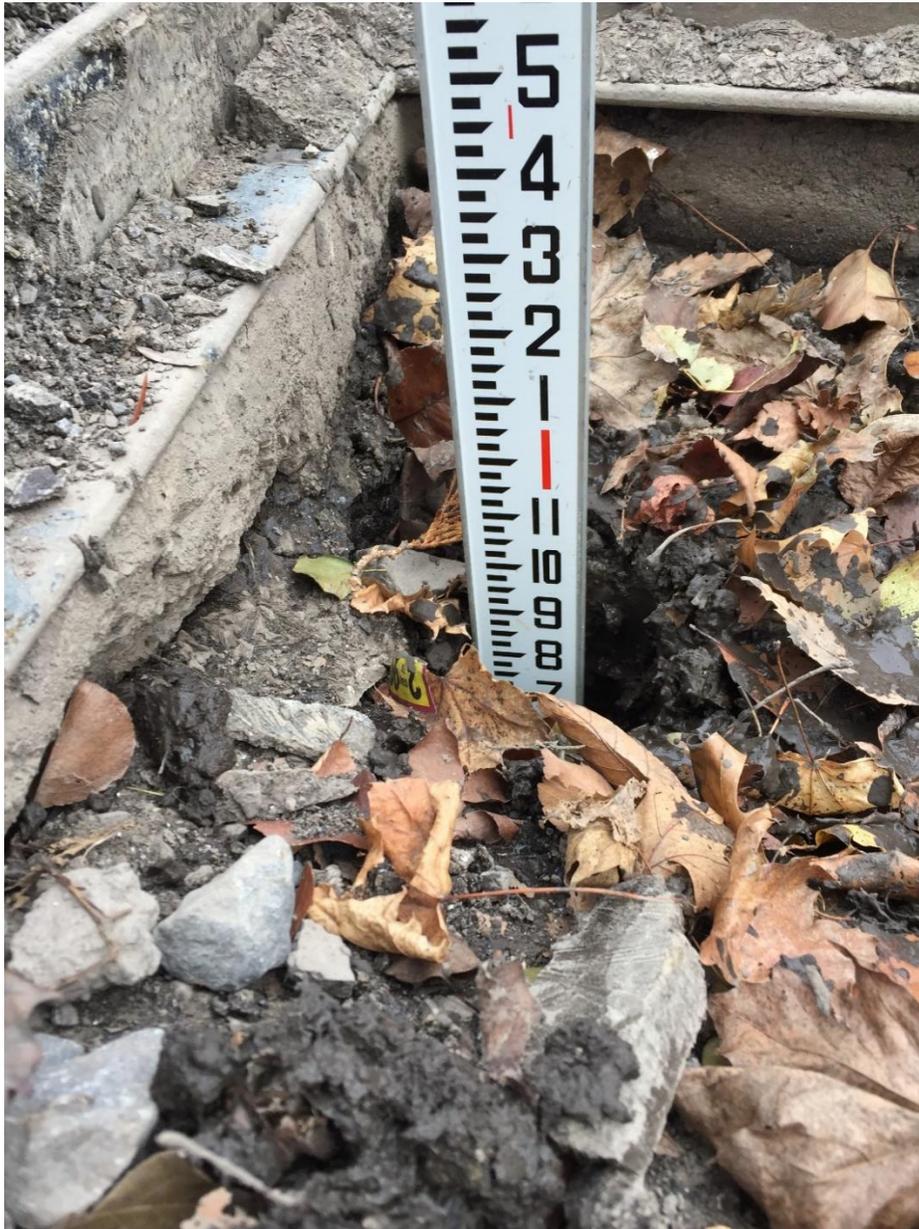
Before work began, a sediment sample was collected by Parsons in the drainage basin. A hand auger was used to reach between 0.5 and 1 feet below the surface, where the sediment sample was collected

Photo #3: Depth and location of sediment sample in the Drainage Basin.
Former Erwin Cleaners
December 18, 2018

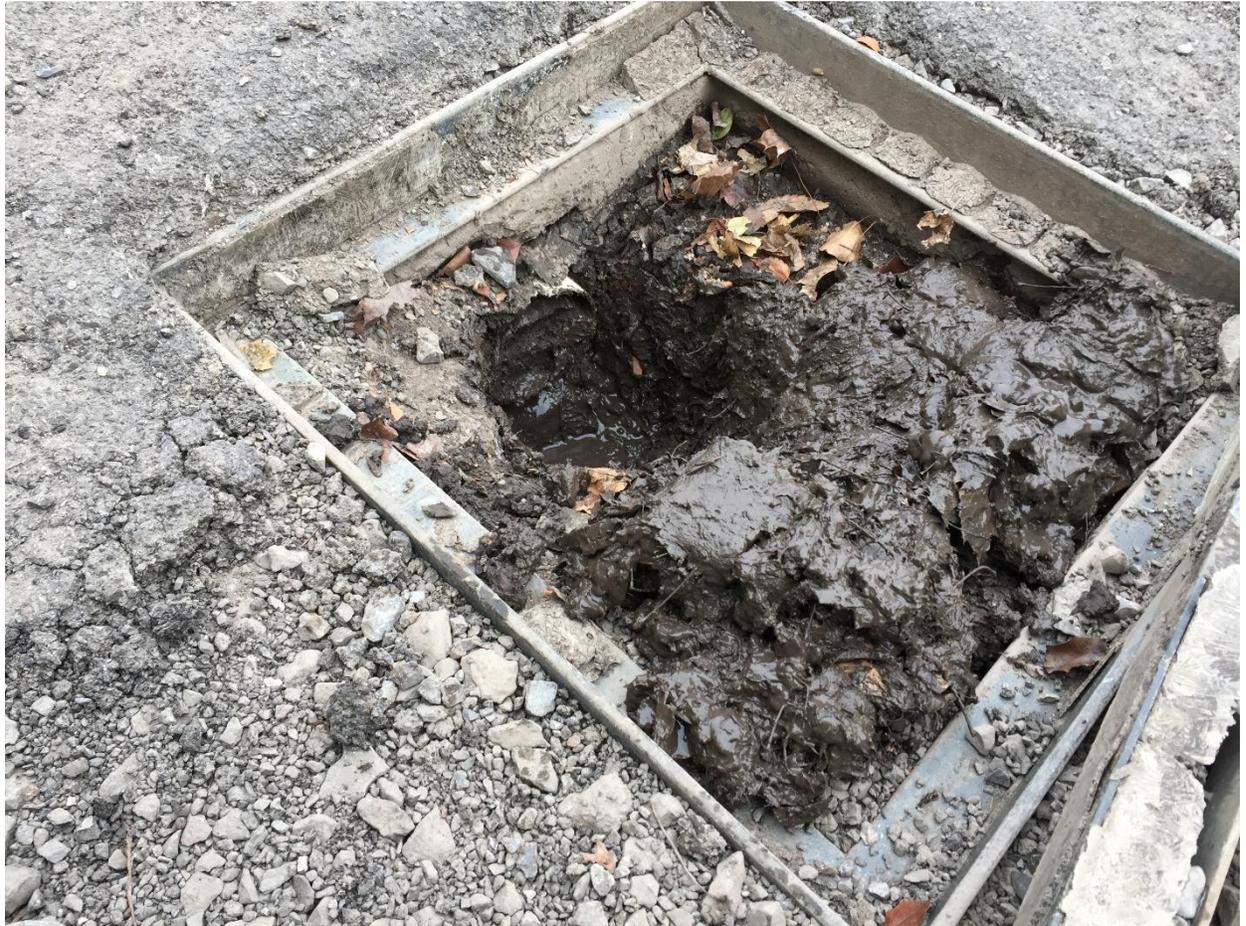
Photo #5: Uncovered outlet pipe in the Drainage Basin.
Former Erwin Cleaners
December 18, 2018

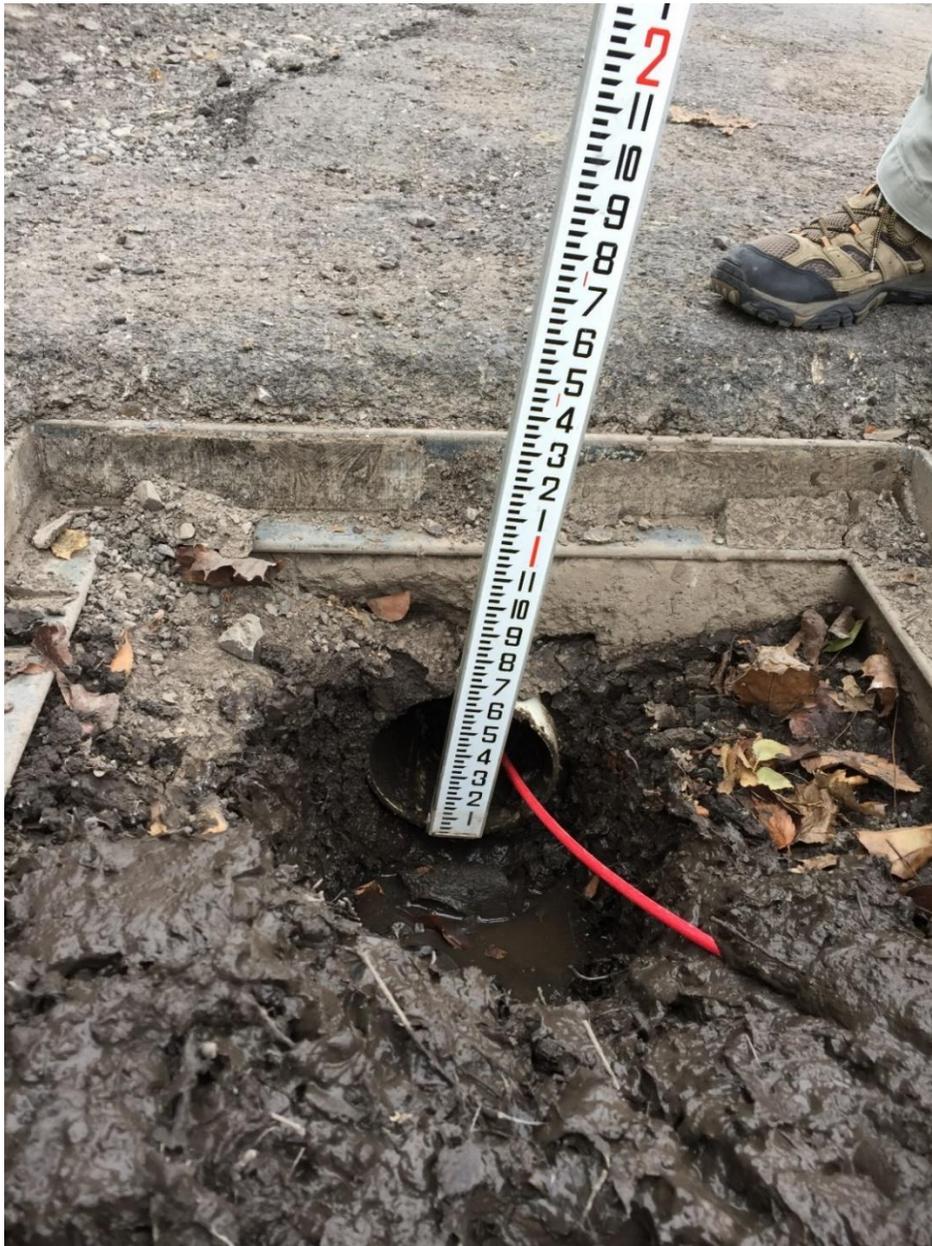
Photo #6: Depth of the outlet pipe in the Drainage Basin with the probe line.
Former Erwin Cleaners
December 18, 2018

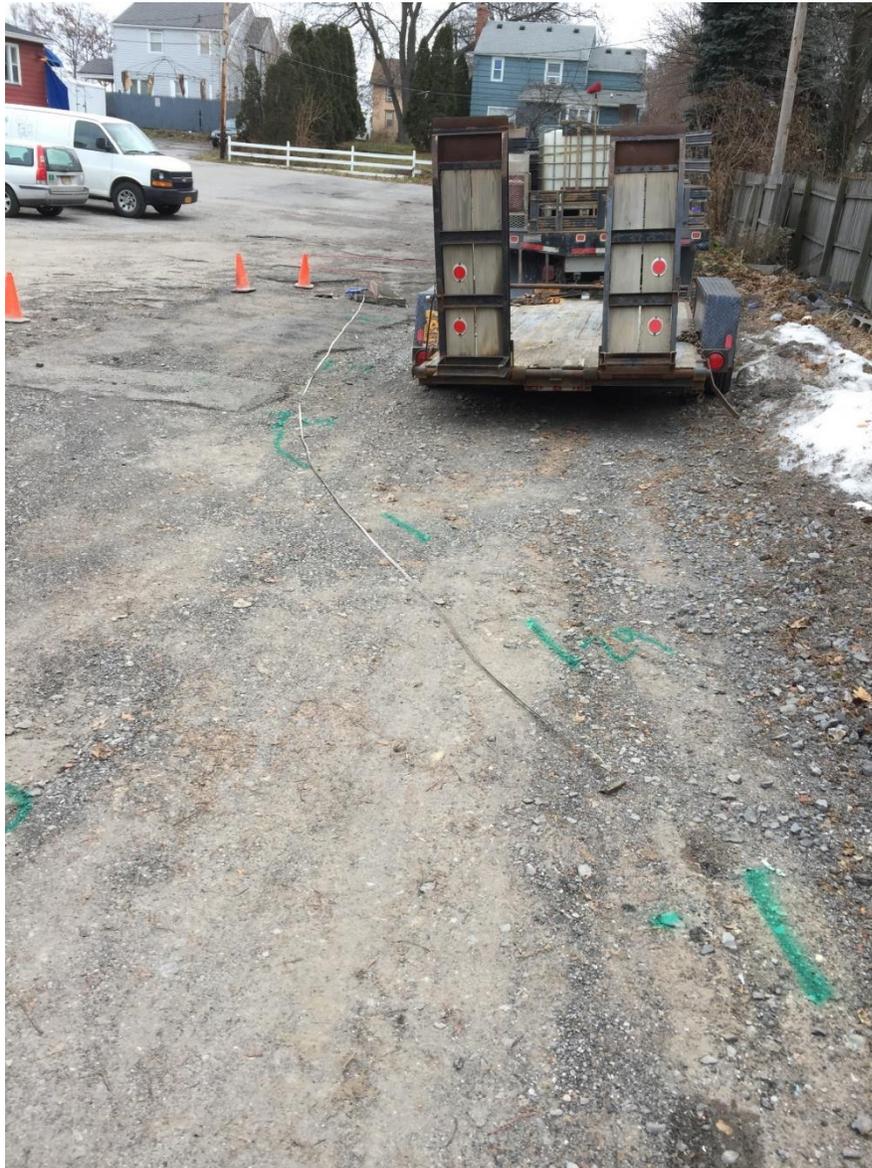
The second method used by Thew to determine pipe location was use of electromagnetic sensing equipment . A copper probe was placed in an open end of a pipe and manually advanced until an obstruction was reached. An electrical current is then introduced to the wire, and an electromagnetic sensor is used to trace the pipeline. The location of the suspected pipes were marked on the surface with green paint. Two different pipelines were investigated using this technique. The first was the pipe leaving the drainage basin. The investigation indicated that the pipe traveled west for approximately 20 feet before turning southwest and heading in the direction of the fence line. After an additional 20' of curving pipe, the probe reached some sort of obstruction and could not be advanced any further.

Photo #8: Results of the probing of the drainage basin pipe. The green marks indicate where the line was detected underground, between 2 and 3 feet below the surface. The probe line was not detected past the final mark in this picture.

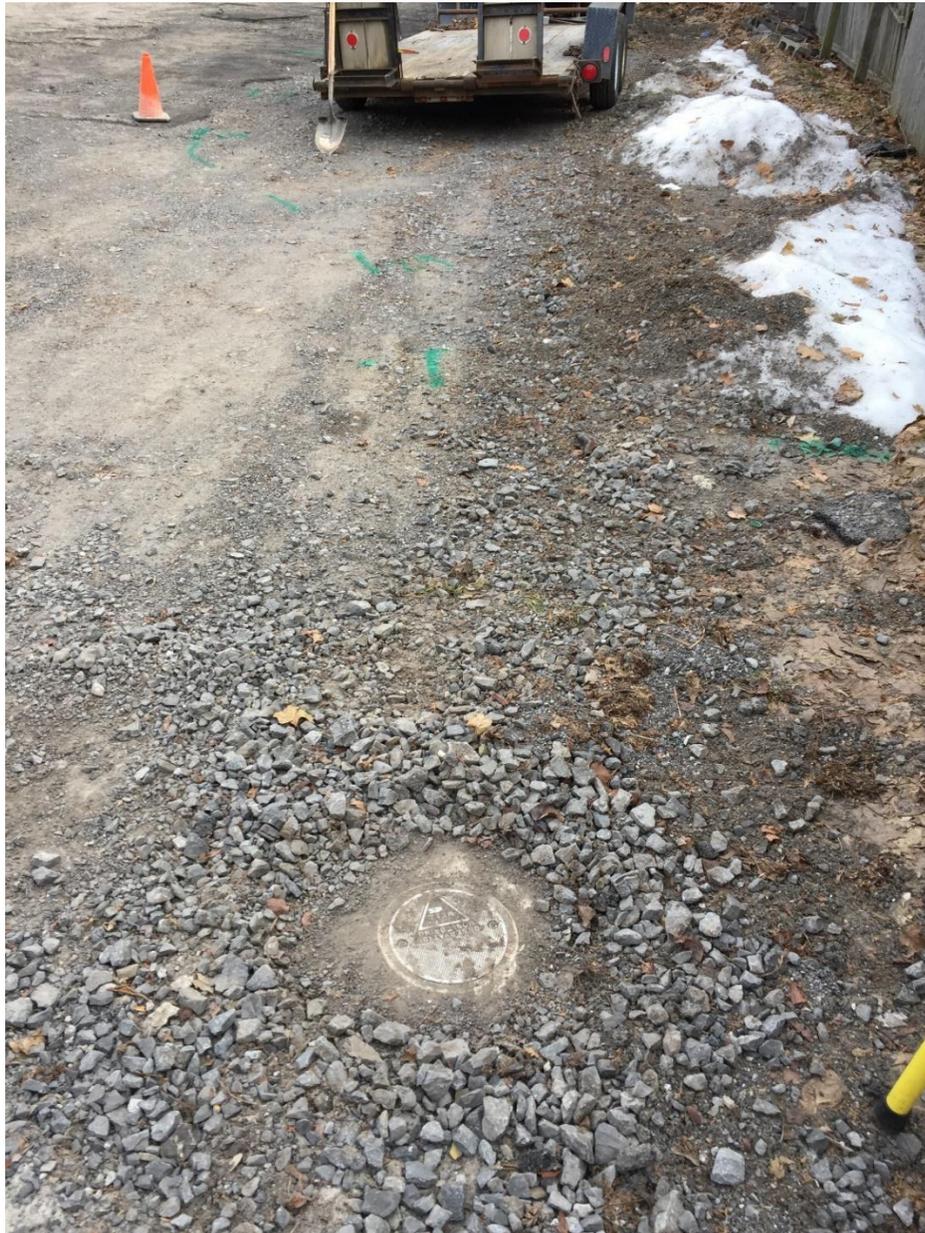
Photo #9: Proximity of the pipe probe detection to monitoring well MW-10.
Former Erwin Cleaners
December 18, 2018

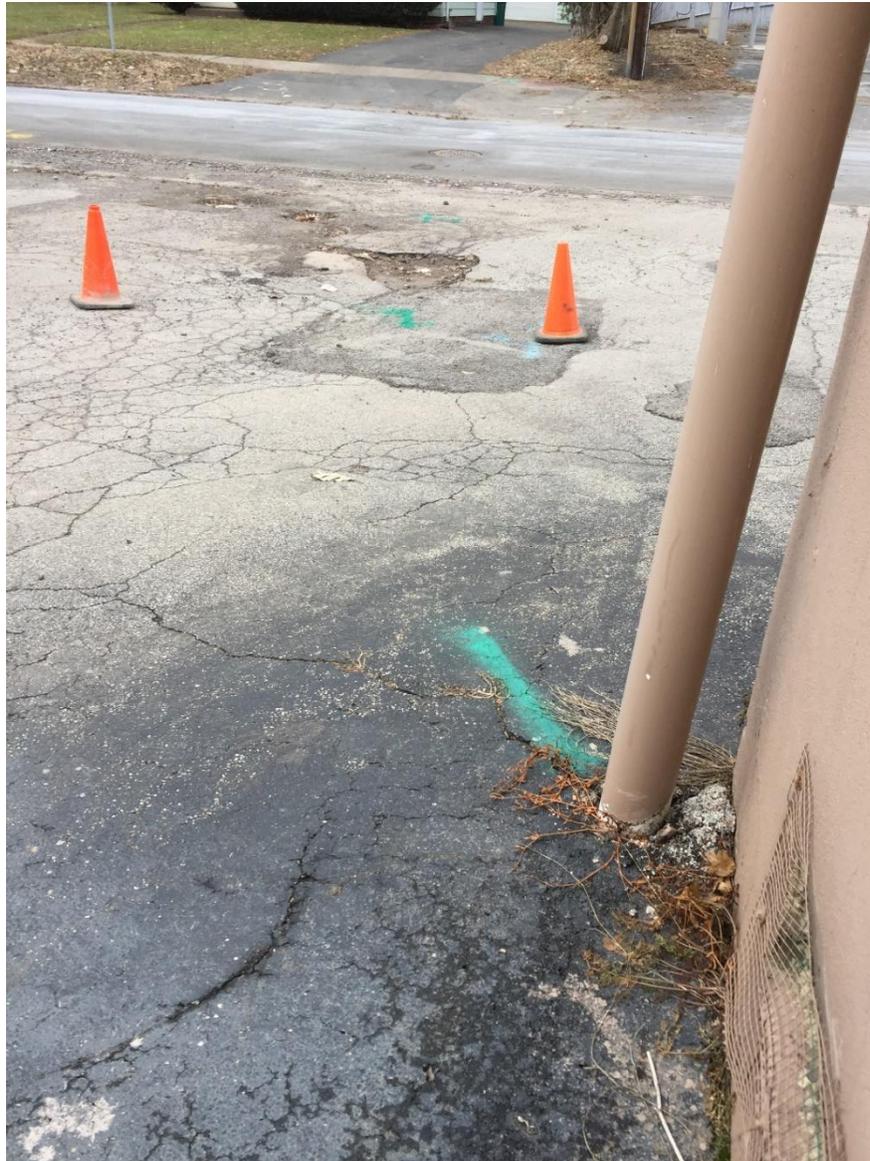
The second pipeline investigated was a lateral pipe entering the stormwater manhole located on Corona Road adjacent to the rear driveway to the site. This lateral pipe was identified during a previous site investigation. Based on its location and entry direction, it was initially thought that this may be the original outlet for the drainage basin. However, upon investigation this line using the electromagnetic techniques described above, it was determined that the lateral pipe was for a stormwater roof drain for the adjacent building.

Photo #10: Investigation of a pipe that was discovered by Parsons during a previous investigation where the pipe was found to be connected to the stormwater sewer. Probing determined that the line was connected to a stormwater drain on the neighboring building.

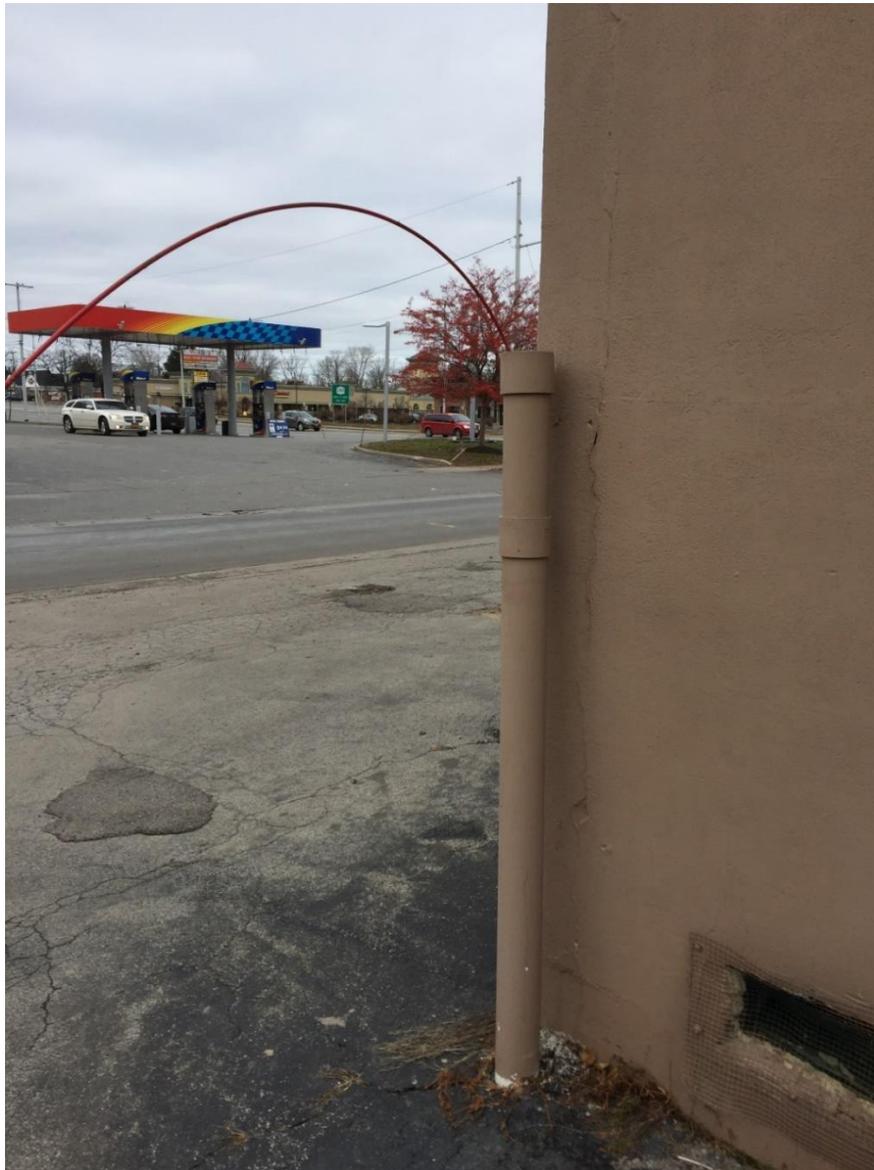
Photo #11: Probing of the stormwater drainage line to confirm that it was not related to the project.

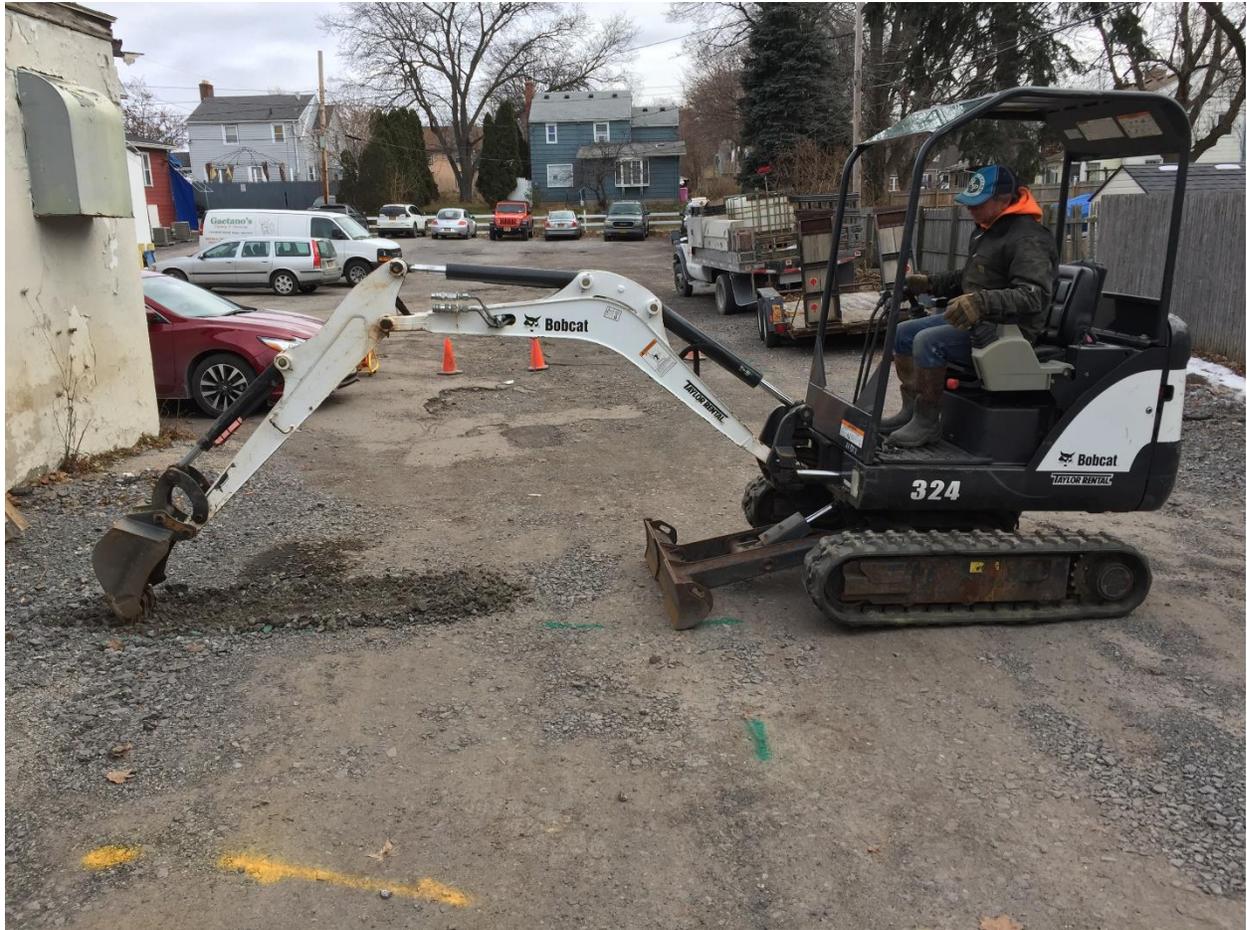
Photo #12: Excavation of Test Pit 1. The goal of this was to find a pipe previously seen in photographs of the initial excavation to confirm its status (See Photo #13).
Former Erwin Cleaners
December 18, 2018

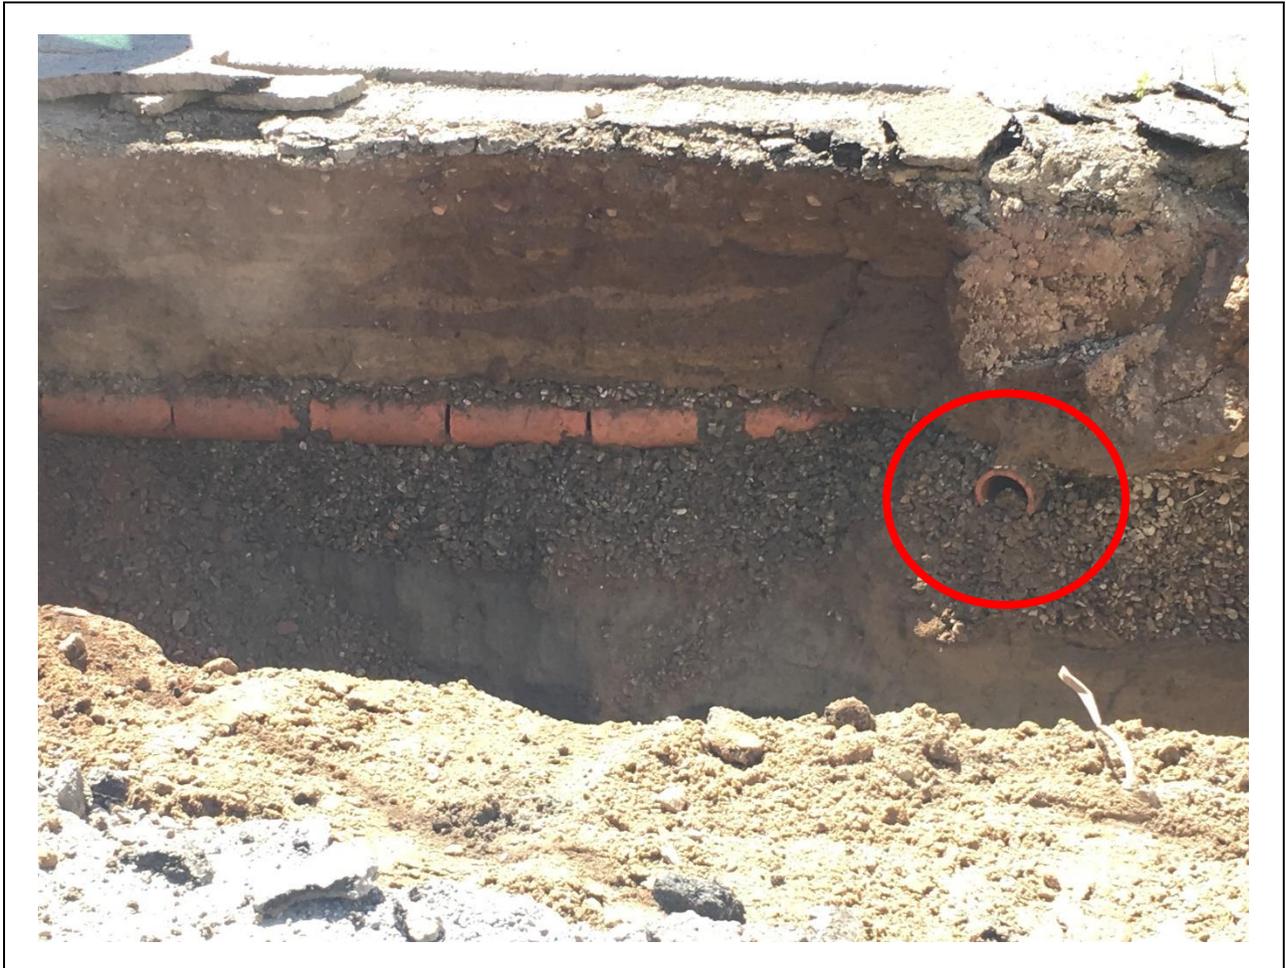
Photo #13: Photo taken during the original excavation with a lateral pipe shown on the western side of the excavation.
Former Erwin Cleaners
December 18, 2018

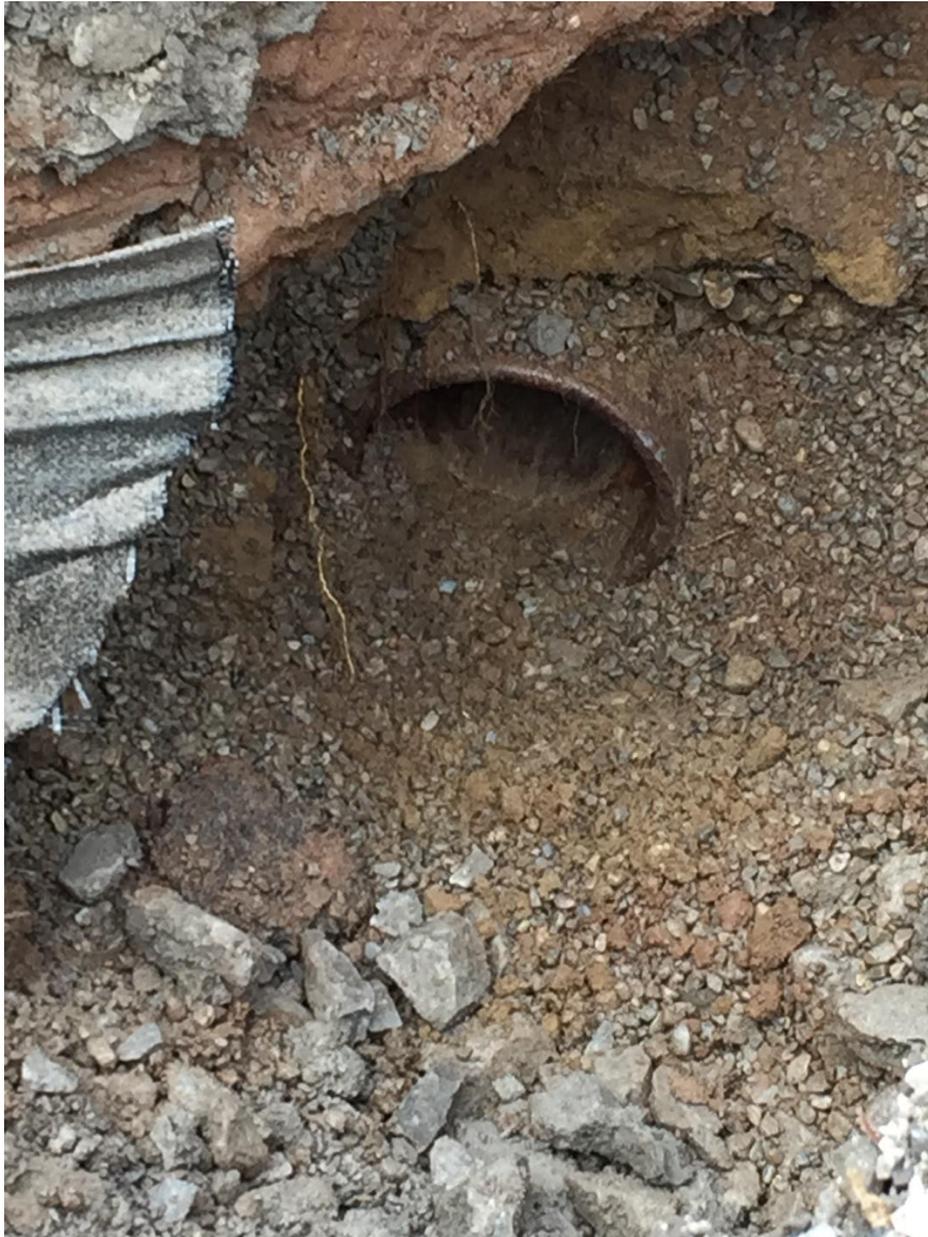
Test Pit 1 was dug in the northwest corner of the original excavation area, with the goal of finding the lateral pipe that was initially seen in pictures from the western side of the original excavation (see Photo #13). The pipe was uncovered approximately 2 feet down. Probing of the pipe determined that it originates from the nearby building and is not related to the stormwater drainage line on site.

Photo #14: Pipe found in Test Pit 1. Probing determined that this pipe leads back towards the Erwin Cleaners building and is unrelated to the drainage line in question.
Former Erwin Cleaners
December 18, 2018

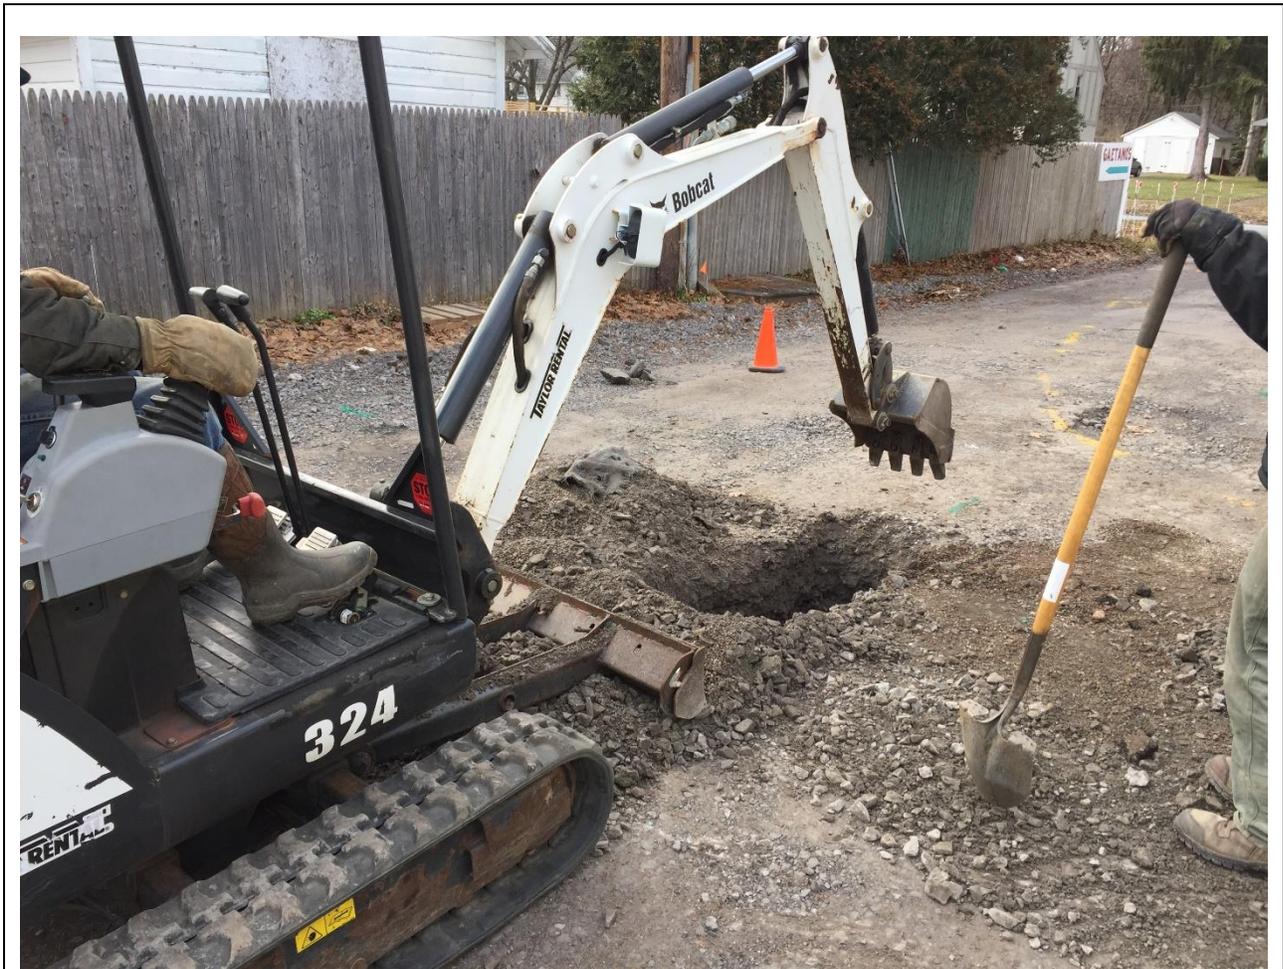
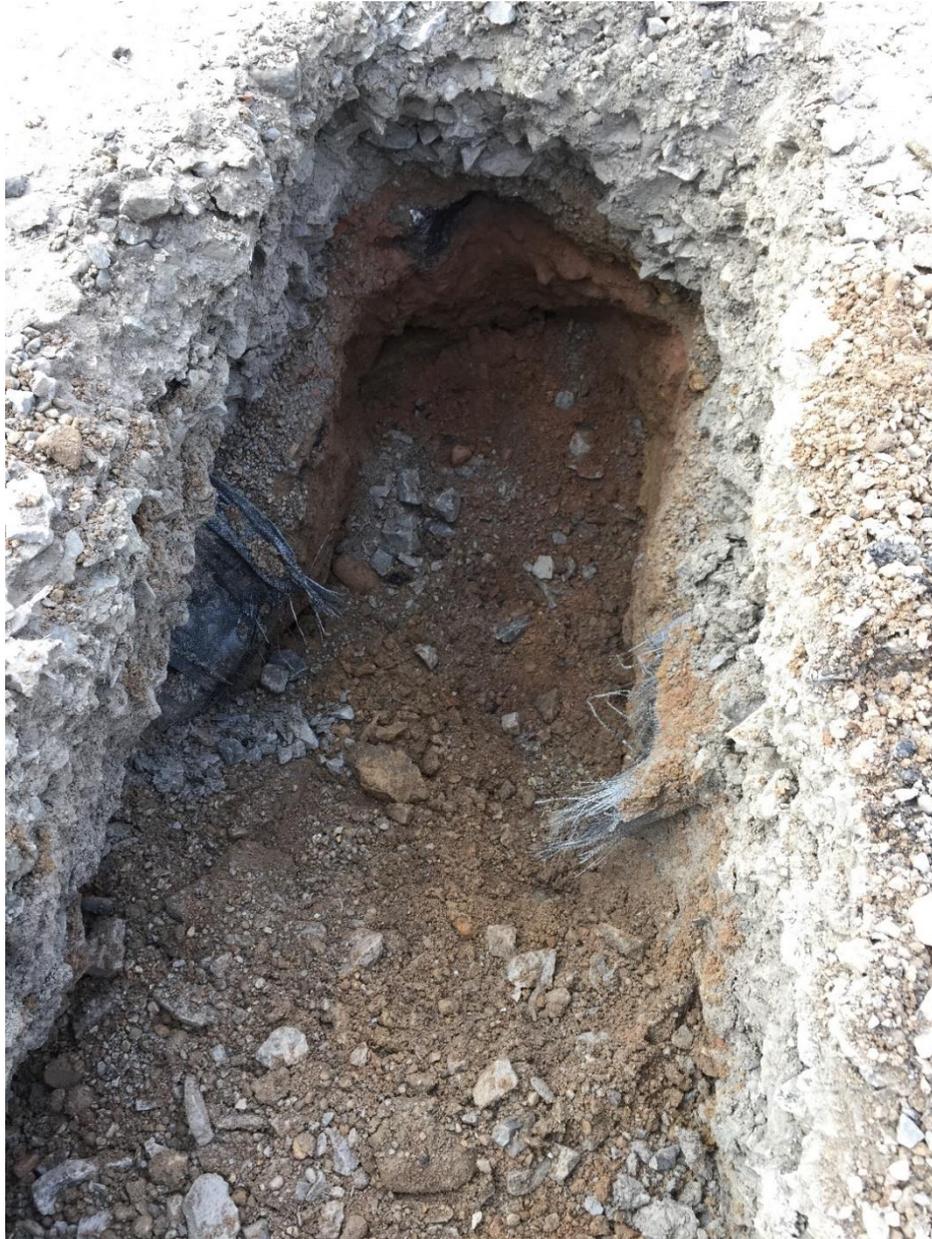
Test Pit 2 was dug along the western edge of the original excavation. Use of the GPR indicated that there may be a pipe in this location approximately 2 feet below the surface, extending from the western side of the excavation towards Corona Road. The test pit was dug to the edge of the original excavation and down approximately 3 feet. However, the feature shown on the GPR was not located.

Photo #15: Excavation of Test Pit 2. The goal of this pit was to find evidence of a probable pipe seen with the GPR. The test pit was dug to the western edge of the original excavation, but the pipe was not found.
Former Erwin Cleaners
December 18, 2018

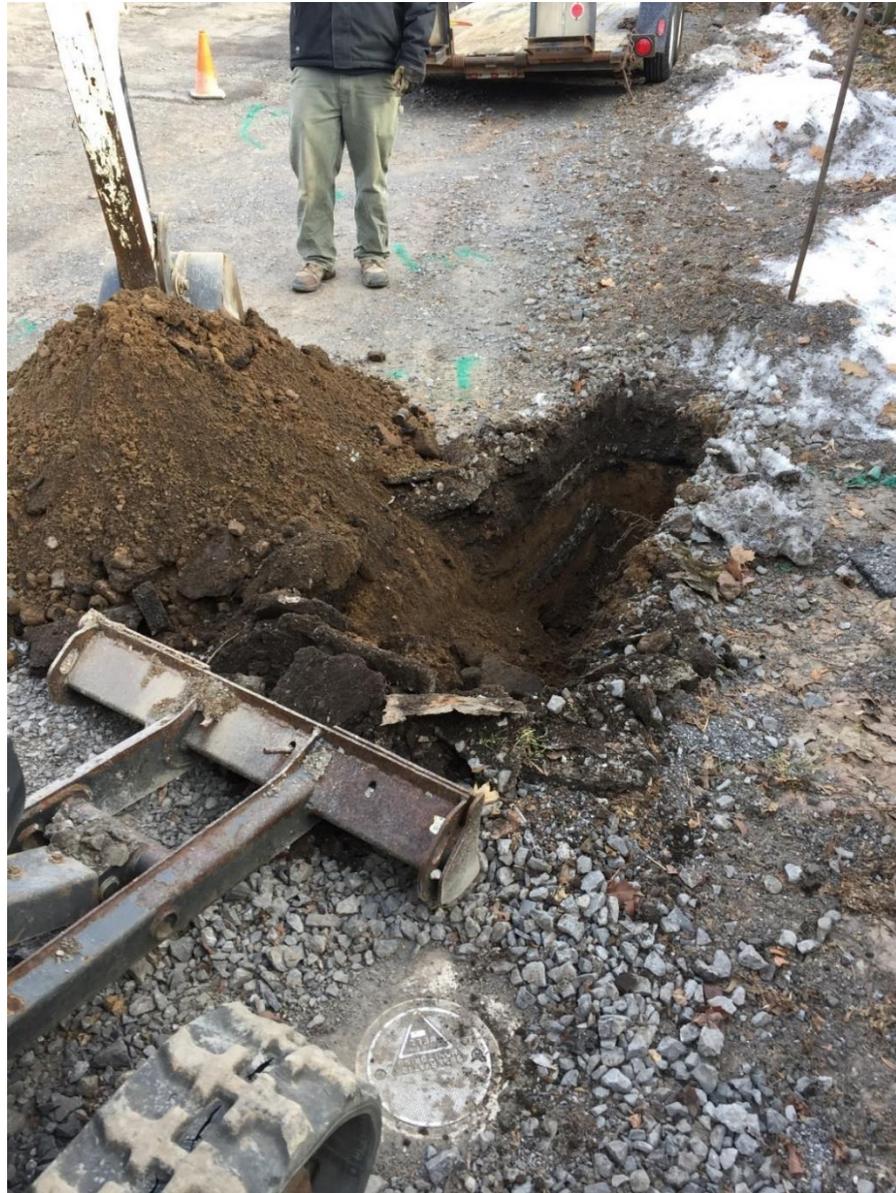
Test Pit 3 was dug approximately 15 feet away from the eastern edge of the original excavation. This location was the last point where the copper probe was detected in the pipe. The drainage pipe was eventually found between 2 and 3 feet below the surface. Overall,

Photo #17: Excavation of Test Pit 3. Excavation of the point where the last detection of the probe in the drainage basin pipe.
Former Erwin Cleaners
December 18, 2018

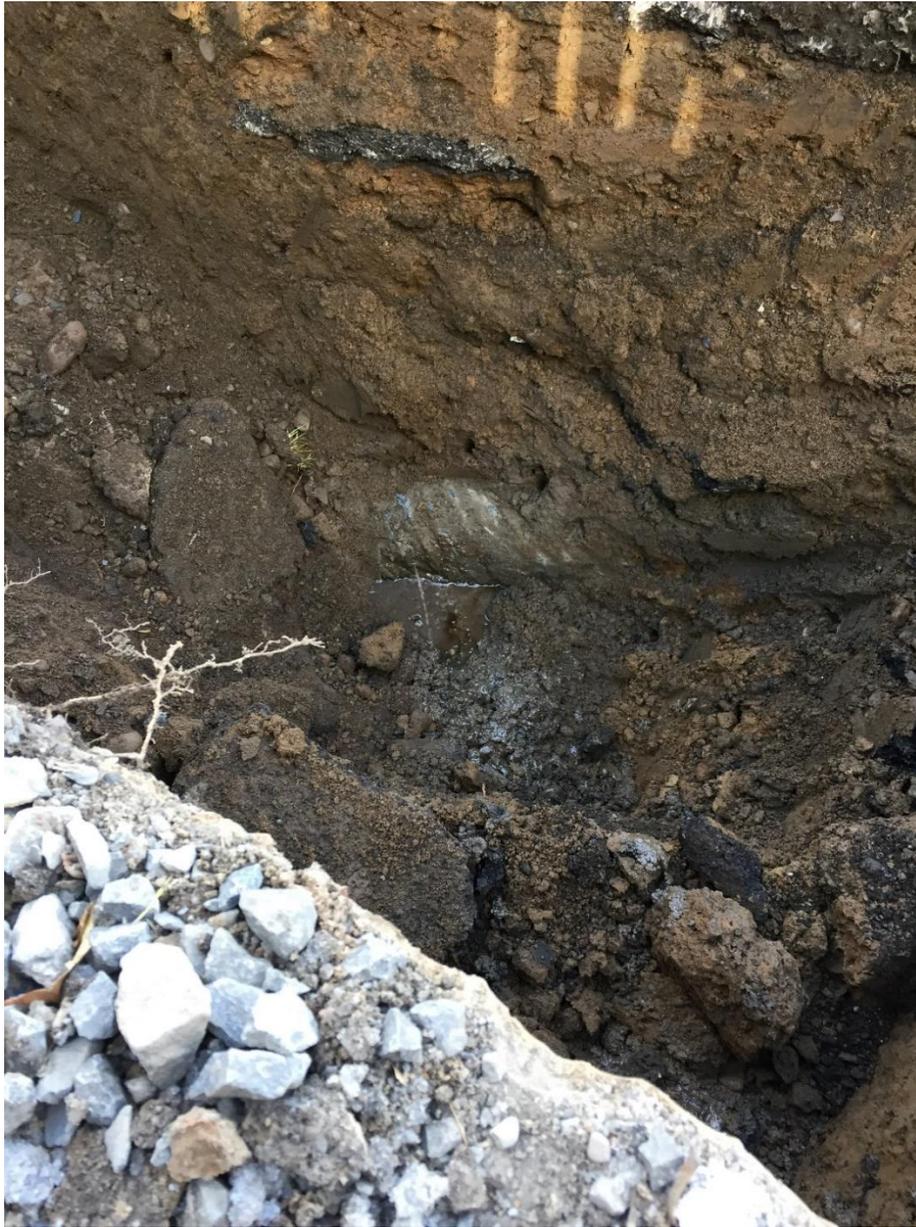
Photo #18: Point of discovery of the drainage basin pipe in Test Pit 3.
Former Erwin Cleaners
December 18, 2018

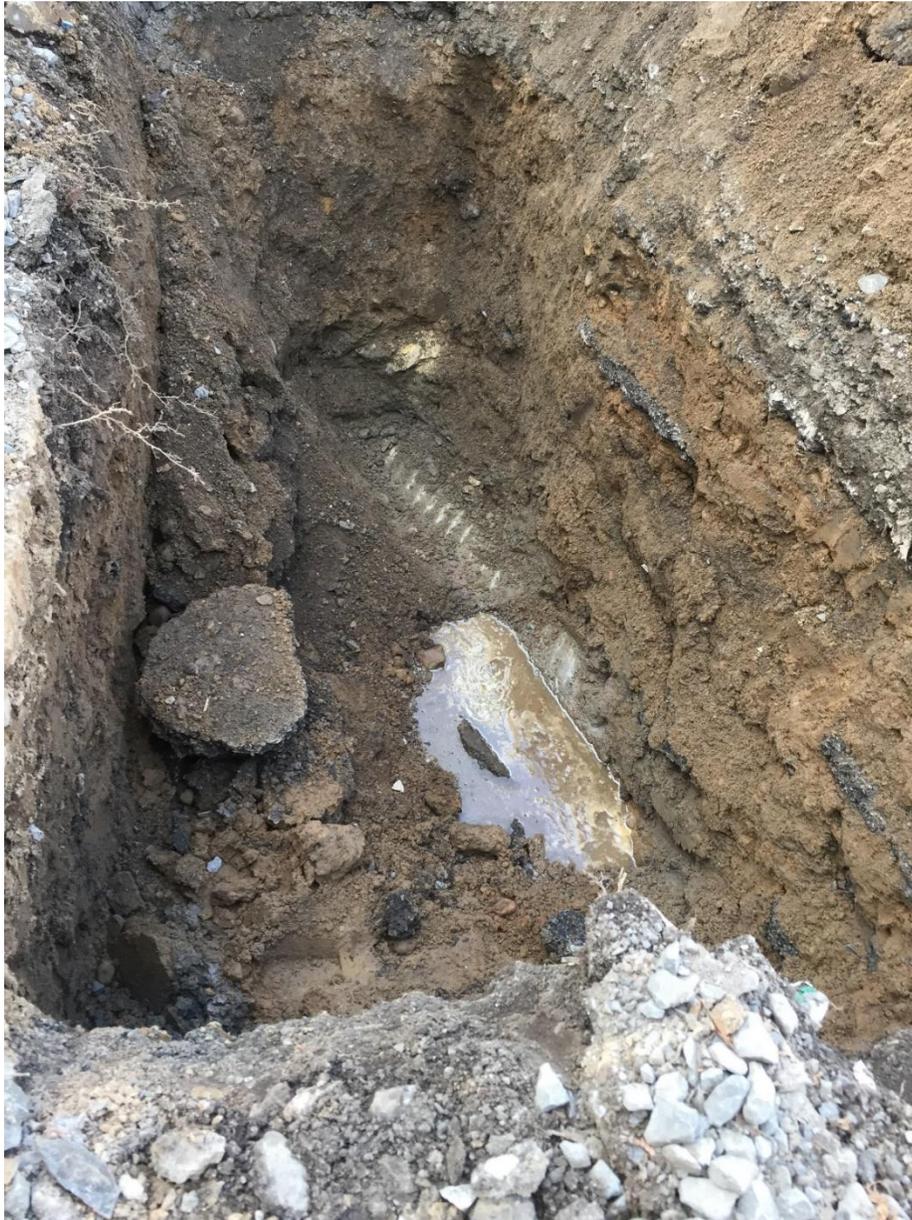
approximately 10 feet of pipe was uncovered, including the section of pipe that the probe could not pass. The stretch of pipe that was uncovered was entirely intact, with no obvious breaks or crushed areas that would cause an obstruction. On the eastern edge of the excavation, a coupling was found in the pipe, which gave the pipe a slight bend. The coupling appeared intact, though there was some indication of water leaking through the joints once it was exposed. The test pit excavation continued along the pipe until the excavation was within approximately 3 feet of monitoring well MW-10. Excavation was stopped due to the location of the well and concerns with compromising the integrity of the monitoring well. However, the current path of the pipe indicated that it may be in line to intercept the location of the well (See Photo #20), leading to the possibility that the boring for the well pierced or obstructed the pipe in some way, causing the current drainage issue. Please note, prior to the installation of MW-10, Dig Safely was called to mark out utilities on the site, a geophysical investigation was conducted, and hand clearing to 5 feet was completed prior to installation of the well. There was no evidence of a drainage line noted at that location at that time.

Photo #19: Larger length of pipe uncovered in Test Pit 3. Water began accumulating in the hole shortly after the pipe was uncovered. The pipe is intact, and water was pouring from a small hole.
Former Erwin Cleaners
December 18, 2018

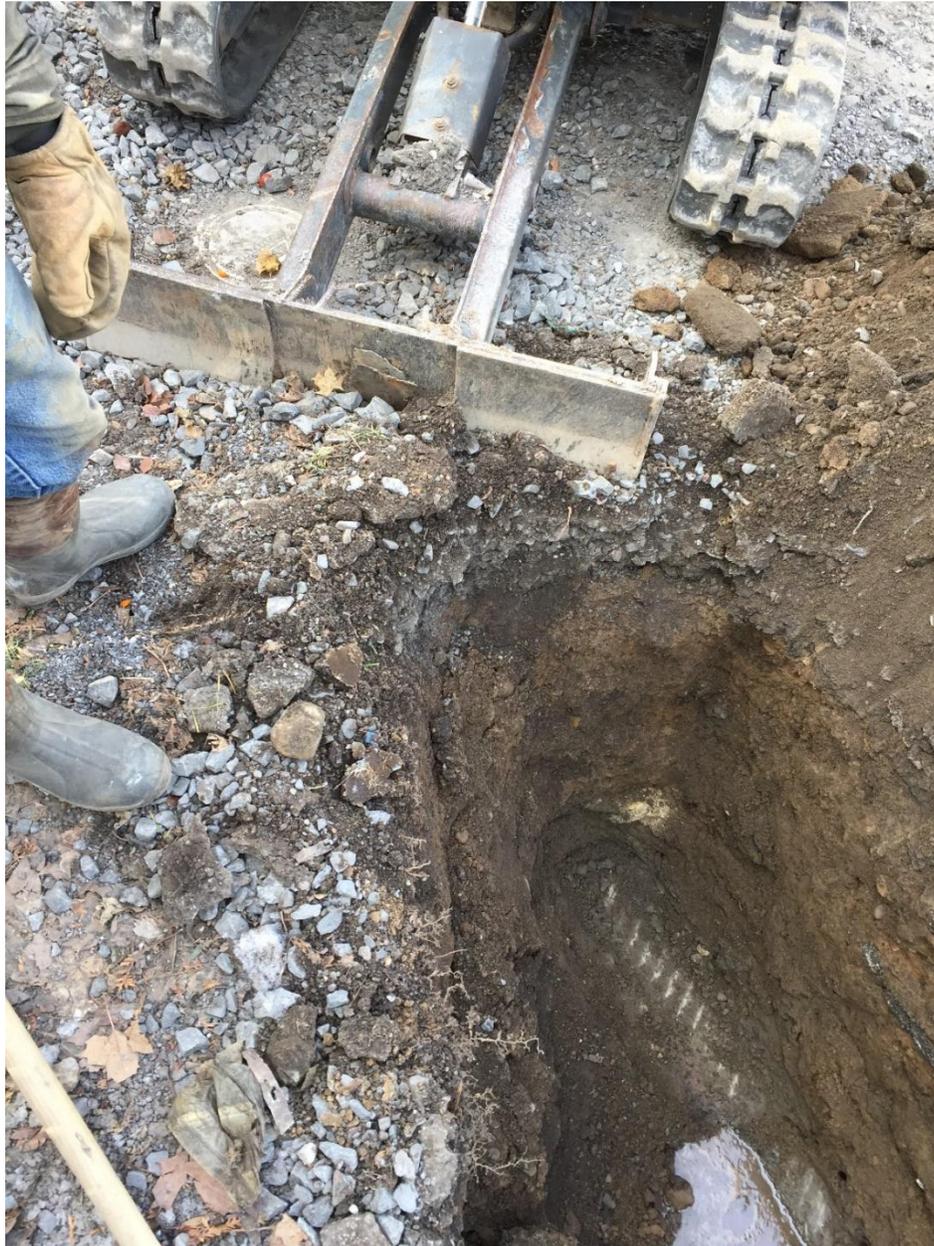
Photo #20: The proximity drainage pipe in Test Pit 3 to MW-10. Further excavation in this direction was not done in fear of compromising the monitoring well.
Former Erwin Cleaners
December 18, 2018
