December 21, 2018

RE: WA 31, Former Erwin Cleaners Project

TEST PIT LOCATIONS
ROCHESTER, NY

FORMER ERWIN CLEANERS

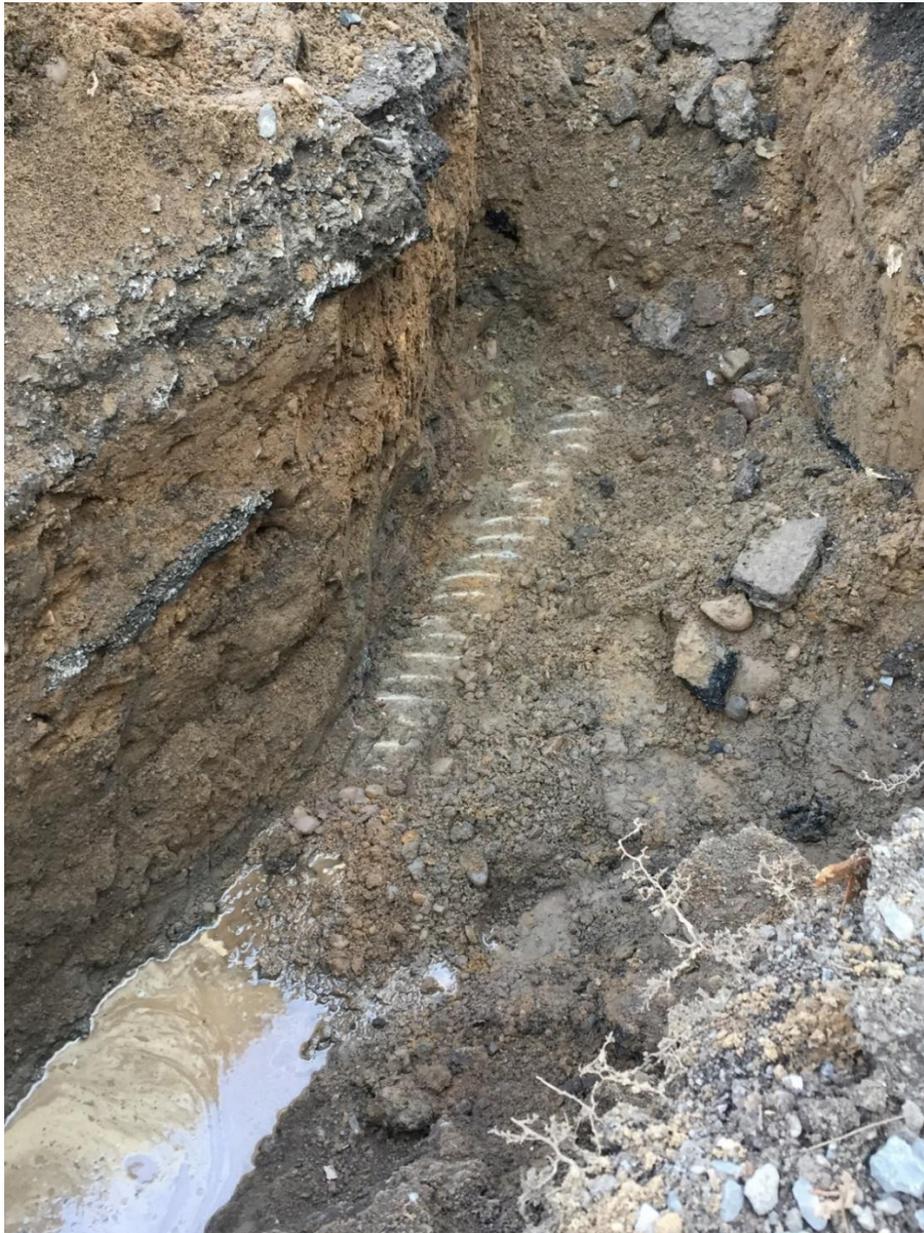
Photo #21: Approximate location of the last detection of the probe. Evidence suggests a blockage is here, though the pipe is intact and does not appear damaged.

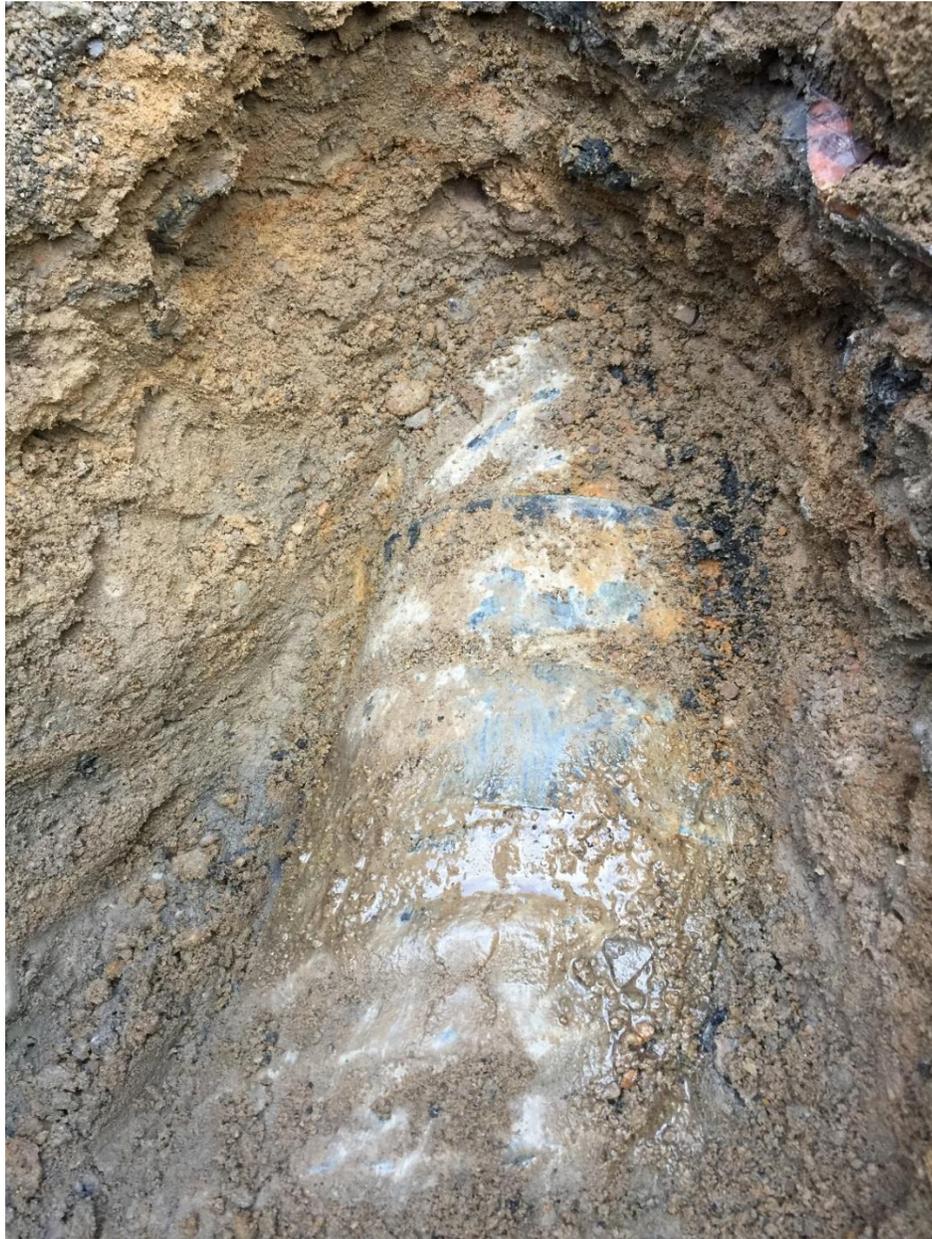
Photo #22: Coupling on the drainage pipe on the eastern end of the test pit excavation.
Former Erwin Cleaners
December 18, 2018

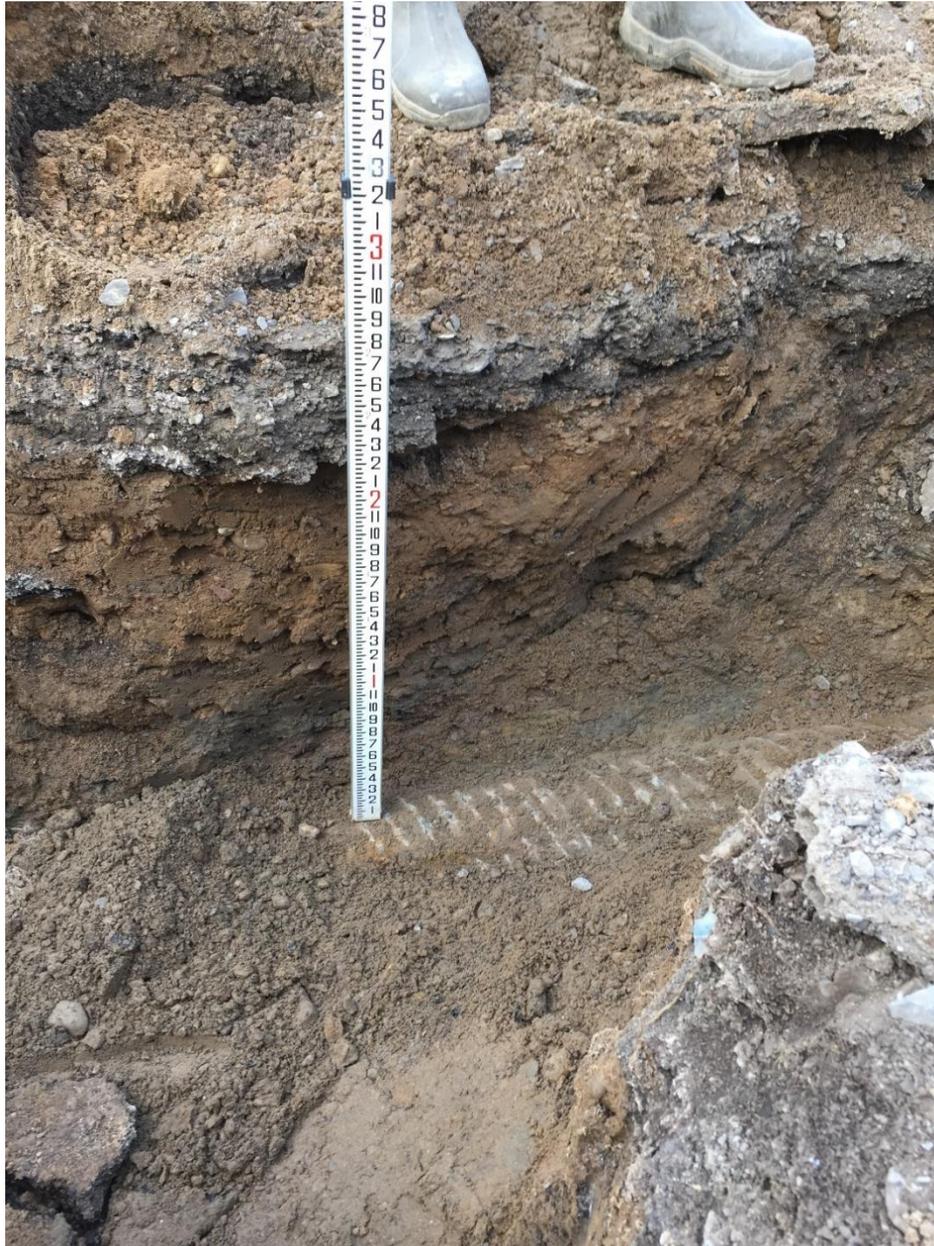
Photo #23: Approximate depth of the drainage pipe at the point of excavation.
Former Erwin Cleaners
December 18, 2018
