MEMORANDUM

To: Matthew Dunham (NYSDEC)
From: Heather Budzich and Tom Drachenberg (Parsons)
Subject: Building Demolition at the Former Erwin Dry Cleaners (Site ID 828154, D009811-15)

Former Erwin Cleaners Building Inspection (Site ID# 828154)

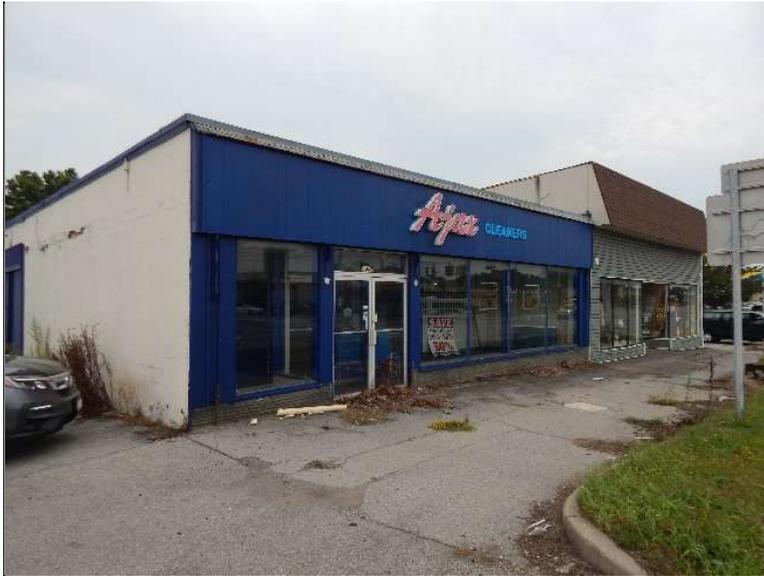
Description: View of front (north) side of building. Main entrance through double glass doors.

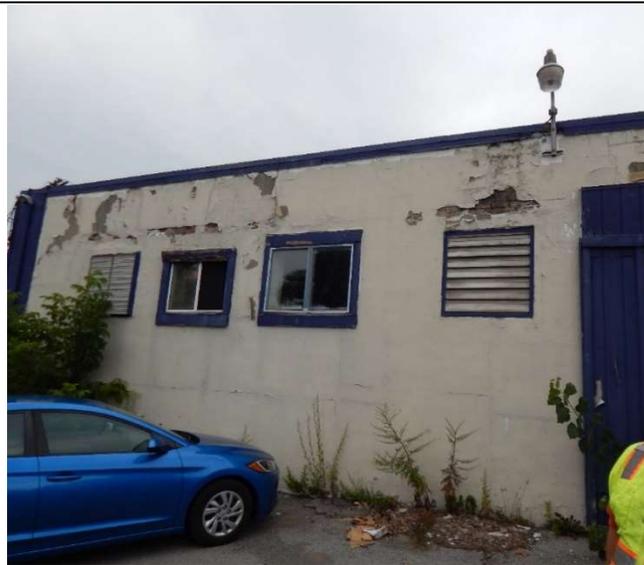
Description: View of east exterior wall. Note exterior has stucco which has been compromised due to water damage, especially in the parapet area.

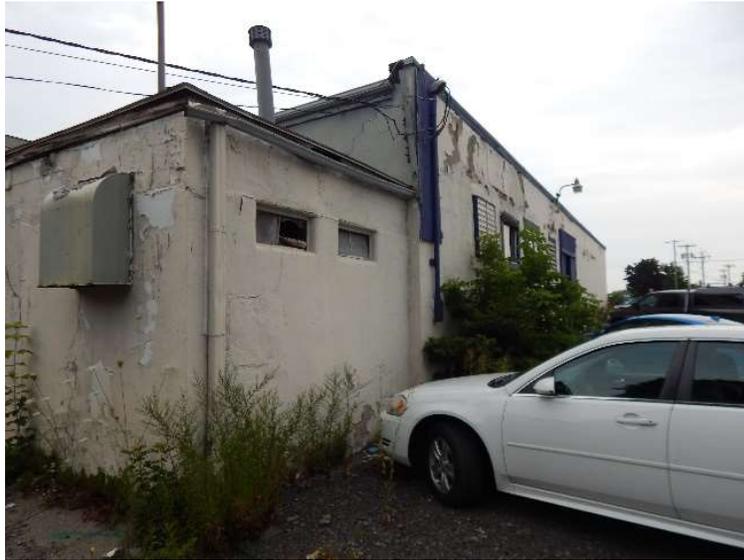
Description: View of southeast corner of building, looking northwest. Note 11-foot extension that was built on the south end of the building. Also shown, overhead three-phase electric service to building.

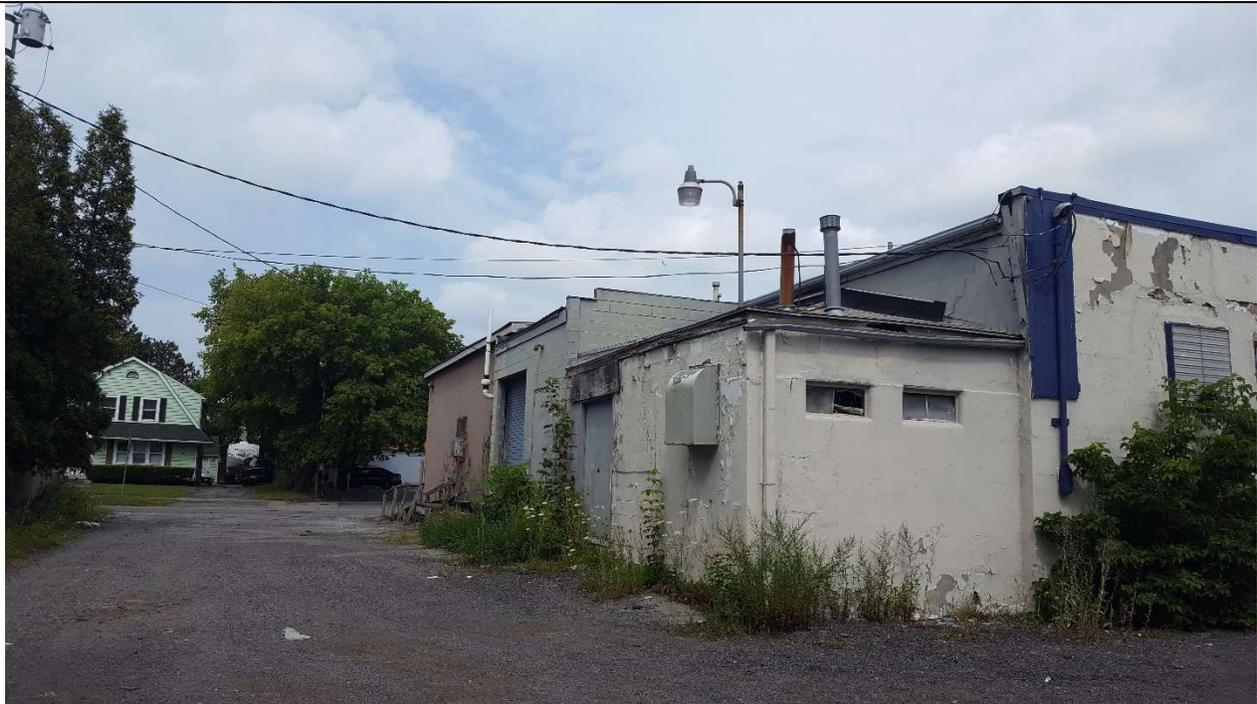
Description: View of east exterior wall and building “extension.”

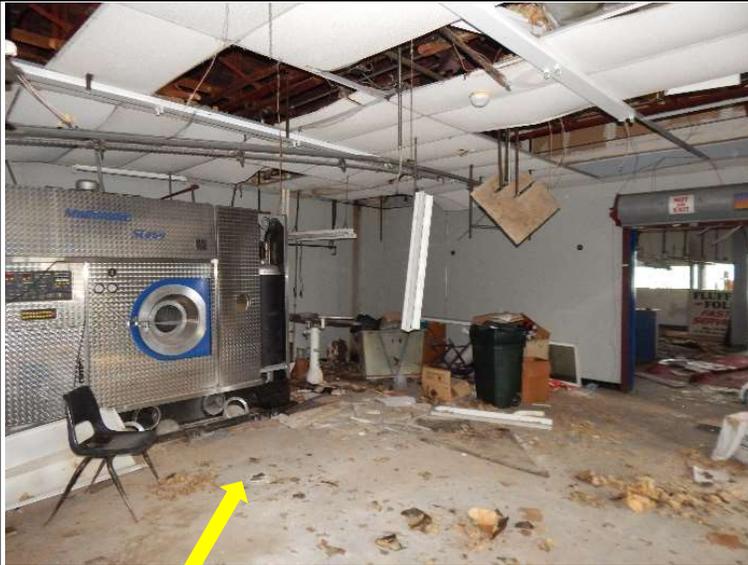
Description: View inside main building, looking west. The reception area and clothing pick-up/drop-off area is through the overhead door to the north (right side of picture). Note the ceiling is compromised throughout due to water infiltration. Former dry-cleaning equipment/machines remain. Yellow arrow pointing to SB-103/MW-13.

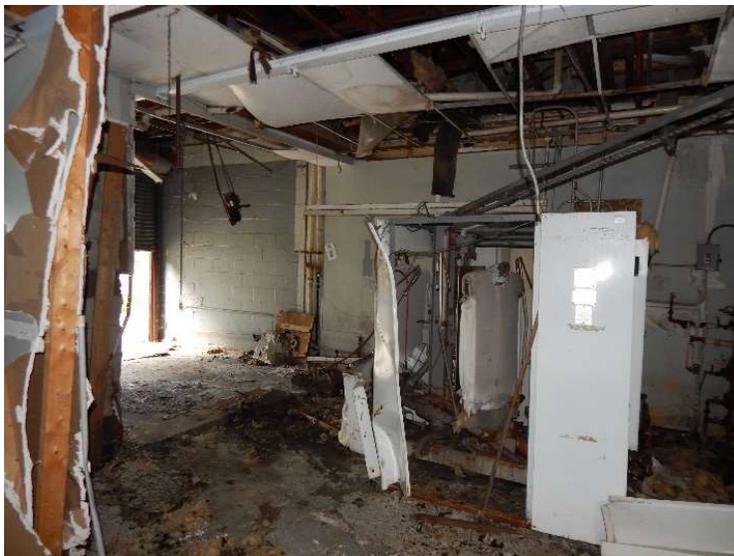
Inspection from the inside of the building found the roof is compromised throughout the building which has allowed water to infiltrate all areas of the building interior. Light was observed coming through the roof in several places. Water infiltration has caused ceiling panels and other debris to fall to the floor throughout the building. While the wooden roof is no longer salvageable, the steel trusses in the main portion of the building appear to be in good condition and can be reused. The brick walls were in fair condition. Both the exterior and interior walls appear to be straight, but both walls show signs of water infiltration from the compromised roof. The extent of damage to the brick walls cannot be fully determined since the exterior face of the walls are covered with stucco and the interior surface of these walls with sheetrock. Despite the presence of water damage, the walls appear to be structurally sound. Since the interior walls are not load bearing, they could easily be removed. The roof of the extension is completely compromised due to water damage.

Description: View inside main building looking southeast towards the "extension" area. Note the ceiling is compromised throughout due to water infiltration.

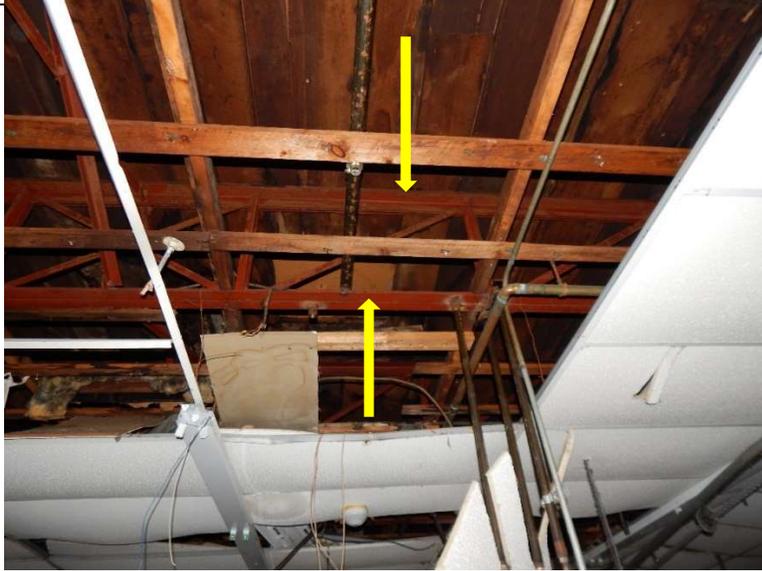
Description: Looking up at transverse steel roof trusses. Note that the suspended ceiling is compromised throughout. Overhead ceiling tiles no longer in place.

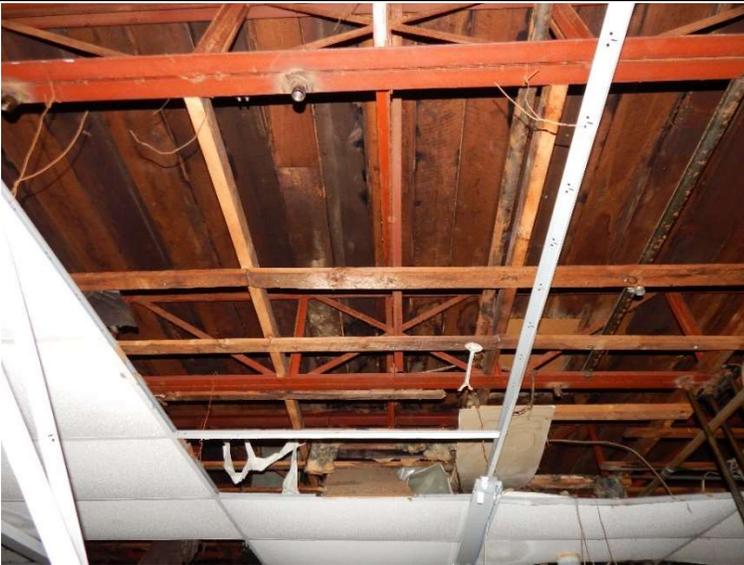
Description: Another view looking up at roof trusses (east-west) which support the roof. Note longitudinal wooden boards that form the roof, north to south.

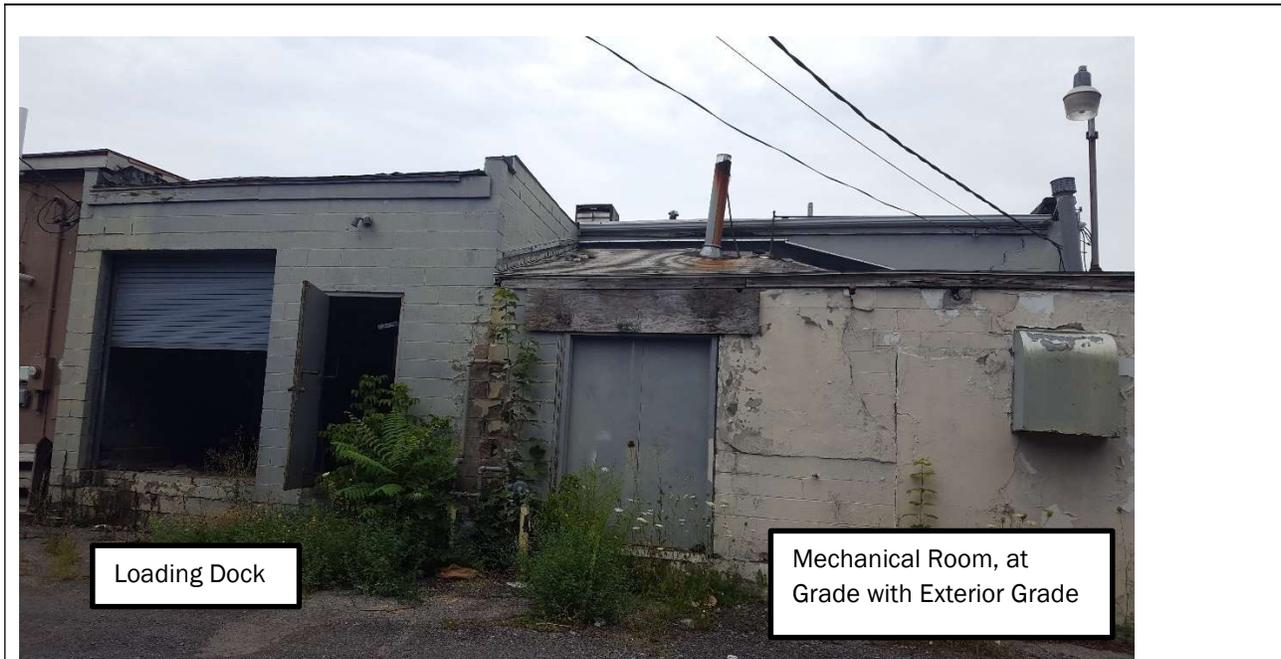
Description: View to the north, looking at southern facing exterior wall.

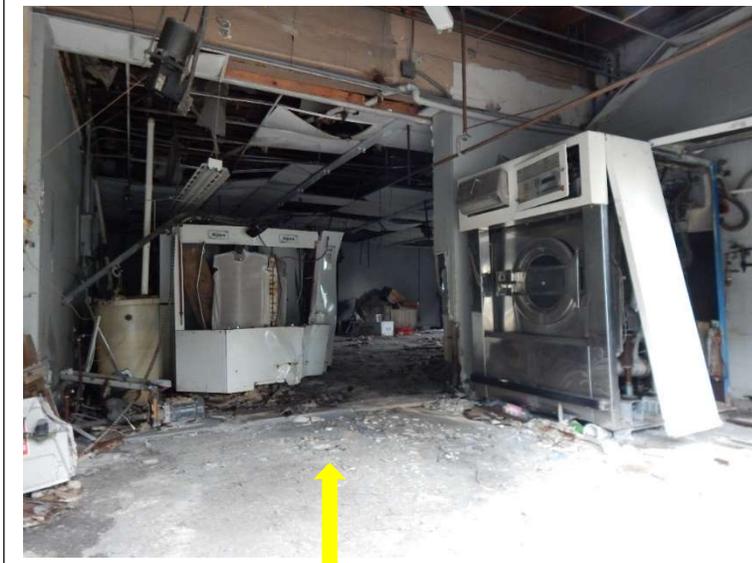
Description: View to the north, standing in the overhead door on south side of building, in the building "extension." This room is referred to as the loading dock. Note compromised ceiling and water infiltration throughout. Additionally, dry cleaning equipment remains. To the right, (not shown in picture), are steps down to the mechanical room, which is located at grade with the building exterior. Yellow arrow is pointing to SB-107.

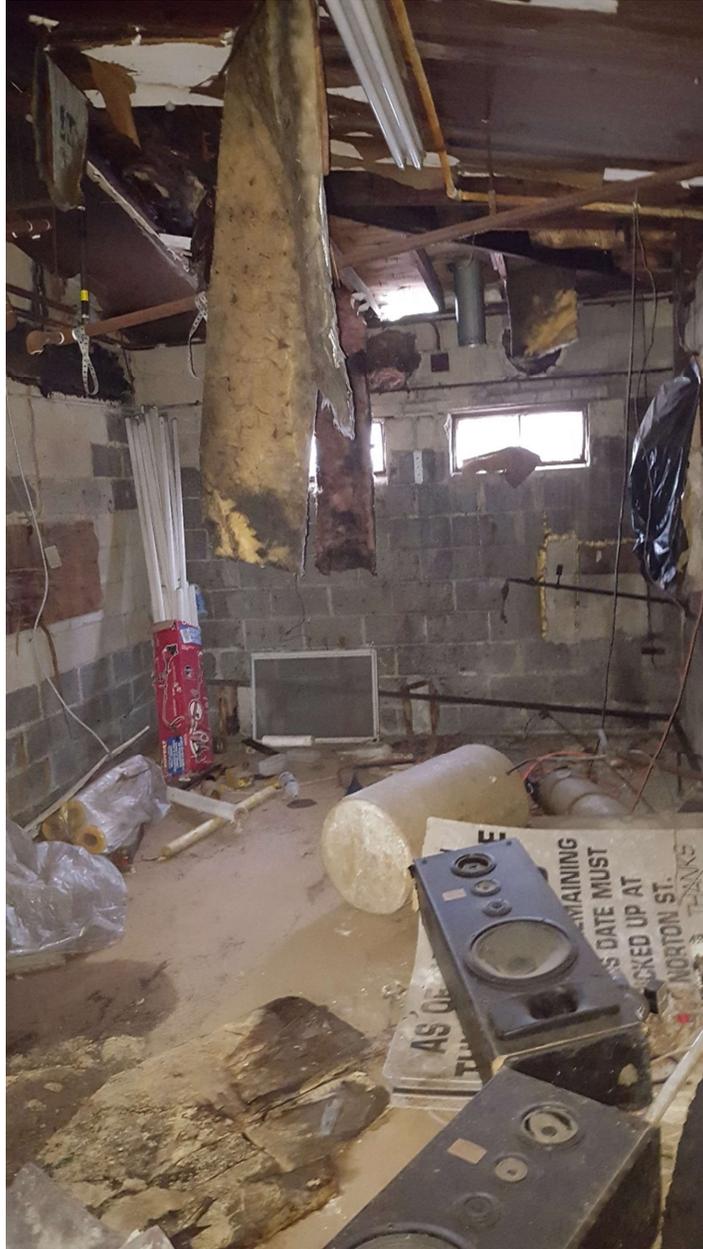
unrestricted soil SCOs were observed inside the building at SB-106, SB-15 and SB-14 in the eastern portion of the main building, During the structural evaluation, no borings were observed in the “mechanical room.” Collection of a sample(s) from this room is recommended.

Description: View is of the “mechanical room.” Standing on the loading dock, looking east. Floor is about 30” below grade of loading dock. Note, cinder block construction. Water damage is evident. Suggest installing soil boring in this room.

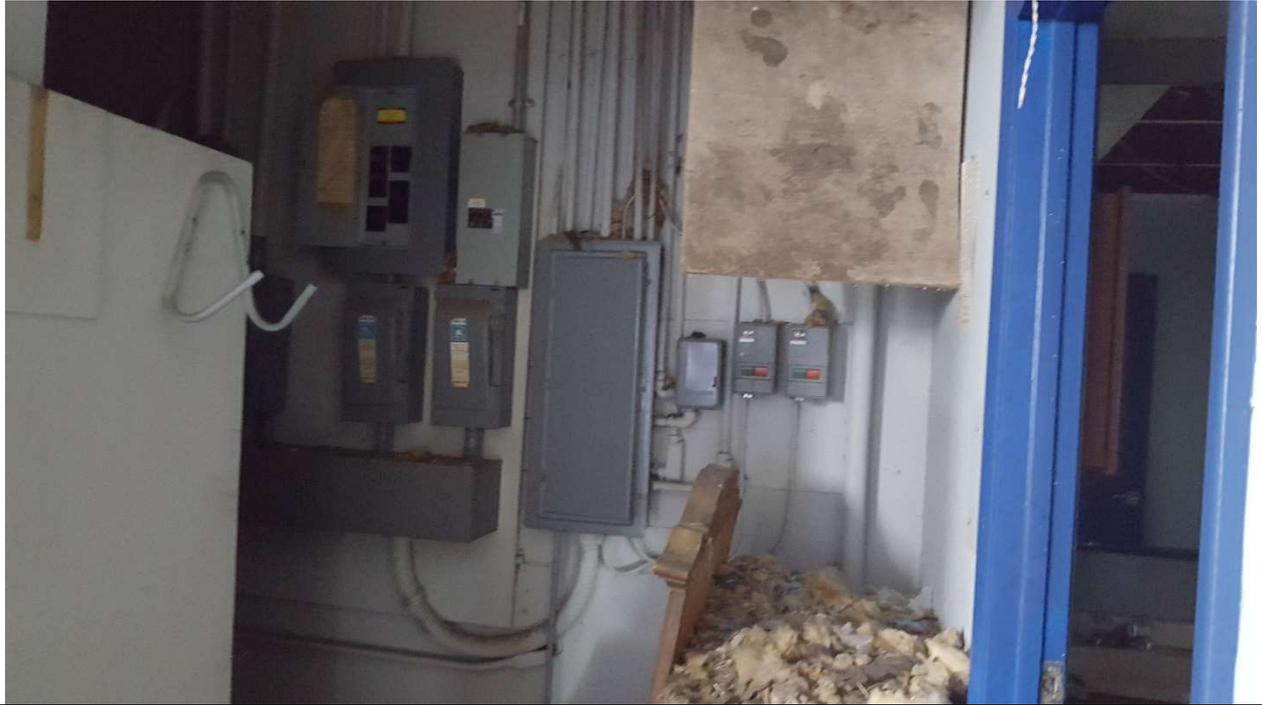
Description: View of electric control panel room. Single bathroom to the right through doorway.

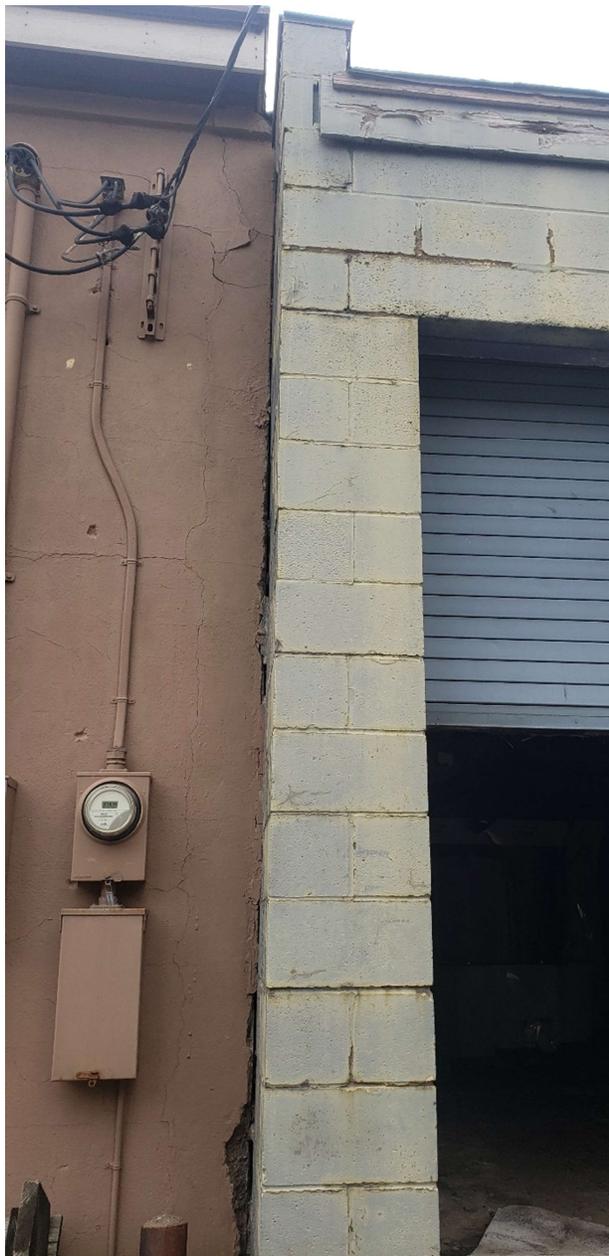
Description: View of south wall of Former Erwin Cleaners building. Electric meter, on brown painted surface is the adjacent building. Yellow cinder block shows the construction of the “extension.” The overhead garage door is to the loading dock area of the Former Erwin Cleaners building.
