# NEW YORK DEPARTMENT OF ENVIRONMENTAL CONSERVATION DIVISION MATERIALS MANAGEMENT

## SOLID WASTE MANAGEMENT FACILITY INSPECTION REPORT

FACILITY NAME:		LOCATION:		FACILITY ID#:	DATE:	IME:	
Air Force Plant #51 Site			e Greece (T), N	Monroe (C)	N/A	10-30-18	09:00
INSPECTOR'S NAME:			CODE:	PERSONS I	NTERVIEWED & TITLES		
Mark Amann			S	N/A	UM TUMGAG ASAD	SHORINGS GEOGRAPHICAL	/ Kokata
REGION WEATHER CONDITIONS:			IS:	DEC PERMIT NUMBER			
8	8 Sunny, 37 °F, WSW wind up to 7 mph			d up to 7 mph	N/A	STIS NULLARIMITATO	
SHEET			CONTINUATION	SHEET	PART(S) 360-		
1	OF	6	⊠ YES □ NO	le Banotona Set	Attached –	Violations of Part (160 are Supple

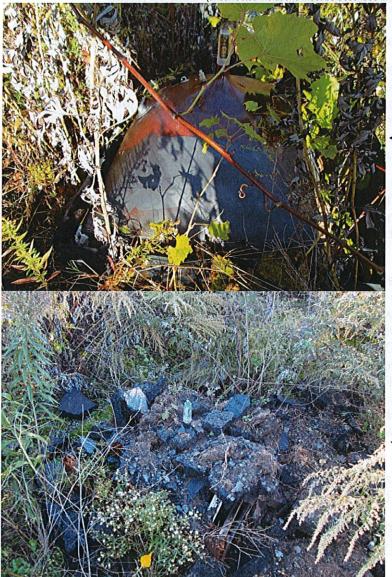
Cathode ray tube (CRT) devices from old TV sets were observed at various locations around the site. Generally, the CRTs were on the ground facing screen-side down and the deflection yokes had been removed. I counted 16 CRTs total. Due to overgrown vegetation and the waste piles, it is possible that more CRTs were present but hidden from view. Most of the CRTs were at the north end of the site. 8 CRTs were located north of Building 2, 1 CRT north of Building 9, 5 CRTs between Buildings 9 and 11, 1 CRT along the fence southeast of former Building 1 South, and 1 CRT along the west perimeter road.

CRT located in overgrown vegetation north of Building 2

CRT partially covered with asphalt pavement between Buildings 9 and 11

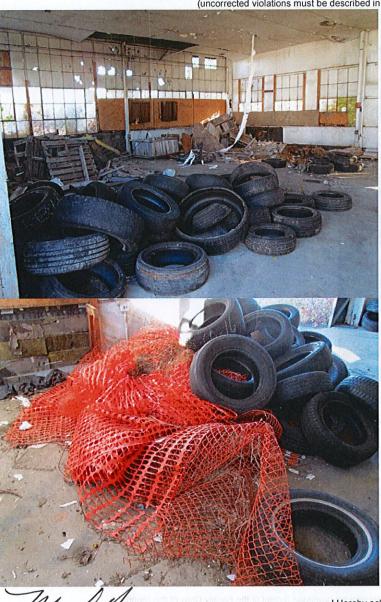
<u>Waste tires</u> were located within Building 9. I counted 89 tires total. The tire pile within the north side of the building had dimensions of approx. 12 ft x 9 ft x 2.5 ft. The tire pile within the south side of the building was intermixed with orange plastic (similar to snow fencing) and measured approx. 13 ft x 11 ft x 2.5 ft. There were 5 tires dumped on the south end of the site just south of former Building 1 South and 1 tire along the west perimeter road.

Waste tires on north interior side of Building 9

Waste tires and orange plastic on south interior side of Building 9

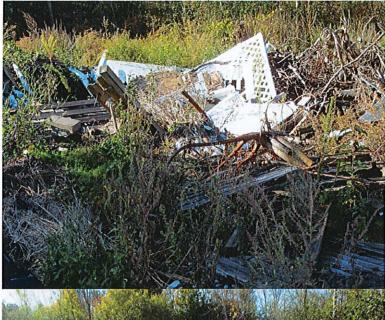
Piles of construction and demolition (C&D) debris were observed primarily on the south end of the site in the area just south of former Building 1 South. The C&D debris consisted of, but was not limited to dimensional lumber, plywood, fencing and posts, roofing debris, windows, paint cans, landscape timbers, and vinyl fencing and lattice. Other solid waste included tree debris, wooden pallets, furniture, carpet, a mattress, a VCR, and piles of broken up asphalt pavement and concrete. Due to the large number of piles and time constraints, I did not attempt to quantify all of the waste present. However, I measured the dimensions of three C&D debris piles that were easily accessible. Pile 1: 15 ft x 9 ft x 2 ft, Pile 2: 19 ft x 15 ft x 2 ft, and Pile 3: 11 ft x 10 ft x 1 ft. Two small piles of asphalt shingles approx. 2 cubic yards in size each were observed along the west perimeter road. On the north end of the site, a pile of asphalt shingles was located in Building 9. Pile dimensions were approx. 13 ft x 9 ft x 2.5 ft. One pile of C&D debris (windows) was observed north of Building 2 and measured approx. 15 ft x 5 ft x 1.5 ft.

Piles of C&D debris at south end of site

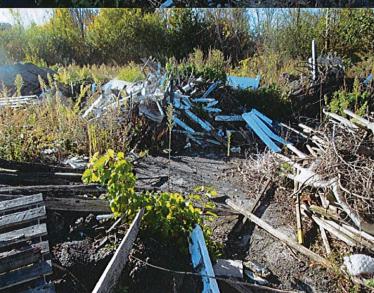
Piles of C&D debris at south end of site

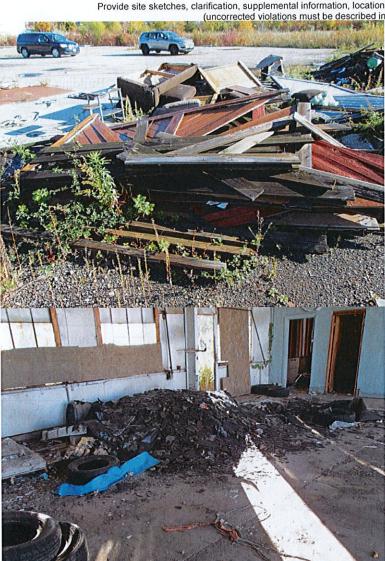
Piles of C&D debris at south end of site

Pile of asphalt shingles in Building 9
