OCTOBER 30, 2008

**PHASE I  
ENVIRONMENTAL SITE ASSESSMENT**

**TURK HILL PARK**  
1000 TURK HILL ROAD  
FAIRPORT, NEW YORK 14450

AEI PROJECT NO. 280862

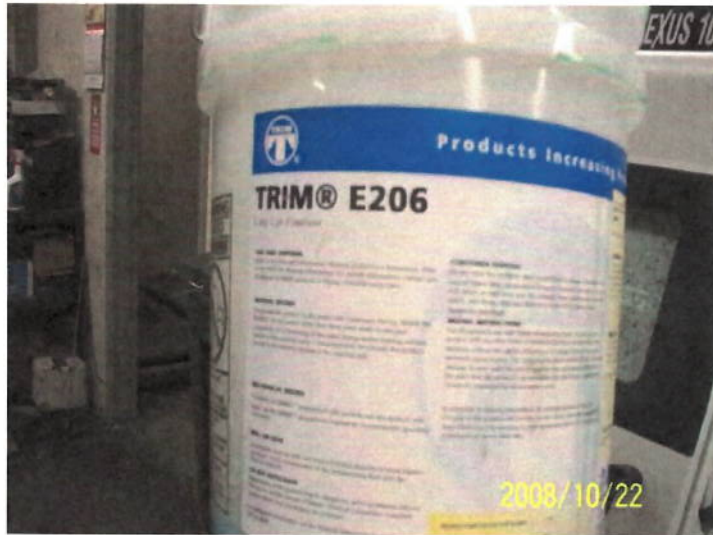
10. Coolant used at Streamline Machine

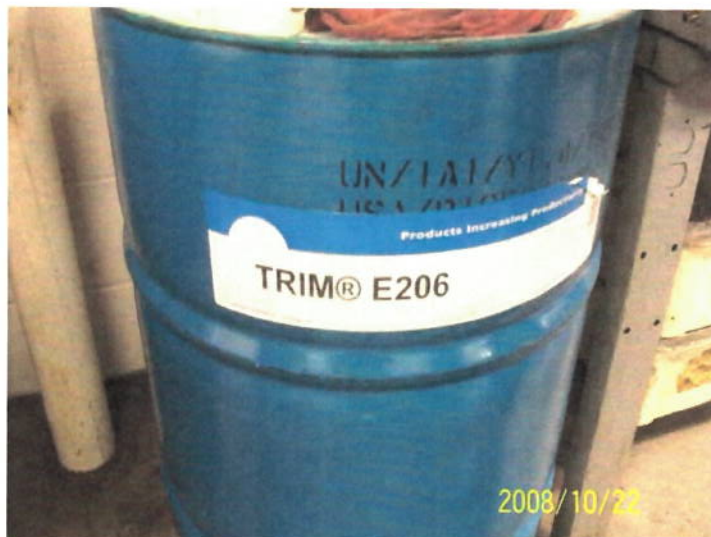
13. Coolant used at Qual Tech

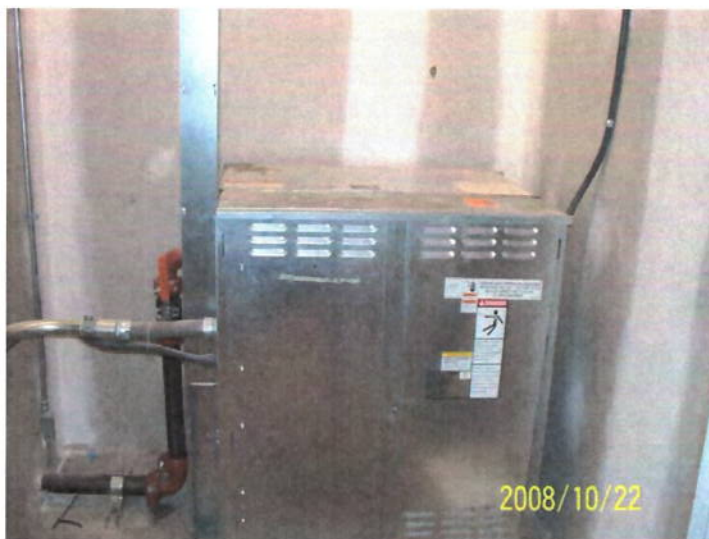
23. Hydraulic reservoir for elevator in Building #2

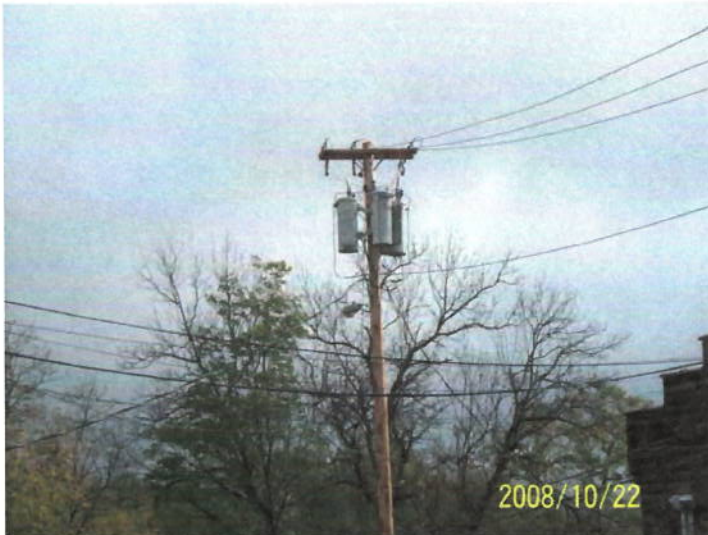
31. Pole-mounted electric transformers

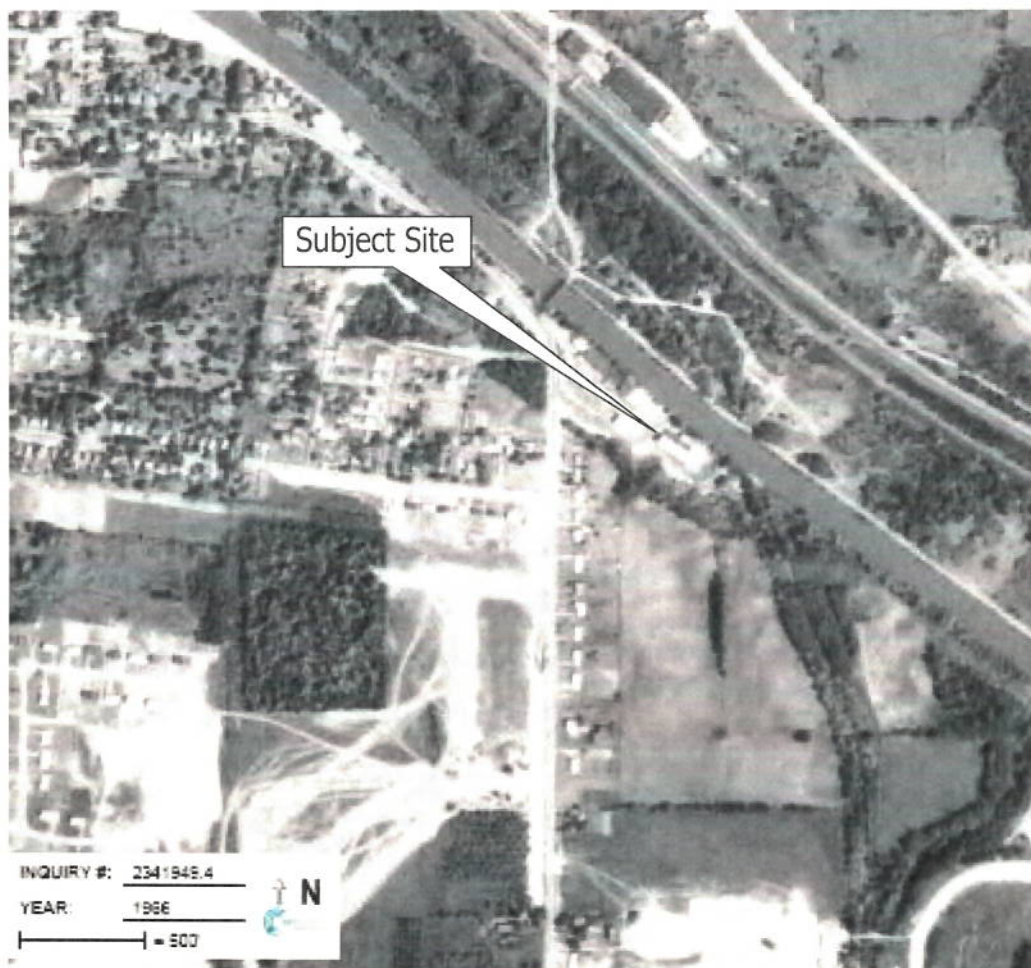
Source: EDR  
Year: 1966

A review of the 1966 aerial photograph indicates a rectangular building observed in the southern portion of the Subject Property in the 1958 aerial photograph has apparently been expanded in an easterly direction. Otherwise, a review of the 1966 aerial photograph indicates no significant changes to the Subject Property or any of the adjoining properties in comparison to the 1958 aerial photograph.
