Re: Monthly Monitoring Report – September 2024  
1000 Turk Hill Road, Fairport, New York  
NYSDEC Site ID No. 828161

**Monthly Monitoring Report – September 2024**  
***1000 Turk Hill Road, Fairport, New York***

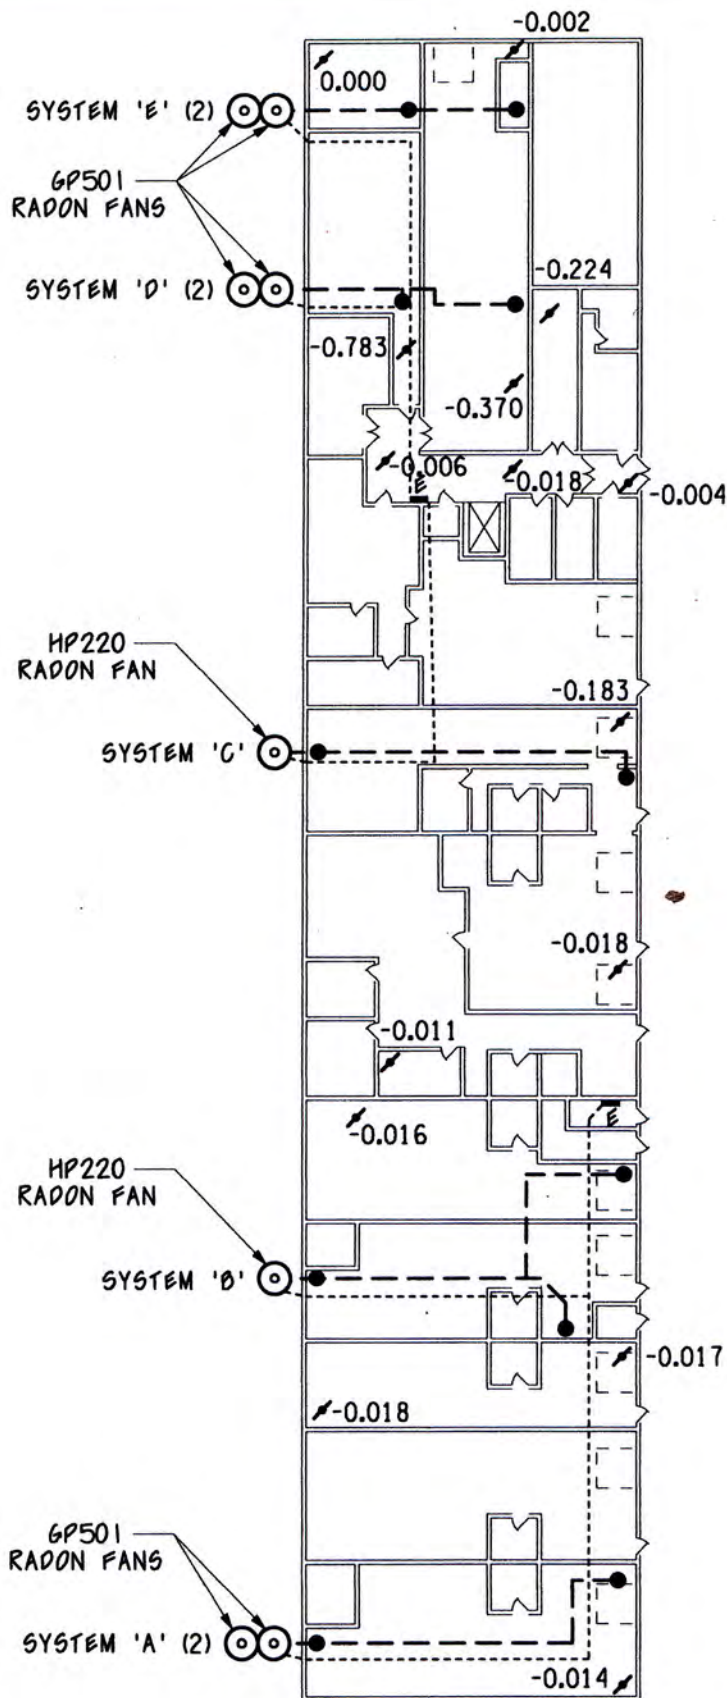
**Figure 1**

The exterior components of each of the five SSDSs on Building 1 and Building 3 were also inspected. As previously noted, the mounting brackets for System A in Building 3 are broken, but the vent pipe remains fastened and will continue to be inspected monthly to ensure operation is not impacted. It was also noted that the vent stack associated with System A in Building 1 is damaged, but still operational. Repairs to the Building 1, System A vent stack is planned to be completed during a future visit.
