Re: Monthly Monitoring Report – January 2026
1000 Turk Hill Road, Fairport, New York
NYSDEC Site ID No. 828161

Table 1. Monthly SSDS Monitoring and Inspection Checklist - January 2026

**Sub Slab
Depressurization Systems**

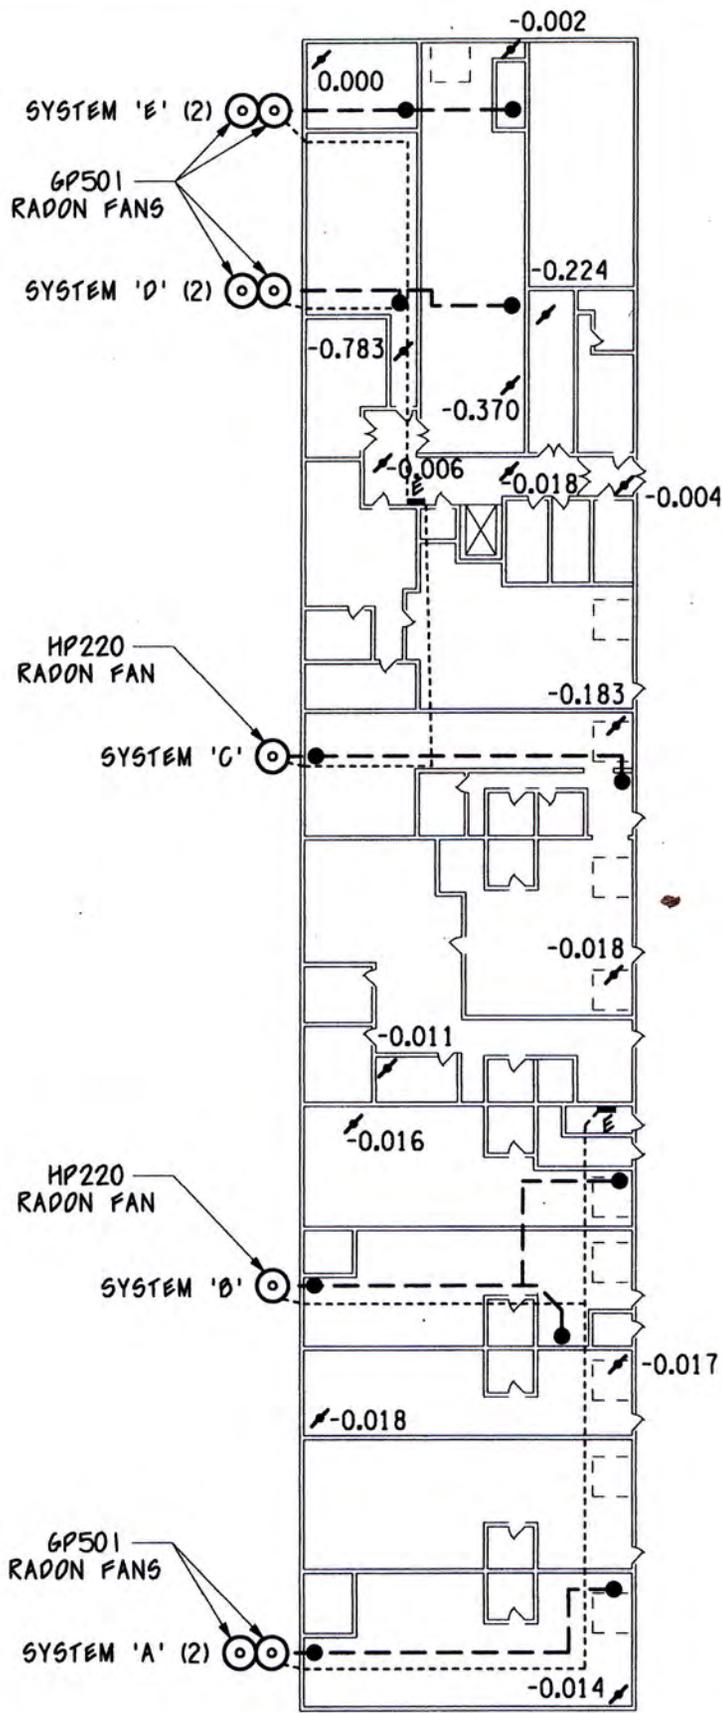
Figure 1

**Building 1
1000 Turk Hill Road
Fairport, NY**

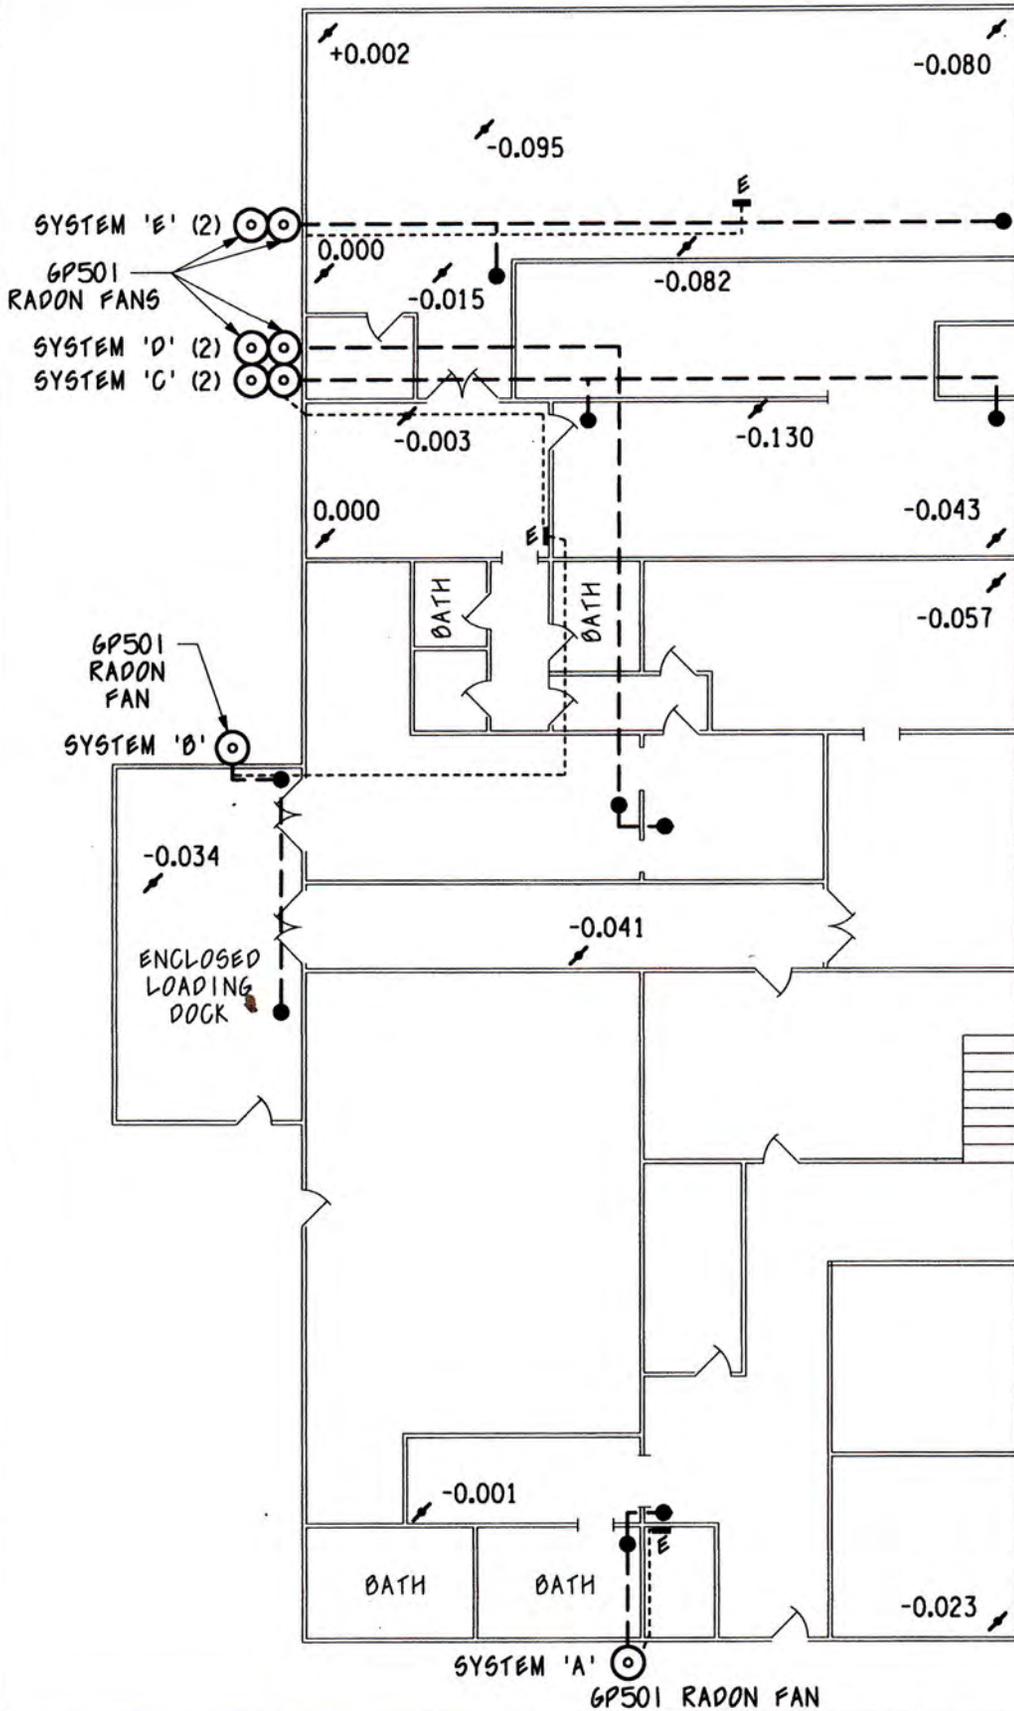
Figure 2

**Building 3
1000 Turk Hill Road
Fairport, NY**
