Re: Monthly Monitoring Report – May 2026  
1000 Turk Hill Road, Fairport, New York  
NYSDEC Site ID No. 828161

**Table 1. Monthly SSDS Monitoring and Inspection Checklist - May 2026**  
**Turk Hill Park, 1000 Turk Hill Road, Fairport, New York - NYSDEC Site No. 828161**

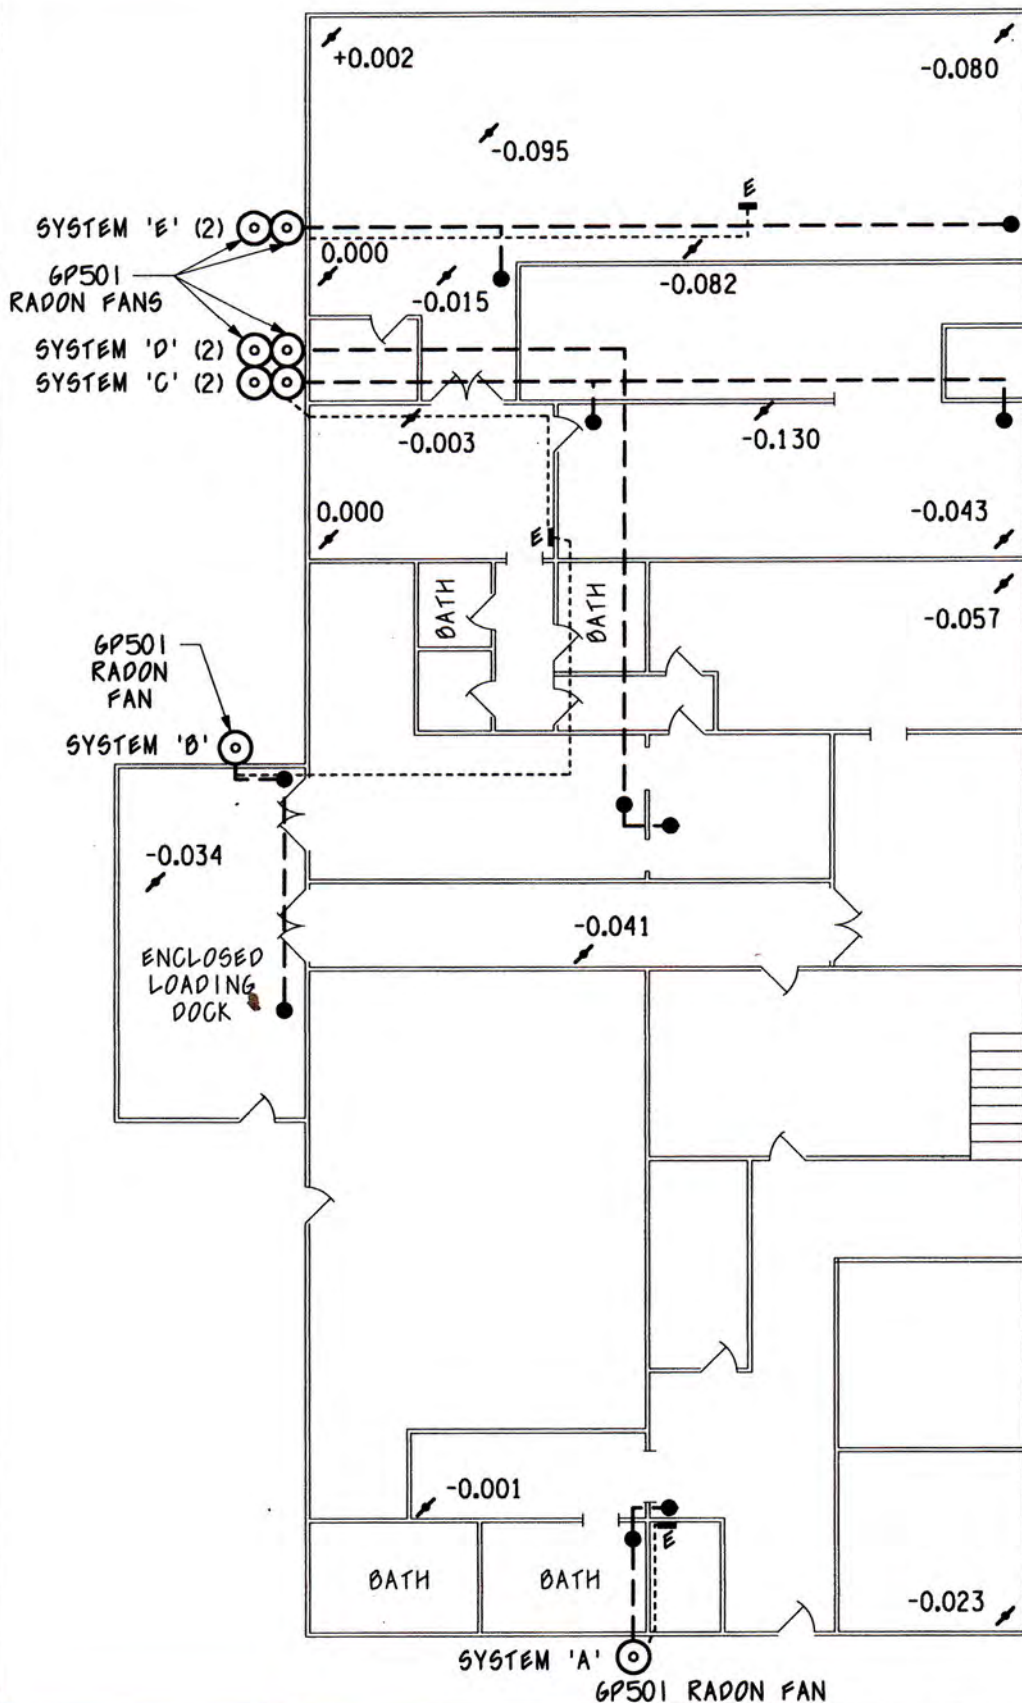
**Figure 2**

The exterior components of each of the five SSDSs on Building 1 and Building 3 were also inspected. As previously noted, the mounting brackets for System A in Building 3 are broken, but the vent pipe remains fastened and will continue to be inspected monthly to ensure operation is not impacted. Vegetation growth on the north side of Building 1 is being monitored monthly to confirm that damage to the discharge piping does not occur.
