**2021 Annual Corrective Measures
Implementation Summary Report
Eastman Business Park
Rochester, New York
Site No. 828177**

December 2023

**ECOLOGY AND ENVIRONMENT ENGINEERING AND GEOLOGY, P.C.
40 La Riviere Drive, Suite 320
Buffalo, NY 14202**

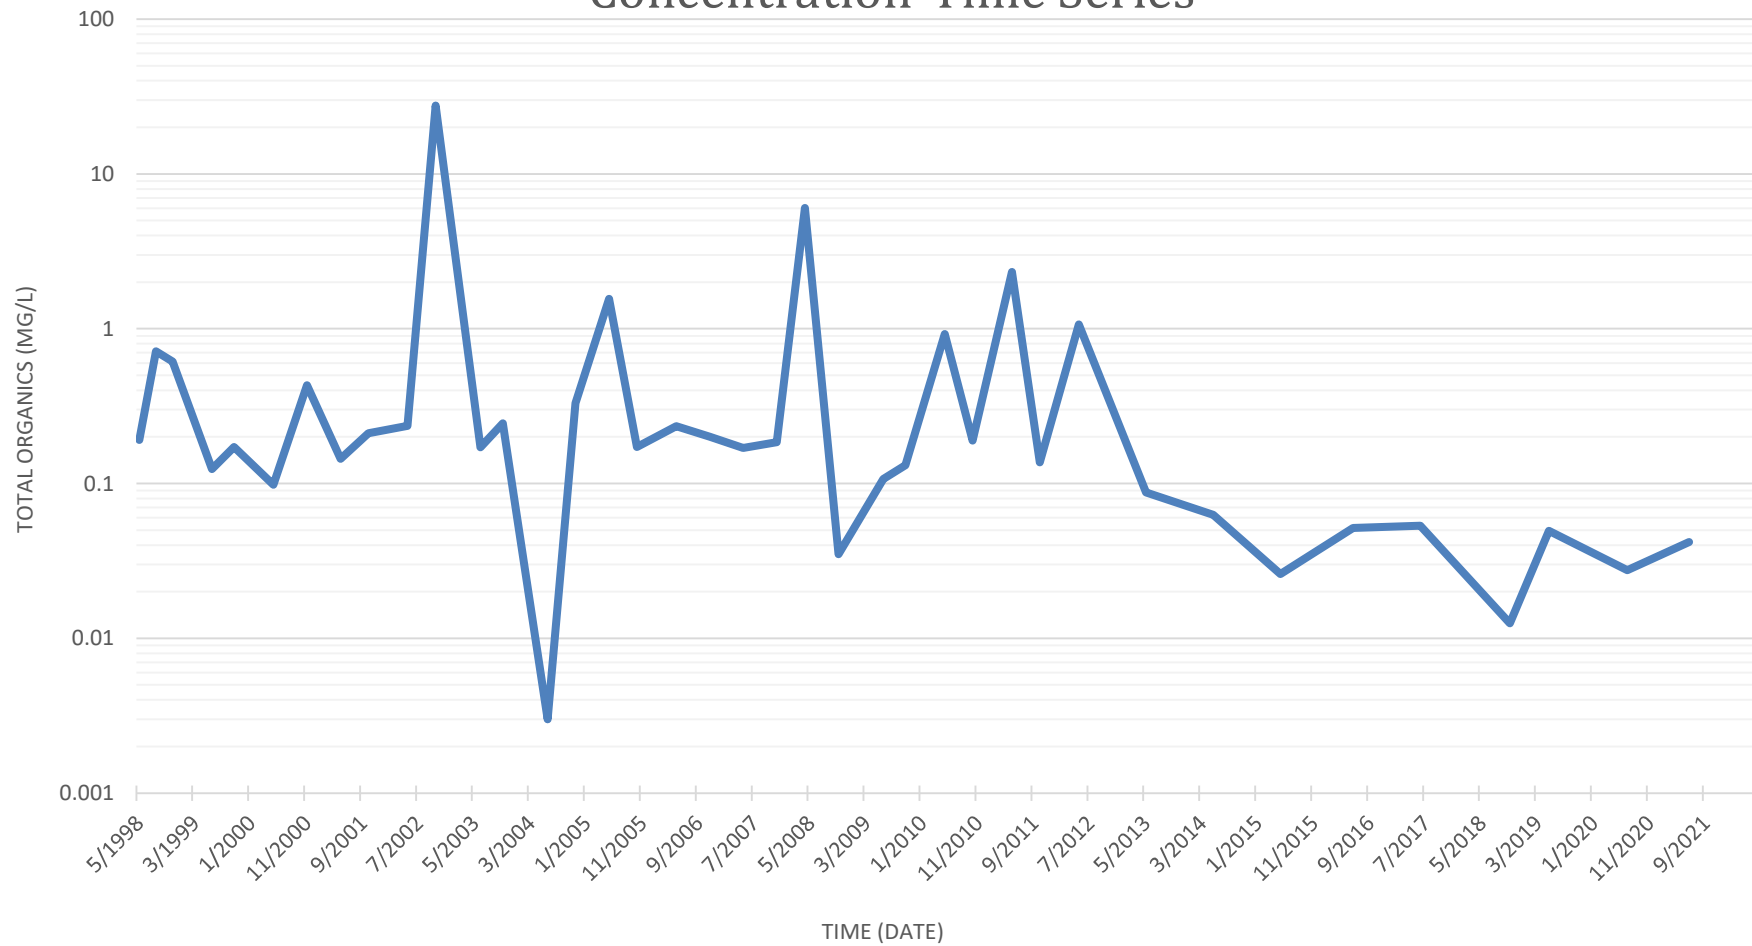
PL54NE Concentration-Time Series

- Total VOC concentrations in PL54NE have been variable, with the highest concentration of organics observed in 2002 (28 mg/L) and the lowest concentration (0.003 mg/L) observed in 2004. Total concentrations in PL54NE have generally decreased since 2008 to 0.04 mg/L in 2021.

A summary of the 2021 maintenance activities for the WIA-EBPW system is provided in Table 7. A new motor was installed in PB135ER on March 3, 2021; a new pump and motor were installed in PL54NE on March 10, 2021; a new pump was installed in PL54E on August 25, 2021 and a new motor was installed on October 28, 2021; a new pump was installed in PL54NE2 on September 21, 2021. Routine cleanings of pumps, motors, transducers, and flow meters occurred at all eight wells at various times throughout 2021. Additional repairs throughout the years include plumbing repairs, cleaning and jetting of discharge lines, well vault maintenance, shed maintenance, electrical repairs, and routine visits to ensure the pumping wells are running correctly. A Warrick controller was installed at pumping well PB135ER as a replacement to the old level controller and transducer as a solution to add resiliency against the heavy iron fouling encountered in those wells. The Warrick control was installed on May 13, 2021. Continued troubleshooting occurred with the Warrick controls previously installed at pumping wells PL54W and PL54E to optimize their operation. Sheds D1, D2, D6, and D7 had various repairs and maintenance done. New floors were installed at sheds D1, D6, and D7. The groundwater elevations at pumping well PL54NE was over the set-point for more than half of the year, likely as a result of reduced flows associated with iron fouling. Pumping wells PL54W and PL54E no longer have water level readings recorded due to the replacement of the transducers with Warrick controllers.

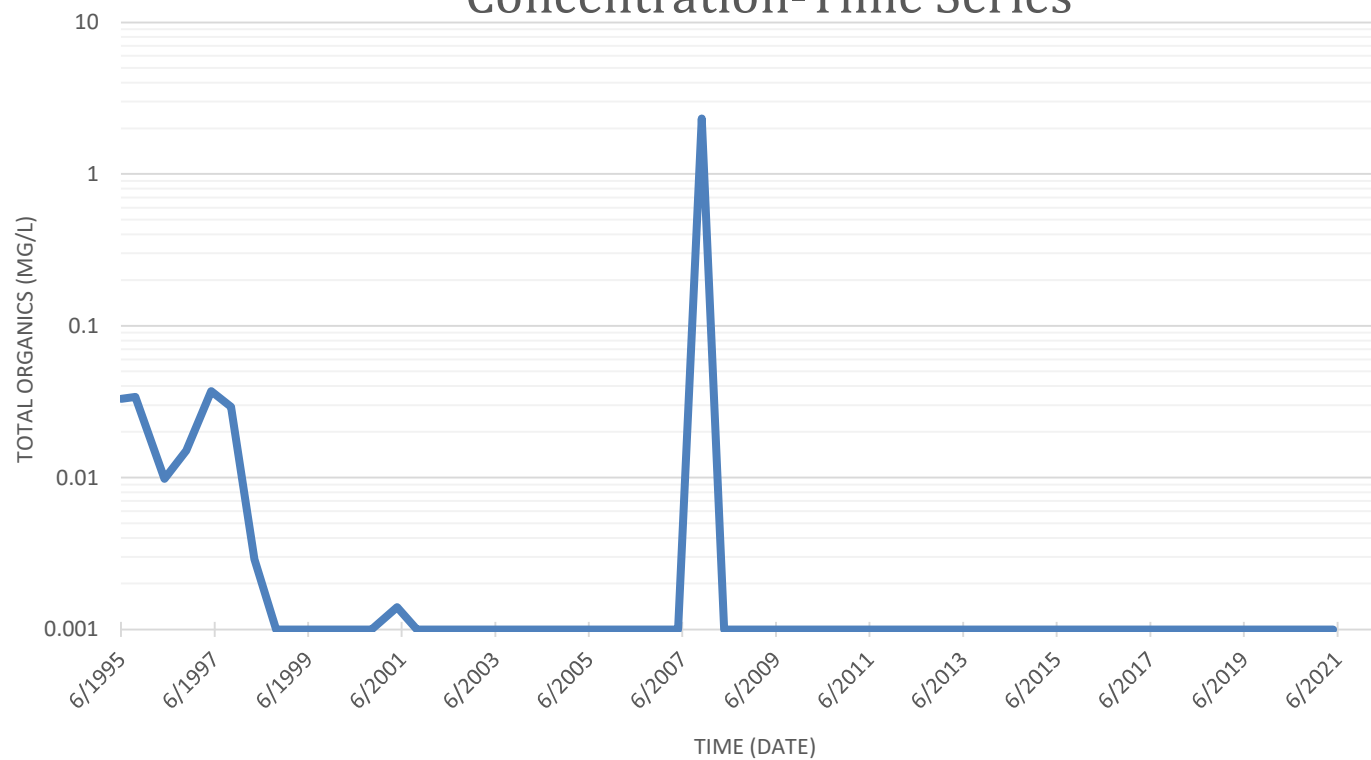
PB349N Concentration-Time Series

- Total VOC concentrations in PB349N have remained non-detect since 2008. Only two isolated sampling events since 1998 have resulted in detections (2001 and 2007).
- Total VOC concentrations in PB329E2 remained undetected or below a value of 0.001 mg/L for several years subsequent to 2004; however, a general increase in total organic concentration was observed in 2013, with total organic concentrations remaining consistent between 0.107 mg/L and 0.155 mg/L between 2013 and 2021, with 0.107 mg/L being the concentration in 2021.

A summary of the 2021 maintenance activities for this system is provided in Table 9. A new flow meter at PB349N was installed on April 14, 2021. The pump head for PB329E2 was replaced on May 19, 2021.

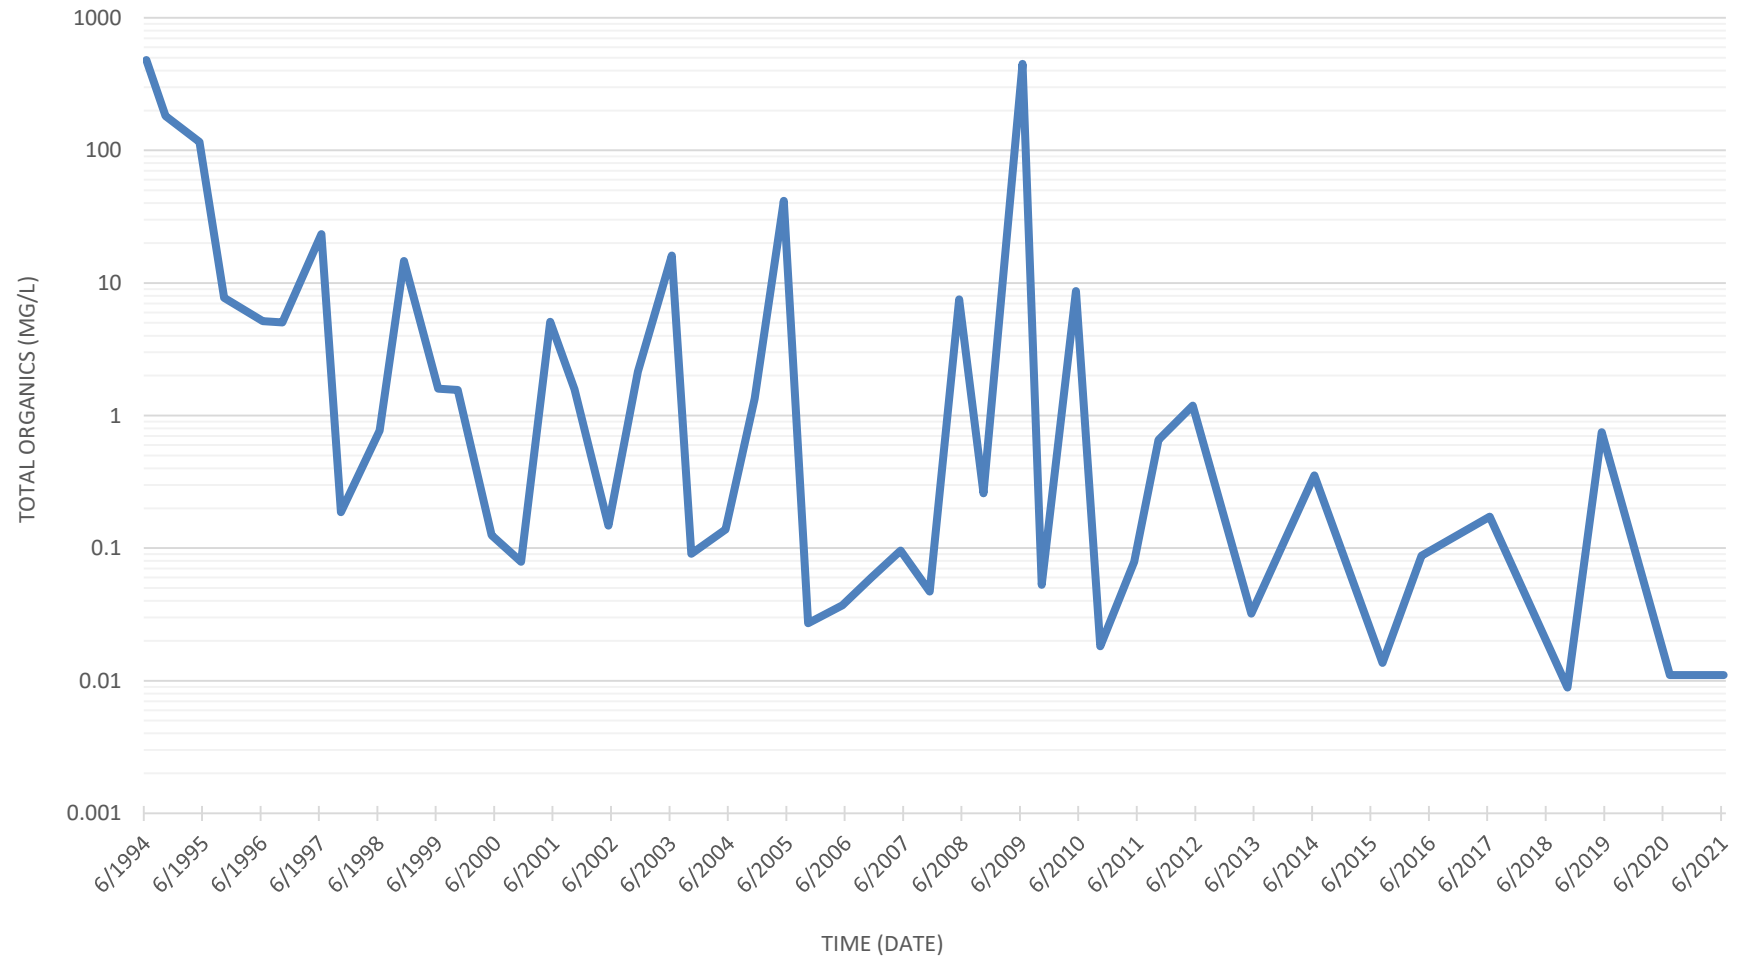
PB54SE Concentration-Time Series

- In PB54SE, concentrations have been highly variable since inception in 1994, although have generally indicated declining concentrations and have remained below 1 mg/L since 2013. In 2021, total organics were detected at 0.0073 mg/L.
- Total organic concentrations have been highly variable in well PB57W. A general decrease trend was observed from 1994 to 2006, concentrations increased to 1,250 mg/L in 2008, with a consistently decreasing concentration trend since 2008. Two groundwater sampling events were conducted at PB57W in 2016 (April and September) because the initial concentration detected (0.20 mg/L in April) varied significantly from 2015 concentration (412 mg/L). The total organic concentrations in this well since 2016 have been consistent with concentrations ranging from 0.030 mg/L in September 2016 to 0.44 mg/L in 2021.
